Air Quality and Dust Monitoring Monthly Report – September 2024 Buckinghamshire Council

A report prepared by EWCs and MWCCs on behalf of HS₂ Ltd.

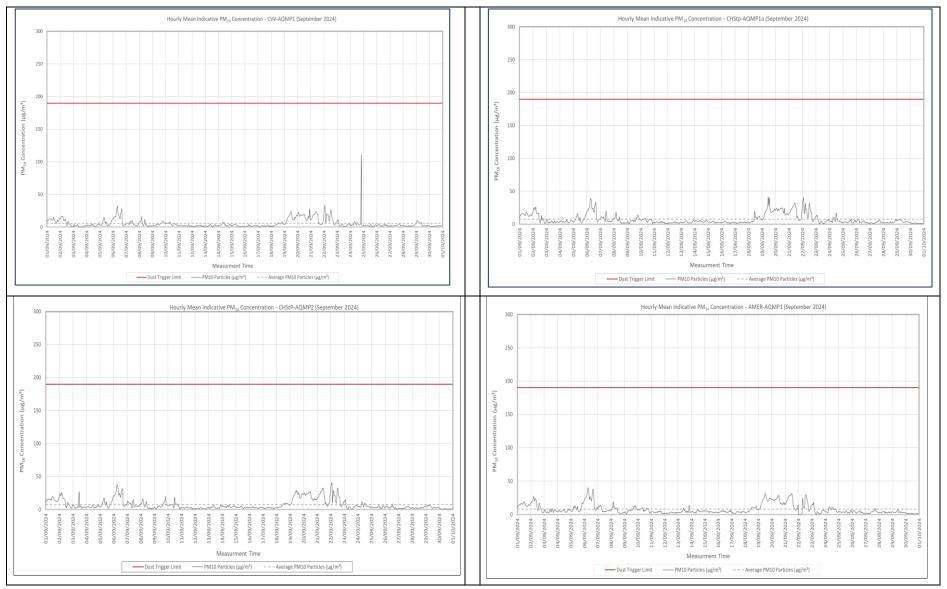
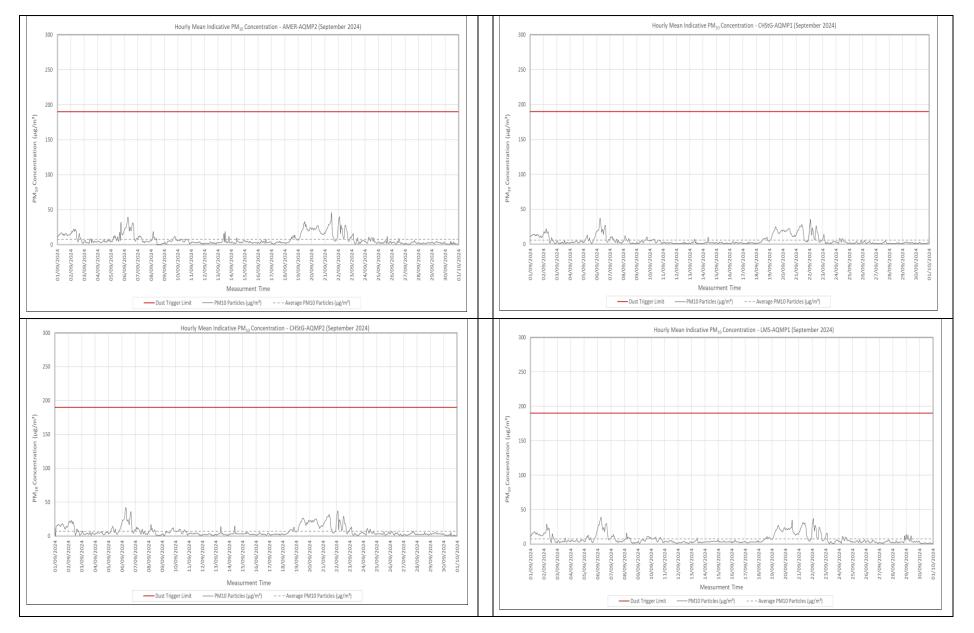
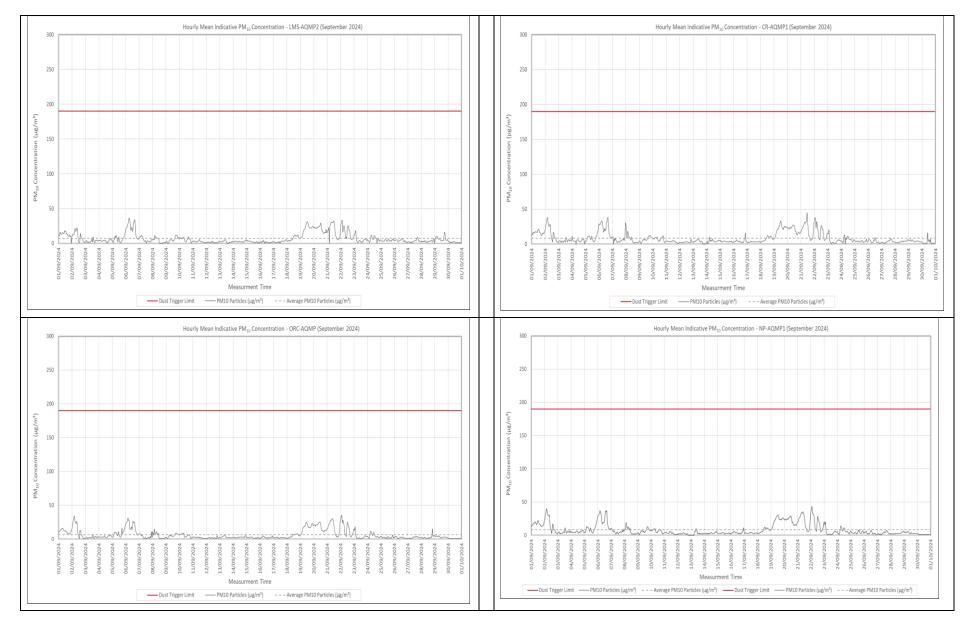
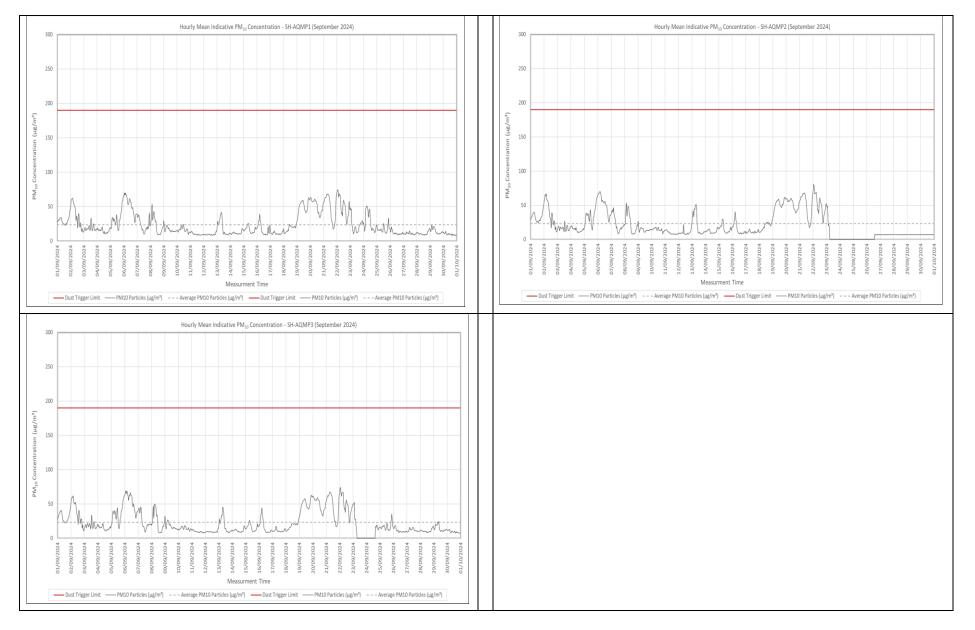
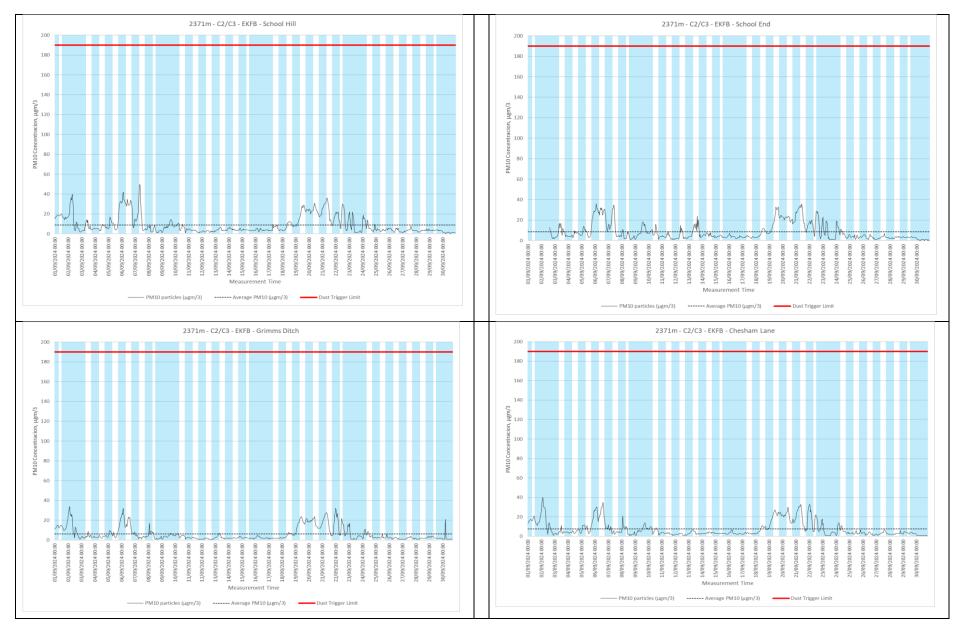
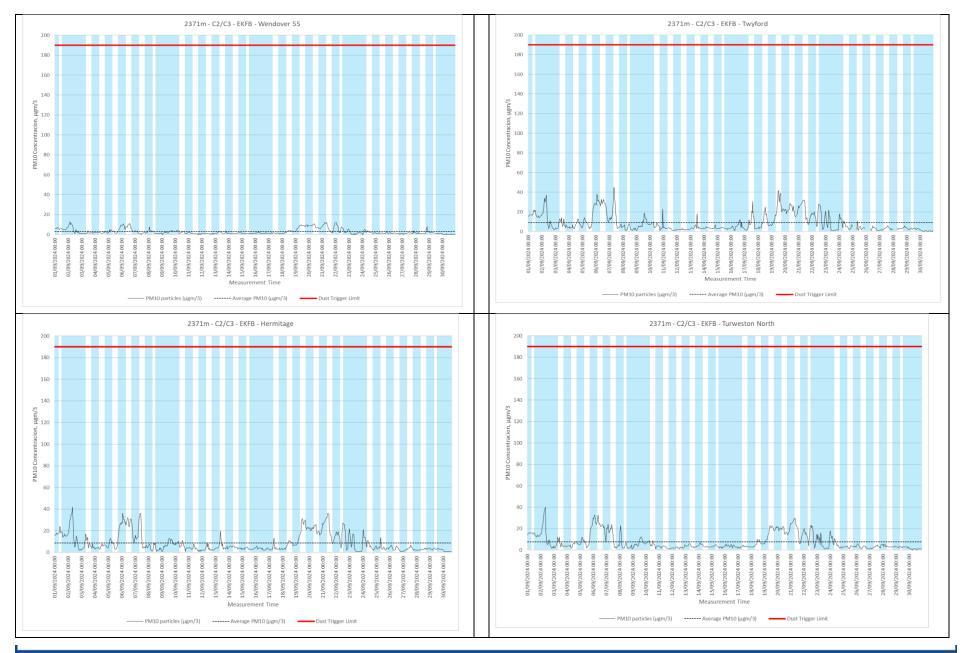
Figure 8: Continuous dust 1-hour mean indicative PM₁₀ concentration for all dust monitors

- 1.1.6 Dust monitoring locations and results are presented in Appendix B, Table 1, together with line charts of monthly data from each dust monitor presented in Figure 8. All continuous dust monitoring is undertaken using indicative monitors. Despite being Environment Agency (MCERTS) certified, indicative monitors carry a higher level of uncertainty than reference monitors, and therefore cannot be strictly compared with Air Quality Standards for human health and the environment. The purpose of the monitoring undertaken is to ensure the effectiveness of the on-site mitigation.

- 1.1.7 The trigger level for PM₁₀ concentrations of 190 μg/m³, measured as a 1-hour mean, in accordance with the updated guidance document '*Guidance on Monitoring in the Vicinity of Demolition and Construction Sites (December 2018)*' has been applied.

- 1.1.8 No (0) dust trigger alerts were recorded during the monitoring period (September 2024).
- 1.1.9 Data capture was below 90% for multiple monitors due to SH-AQMP2 suffering water ingress and subsequently becoming damaged. Sub-contractors have been sent to site in October and will repair or swap out the monitor. No data captured at FCC for the month of September 2024 due to no communications cable for the dust monitor. The replacement cable was installed on 1st October. No data capture from 22nd September onwards for the Grove Farm monitor due to a communications cable fault.
