Construction Noise and Vibration Monthly Report – September 2024

London Borough of Camden

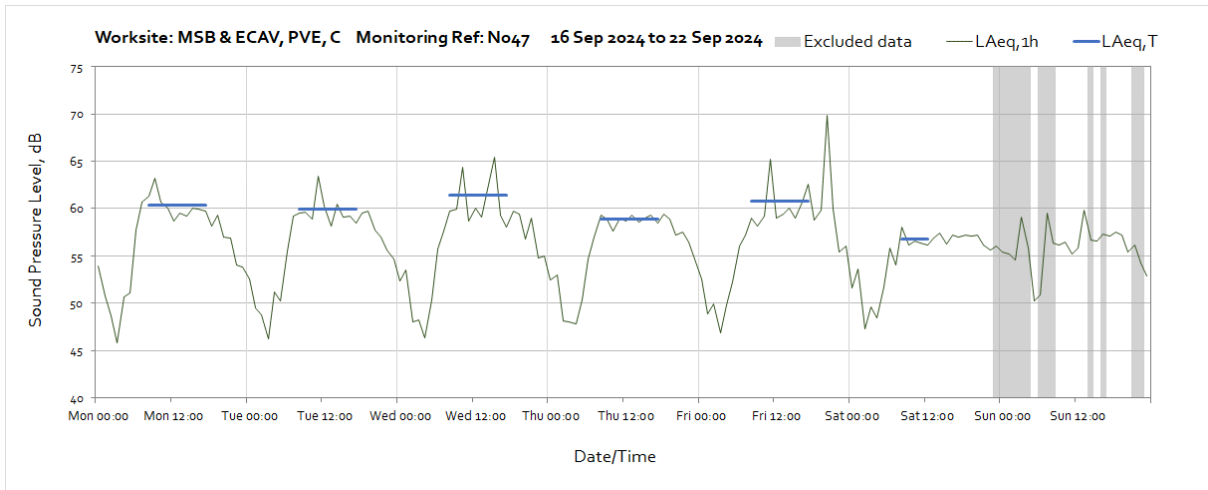
Worksite: MSB & ECAV, PVE, C - Monitoring Ref: N047

The following graphs show the hourly measured ambient noise level $L_{Aeq,1h}$ and, where relevant, the averaged noise level $L_{Aeq,T}$ values, where the time period T is as specified in Table 1 of HS2 Information Paper E23. Periods where noise levels are adversely affected by weather or only measured for part of the period, which are not representative of HS2 construction works, have been greyed out and excluded from the calculation of the $L_{Aeq,T}$ values in in Table 3 of the main report.
