Construction noise and vibration Monthly Report – September 2024

London Borough of Hillingdon

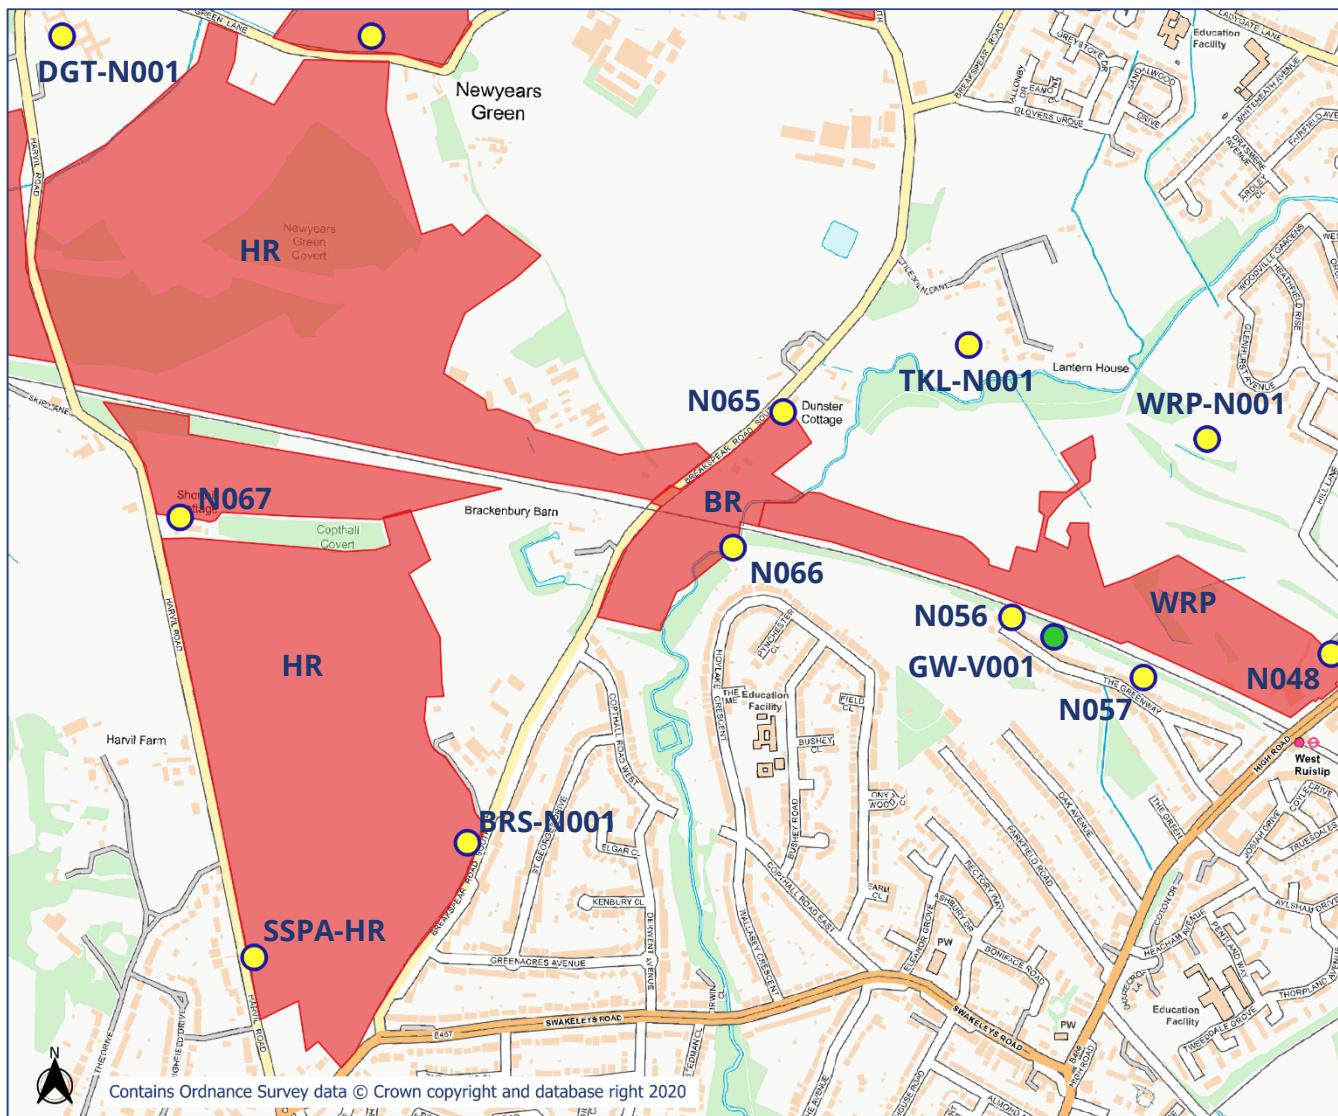
Noise and Vibration Monitoring Plan - 2

- Noise Monitor (Yellow Circle)
- Vibration Monitor (Green Circle)
- Active Worksites (Red Shaded Area)

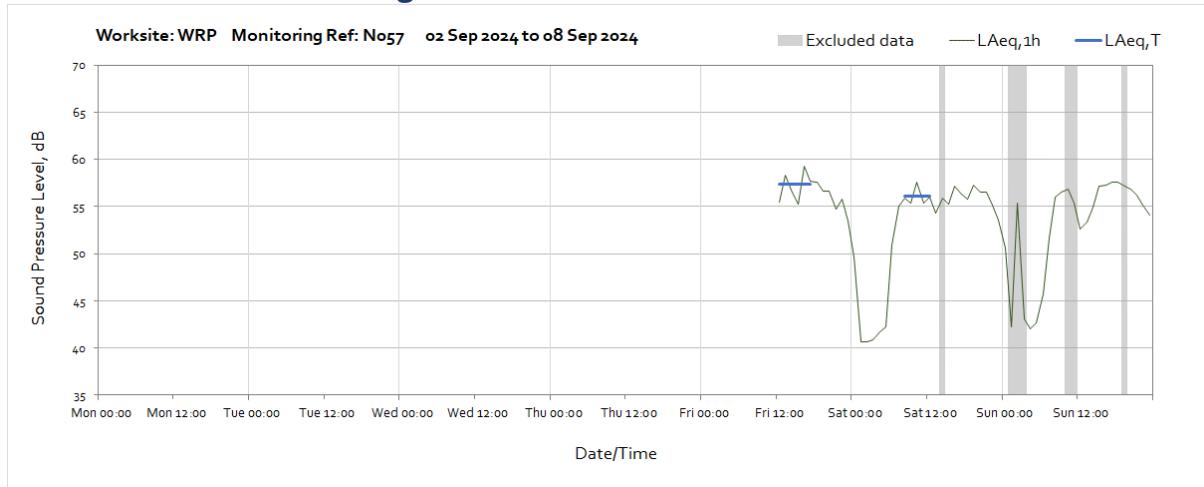
Worksite: WRP – Monitoring Ref: N057

Note: Missing data between the start of the month and 11:00 on Friday 6th of September was due to a memory card error.

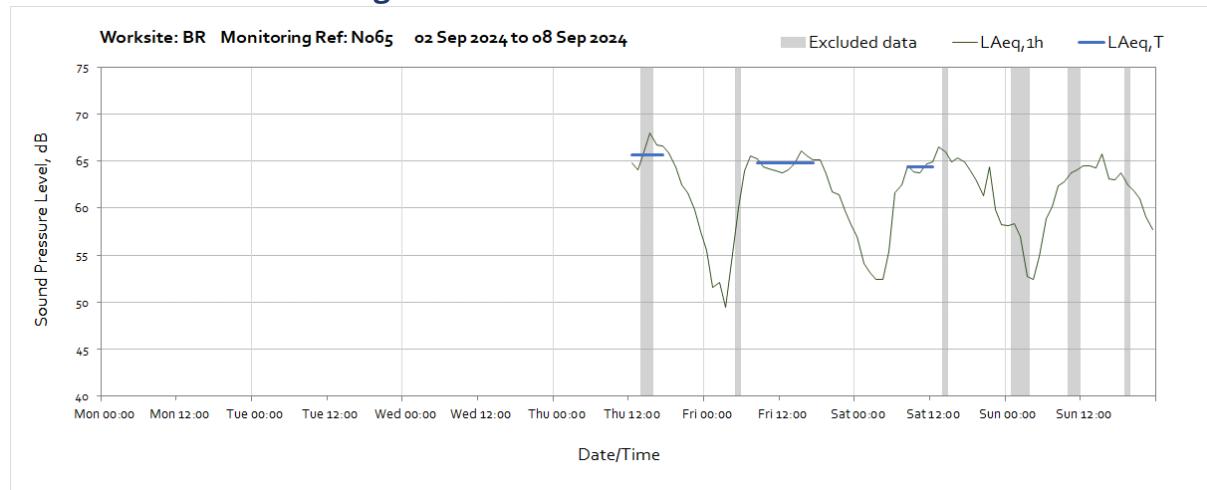
Worksite: BR – Monitoring Ref: N065

Note: Missing data from the start of the month until 11:00 on Thursday 05th of September was due to a loss of power to the monitoring station caused by poor weather conditions preventing sufficient light reach the solar panel.
