Construction Noise and Vibration Monthly Report – September 2024

Warwick District Council

This Noise and Vibration Monitoring Report fulfils HS2 Limited's commitment detailed in the Environmental Minimum Requirements (EMRs), Annex 1, Code of Construction Practice, to present the results of noise and vibration monitoring carried out within Warwick District Council (WDC) area during the month of September 2024.

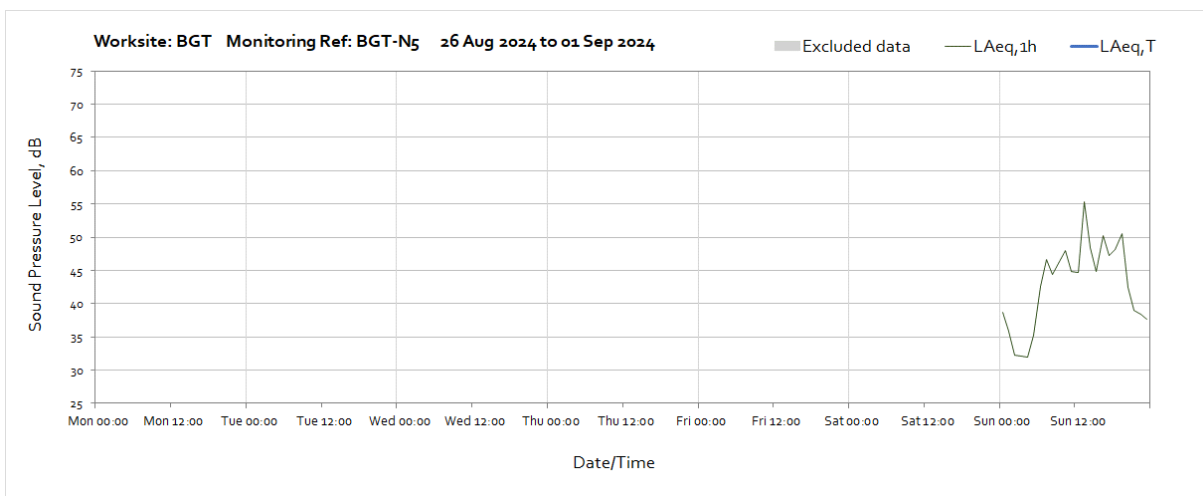
Worksite: BGT – Monitoring Ref: BGT-N5

The following graphs show the hourly measured ambient noise level $L_{Aeq,1h}$ and, where relevant, the averaged noise level $L_{Aeq,T}$ values, where the time period T is as specified in Table 1 of HS2 Information Paper E23. Periods where noise levels are adversely affected by weather or only measured for part of the period, which are not representative of HS2 construction works, have been greyed out and excluded from the calculation of the $L_{Aeq,T}$ values in in Table 3 of the main report.

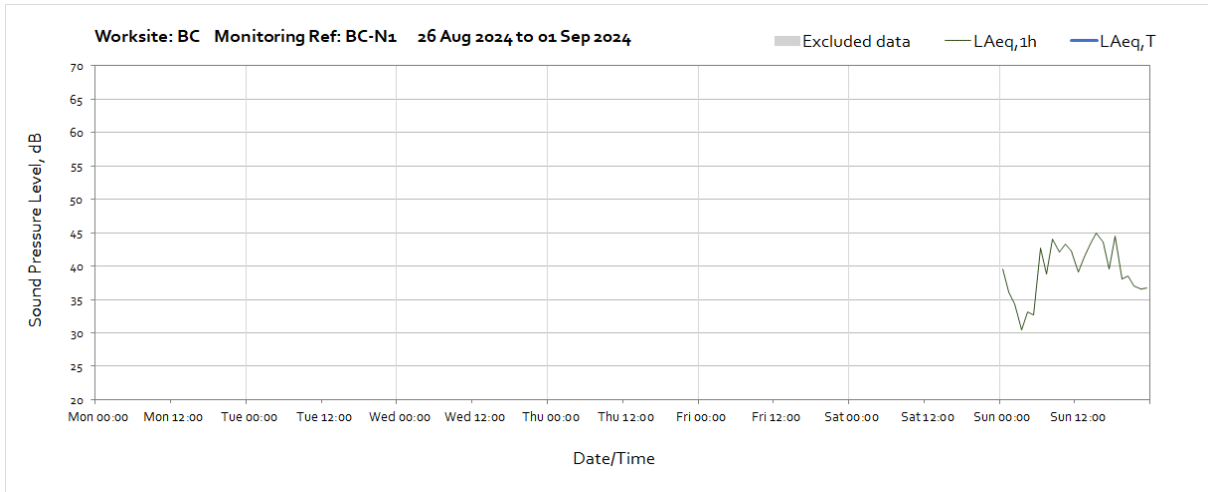
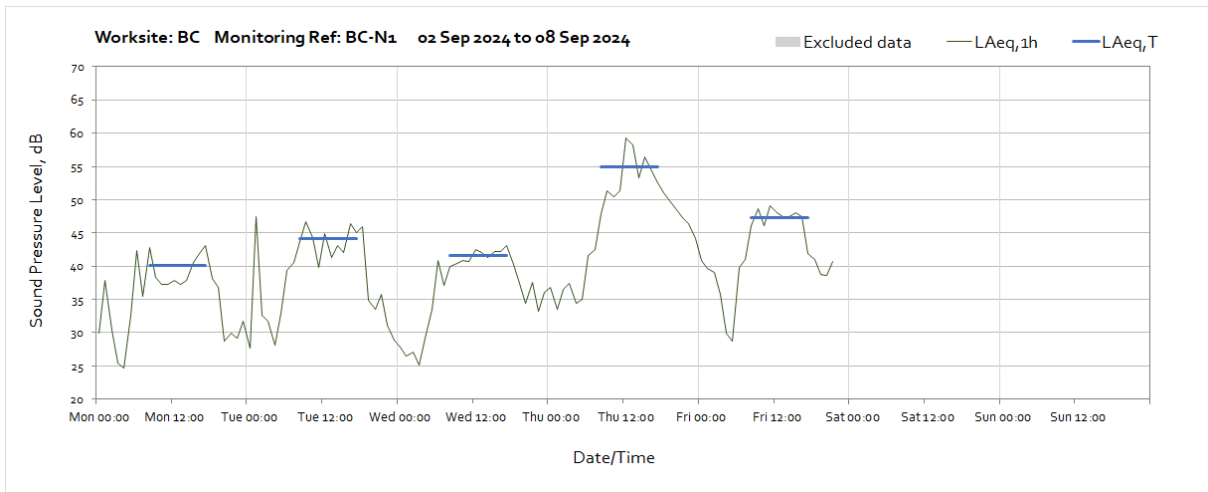
Worksite: BC – Monitoring Ref: BC-N1

Note: Missing data throughout the week was due to a loss of power to the monitoring station caused by vegetation overgrowth preventing sufficient light reach the solar panel.

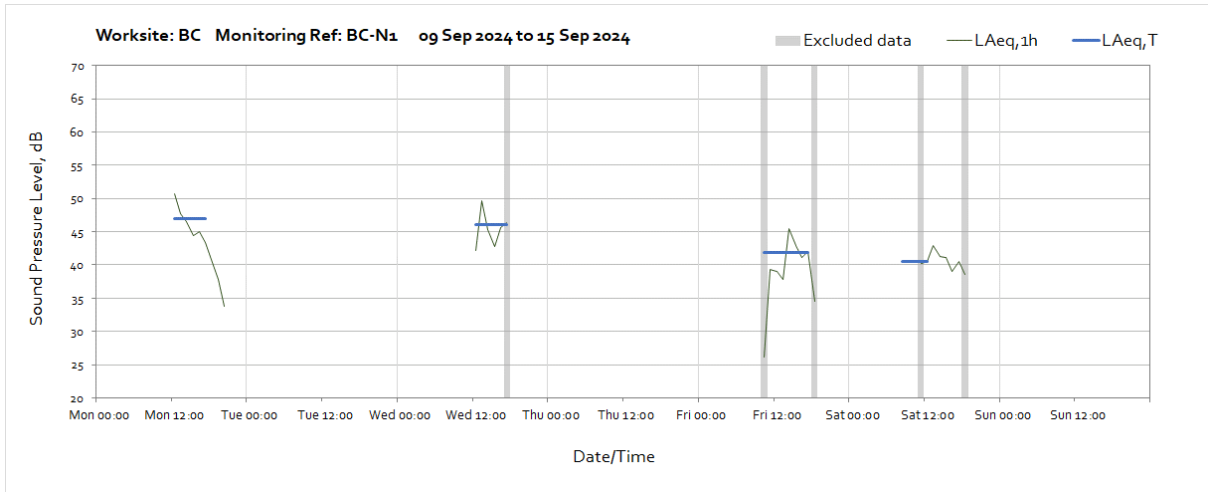
Note: Missing data throughout the week was due to a loss of power to the monitoring station caused by vegetation overgrowth preventing sufficient light reach the solar panel.

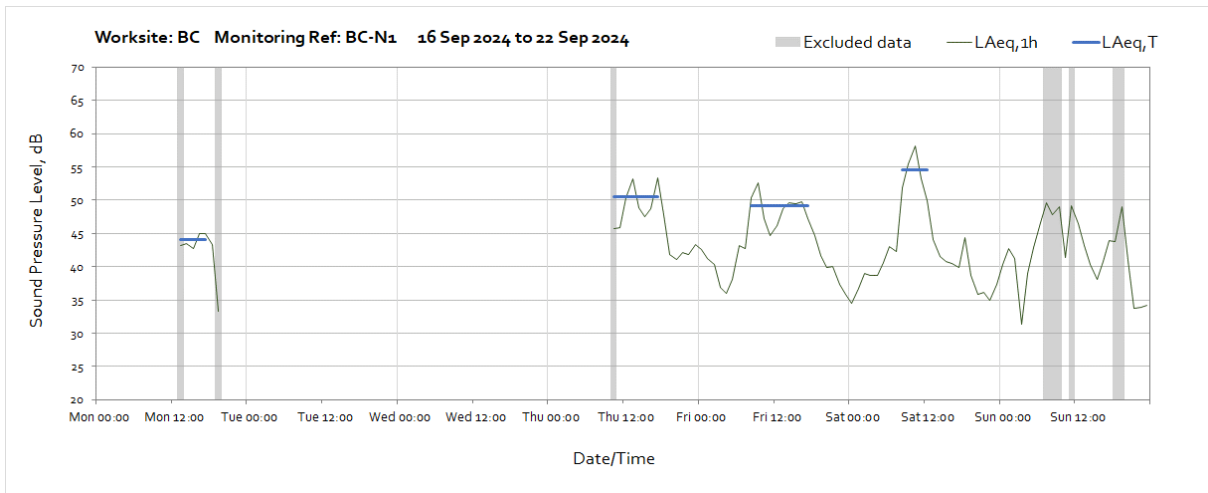
Note: Missing data throughout the week was due to a loss of power to the monitoring station caused by vegetation overgrowth preventing sufficient light reach the solar panel.

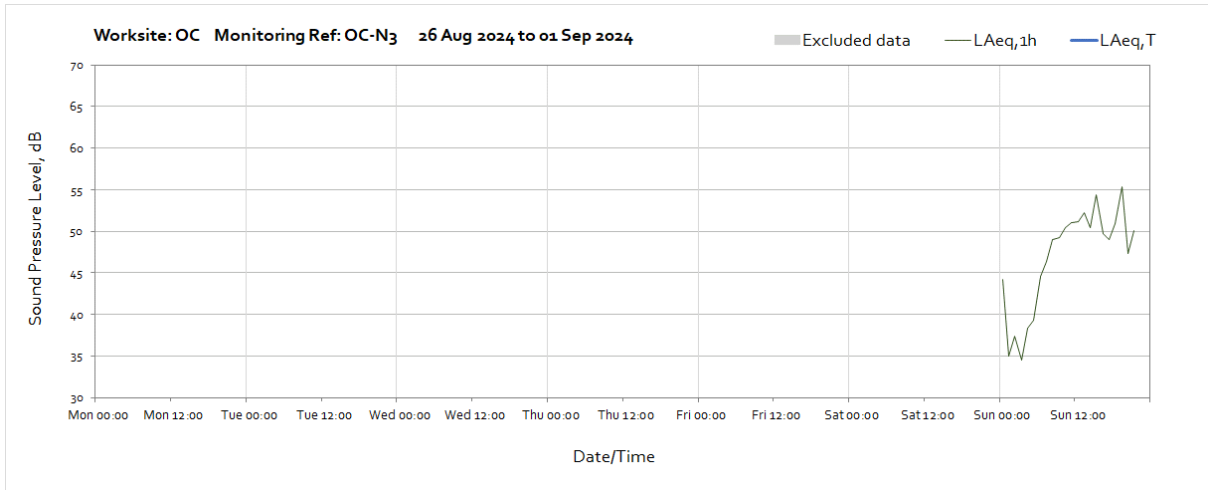
Worksite: OC – Monitoring Ref: OC-N3

Note: Missing data between 22:00 on Sunday 01st of September and 02:00 on Monday 02nd of September was due to a monitoring station error.

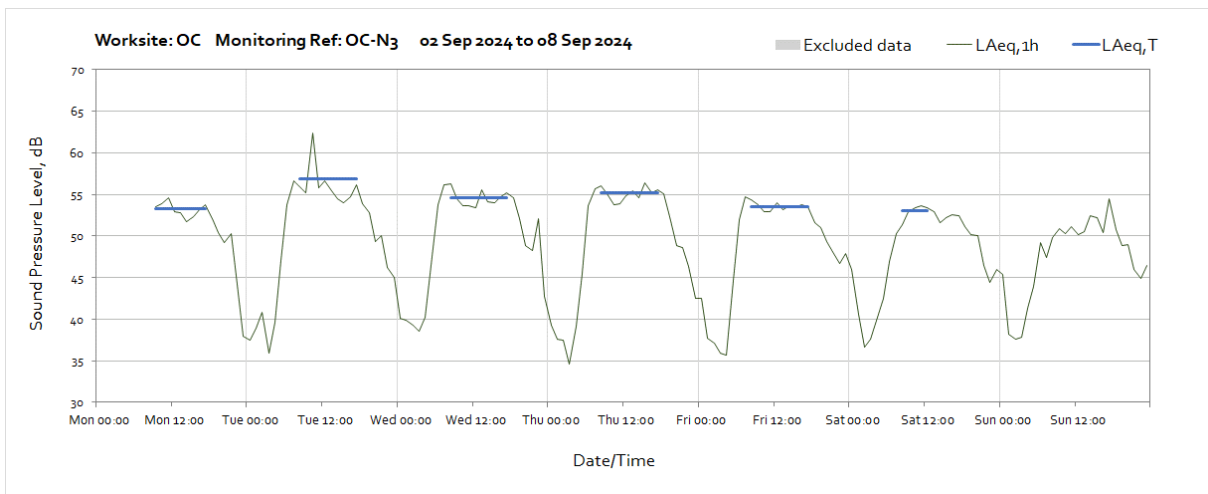
Note: Missing data between 22:00 on Sunday 01st of September and 02:00 on Monday 02nd of September was due to a monitoring station error.

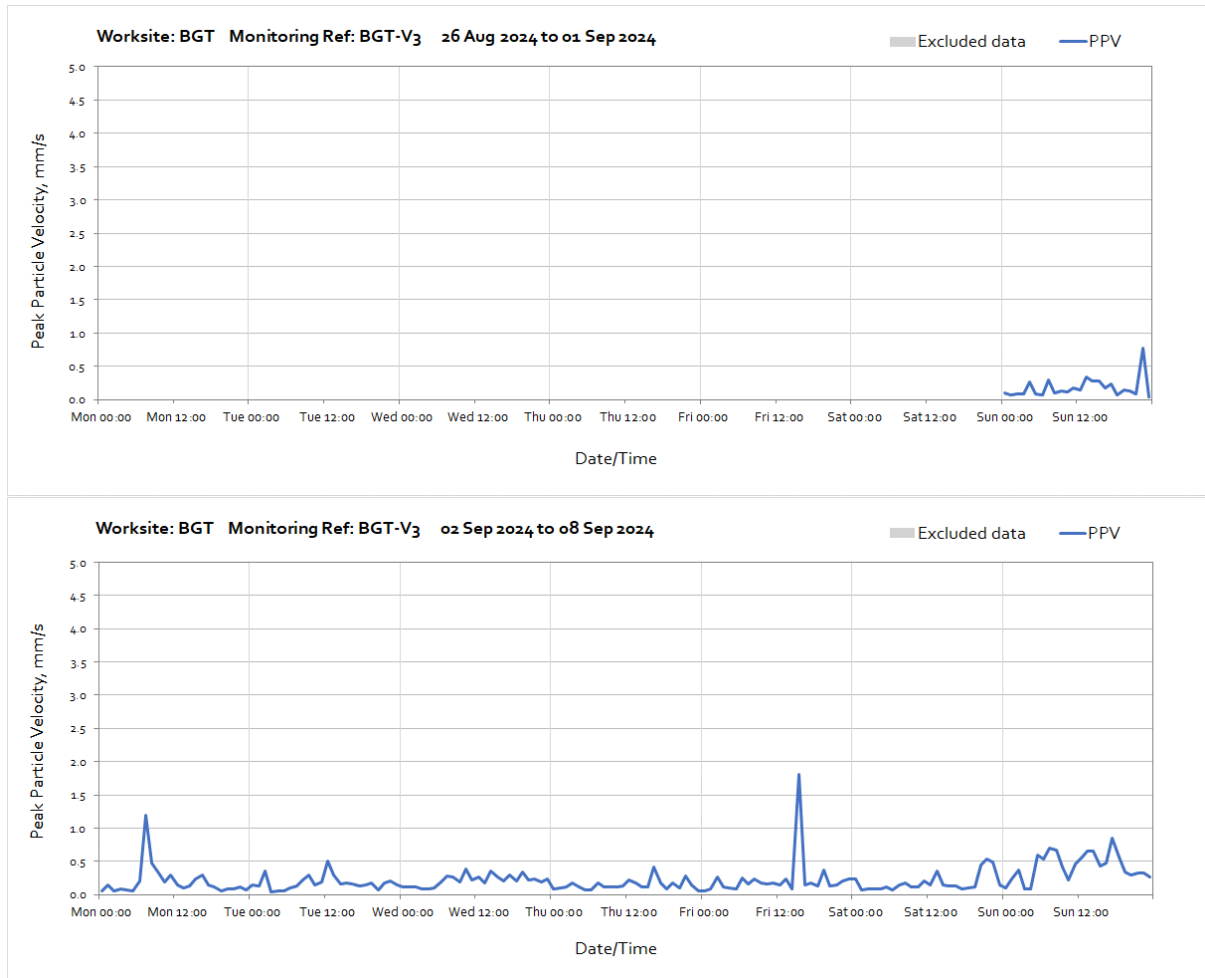
Worksite: BGT - Monitoring Ref: BGT-V3

The following graphs show the hourly measured peak particle velocity PPV recorded during the monitoring period. The graphs show the highest PPV of the three orthogonal axes x, y and z . Periods where PPV values have been affected by local interference with the vibration monitor or only measured for part of the period, which are not representative of HS2 construction works , have been greyed out and excluded when calculating values in Table 4 of the main report.

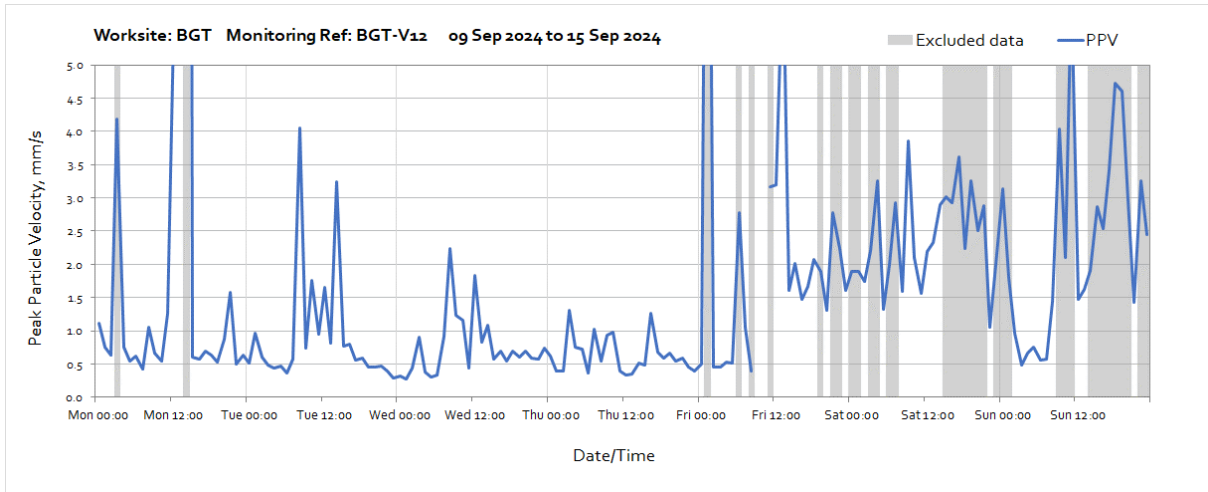
Note: Missing data between 08:00 and 11:00 on Friday 13th of September was due to a monitoring station error.

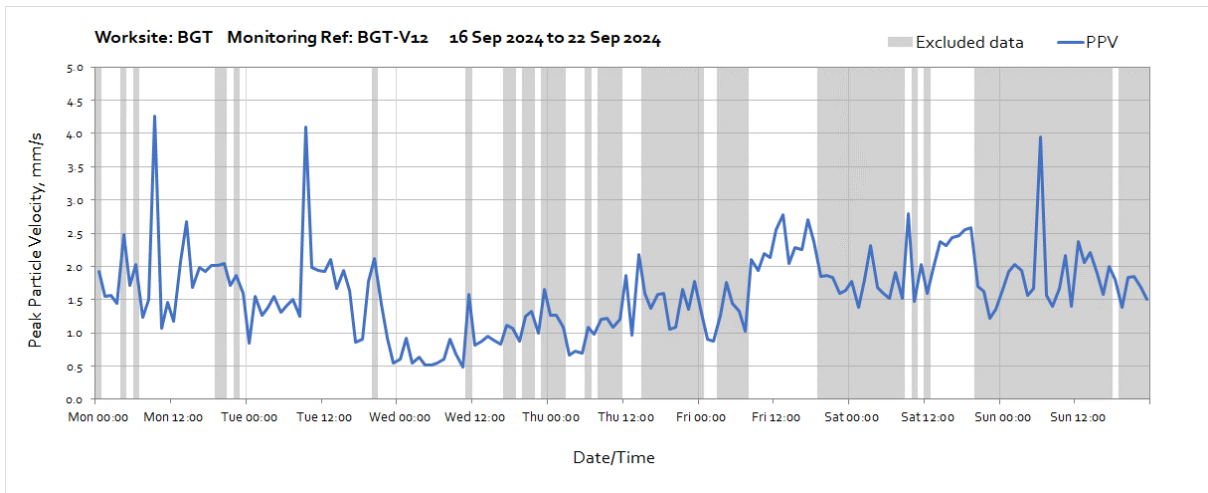
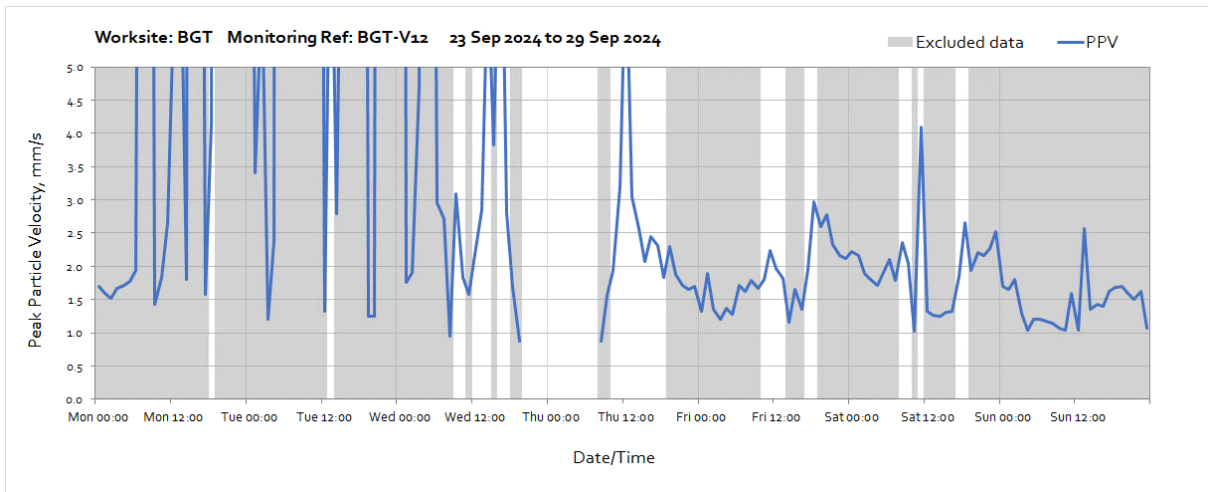
Note: Missing data between 20:00 on Wednesday 25th of September and 07:00 on Thursday 26th of September was due to a monitoring station error.

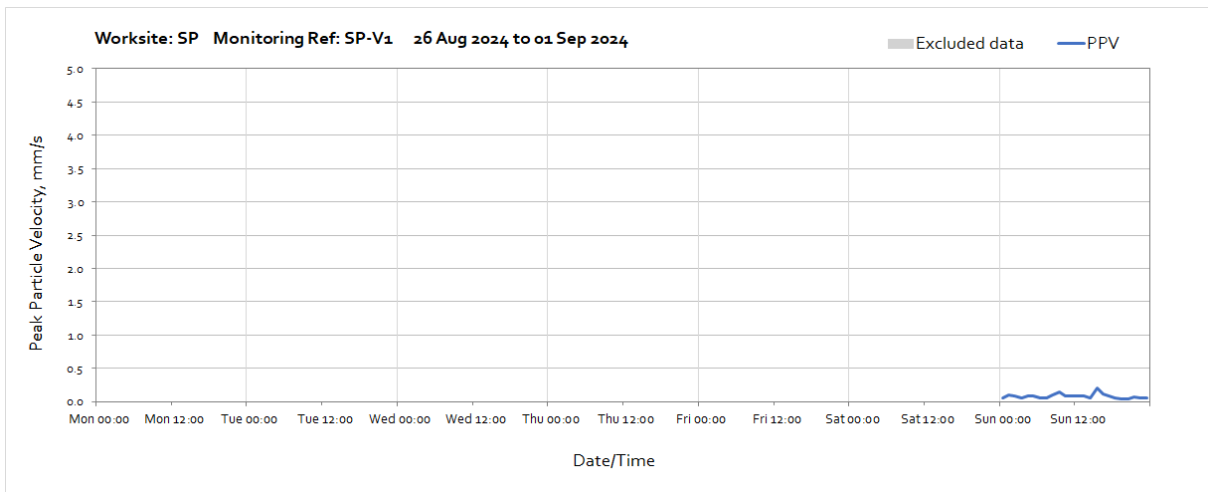
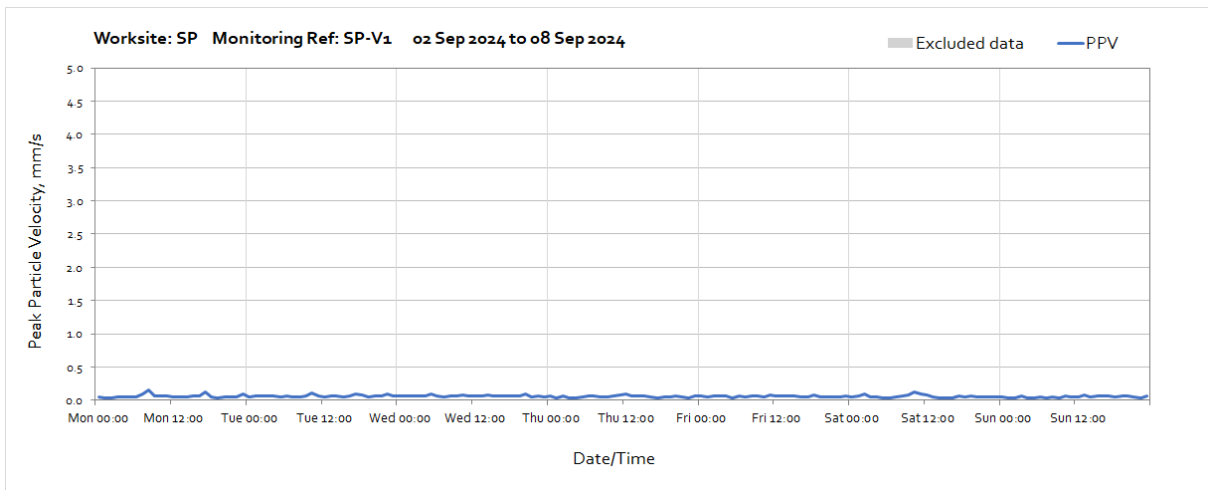
Worksite: SP – Monitoring Ref: SP-V1

Note: Missing data between 22:00 on Monday 16th of September and 14:00 on Thursday 26th of September was due to a power supply issue at the monitoring station.

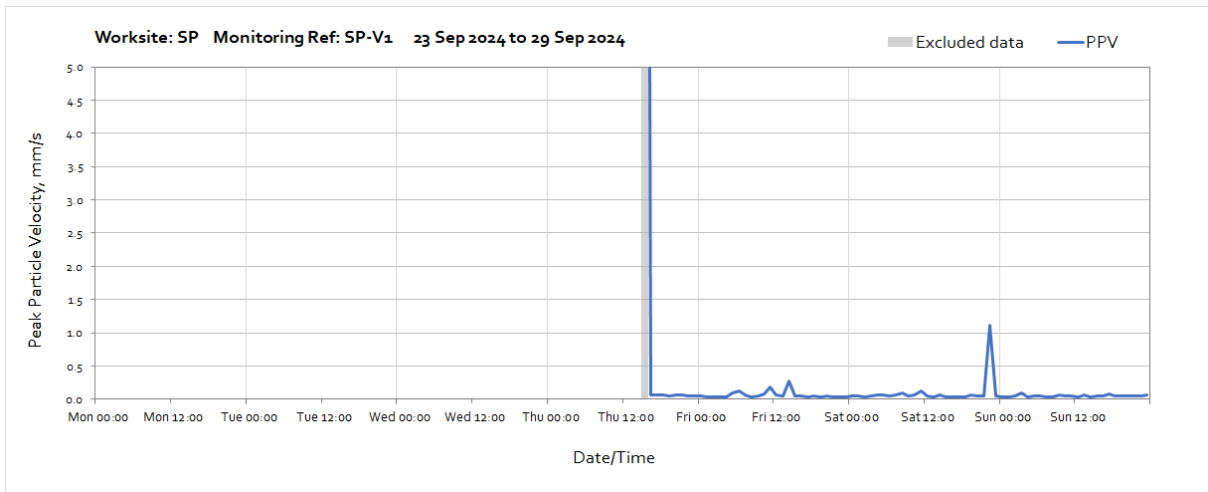
Note: Missing data between 22:00 on Monday 16th of September and 14:00 on Thursday 26th of September was due to a power supply issue at the monitoring station.
