Photographs Showing Breaches of Planning Conditions
and Disregard for Protection of Priors Wood (Ancient
Woodland) During Construction of UTT/22/2744/FUL

Photographs Taken May 2024

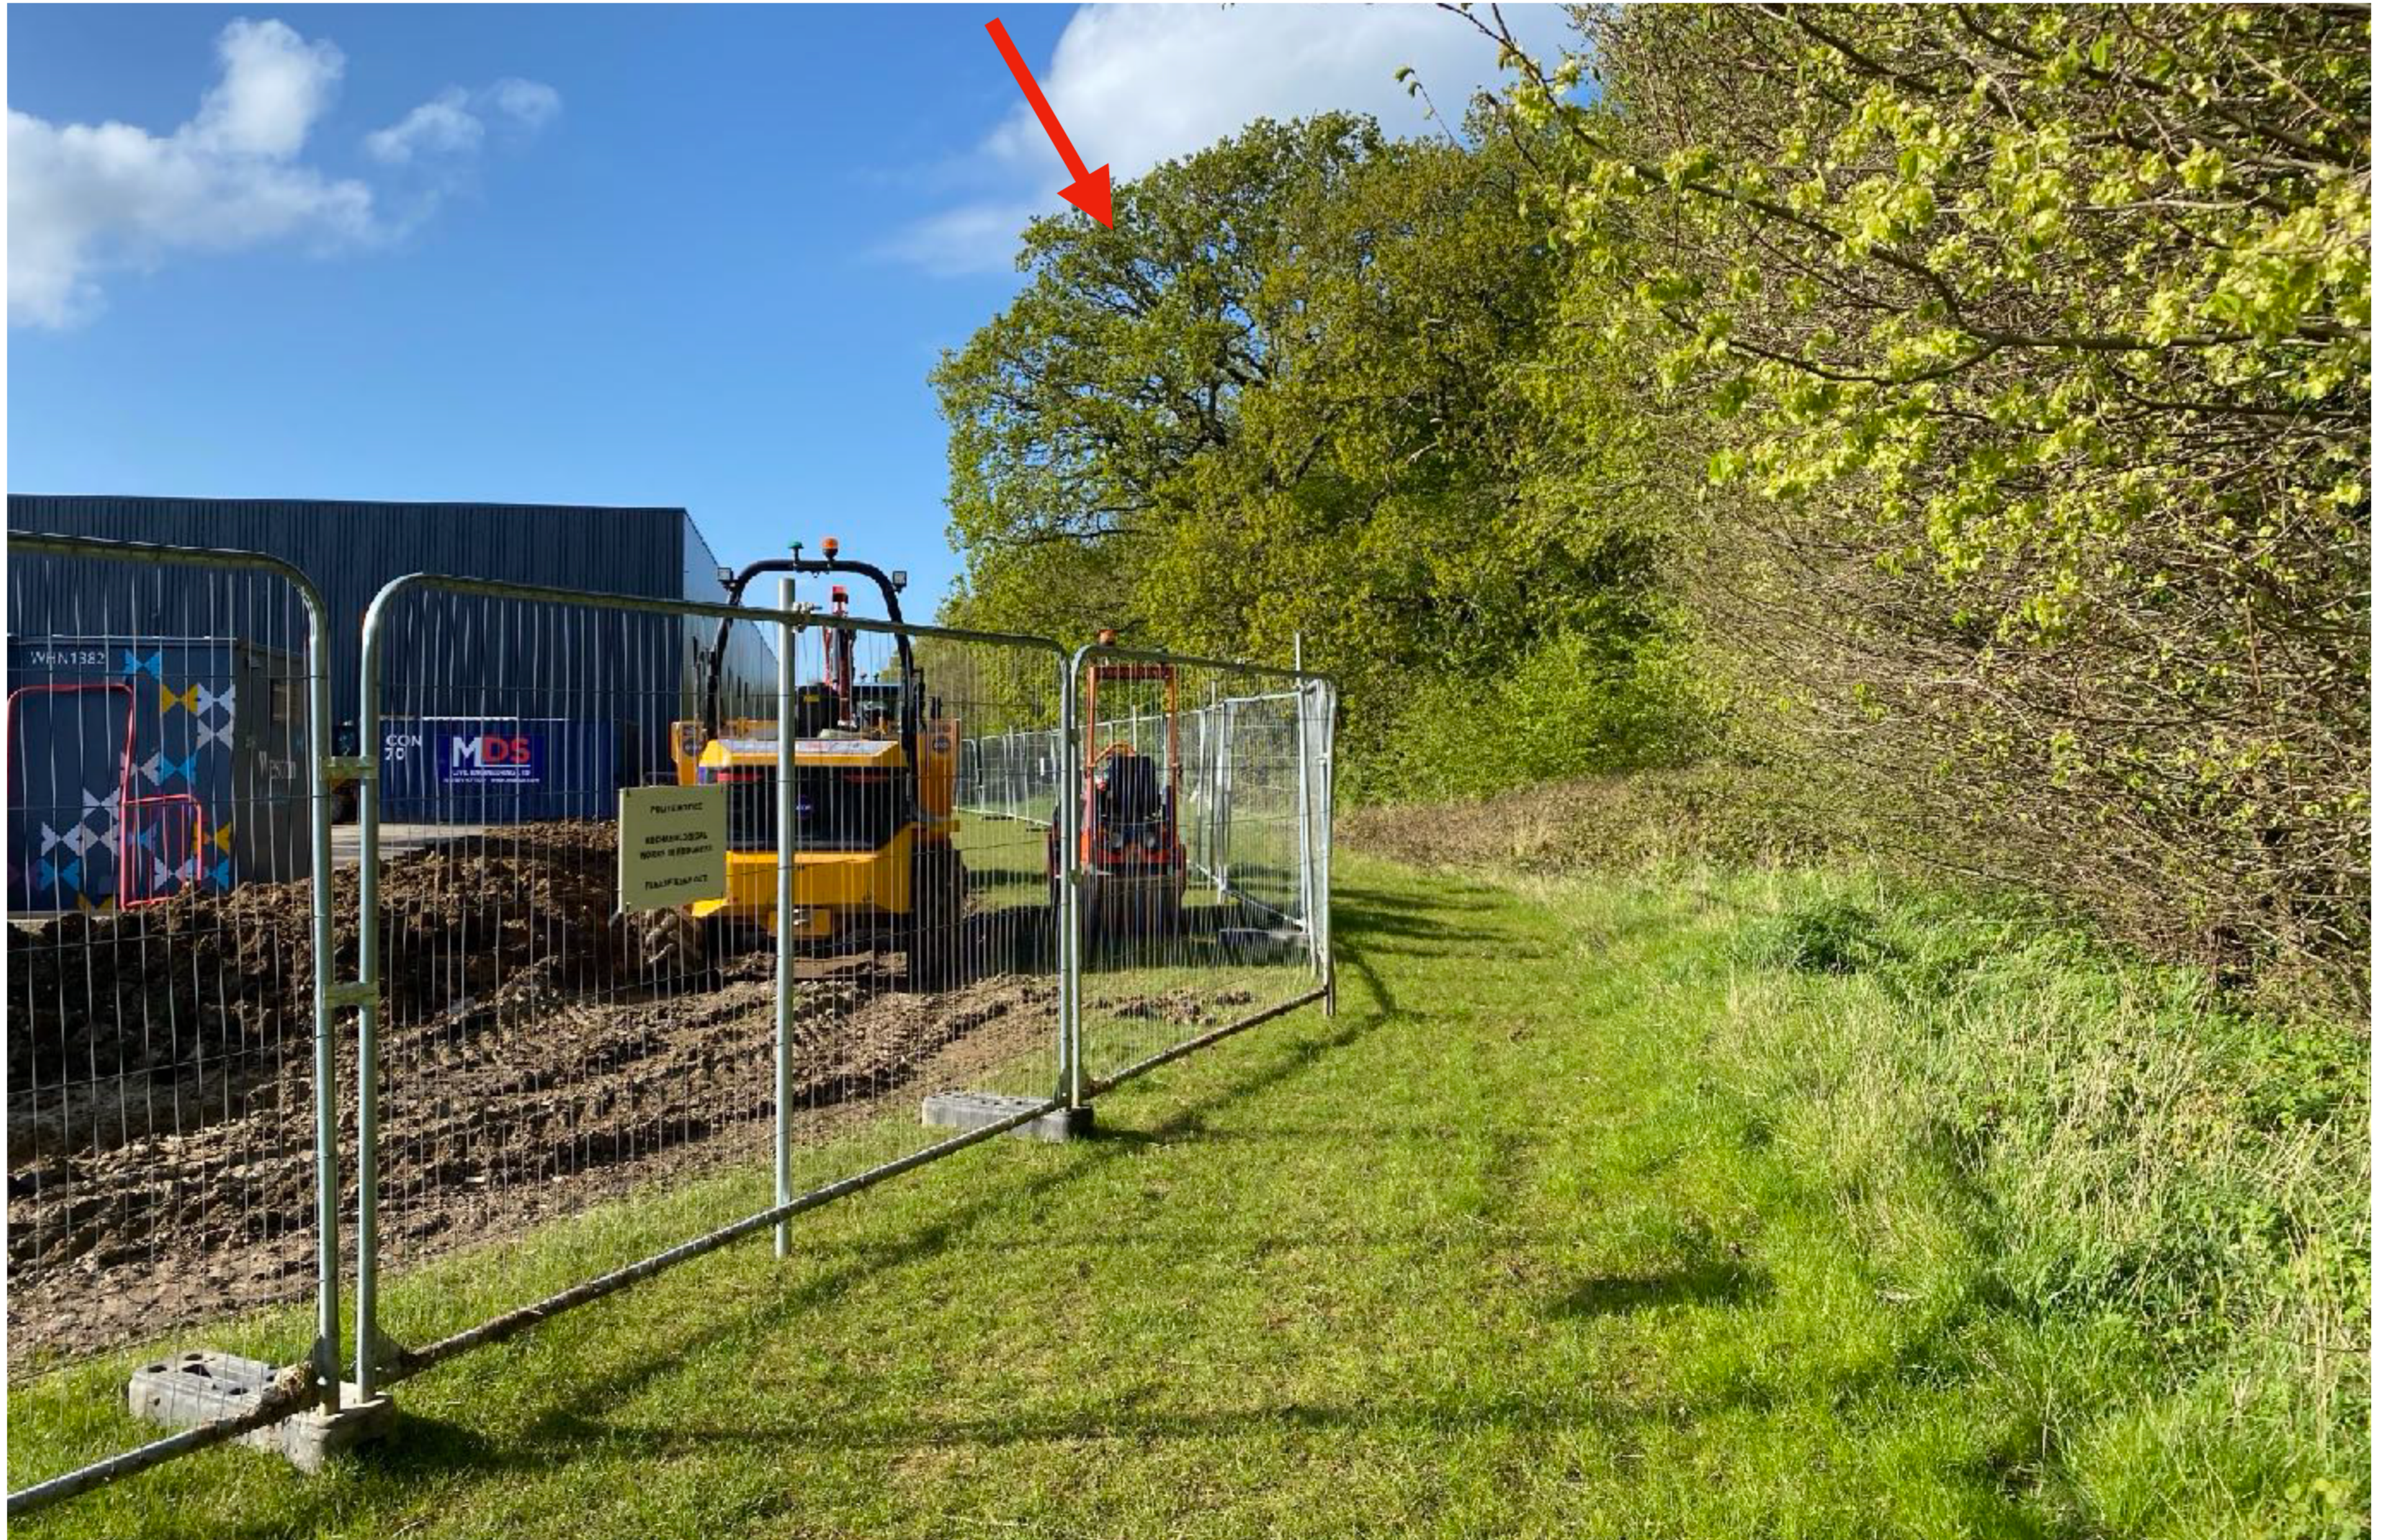
Photo 1: Fencing and heavy construction equipment well within the 15m buffer zone of Priors Wood. The ground is being extensively disturbed within RPA (Root Protection Area) including that of the veteran oak tree identified in the Arboricultural Impact Assessment as T20 (highlighted by red arrow).

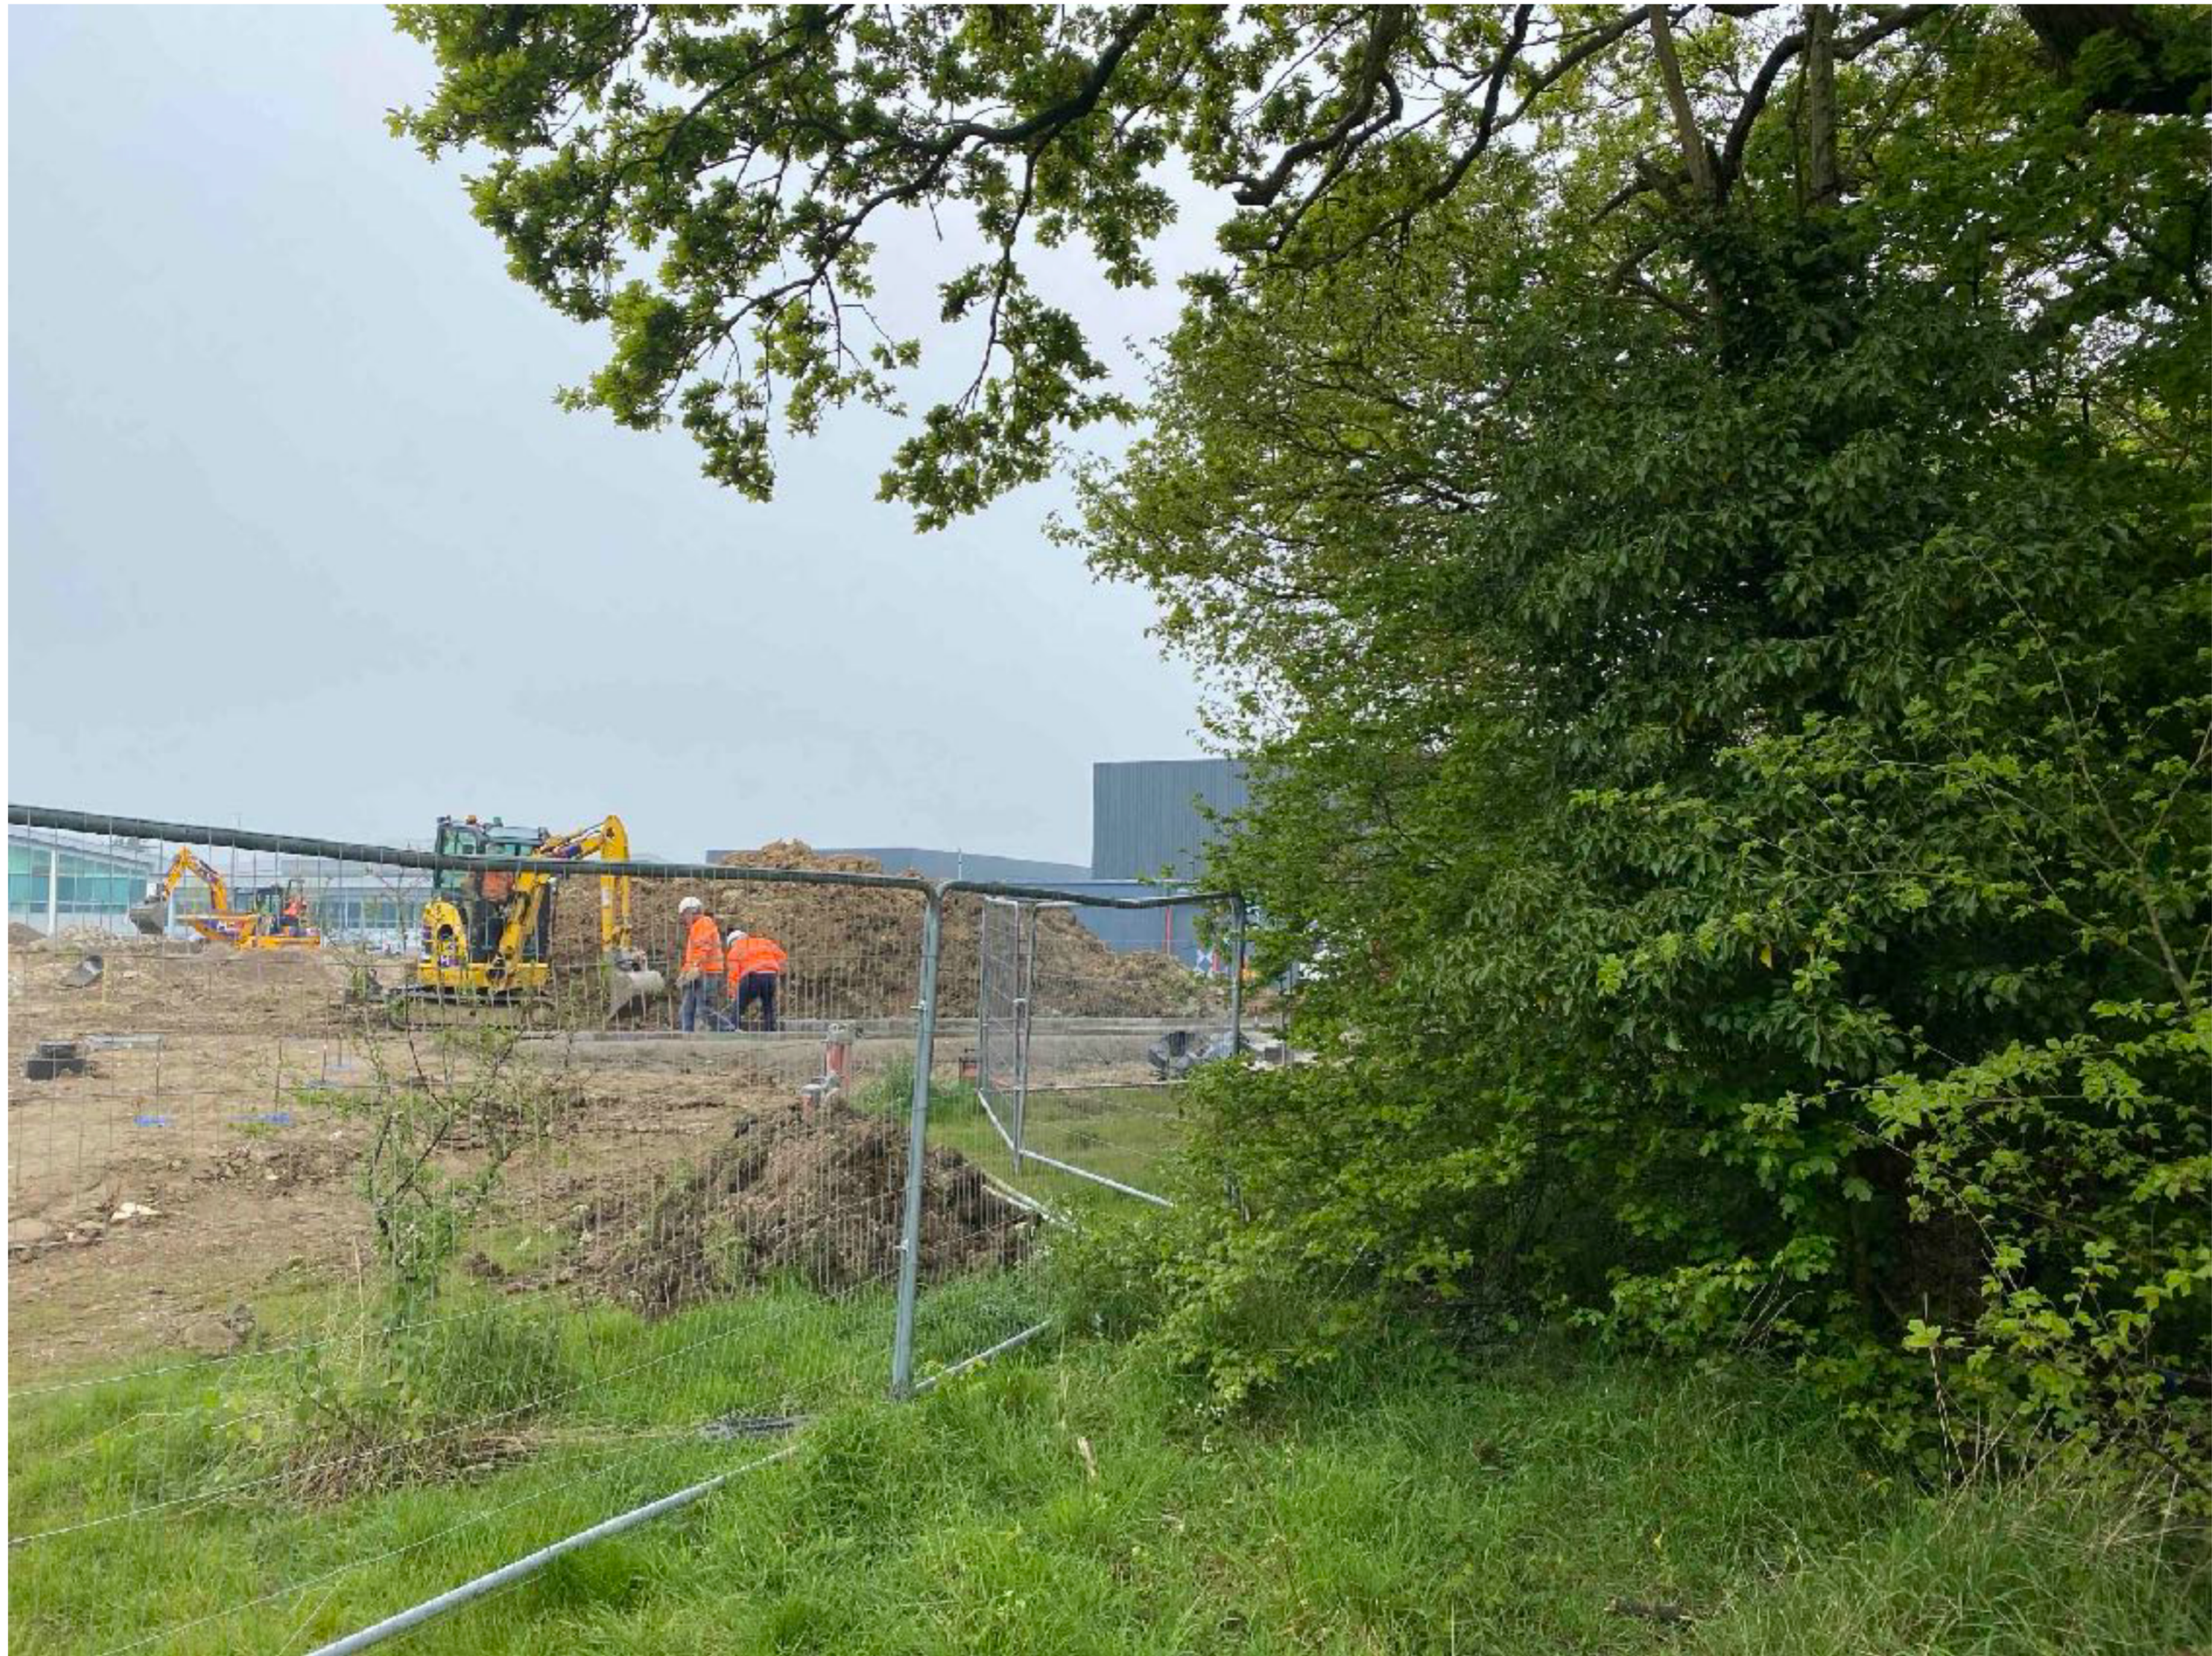
Photo 2: Photograph showing total disregard for 15m buffer zone at the SW corner of Priors Wood. Fencing is not opaque as required by the Construction Ecological Management Plan (Biodiversity)

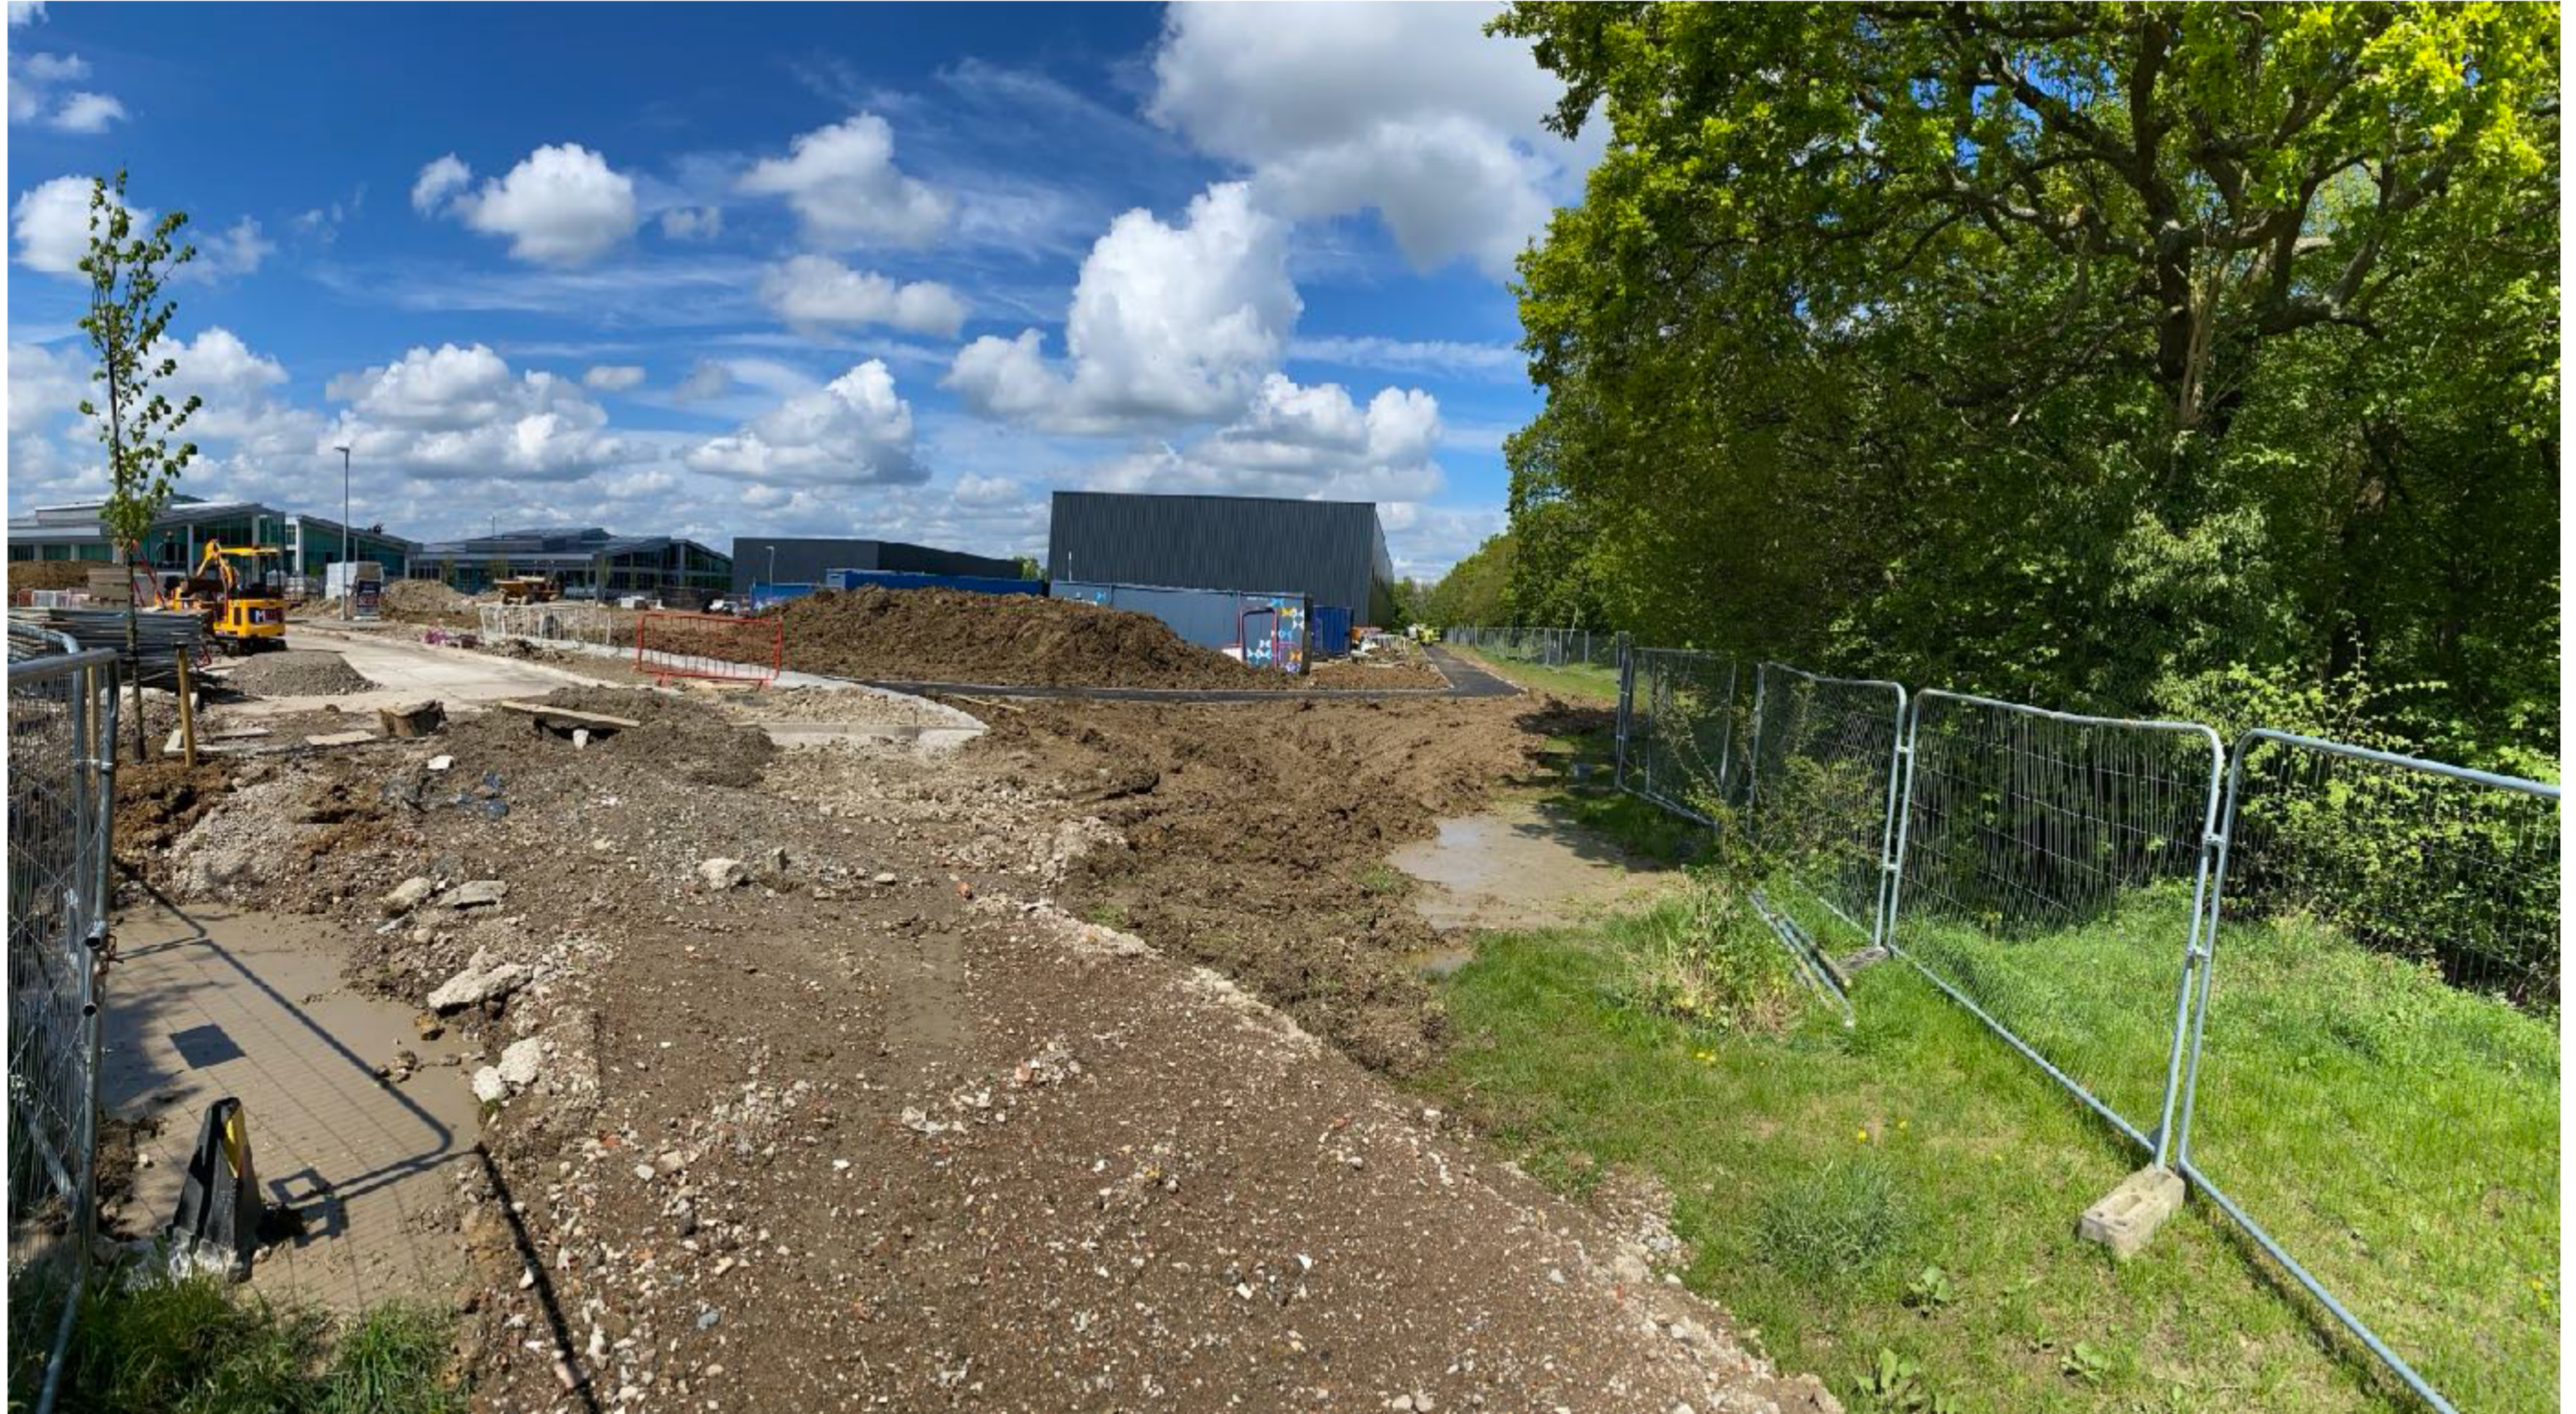
Photo 3: Photograph showing continued disregard for 15m buffer zone at the SW corner of Priors Wood and roadway under construction without planning permission.

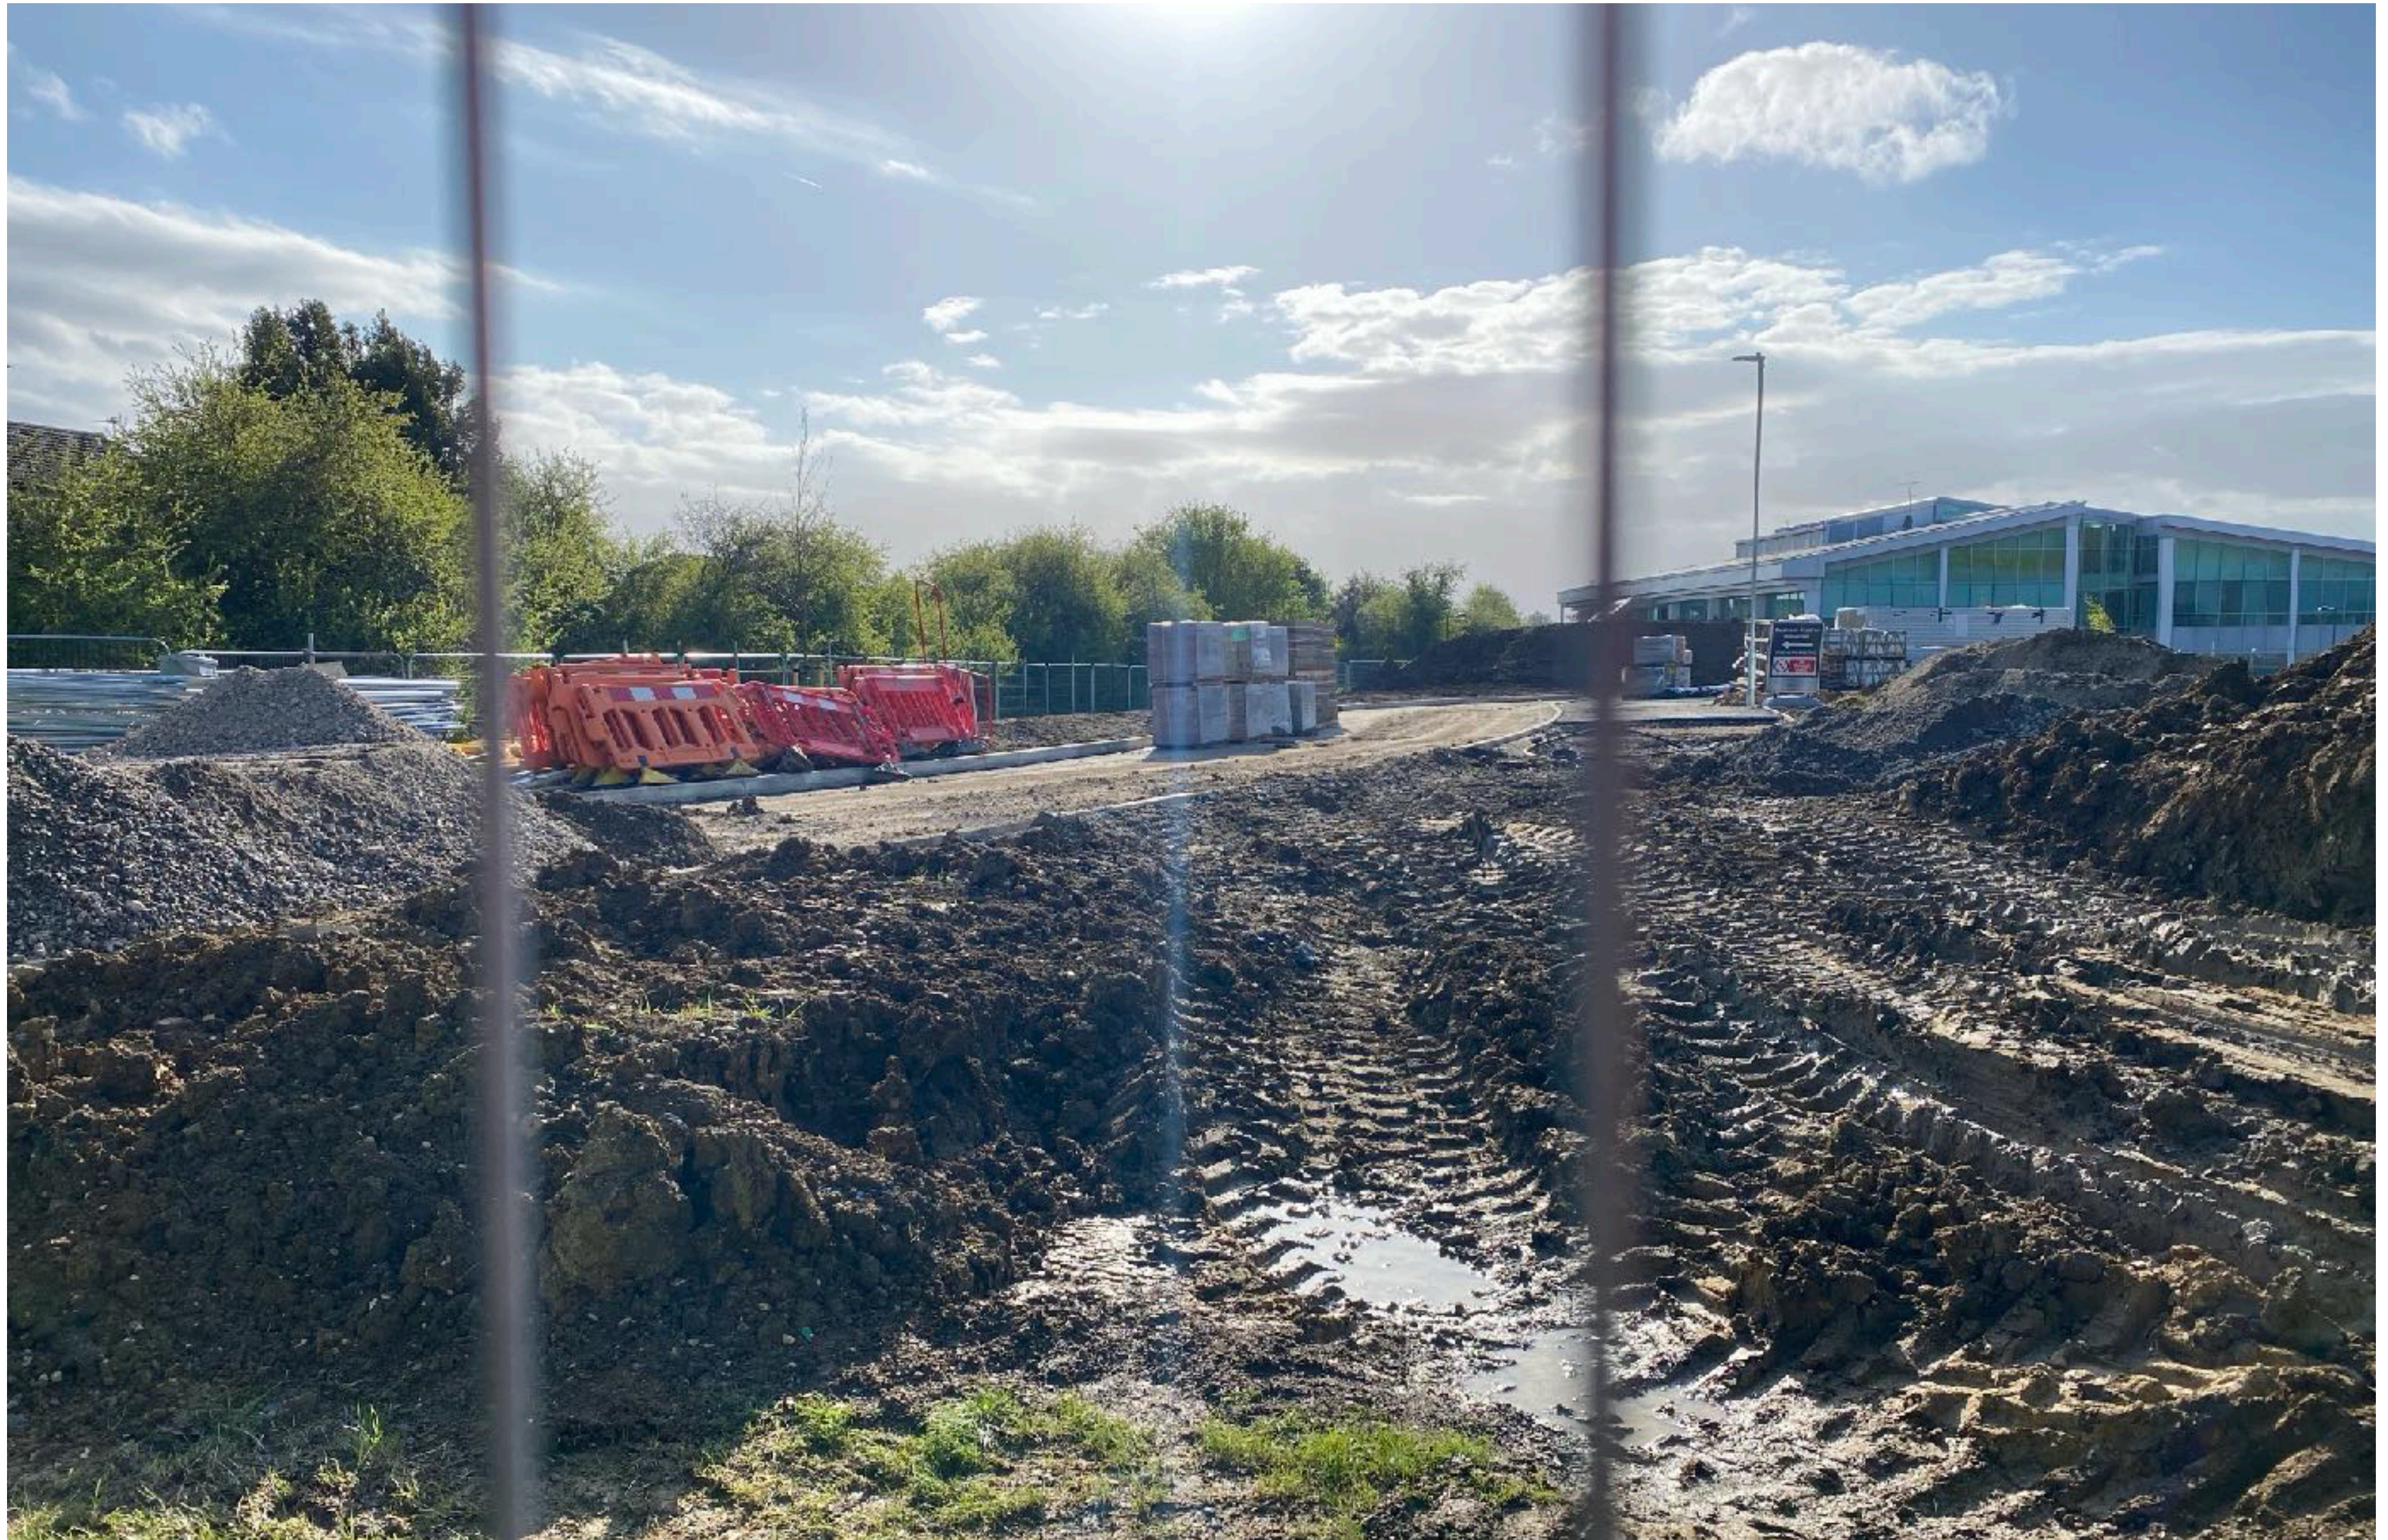
Photo 3: Section of roadway under construction in south east corner of site not shown on planning application documents. Note the heavy vehicle movements right next to Priors Wood.

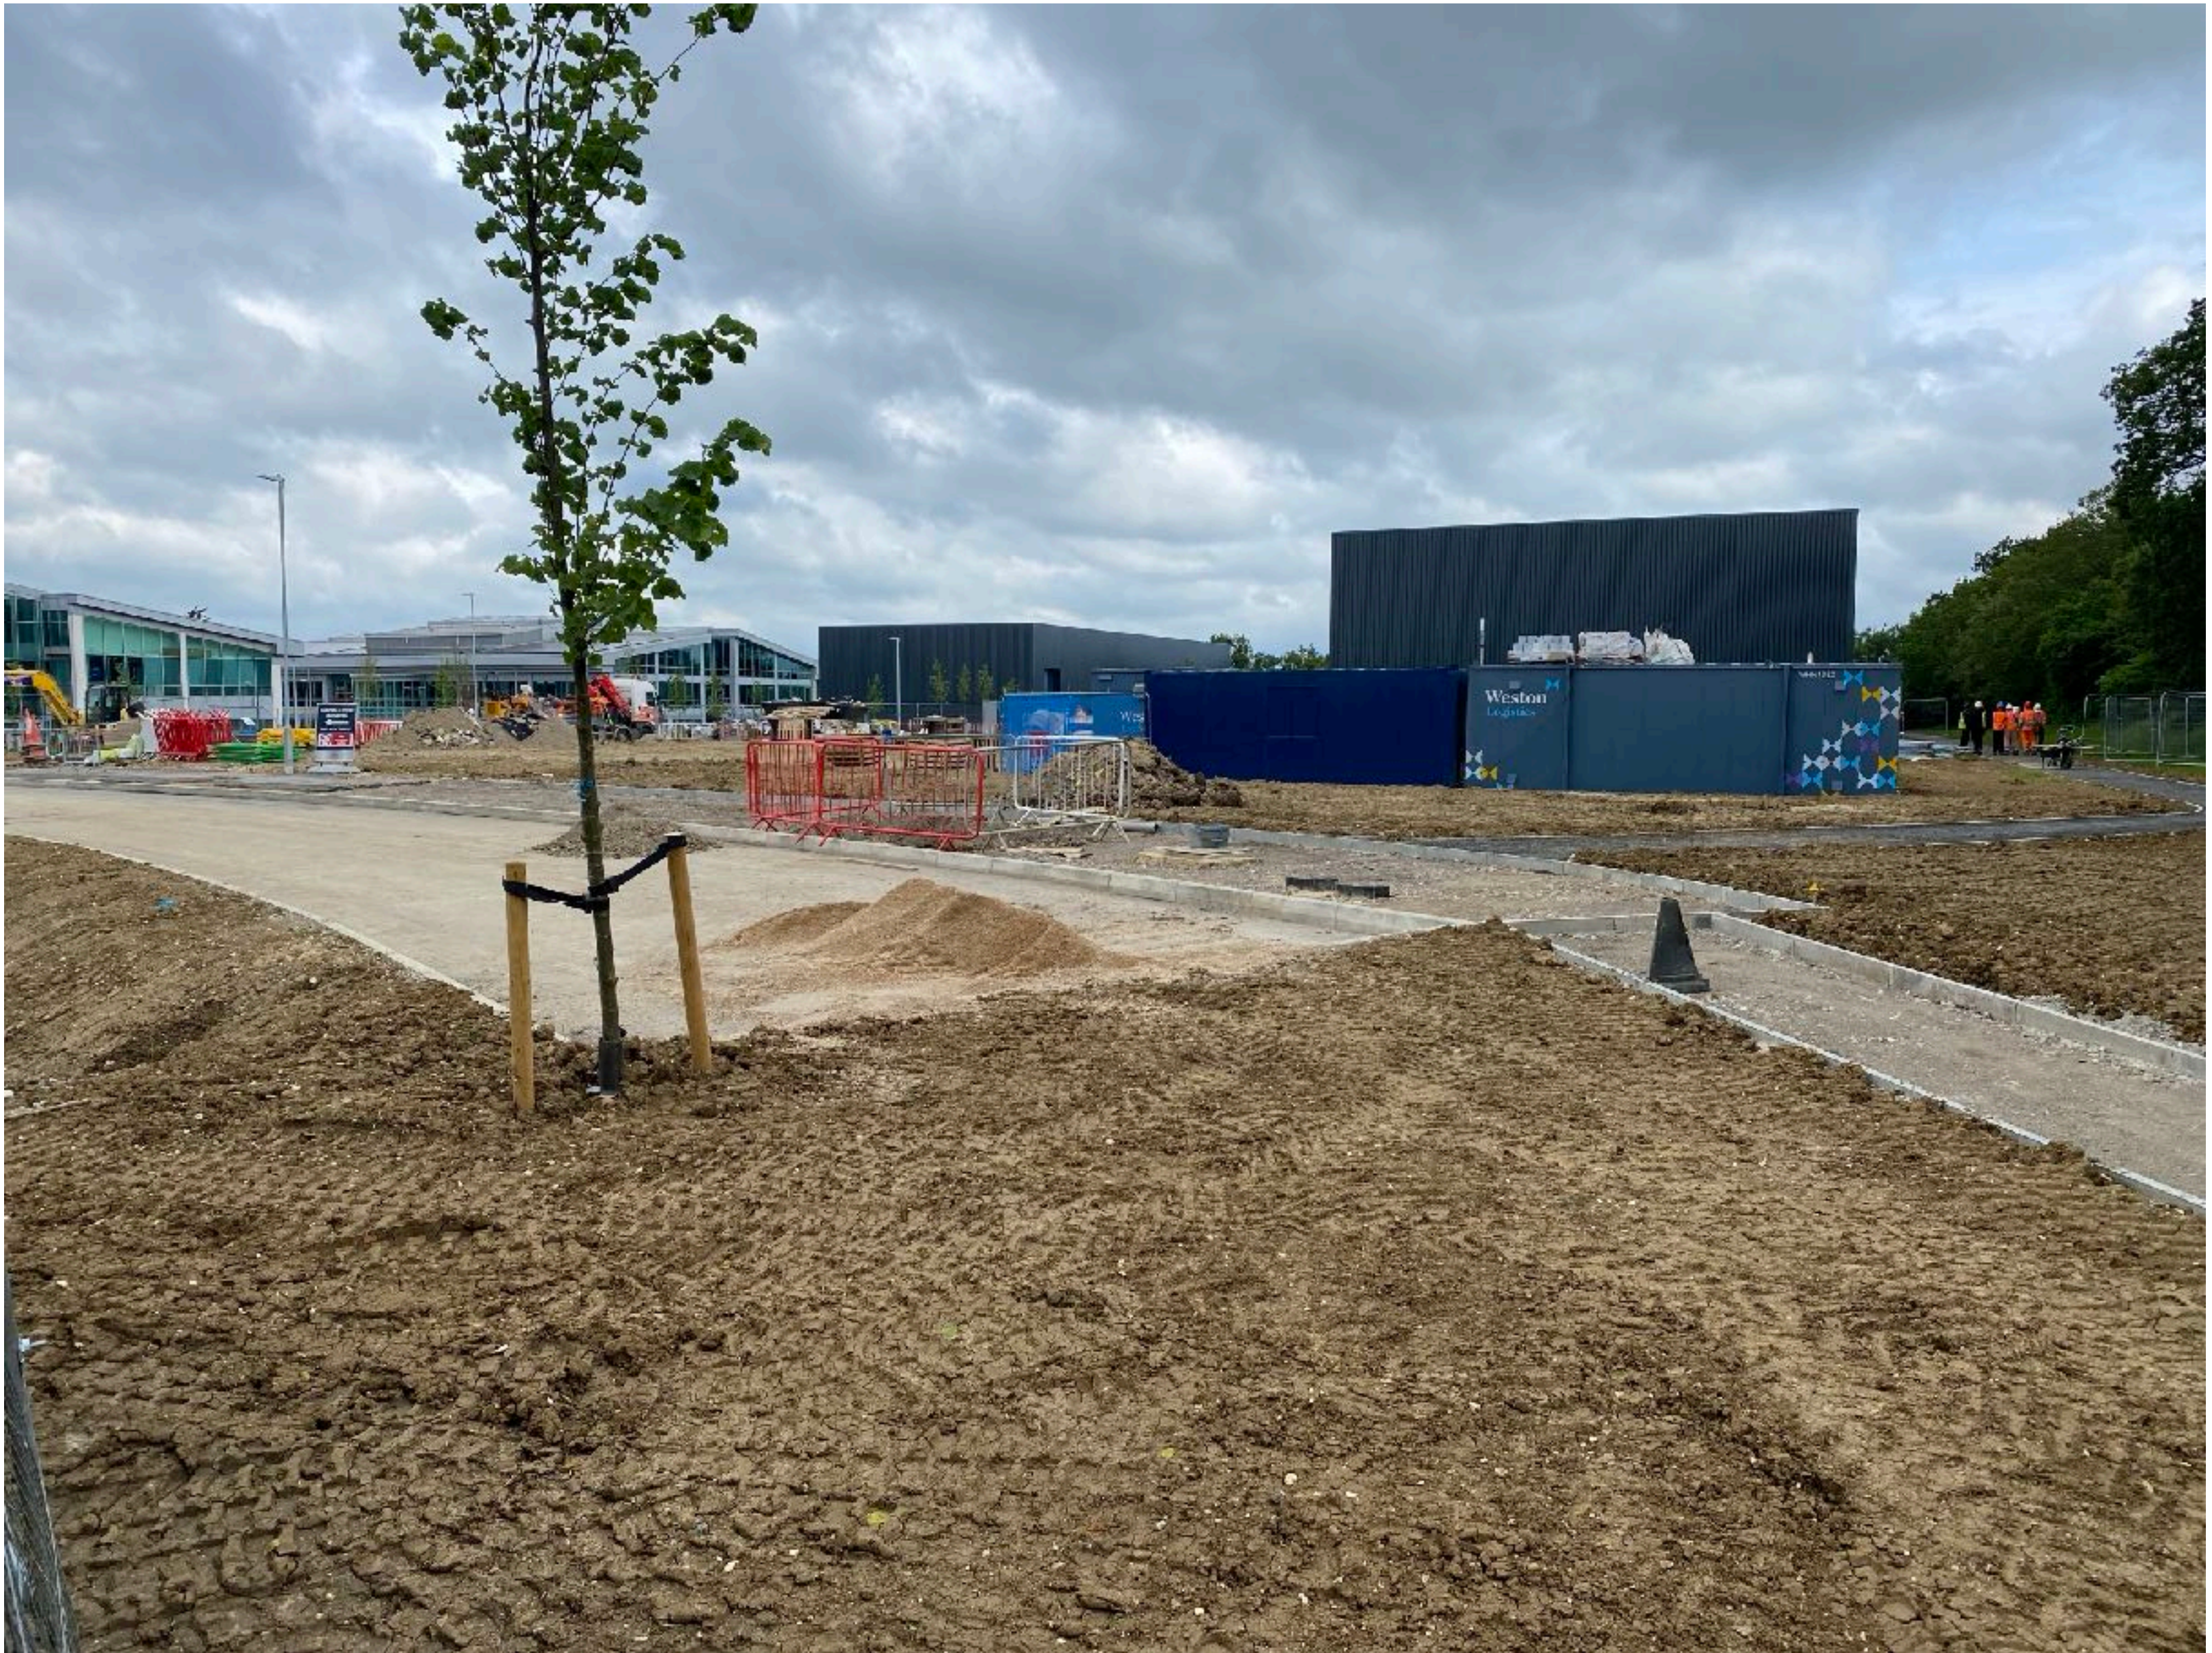
Photo 4: Completed roadway running to SW corner of Priors Wood which was never shown on approved planning documents.
