Construction Noise and Vibration Monthly Report – November 2024

Buckinghamshire

Non-Technical Summary

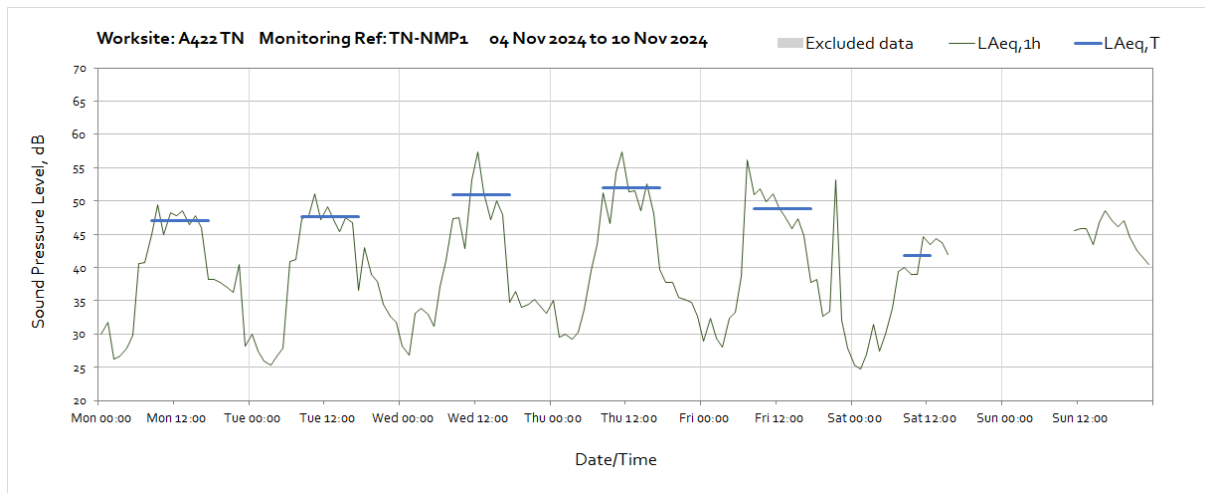
Worksite: A422 TN – Monitoring Ref: TN-NMP1

Note: Missing data between 16:00 on Saturday 9th November until 11:00 on Sunday 10th November was due to a depleted monitor battery.

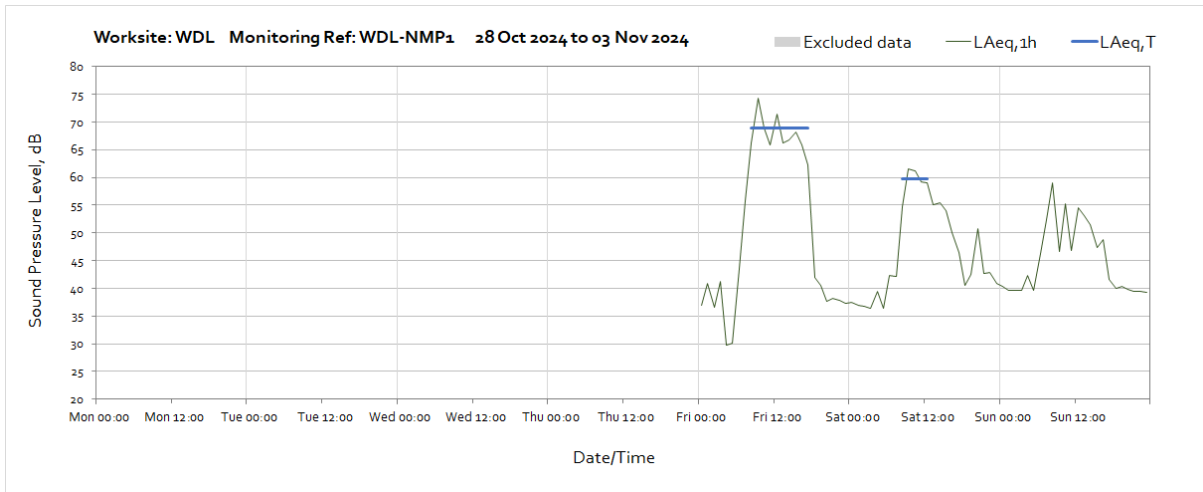
Worksite: WDL – Monitoring Ref: WDL-NMP1

Note: Missing data between 09:00 on 12:00 on Sunday 10th November was due to a depleted monitor battery.
