## **Construction Noise and Vibration Monthly Report – November 2024**

**London Borough of Camden**

# Non-Technical Summary

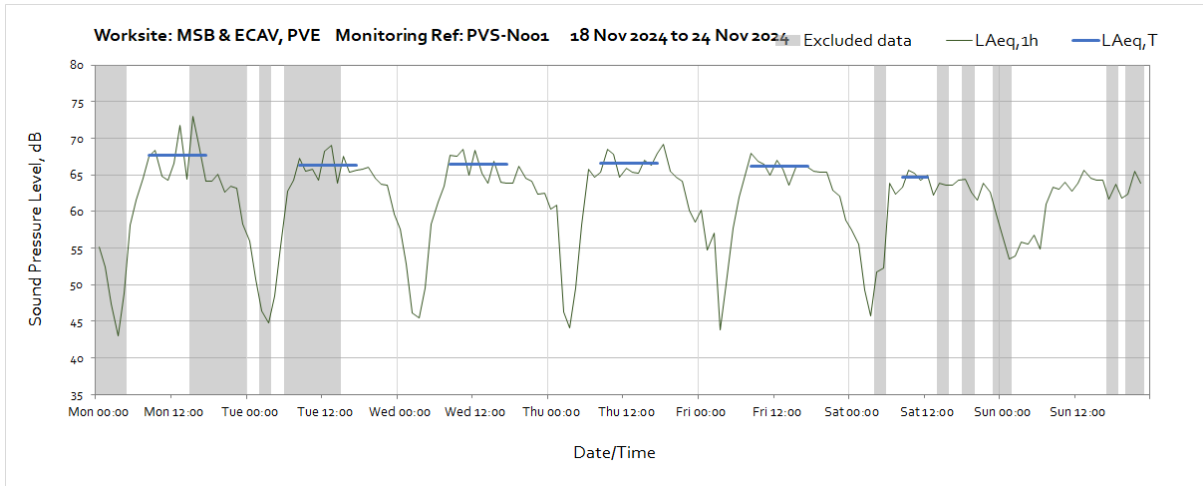
## Worksite: MSB & ECAV, PVE – Monitoring Ref: PVS-N001

Note: Missing data between 23:00 on Sunday 24<sup>th</sup> of November and 07:00 on Monday 25<sup>th</sup> of November was due to loss of power at the monitoring station.
