# **Construction noise and vibration Monthly Report – November 2024**

**London Borough of Hillingdon**

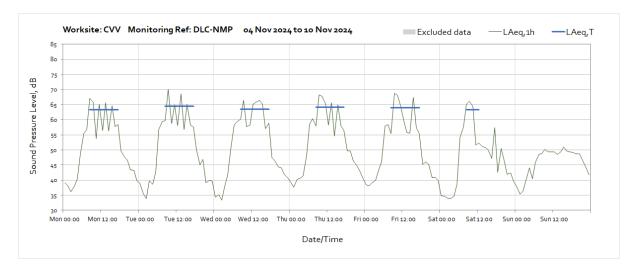
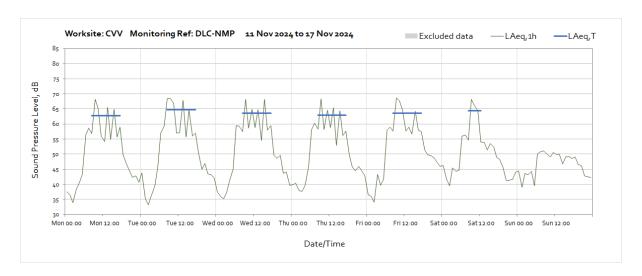
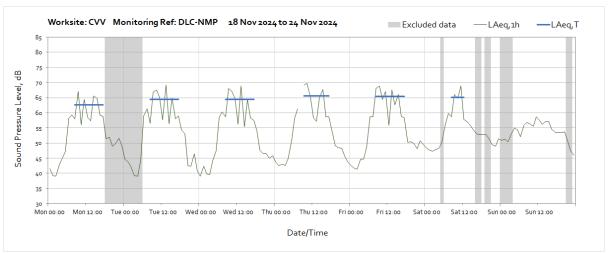
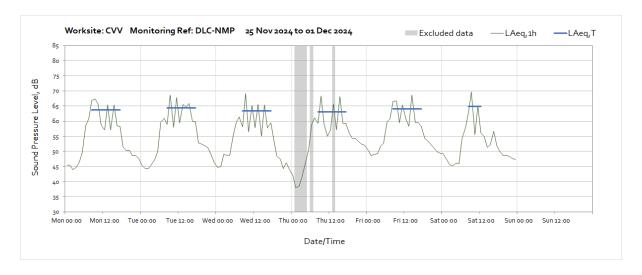
#### Worksite: CVV - Monitoring Ref: DLC-NMP

Note: Missing data between 08:00 and 09:00 on Thursday  $21^{st}$  November was due to a transmission error at the monitoring station.

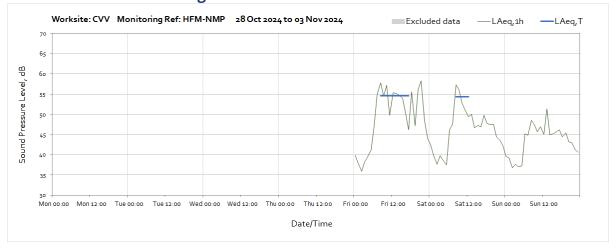
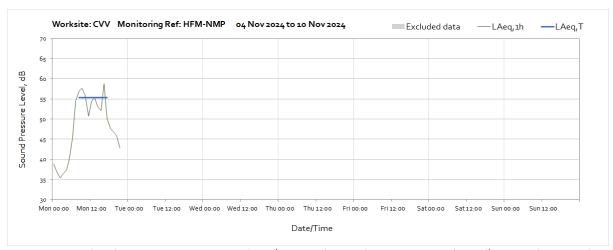
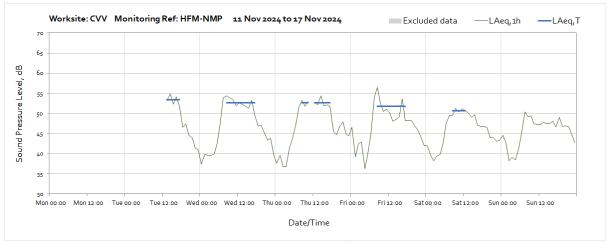
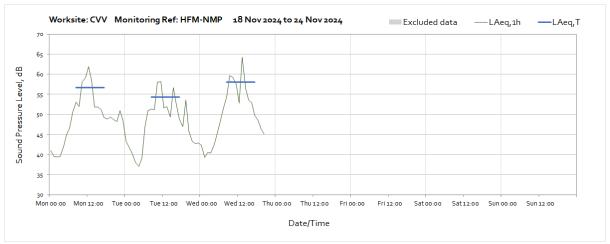
#### **Worksite: CVV - Monitoring Ref: HFM-NMP**

Note: Missing data between 22:00 on Monday 4<sup>th</sup> November and 13:00 on Tuesday 12<sup>th</sup> November was due to insufficient light reaching the solar panels at the monitoring station.

Note: Missing data between 11:00 and 12:00 on Thursday 14<sup>th</sup> November was due to insufficient light reaching the solar panels at the monitoring station.

Note: Missing data between 21:00 on Wednesday 20<sup>th</sup> November and the end of the month was due to insufficient light reaching the solar panels at the monitoring station.

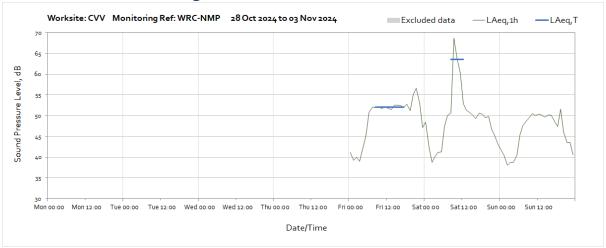
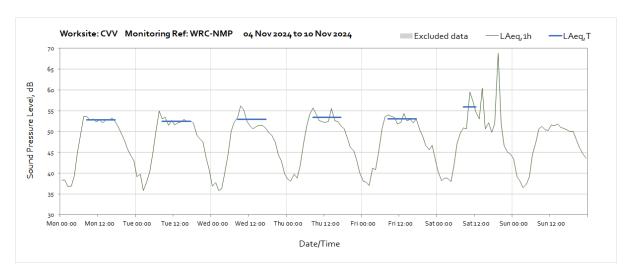
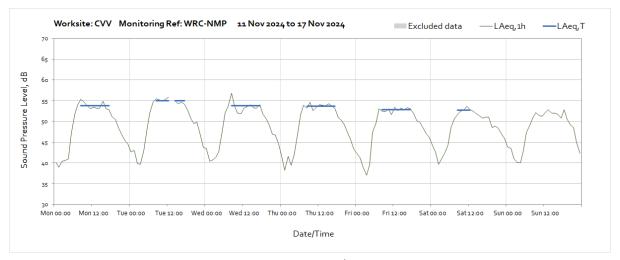
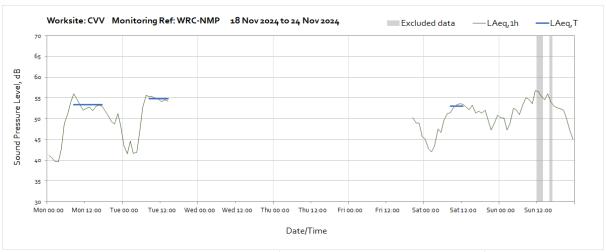
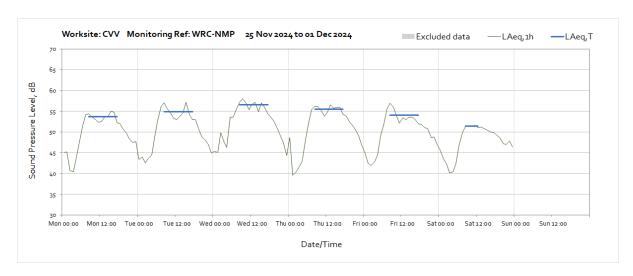
#### Worksite: CVV - Monitoring Ref: WRC-NMP

Note: Missing data between 13:00 and 14:00 on Tuesday 12<sup>th</sup> November was due to field calibration.

Note: Missing data between 15:00 on Tuesday 19<sup>th</sup> November and 20:00 on Friday 22<sup>nd</sup> November was due to insufficient light reaching the solar panels at the monitoring station.

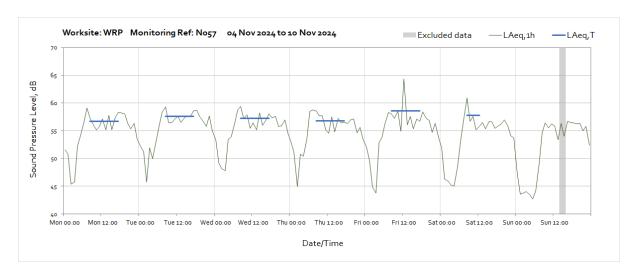
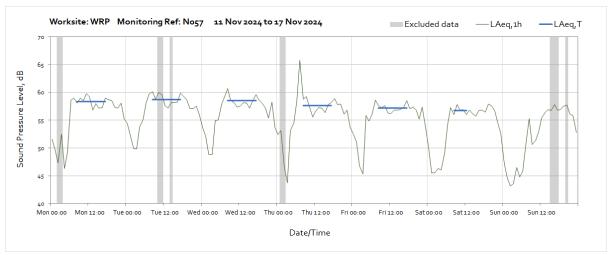
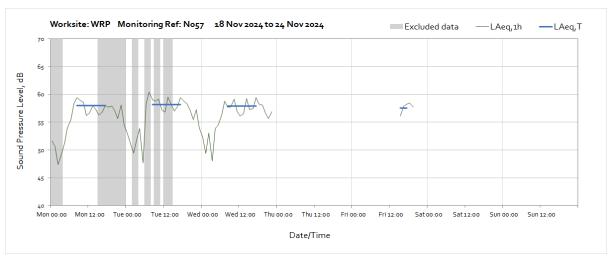
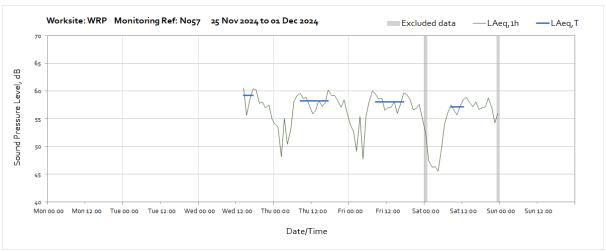
# Worksite: WRP - Monitoring Ref: N057

Note: Missing data throughout the week was due to loss of site power.

Note: Missing data between 20:00 on Friday 22<sup>nd</sup> November and 14:00 on Wednesday 27<sup>th</sup> November was due to loss of site power.

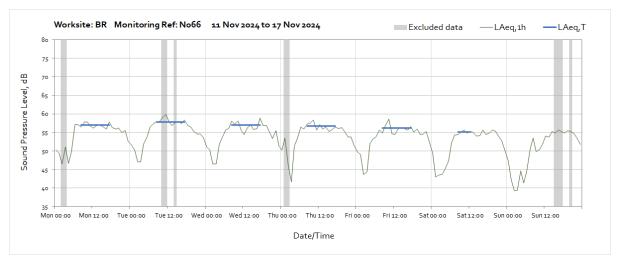
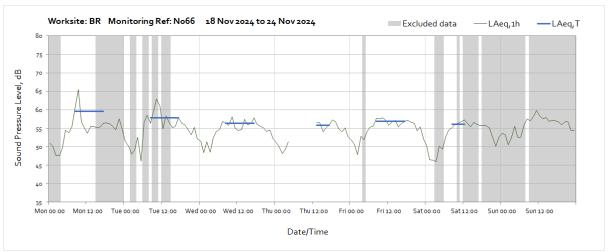
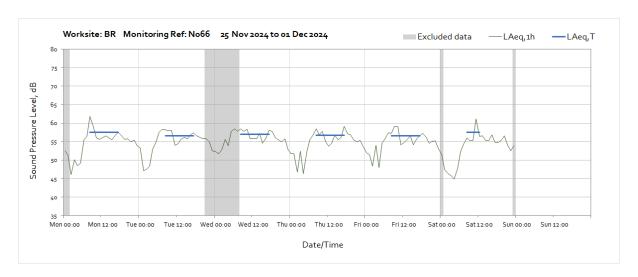
## **Worksite: BR - Monitoring Ref: N066**

Note: Missing data between 05:00 and 13:00 on Thursday 21st November was due to depleted battery at the monitoring station.

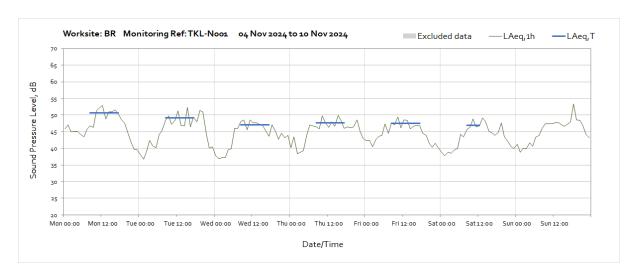
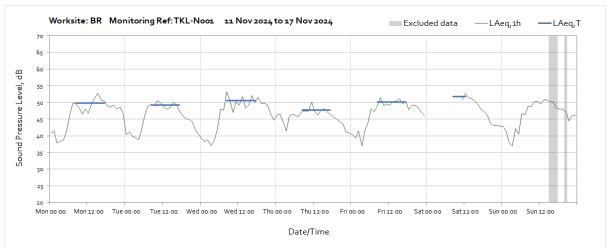
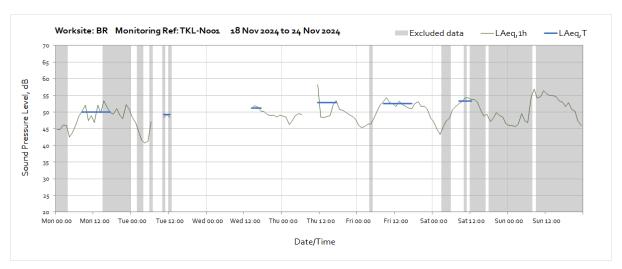
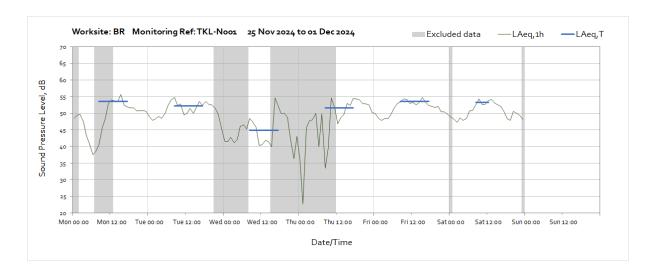
## **Worksite: BR - Monitoring Ref: TKL-N001**

Note: Missing data between 00:00 and 11:00 on Saturday 16<sup>th</sup> November was due to depleted battery at the monitoring station.

Note: Missing data throughout the week was due to depleted battery at the monitoring station.

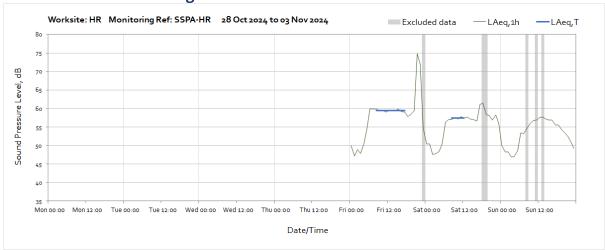
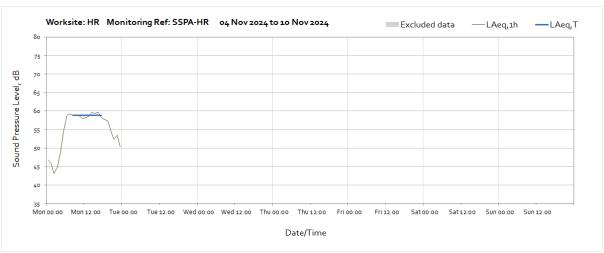
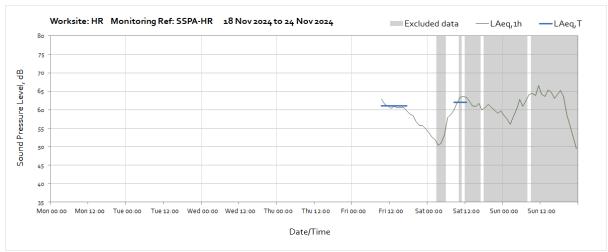
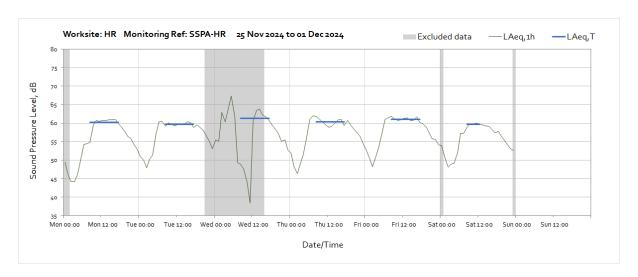
#### **Worksite: HR - Monitoring Ref: SSPA-HR**

Note: Missing data between 00:00 on Tuesday 5<sup>th</sup> November and 09:00 on Friday 22<sup>nd</sup> November was due to depleted battery at the monitoring station.

Note: Missing data between 00:00 on Tuesday  $5^{th}$  November and 09:00 on Friday  $22^{nd}$  November was due to depleted battery at the monitoring station.

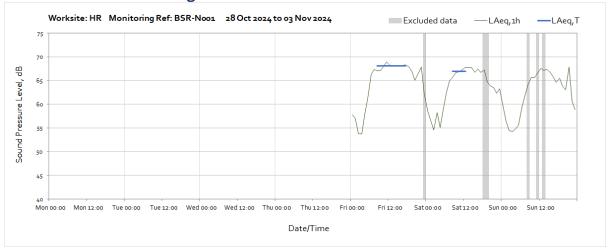
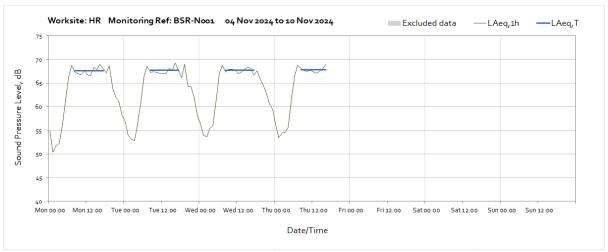
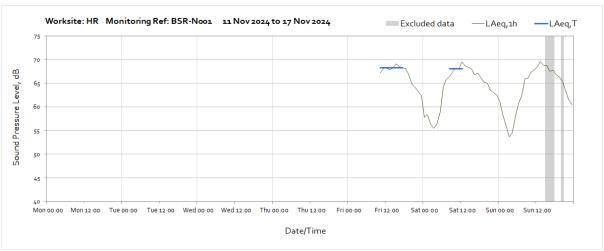
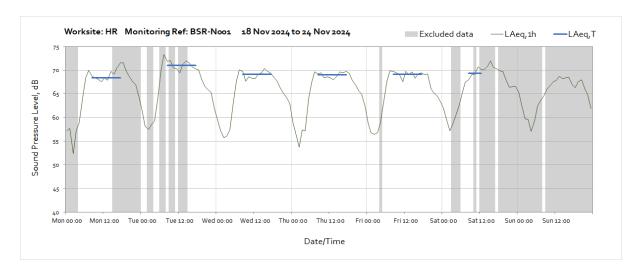
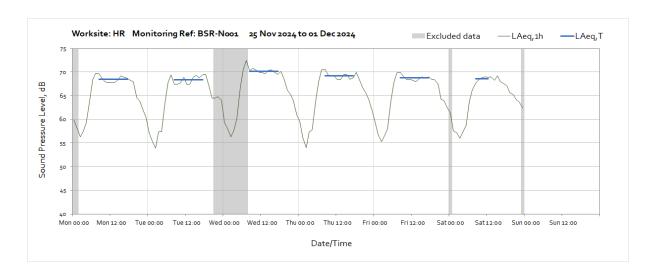
#### Worksite: HR - Monitoring Ref: BSR-N001

Note: Missing data between 17:00 on Thursday 7<sup>th</sup> November and 10:00 on Friday 15<sup>th</sup> November was due to depleted battery at the monitoring station.

Note: Missing data between 17:00 on Thursday  $7^{th}$  November and 10:00 on Friday  $15^{th}$  November was due to depleted battery at the monitoring station.

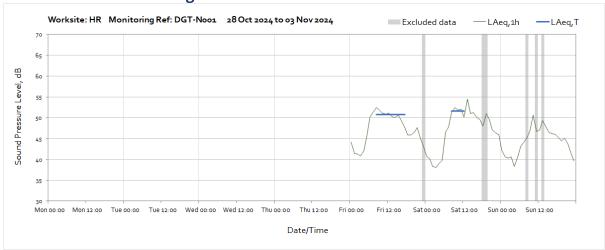
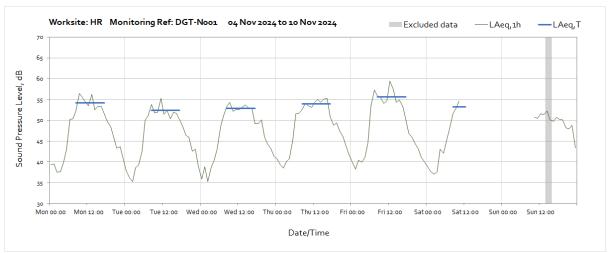
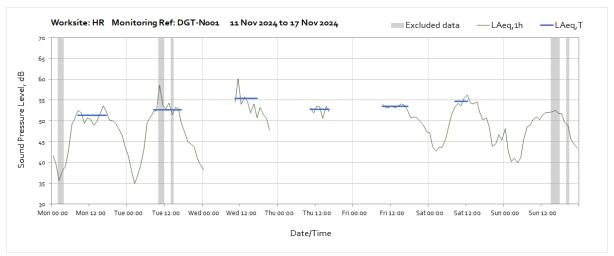
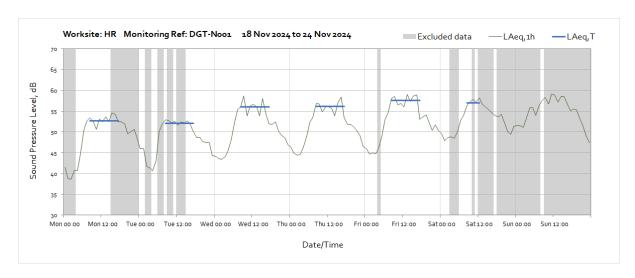
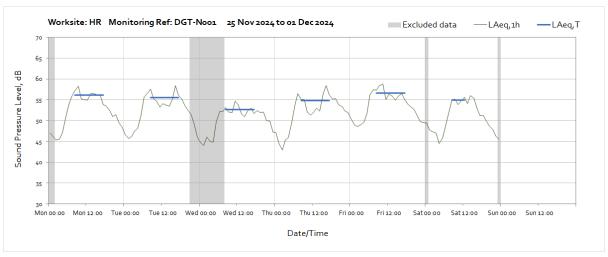
## **Worksite: HR - Monitoring Ref: DGT-N001**

Note: Missing data between 11:00 on Saturday 9<sup>th</sup> November and 10:00 on Sunday 10<sup>th</sup> November was due to depleted battery at the monitoring station.

Note: Missing data throughout the week was due to depleted battery at the monitoring station.
