# HS2

## **Construction Noise and Vibration Monthly Report – November 2024**

### Solihull Metropolitan Borough Council

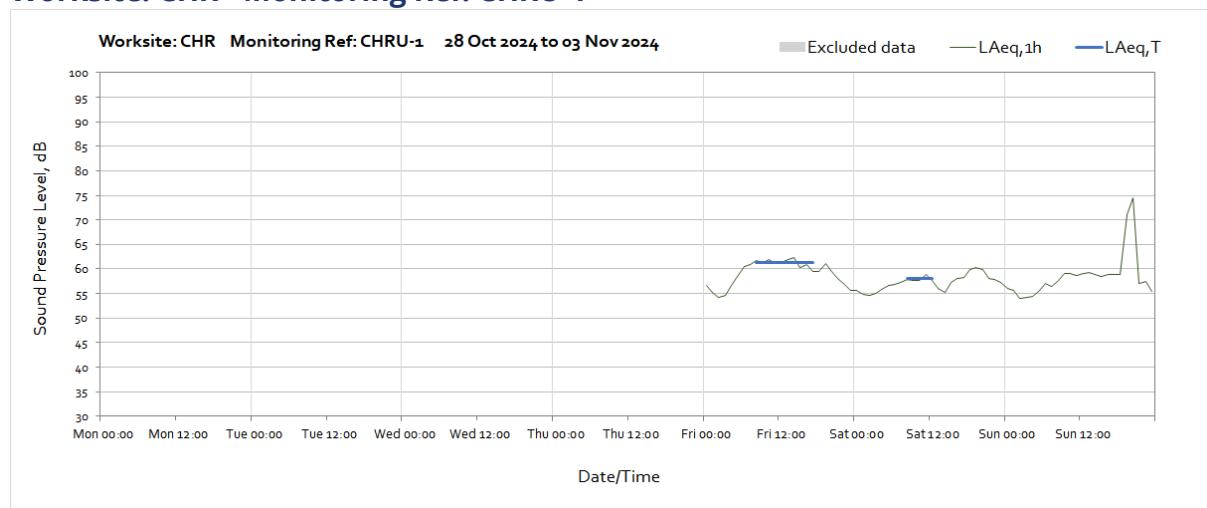
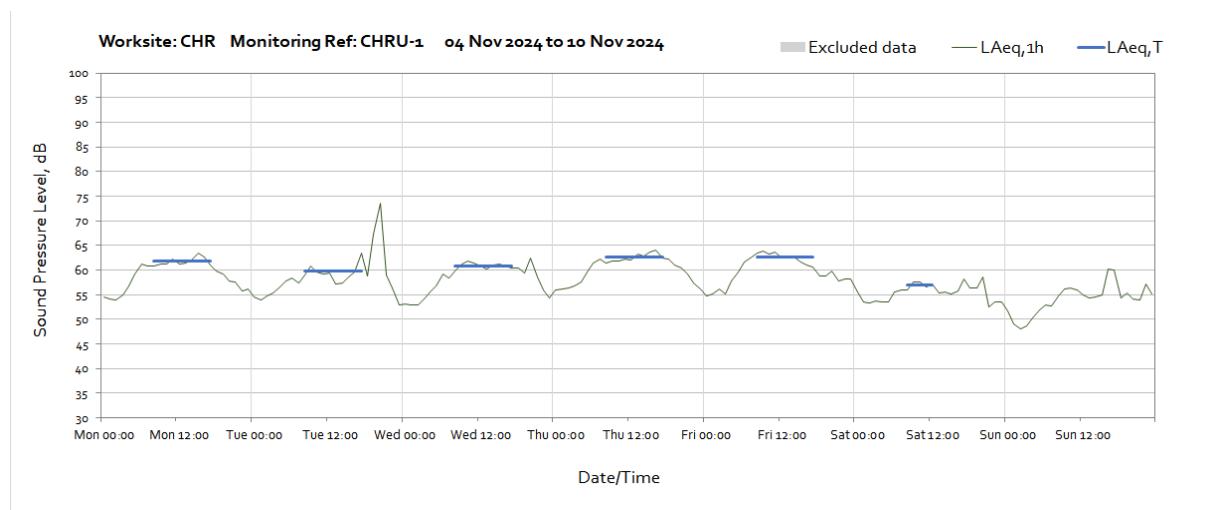
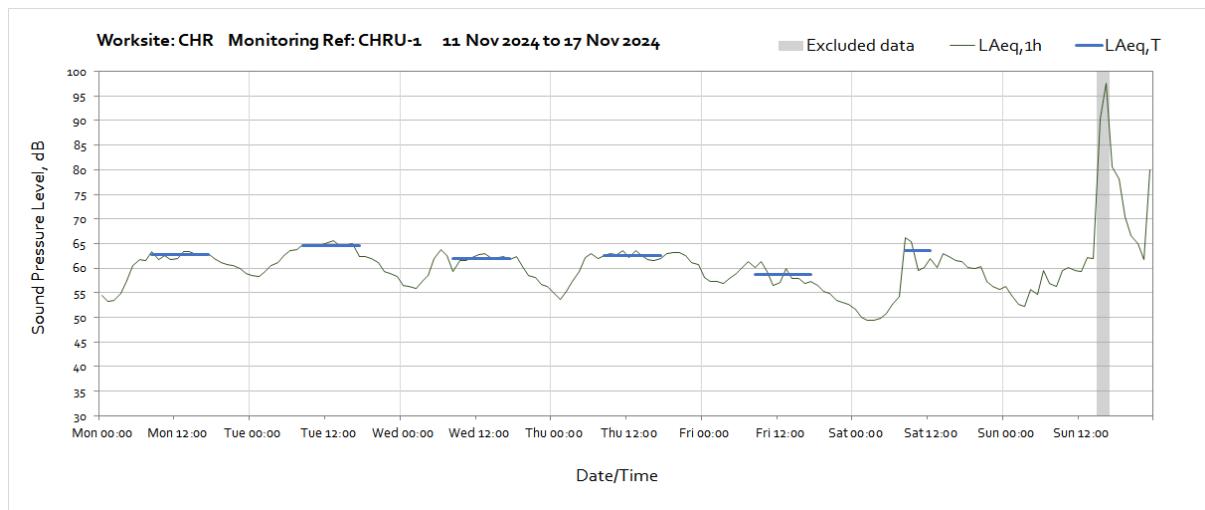
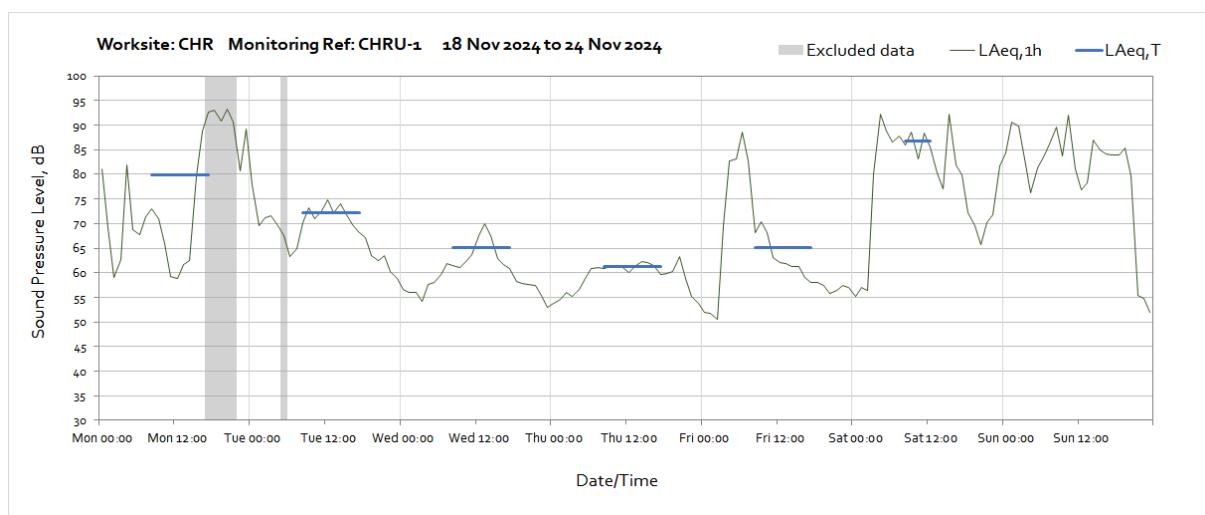
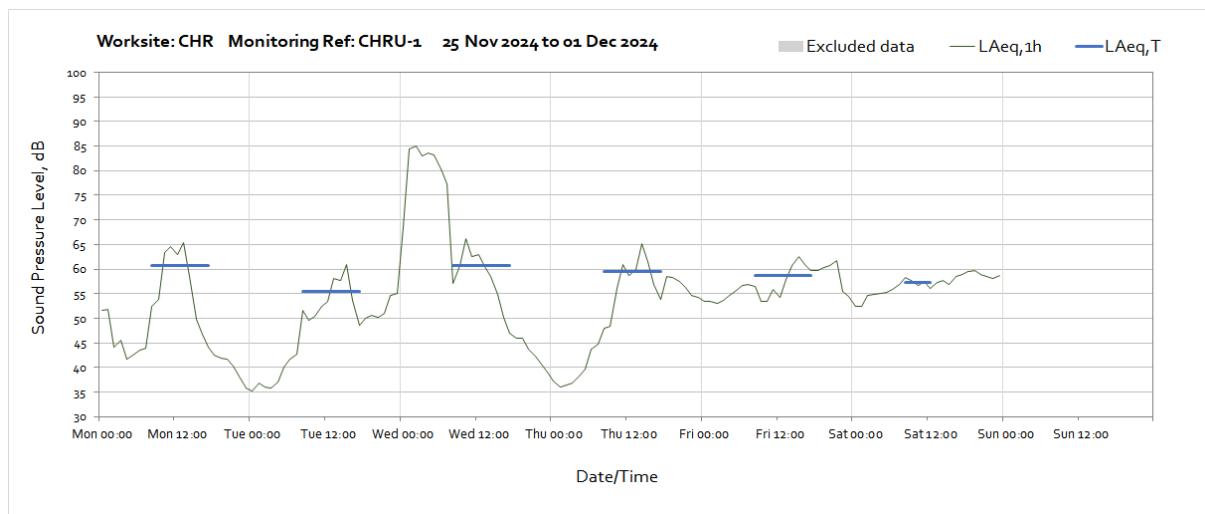
### Worksite: CHR - Monitoring Ref: CHRU-1

The following graphs show the hourly measured ambient noise level  $L_{Aeq,1h}$  and, where relevant, the averaged noise level  $L_{Aeq,T}$  values, where the time period T is as specified in Table 1 of HS2 Information Paper E23. Periods where noise levels are adversely affected by weather or only measured for part of the period, which are not representative of HS2 construction works, have been greyed out and excluded from the calculation of the  $L_{Aeq,T}$  values in the main report.

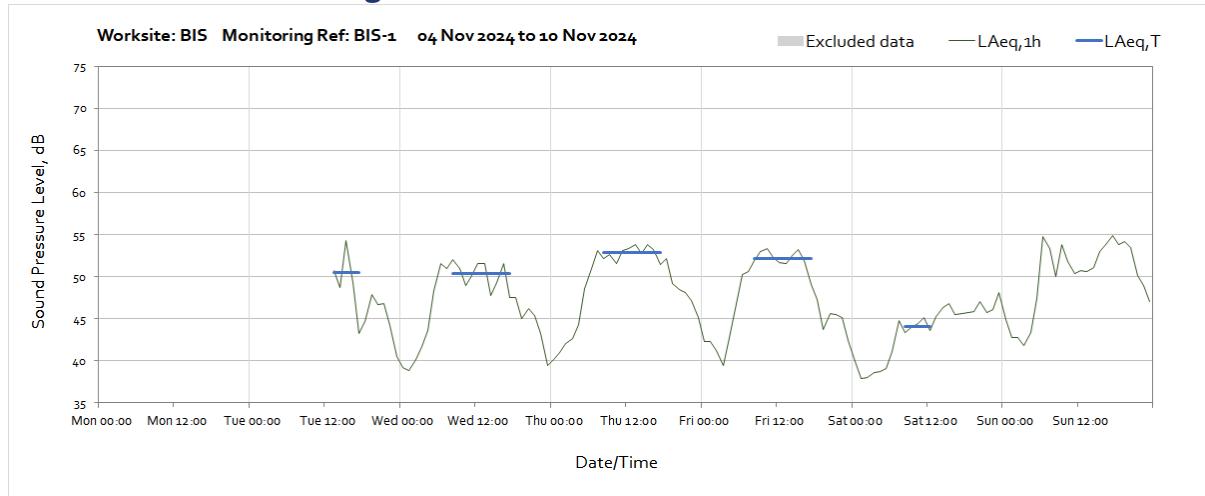
### Worksite: BIS- Monitoring Ref: BIS-1

Note: Missing data from the beginning of the month until 13:00 on Tuesday 5<sup>th</sup> November was due to a hardware issue at the monitoring station.

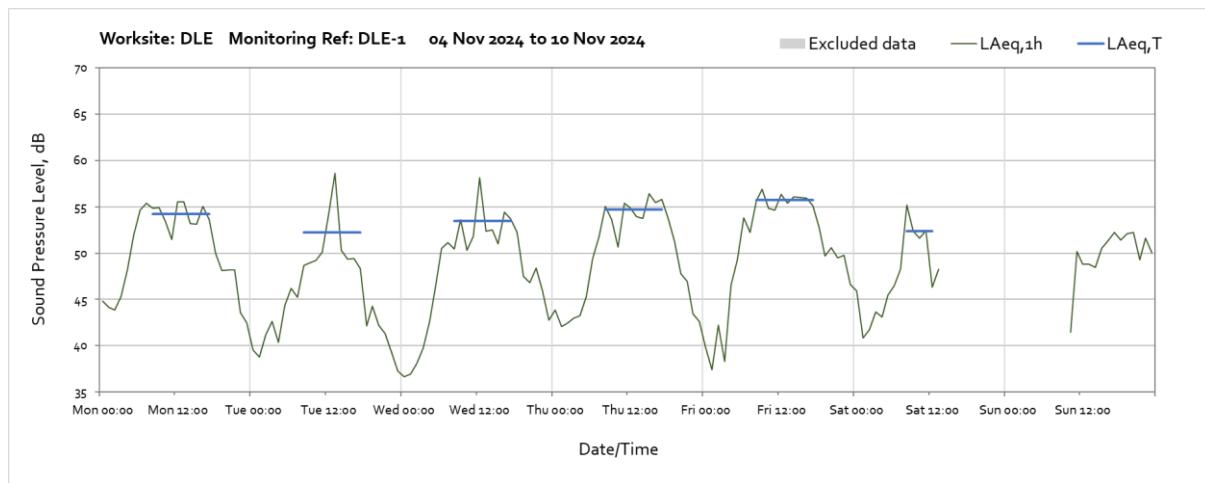
### Worksite: DLE - Monitoring Ref: DLE-1

Note: Missing data between 14:00 on Saturday 9<sup>th</sup> and 10:00 on Sunday 10<sup>th</sup> November was due to a system error at the monitoring station.

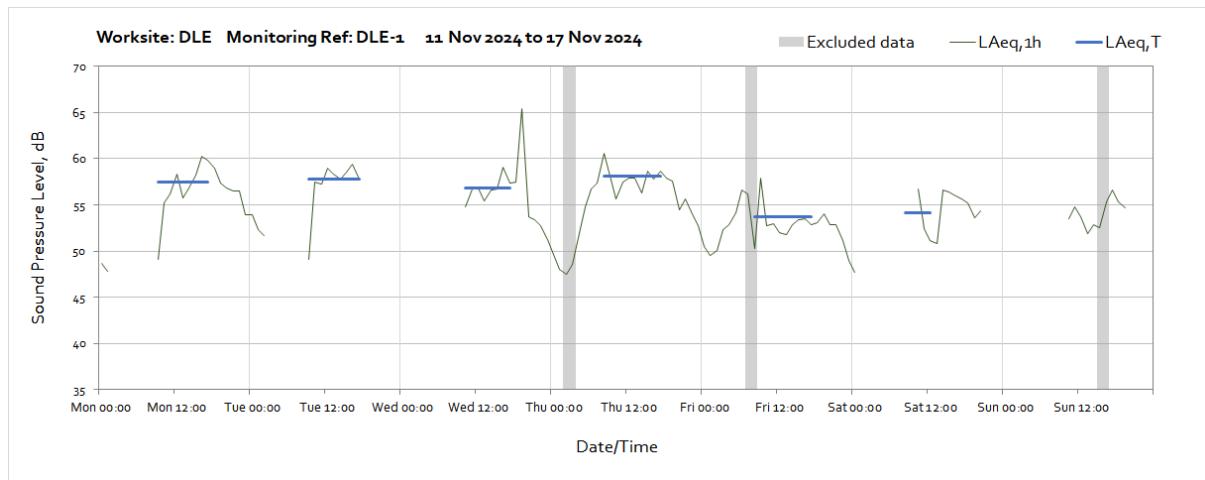
Note: Missing data throughout the week was due to a system error at the monitoring station.

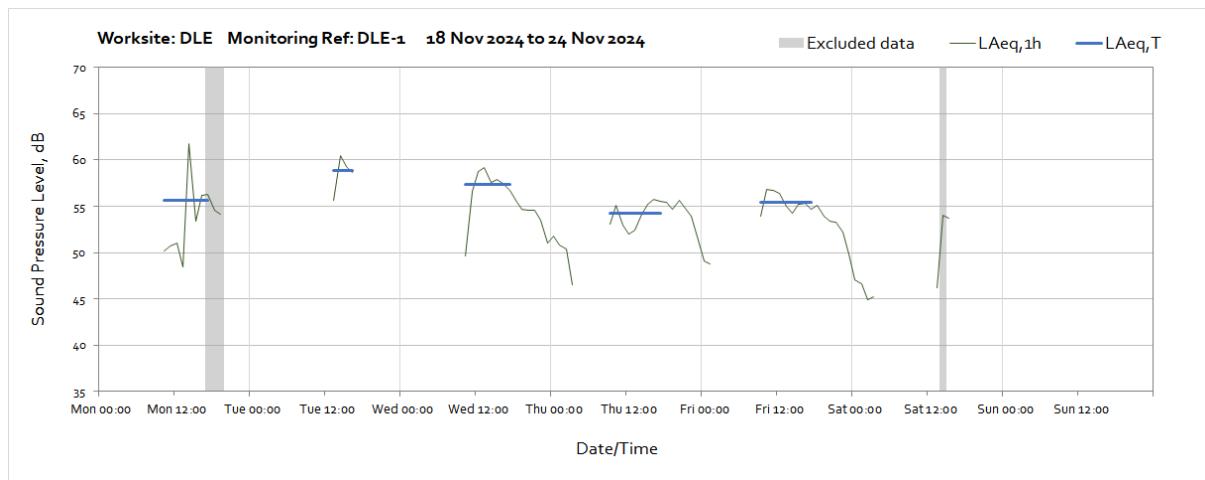
Note: Missing data throughout the week was due to a system error at the monitoring station.

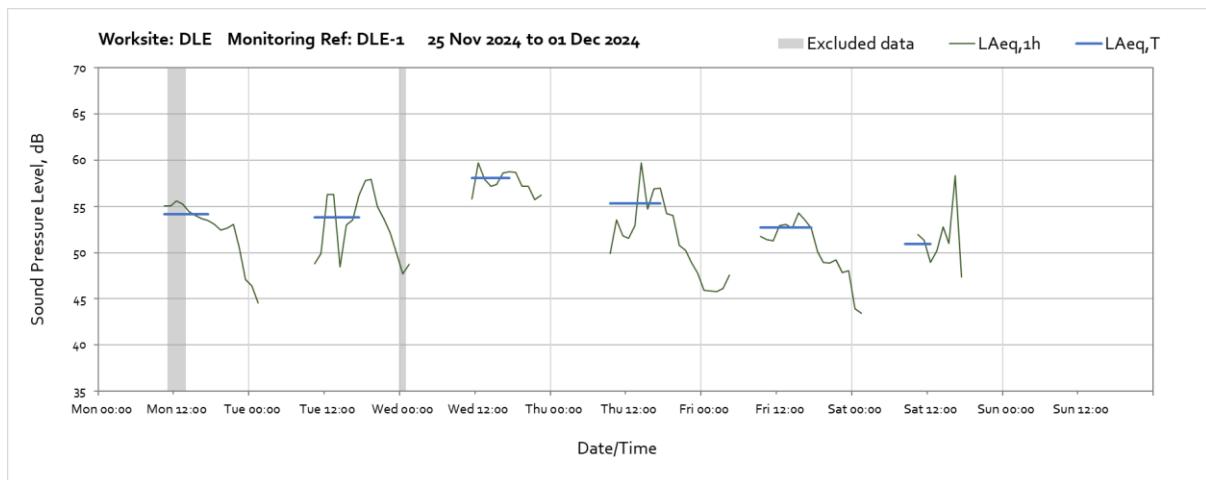
Note: Missing data throughout the week was due to a system error at the monitoring station.

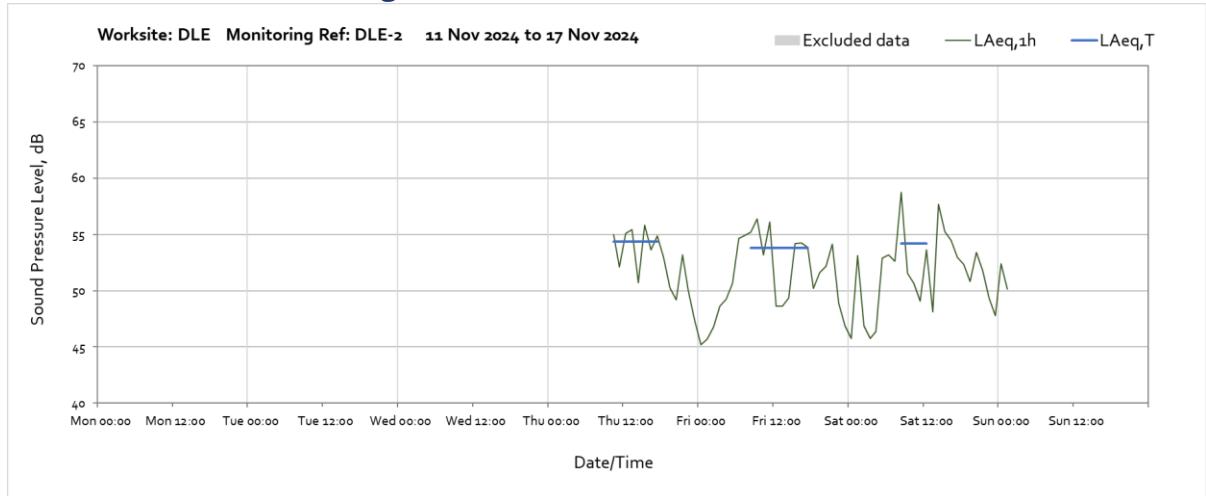
### Worksite: DLE - Monitoring Ref: DLE-2

Note: Missing data from the beginning of the month until 10:00 on Thursday 14<sup>th</sup> November and from 02:00 on Sunday 17<sup>th</sup> November until the end of the month was due to poor solar conditions impacting power supply to the monitoring station.

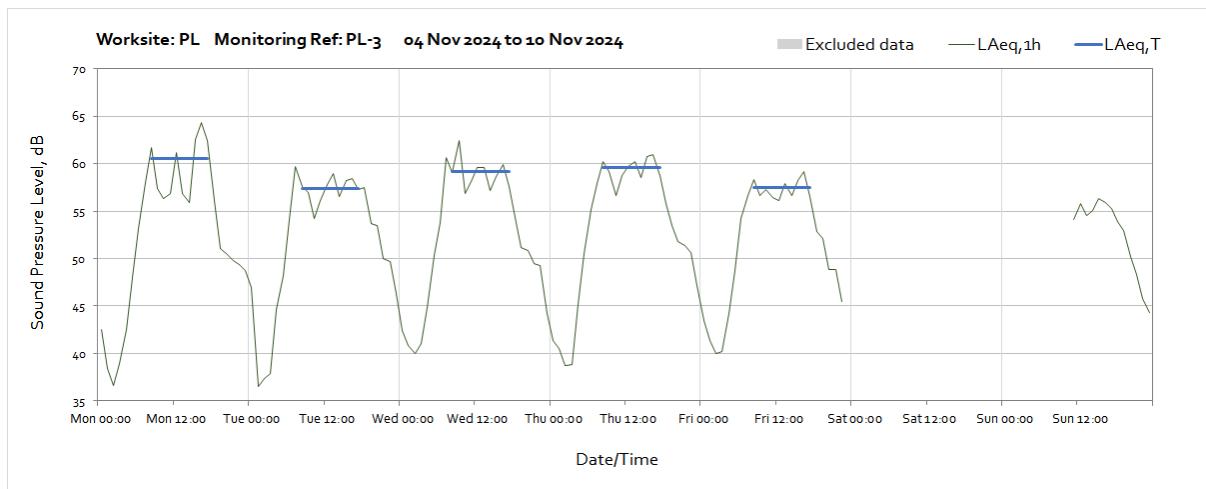
Note: Missing data between 23:00 on Friday 8<sup>th</sup> and 11:00 on Sunday 10<sup>th</sup> November was due to poor solar conditions impacting power supply to the monitoring station.

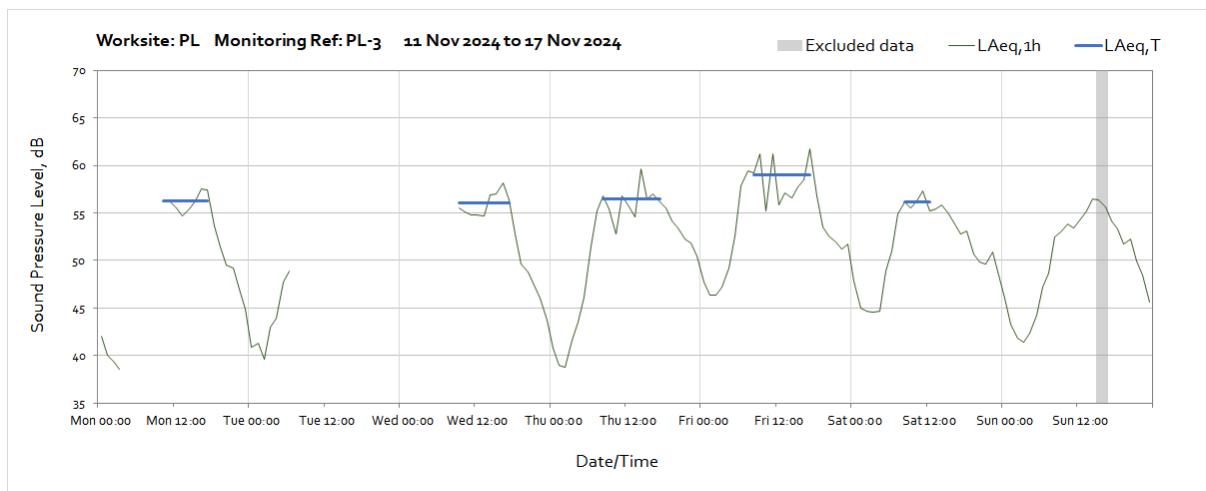
Note: Missing data between 04:00 and 10:00 on Monday 11<sup>th</sup> November and between 07:00 on Tuesday 12<sup>th</sup> and 09:00 on Wednesday 13<sup>th</sup> November was due to poor solar conditions impacting power supply to the monitoring station.

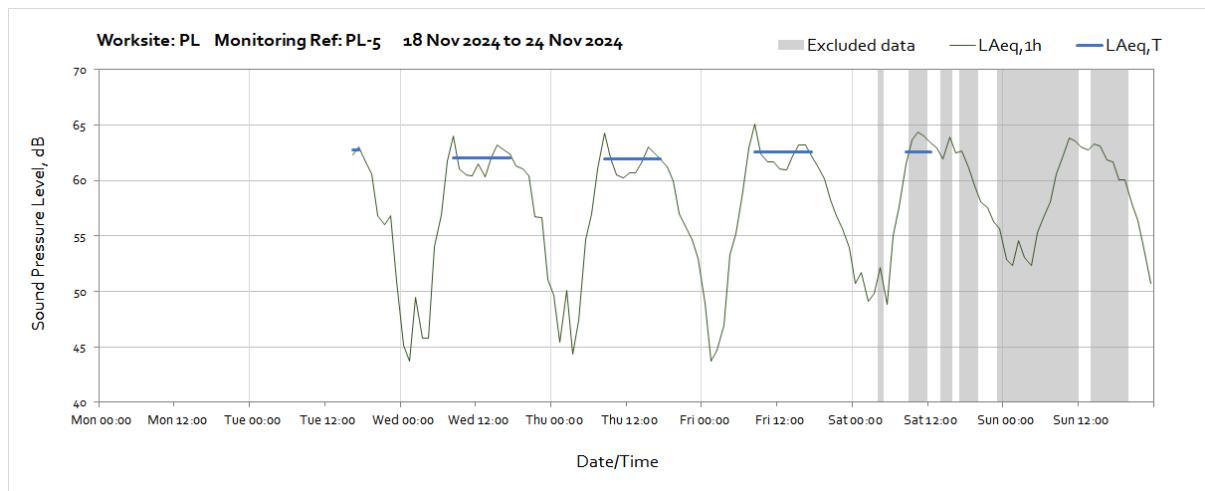
## Worksite: PL – Monitoring Ref: PL-5

Note: Missing data from the beginning of the month until 16:00 on Tuesday 19<sup>th</sup> November was due to damage to the monitoring system.

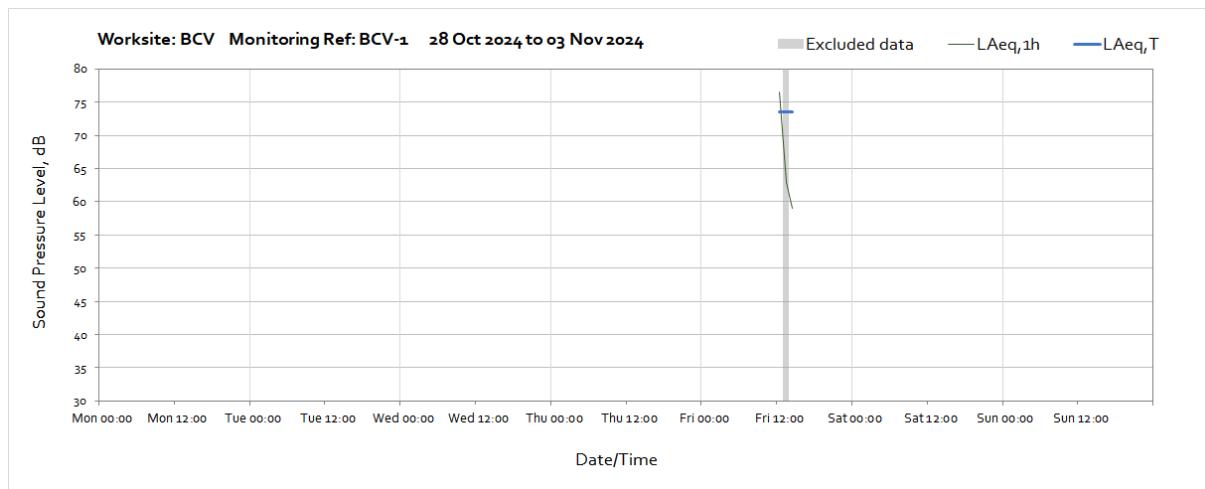
## Worksite: BCV – Monitoring Ref: BCV-1

Note: Missing data throughout the week was due to poor solar conditions impacting power supply to the monitoring station.

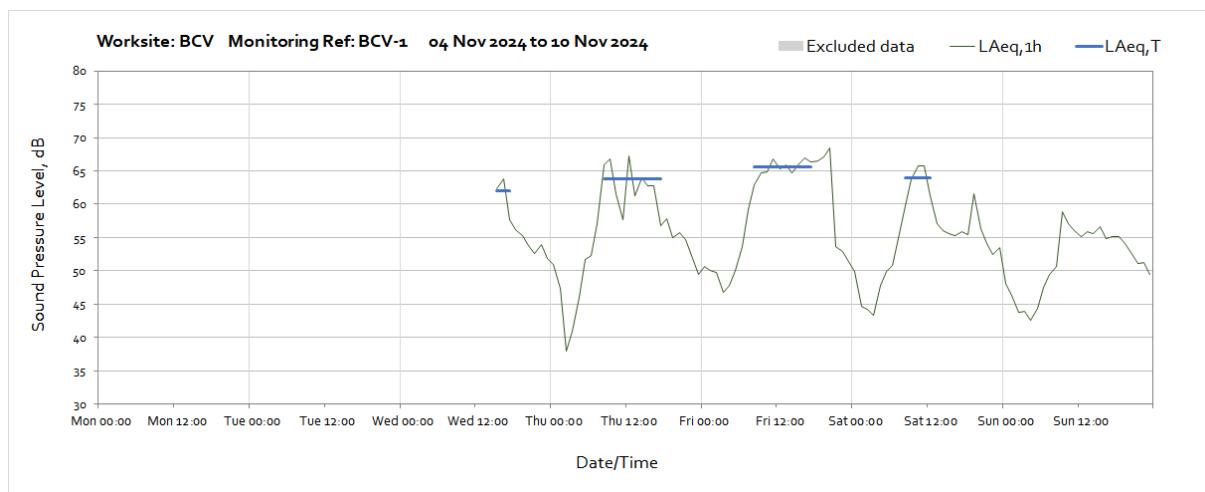
Note: Missing data between 15:00 on Friday 1<sup>st</sup> and 15:00 on Wednesday 6<sup>th</sup> November was due to poor solar conditions impacting power supply to the monitoring station.

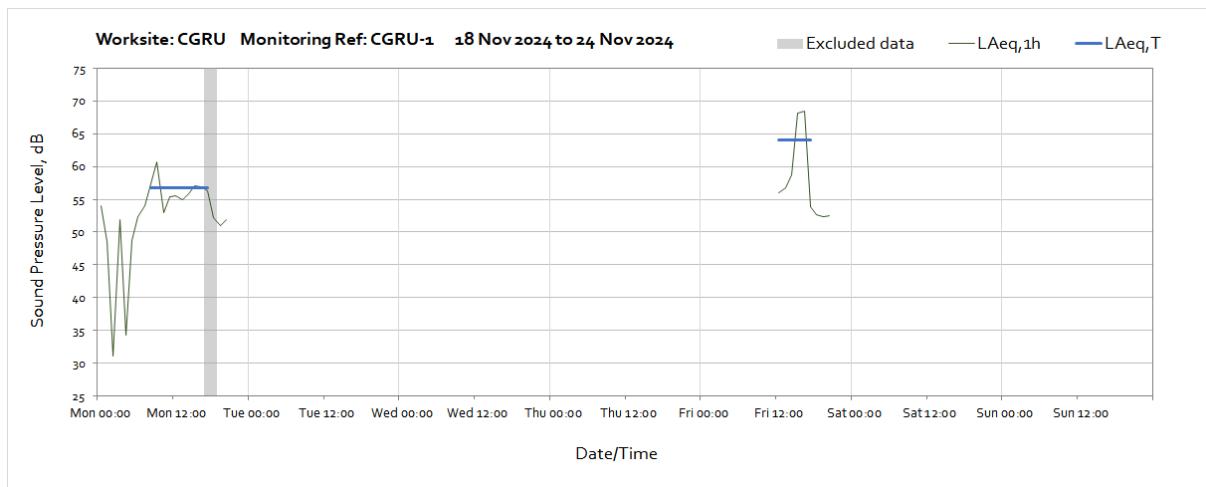
Note: Missing data between 21:00 on Monday 18<sup>th</sup> and 12:00 on Friday 22<sup>nd</sup> November and between 21:00 on Friday 22<sup>nd</sup> and 12:00 on Wednesday 27<sup>th</sup> November was due to poor solar conditions impacting power supply to the monitoring station.

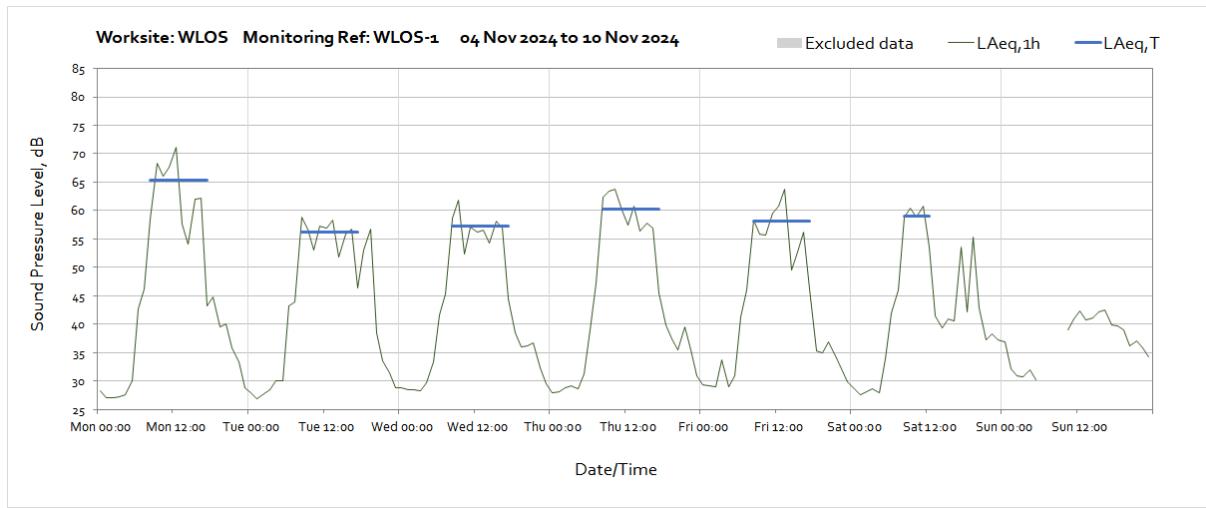
Note: Missing data between 06:00 and 10:00 on Sunday 10<sup>th</sup> November was due to poor solar conditions impacting power supply to the monitoring station.

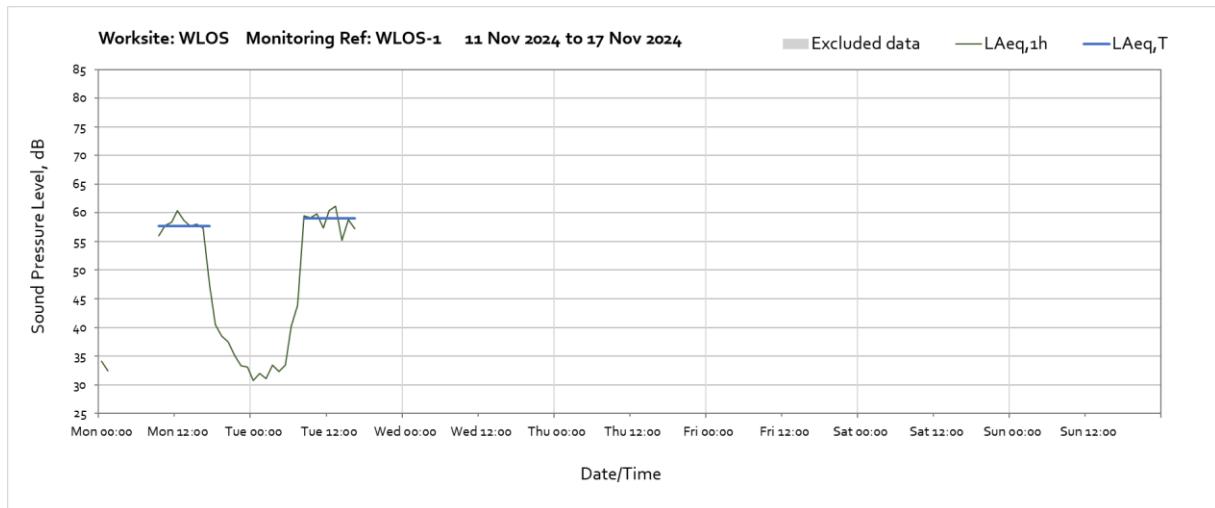
Note: Missing data between 02:00 and 09:00 on Monday 11<sup>th</sup> November and between 17:00 on Tuesday 12<sup>th</sup> and 12:00 on Monday 25<sup>th</sup> November was due to poor solar conditions impacting power supply to the monitoring station.

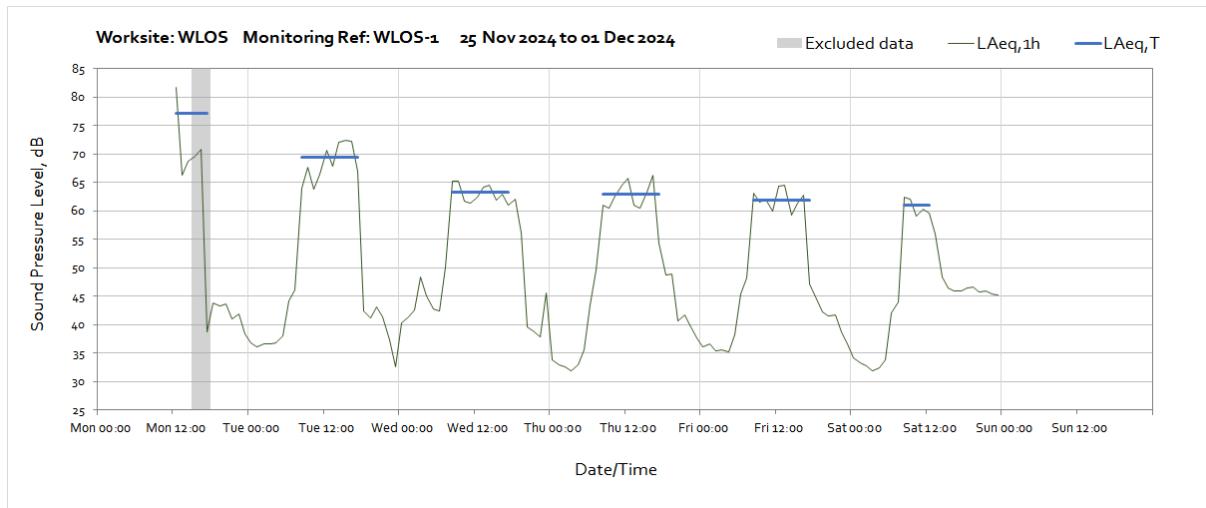
Note: Missing data between 17:00 on Tuesday 12<sup>th</sup> and 12:00 on Monday 25<sup>th</sup> November was due to poor solar conditions impacting power supply to the monitoring station.

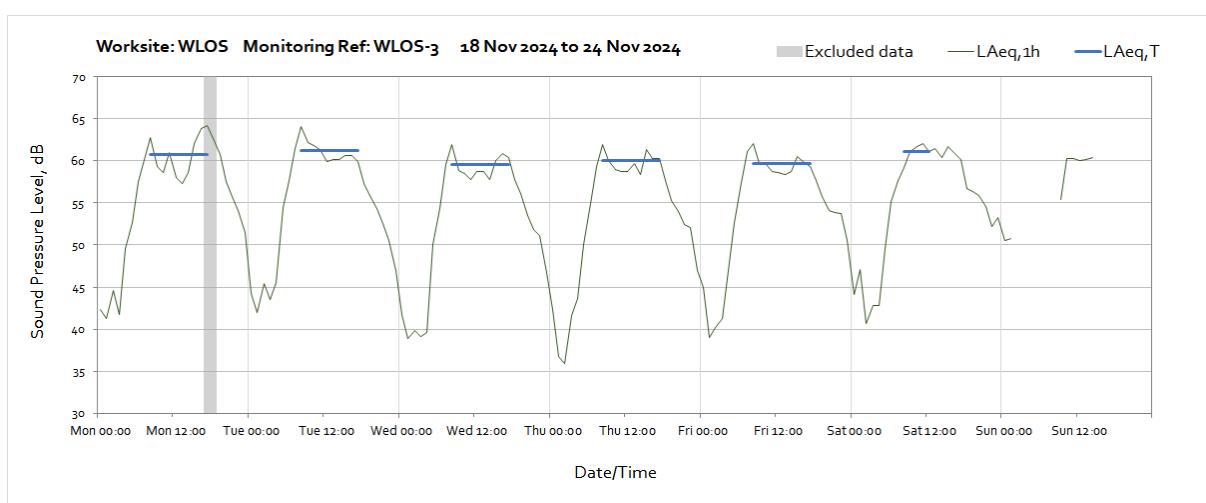
Note: Missing data between 02:00 and 08:00 on Sunday 24<sup>th</sup> November and between 15:00 on Sunday 24<sup>th</sup> and 08:00 on Monday 25<sup>th</sup> November was due to poor solar conditions impacting power supply to the monitoring station.

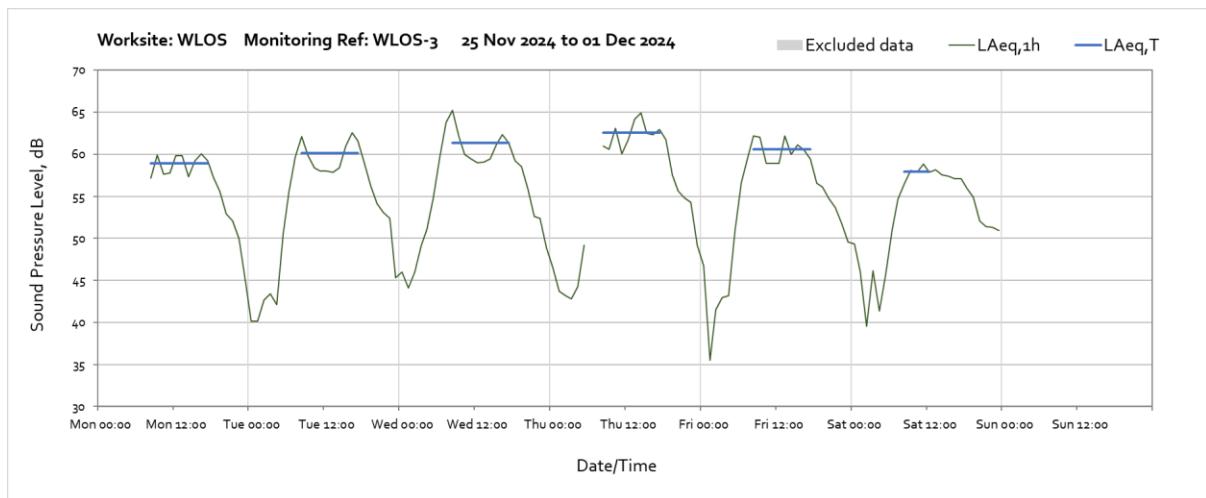
Note: Missing data between 15:00 on Sunday 24<sup>th</sup> and 08:00 on Monday 25<sup>th</sup> November and between 06:00 and 08:00 on Thursday 28<sup>th</sup> November was due to poor solar conditions impacting power supply to the monitoring station.

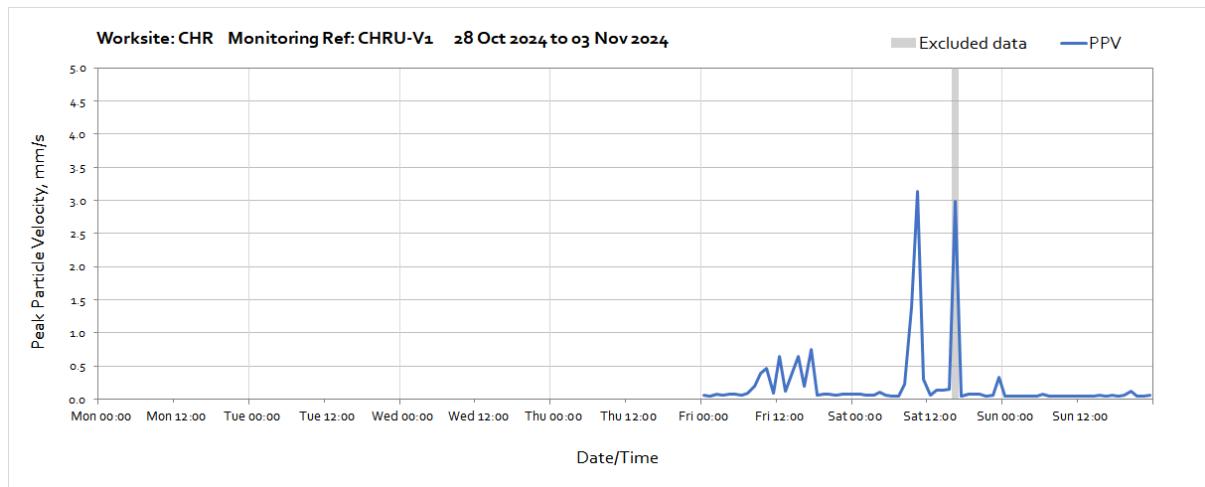
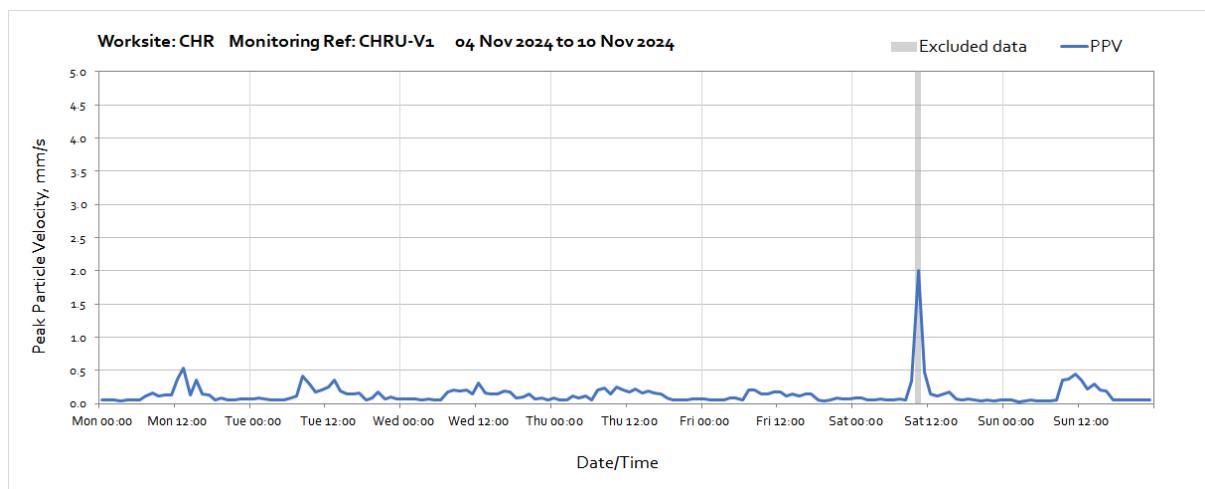
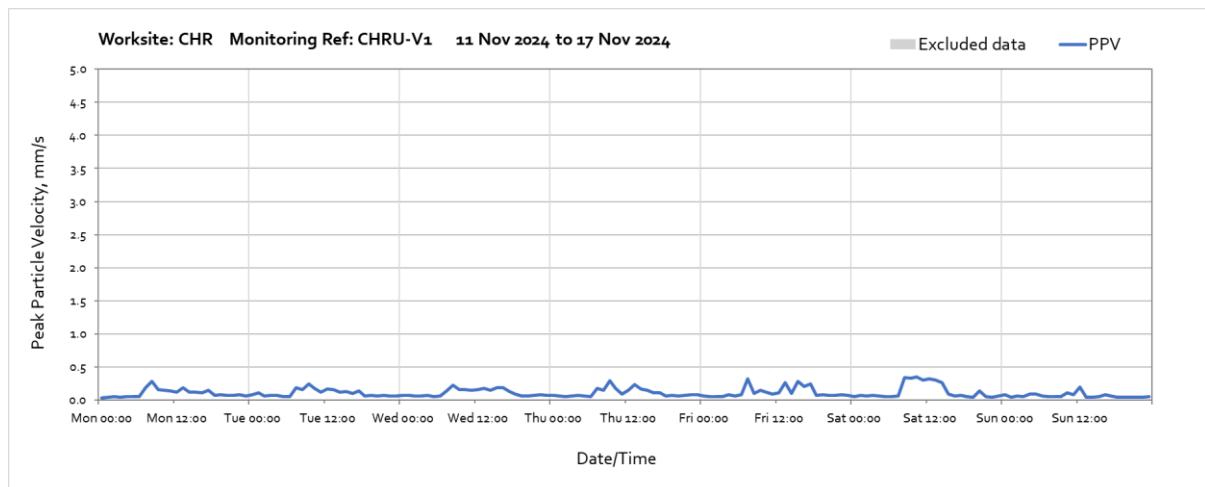
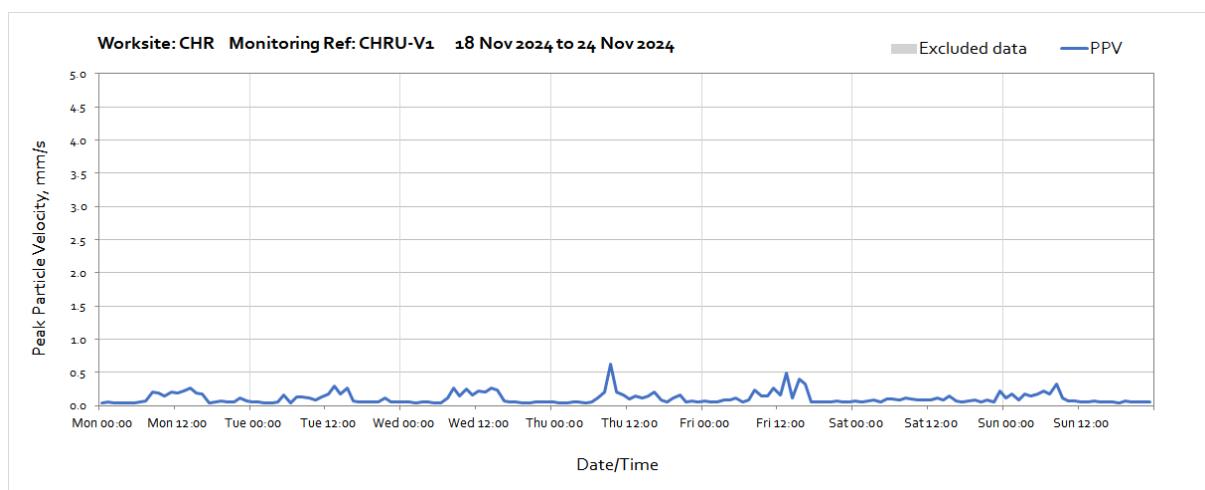
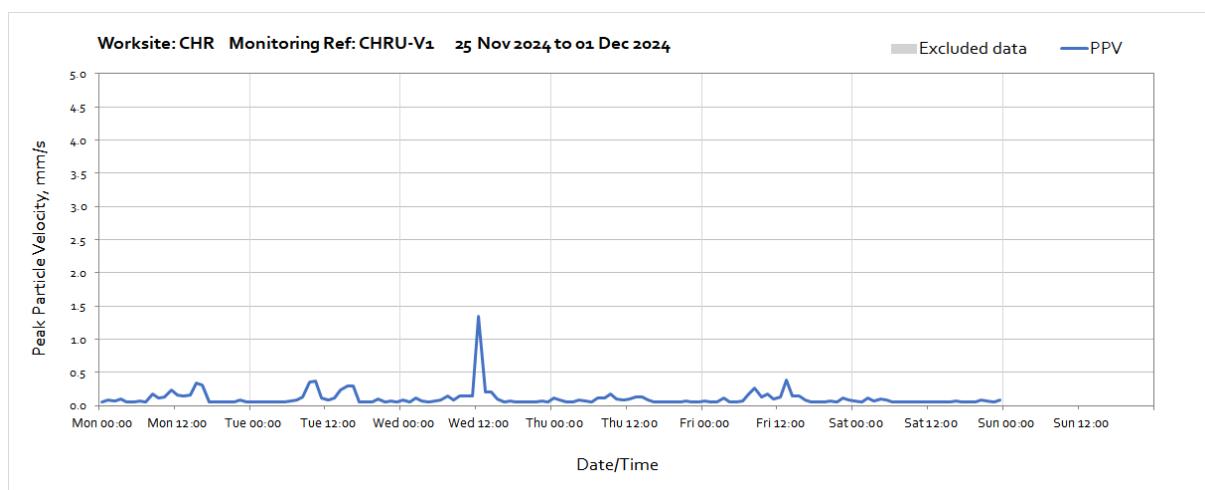
### Worksite: CHR – Monitoring Ref: CHRU-V1

The following graphs show the hourly measured peak particle velocity PPV recorded during the monitoring period. The graphs show the highest PPV of the three orthogonal axes x, y and z. Periods where PPV values have been affected by local interference with the vibration monitor or only measured for part of the period, which are not representative of HS2 construction works, have been greyed out and excluded when calculating values in of the main report.

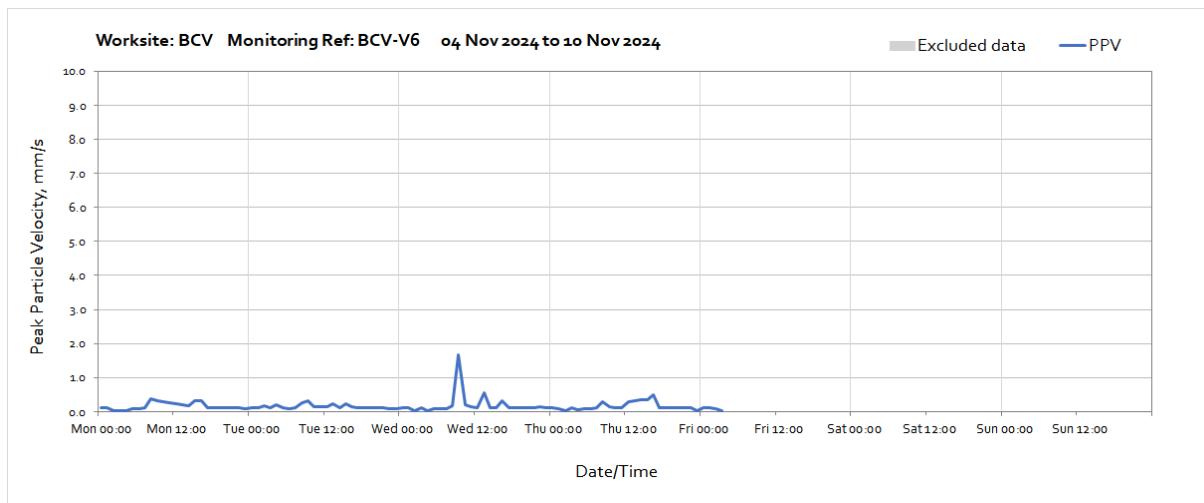
Note: Missing data between 04:00 on Friday 8<sup>th</sup> and 11:00 on Thursday 14<sup>th</sup> November was due to poor solar conditions impacting power supply to the monitoring station.

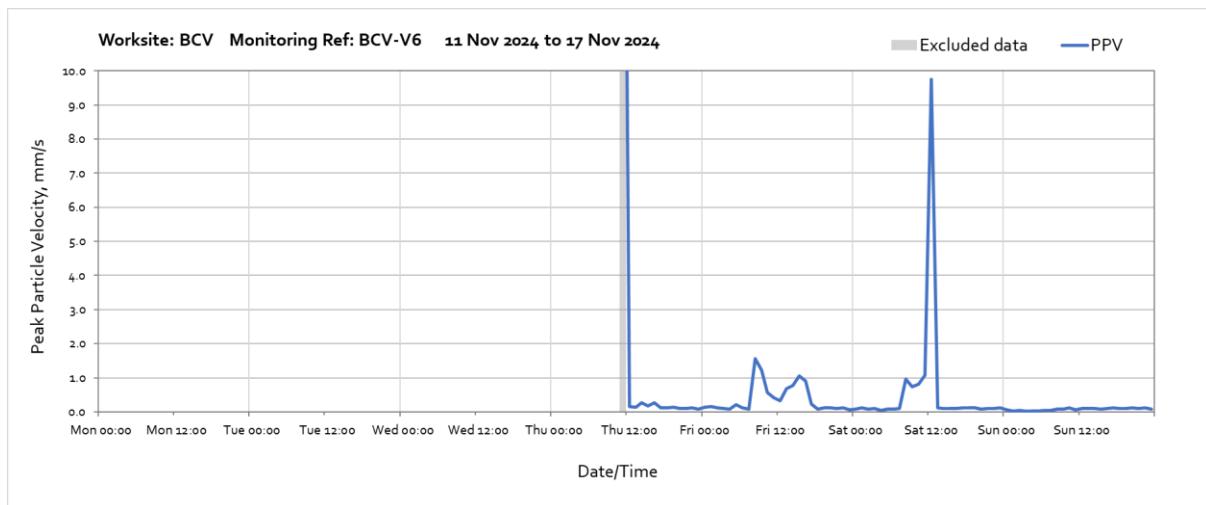
Note: Missing data between 04:00 on Friday 8<sup>th</sup> and 11:00 on Thursday 14<sup>th</sup> November was due to poor solar conditions impacting power supply to the monitoring station.

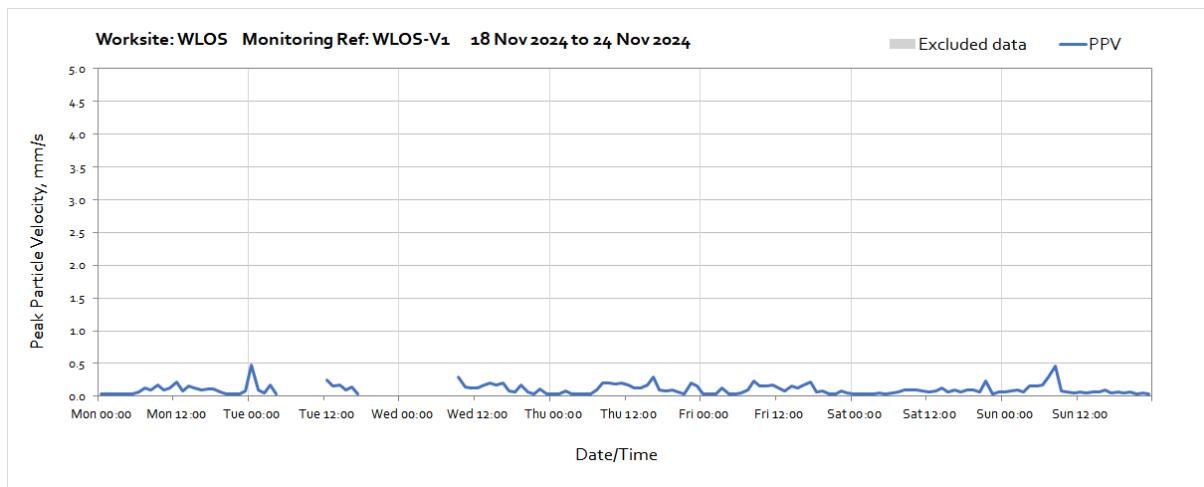
Note: Missing data between 04:00 and 12:00 on Tuesday 19<sup>th</sup> November and between 18:00 on Tuesday 19<sup>th</sup> and 09:00 on Wednesday 20<sup>th</sup> was due to poor solar conditions impacting power supply to the monitoring station.

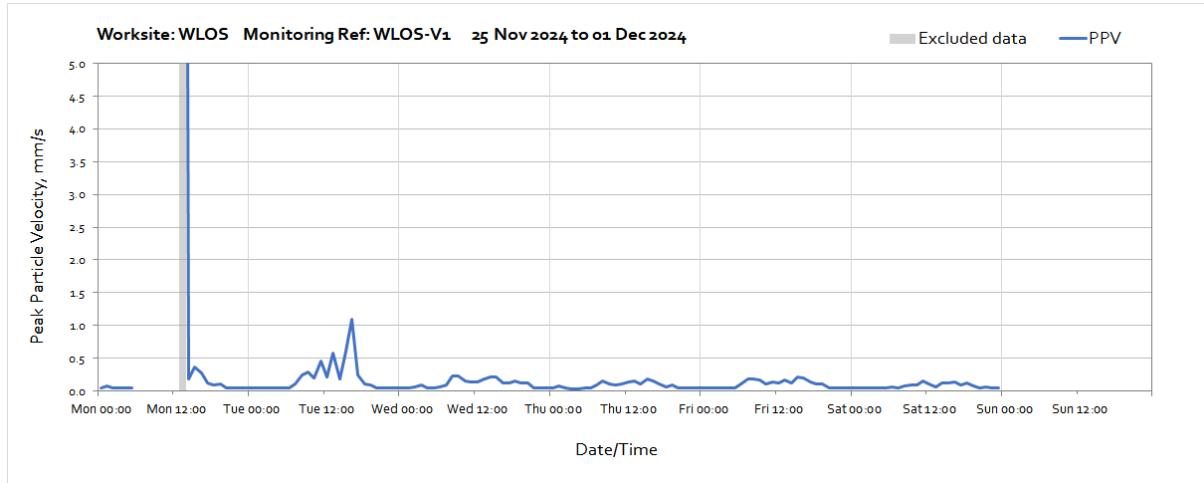
Note: Missing data between 06:00 and 13:00 on Monday 25<sup>th</sup> November was due to poor solar conditions impacting power supply to the monitoring station.
