Construction Noise and Vibration Monthly Report – November 2024

Warwick District Council

This Noise and Vibration Monitoring Report fulfils HS2 Limited's commitment detailed in the Environmental Minimum Requirements (EMRs), Annex 1, Code of Construction Practice, to present the results of noise and vibration monitoring carried out within Warwick District Council (WDC) area during the month of November 2024.

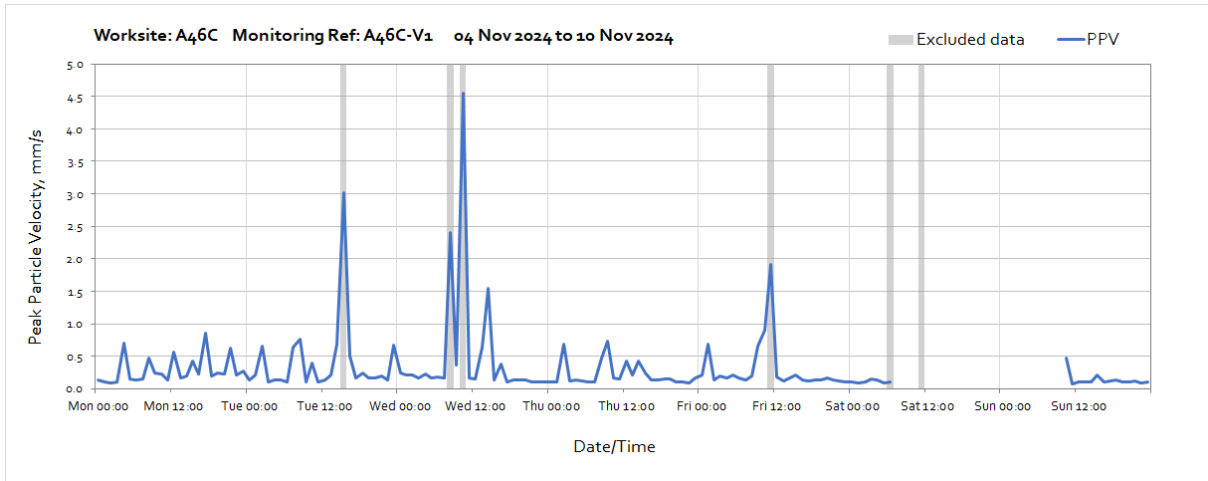
Note: Missing data throughout the week was due to a loss of power to the monitoring station caused by poor weather conditions preventing sufficient light to reach the solar panel.

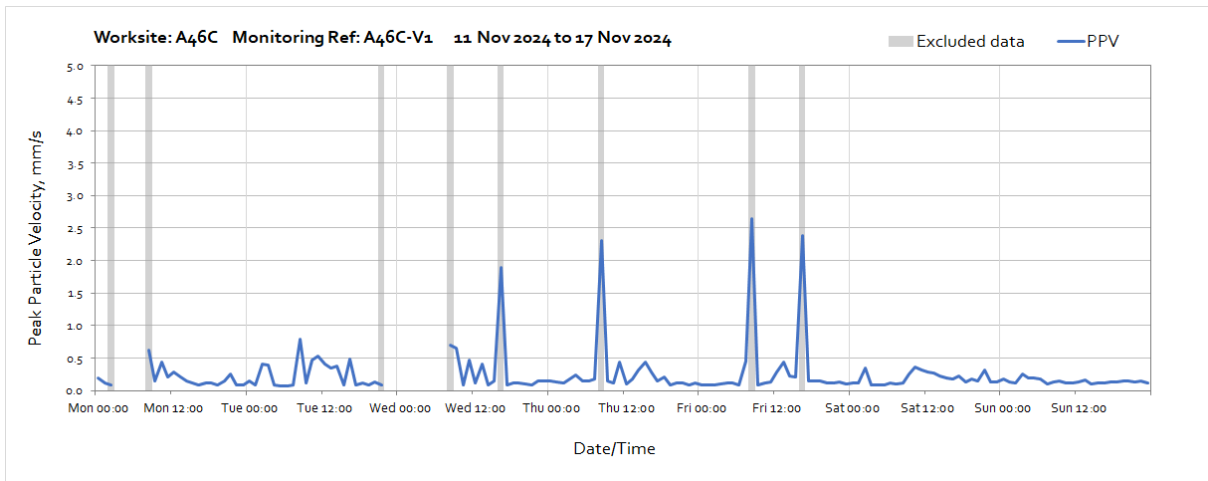
Note: Missing data throughout the week was due to a loss of power to the monitoring station caused by poor weather conditions preventing sufficient light to reach the solar panel.
