515 Stockwood Road, Brislington

Interpretive Report on Ground Investigation

Project No: 732959

Client: 515 Stockwood LLP

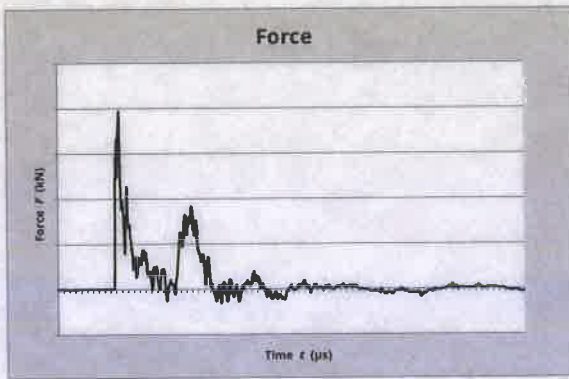
Fig. B.1 and B.2 BS EN ISO 22476-3 : 2005 + A1 : 2011

Diameter: $d_r = 0.052 \text{ m}$
 Length of the instrumented rod: 0.558 m
 Area: $A = 11.61 \text{ cm}^2$
 Modulus: $E_a = 206843 \text{ MPa}$

$E_{\text{meas}} = 0.308 \text{ kN-m}$
 $E_{\text{theor}} = 0.473 \text{ kN-m}$

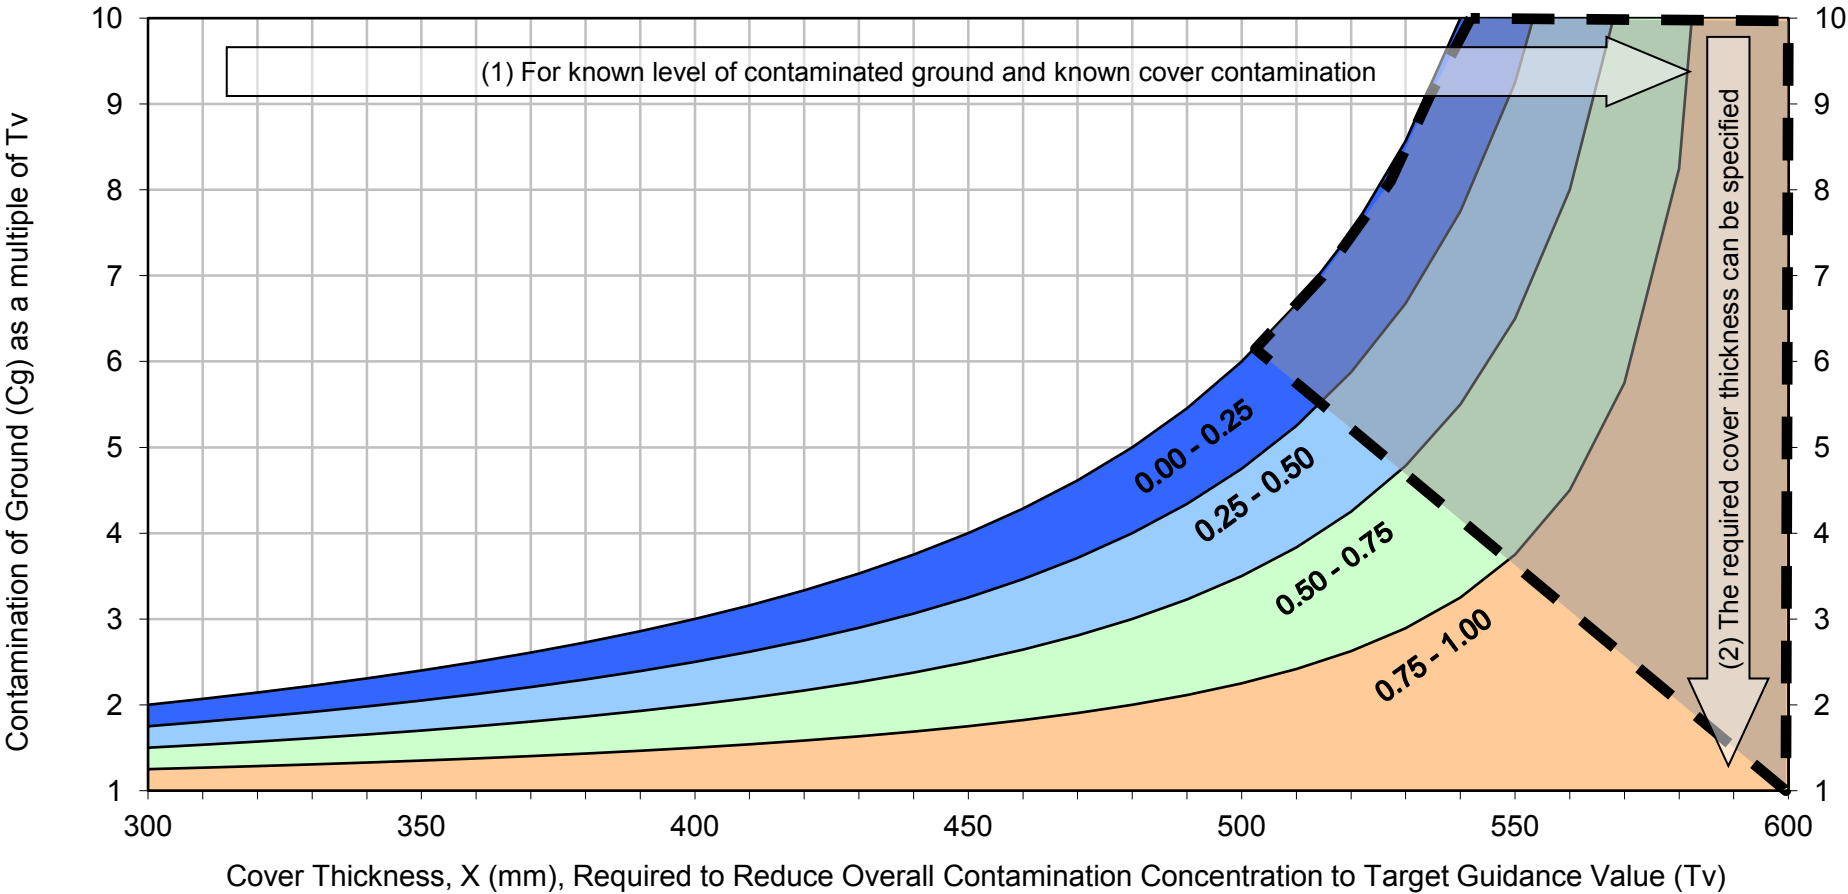
Design Chart

- $C_c = 0.00 - 0.25 \times$ Trigger levels
 - $C_c = 0.25 - 0.50 \times$ Trigger levels
 - $C_c = 0.50 - 0.75 \times$ Trigger levels
 - $C_c = 0.75 - 1.00 \times$ Trigger levels
 - ▲ Target Guideline Value 2
 - ▲ Target Guideline Value 1
- If site specific data falls in shaded area consideration should be given to the applicability of using a cover system

The required depth of clean cover can be calculated using BRE report BR465 and this gives a result of 280 mm (spreadsheet presented in Appendix E) but it should be noted that the report states that a minimum of 300mm should always be used. The viability graph shows that simple cover system is suitable. The following assumptions have been made:
