Construction Noise and Vibration Monthly Report – December 2024

London Borough of Camden

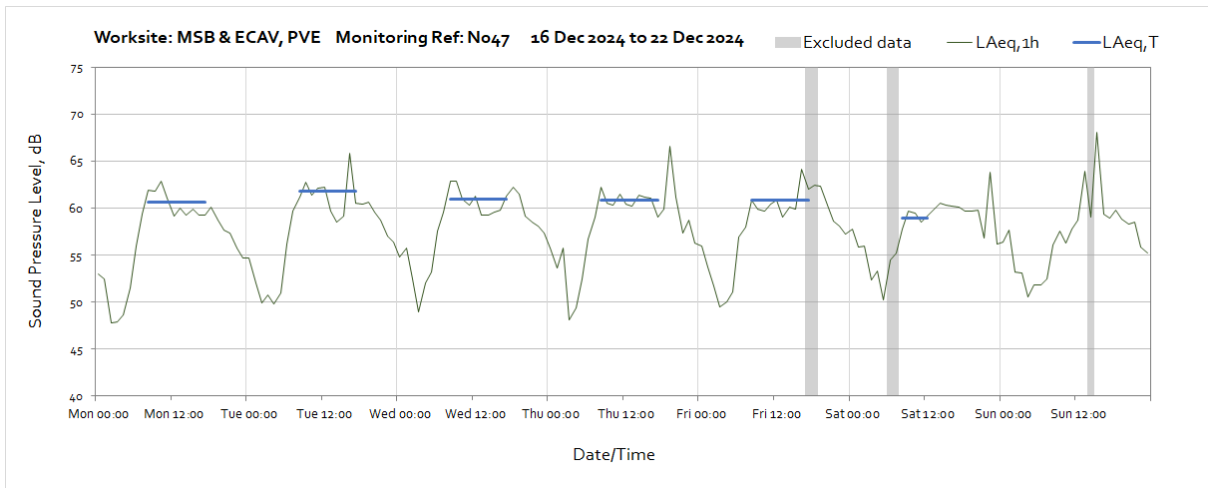
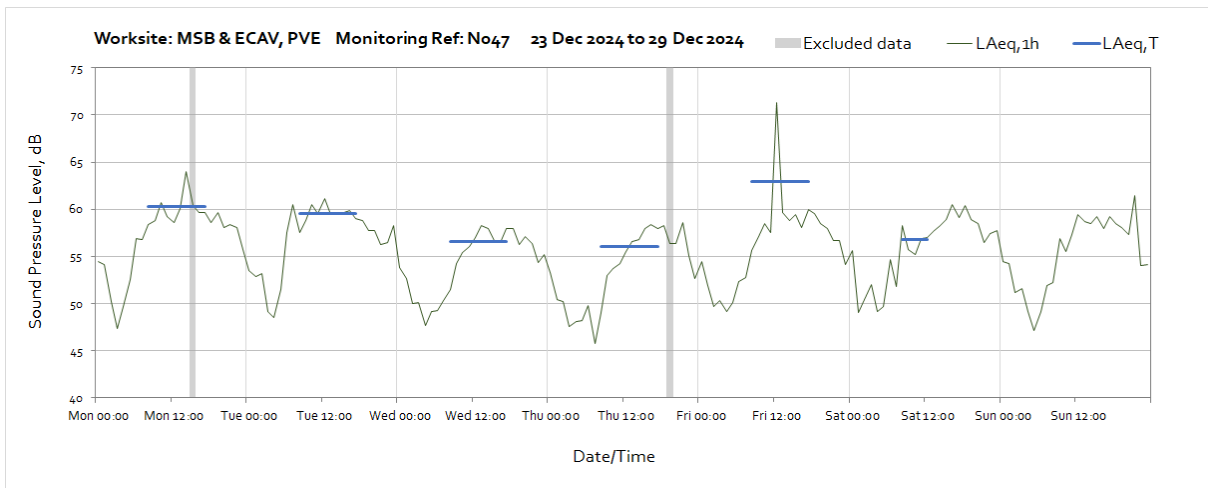
Worksite: MSB & ECAV, PVE – Monitoring Ref: N047

The following graphs show the hourly measured ambient noise level $L_{Aeq,1h}$ and, where relevant, the averaged noise level $L_{Aeq,T}$ values, where the time period T is as specified in Table 1 of HS2 Information Paper E23. Periods where noise levels are adversely affected by weather or only measured for part of the period, which are not representative of HS2 construction works, have been greyed out and excluded from the calculation of the $L_{Aeq,T}$ values in in Table 3 of the main report.
