Construction Noise and Vibration Monthly Report – December 2024

Lichfield District Council

Non-Technical Summary

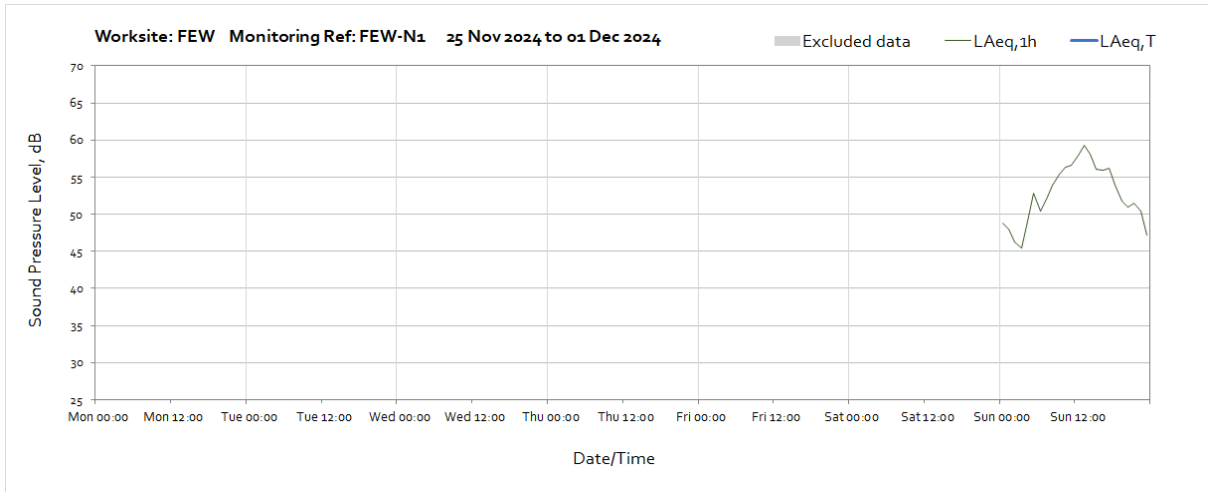
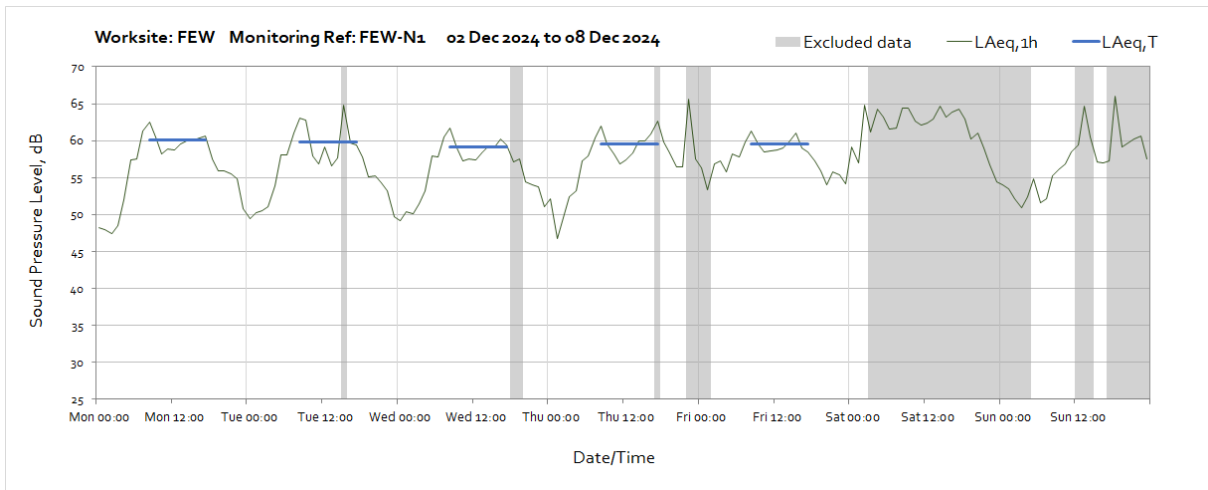
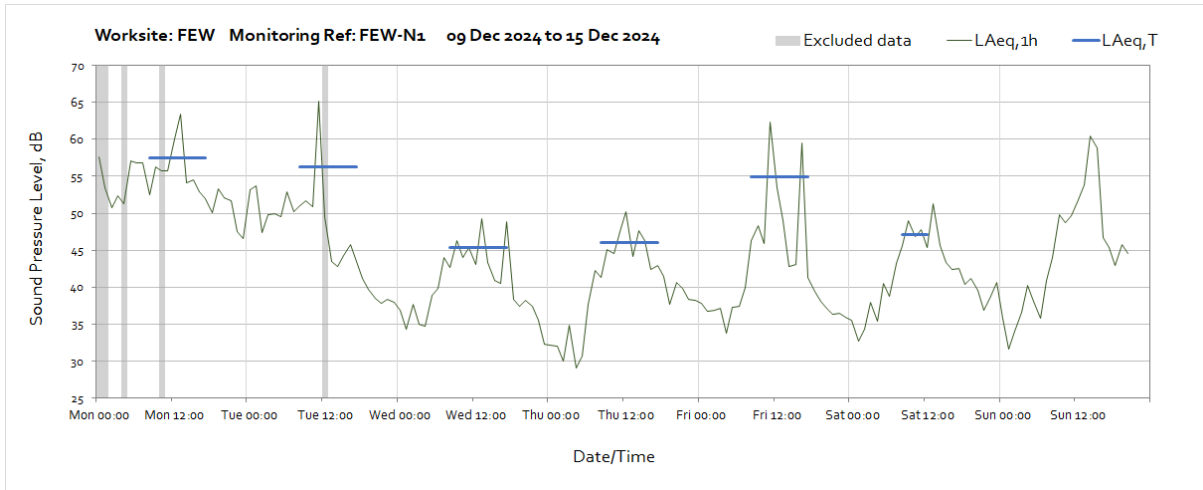
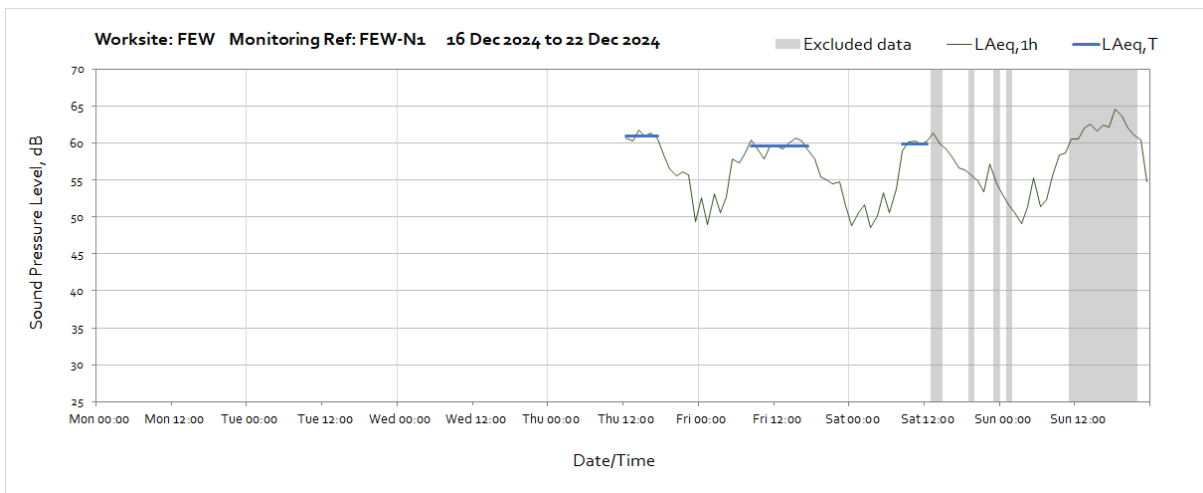
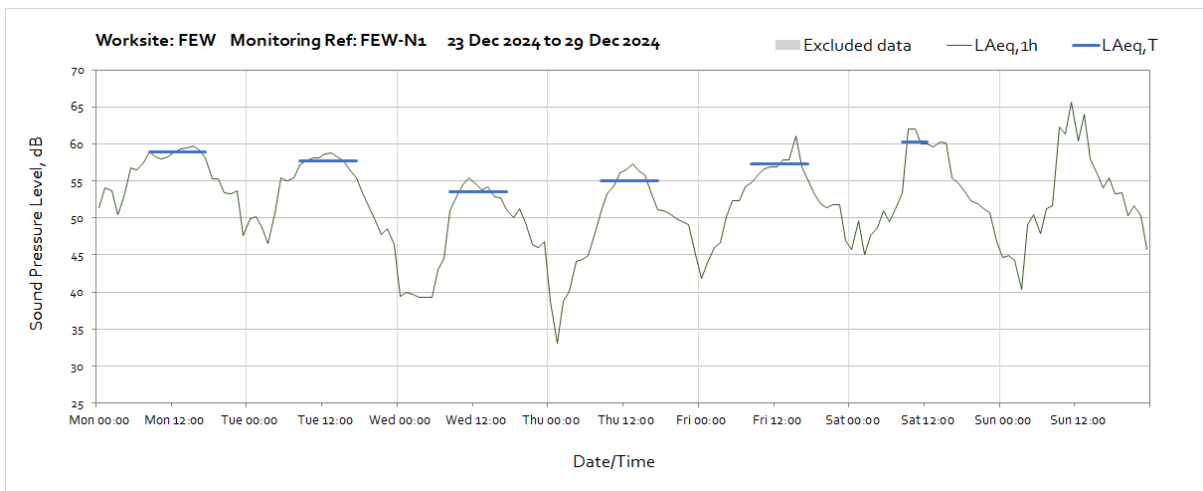
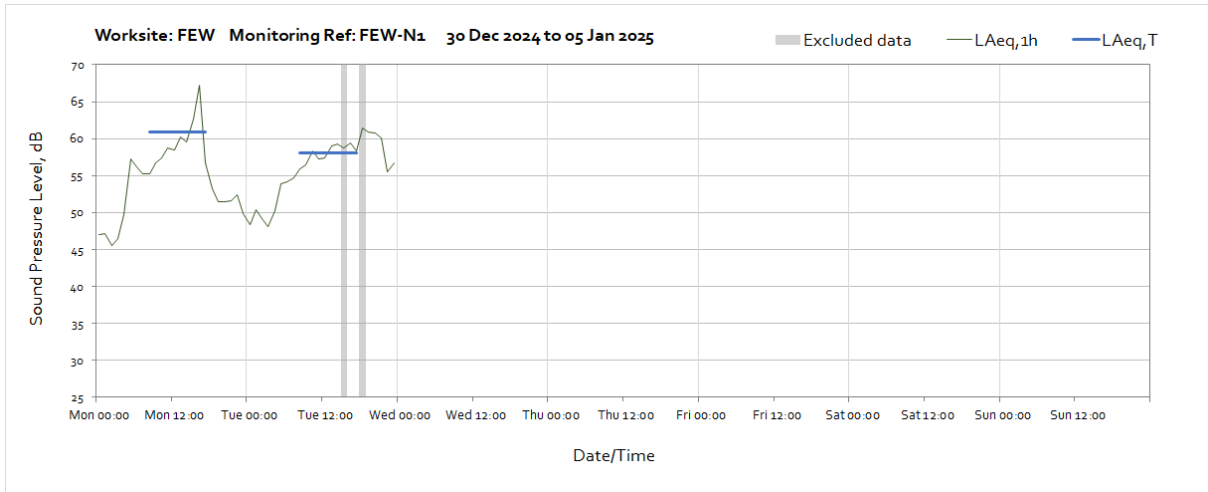
Worksite:FEW – Monitoring Ref: FEW-N1

Note: Missing data between 21:00 on Sunday 15th December and 11:00 on Thursday 19th December was due to a loss of power to the monitoring station caused by poor weather conditions preventing sufficient light reaching the solar panel.

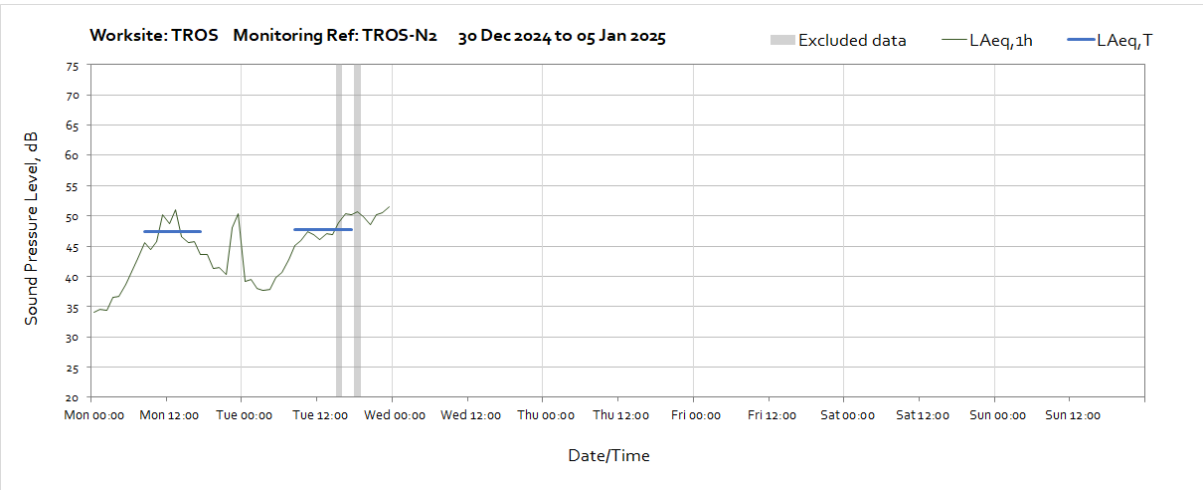
Worksite:TROS – Monitoring Ref: TROS-N2

Note: Missing data between the start of the month and 09:00 on Tuesday 3rd December was due to a loss of power to the monitoring station caused by poor weather conditions preventing sufficient light reach the solar panel.

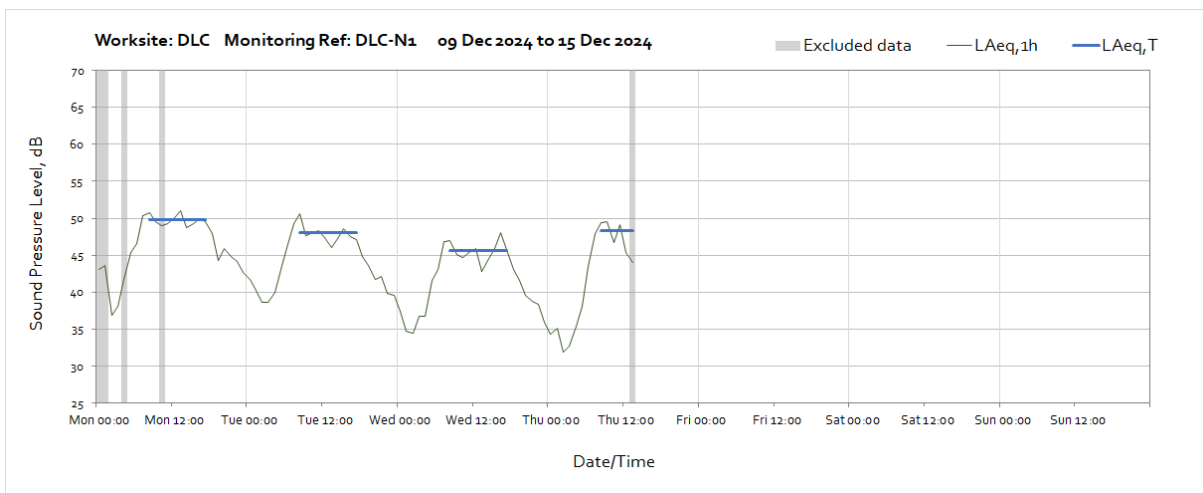
Worksite: DLC - Monitoring Ref: DLC-N1

Note: Missing data between 14:00 on Thursday 12th December and 12:00 on Thursday 19th December was due to a loss of power to the monitoring station caused by poor weather conditions preventing sufficient light reach the solar panel.

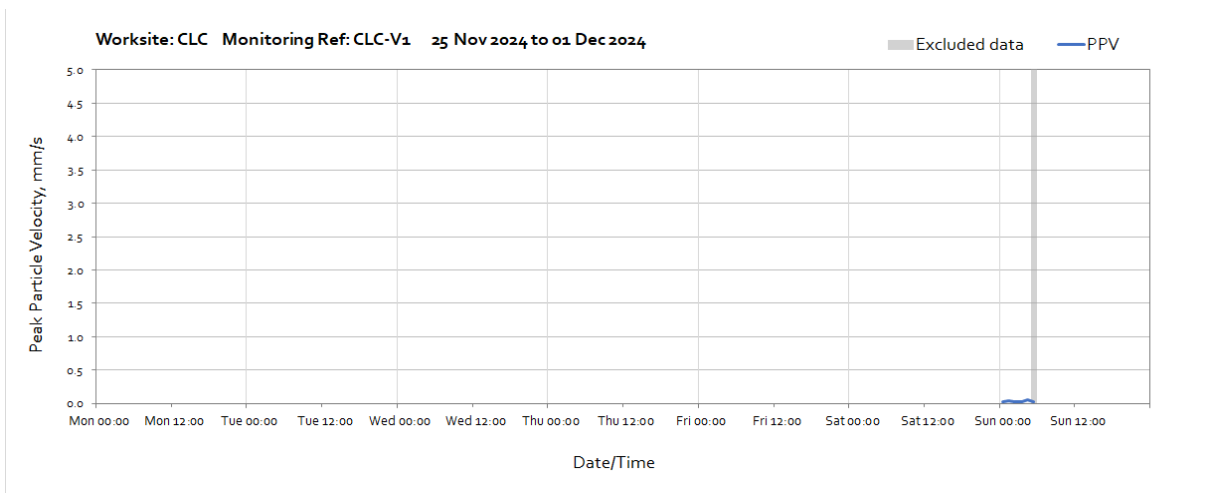
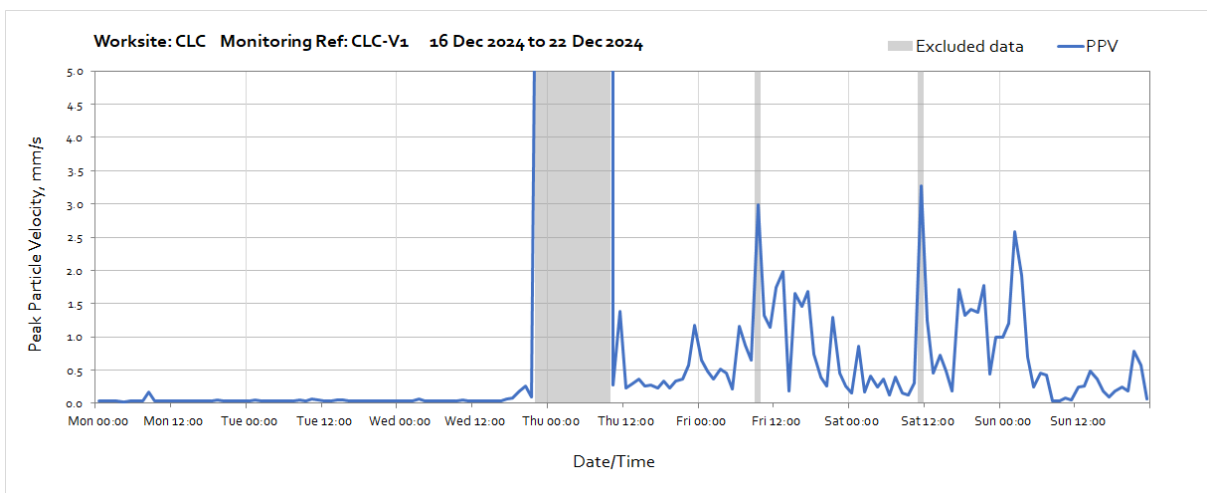
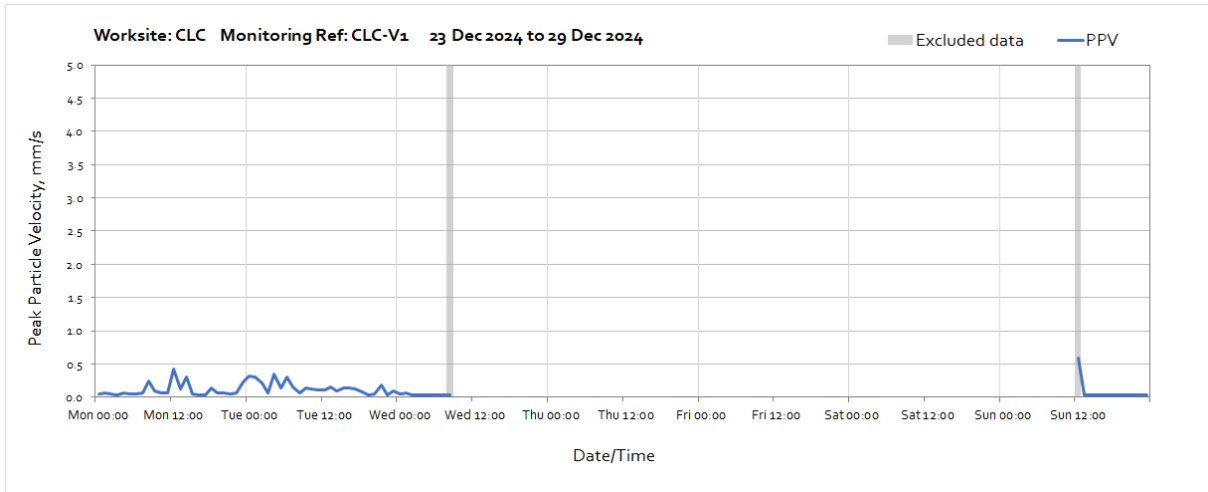
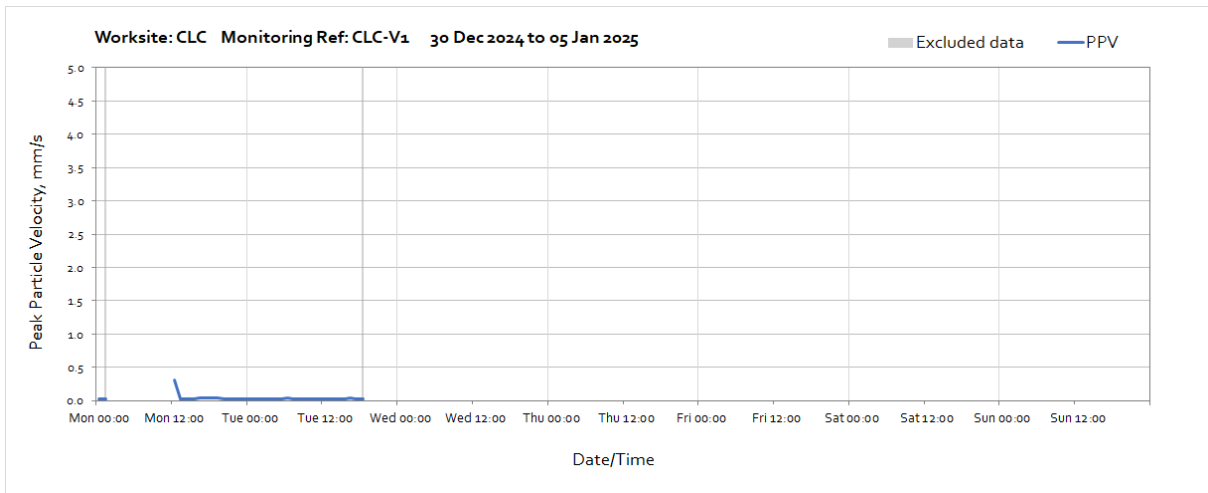
Worksite: CLC – Monitoring Ref: CLC-V1

Note: Missing data throughout the month was due to a loss of power to the monitoring station caused by poor weather conditions preventing sufficient light reach the solar panel.

Note: Missing data throughout the month was due to a loss of power to the monitoring station caused by poor weather conditions preventing sufficient light reach the solar panel

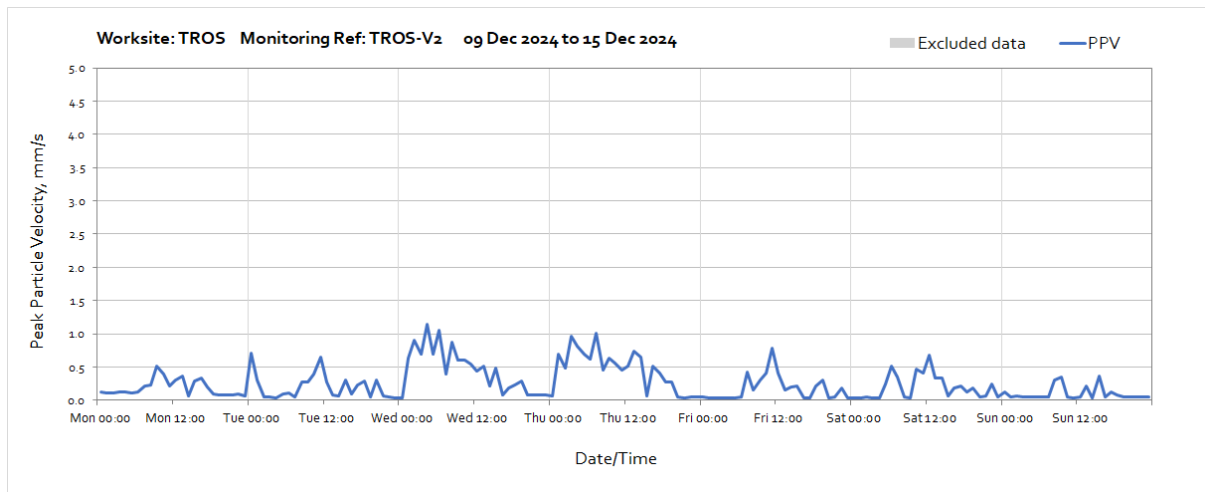
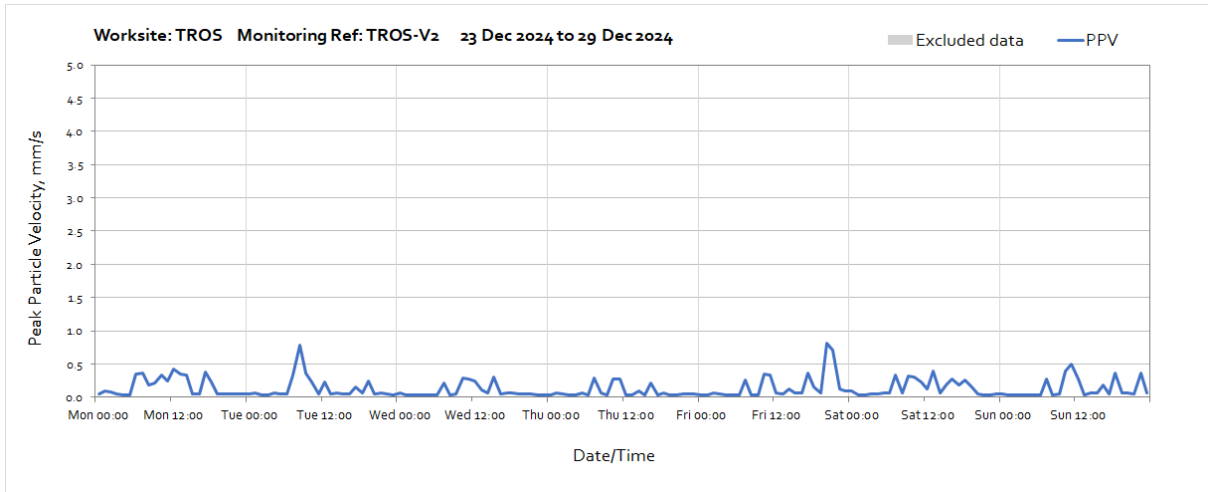
Worksite: TROS – Monitoring Ref: TROS-V2

Note: Missing data throughout the month was due to a loss of power to the monitoring station caused by poor weather conditions preventing sufficient light reach the solar panel
