## **Construction Noise and Vibration Monthly Report – December 2024**

**Solihull Metropolitan Borough Council**

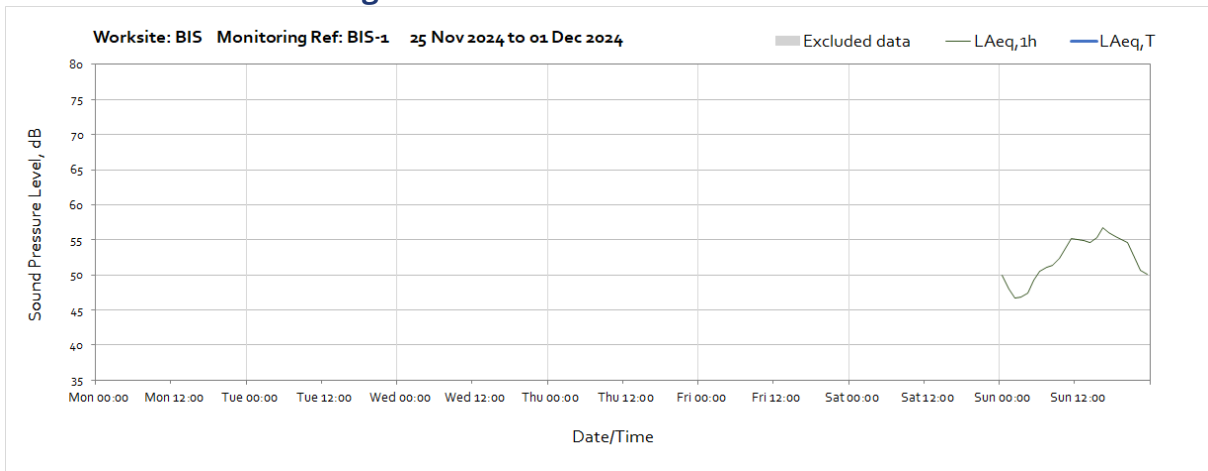
**Worksite: BIS- Monitoring Ref: BIS-1**

Note: Missing data between 00:00 and 08:00 on Sunday 29<sup>th</sup> December was due to a loss of power to the monitoring station caused by poor weather conditions preventing sufficient light reaching the solar panel.

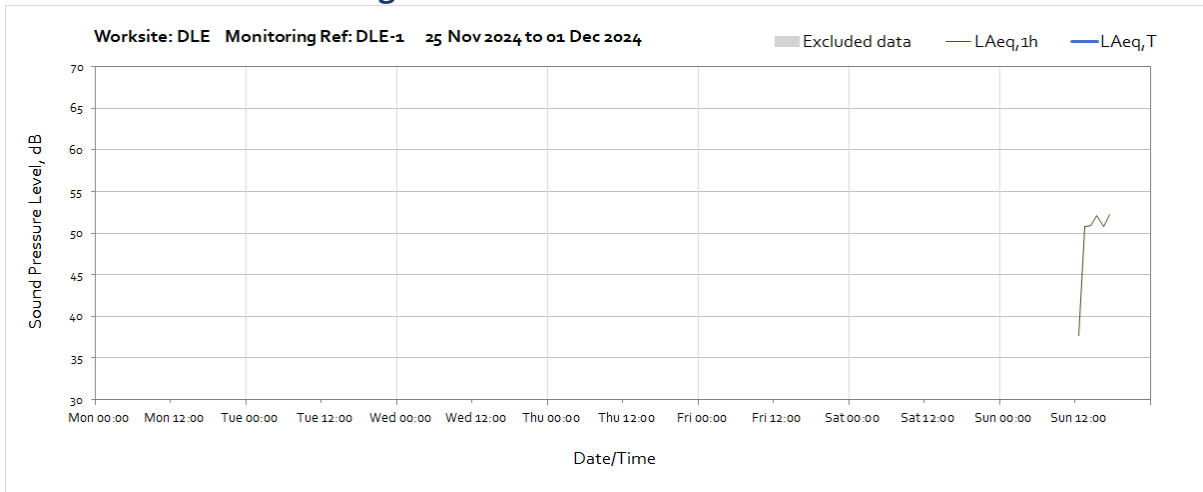
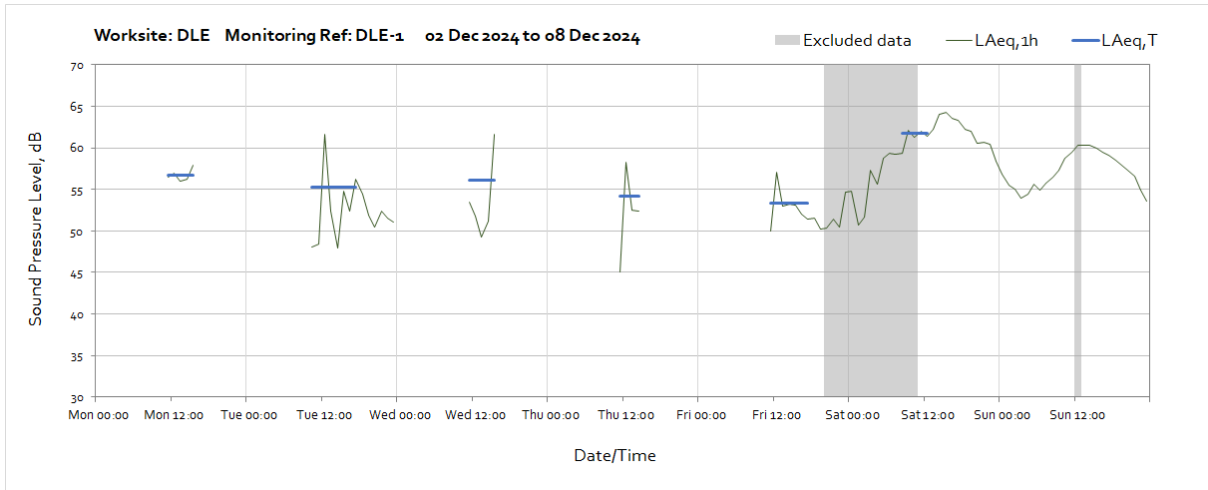
**Worksite: DLE - Monitoring Ref: DLE-1**

Note: Missing data throughout the week was due to a loss of power to the monitoring station caused by poor weather conditions preventing sufficient light reaching the solar panel.

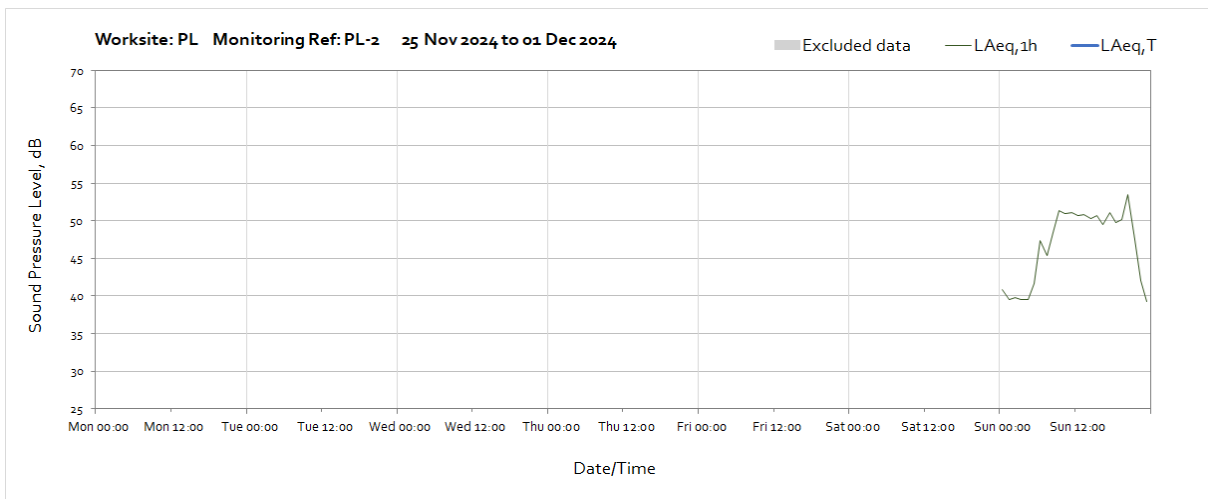
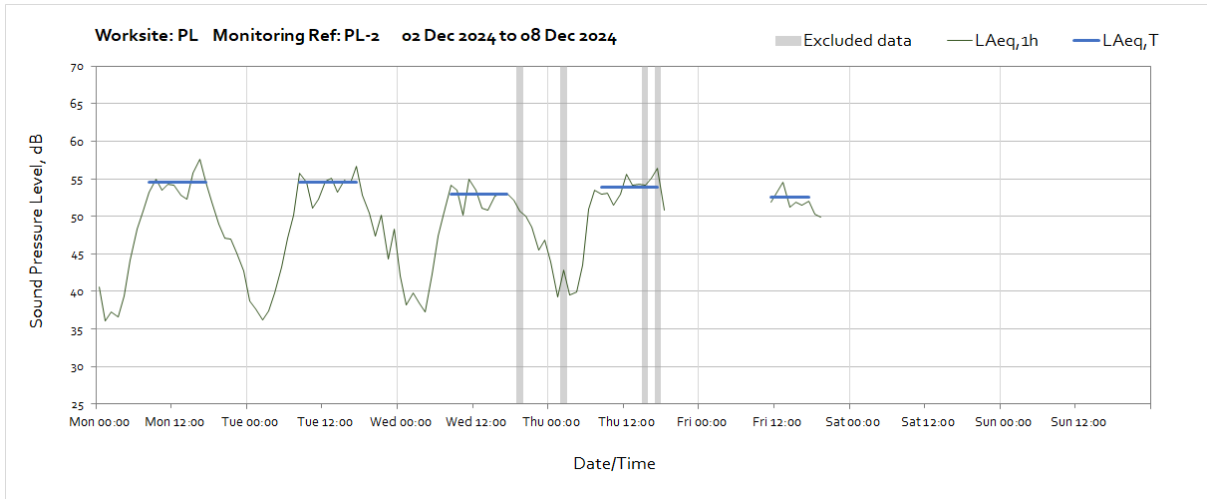
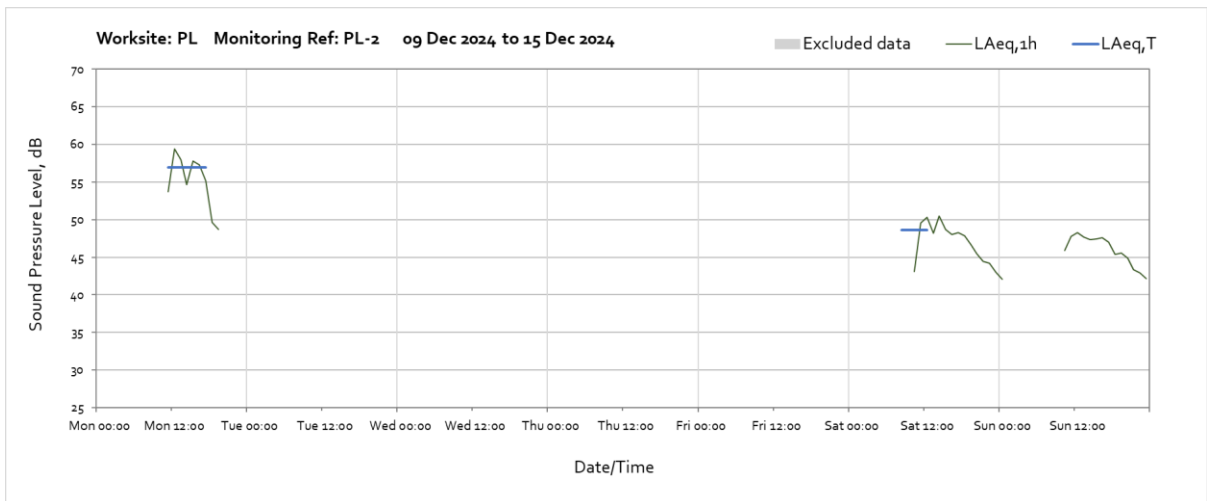
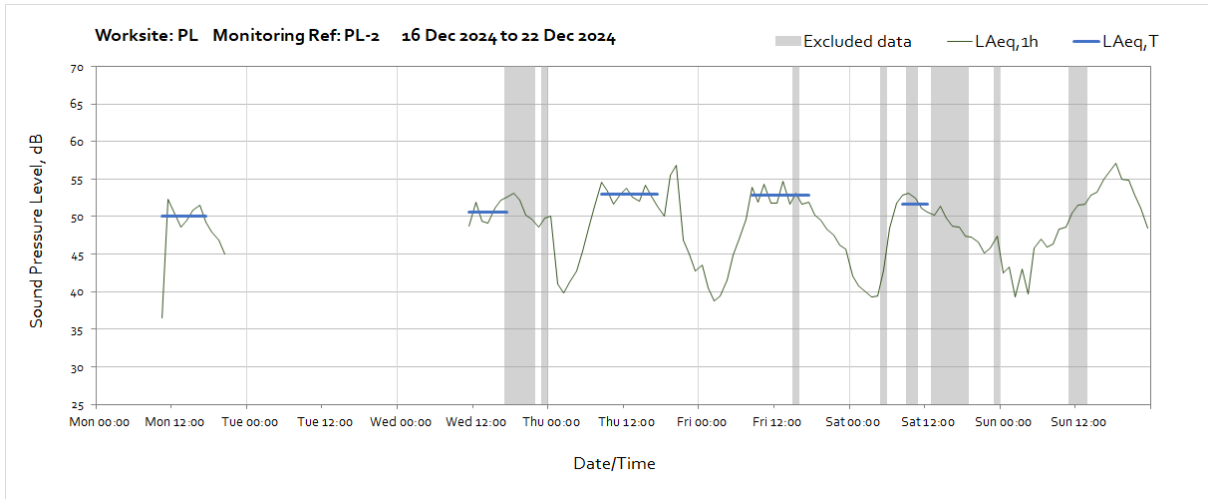
### Worksite: PL - Monitoring Ref: PL-2

Note: Missing data throughout the month was due to poor solar conditions impacting power supply to the monitoring station.

Note: Missing data throughout the month was due to a loss of power to the monitoring station caused by poor weather conditions preventing sufficient light reaching the solar panel.

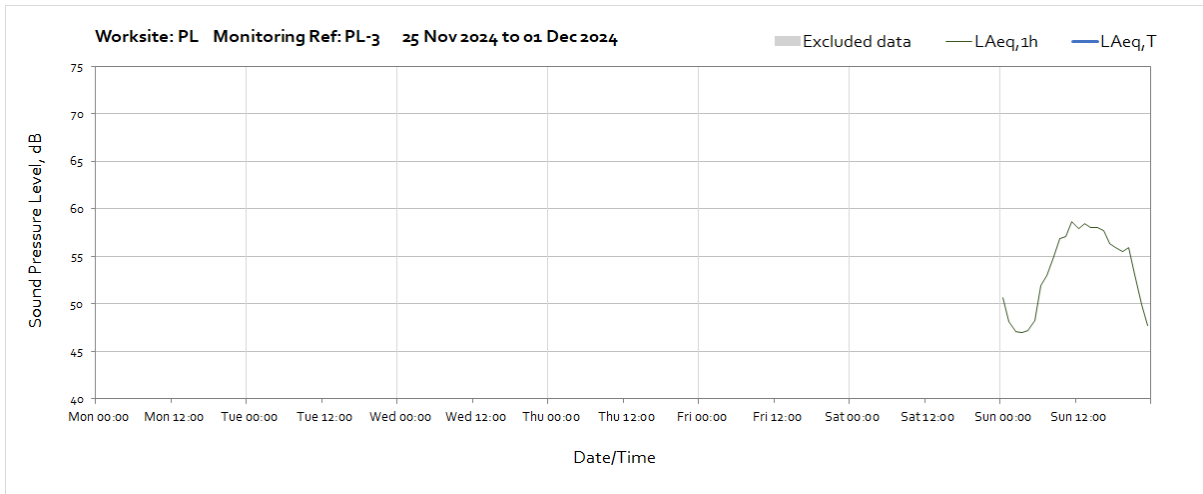
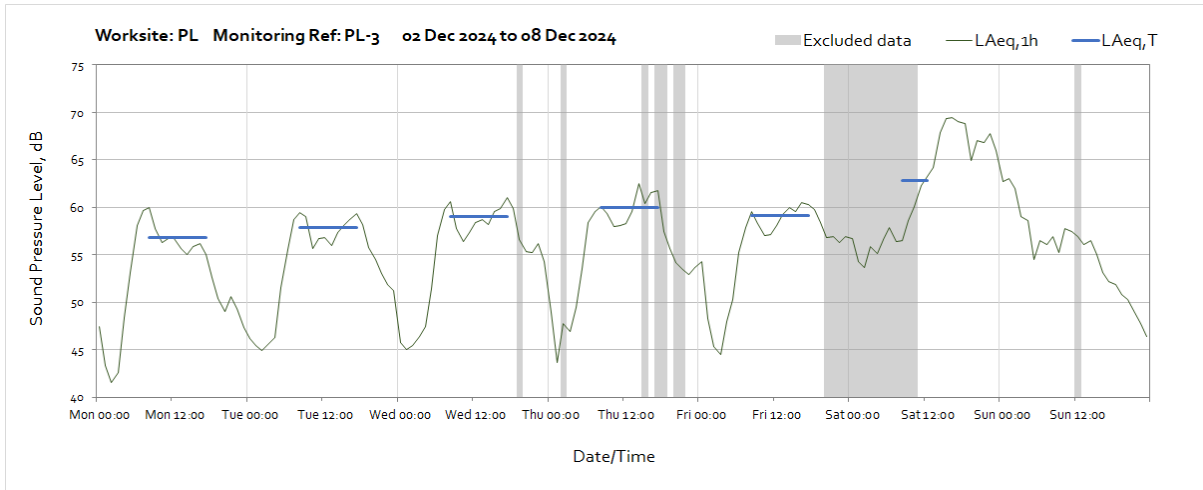
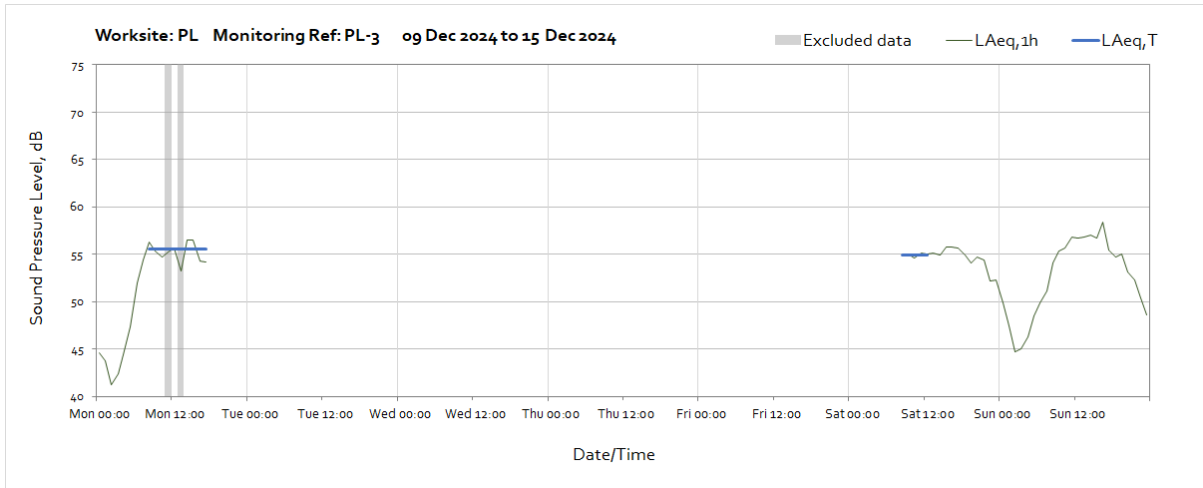
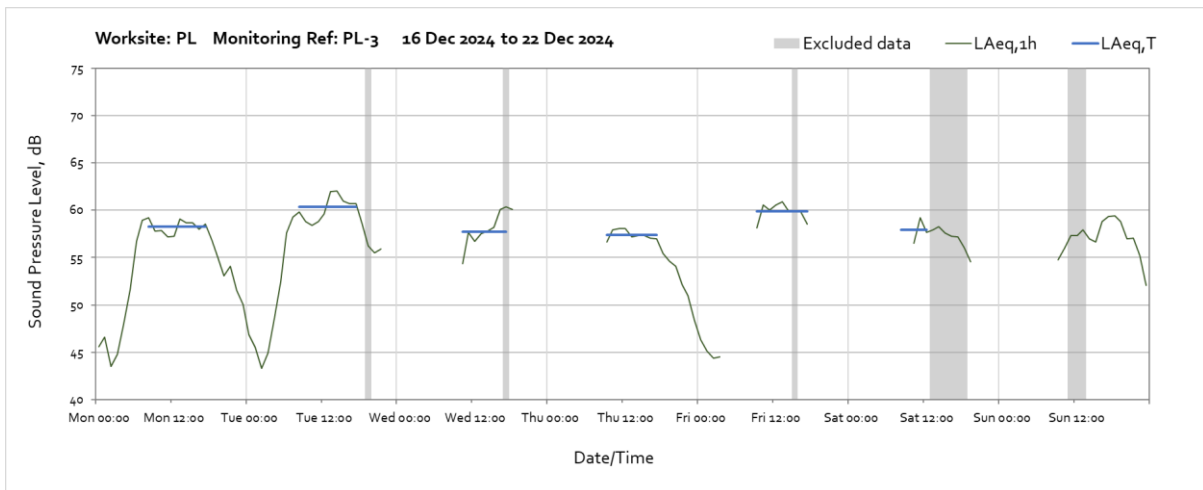
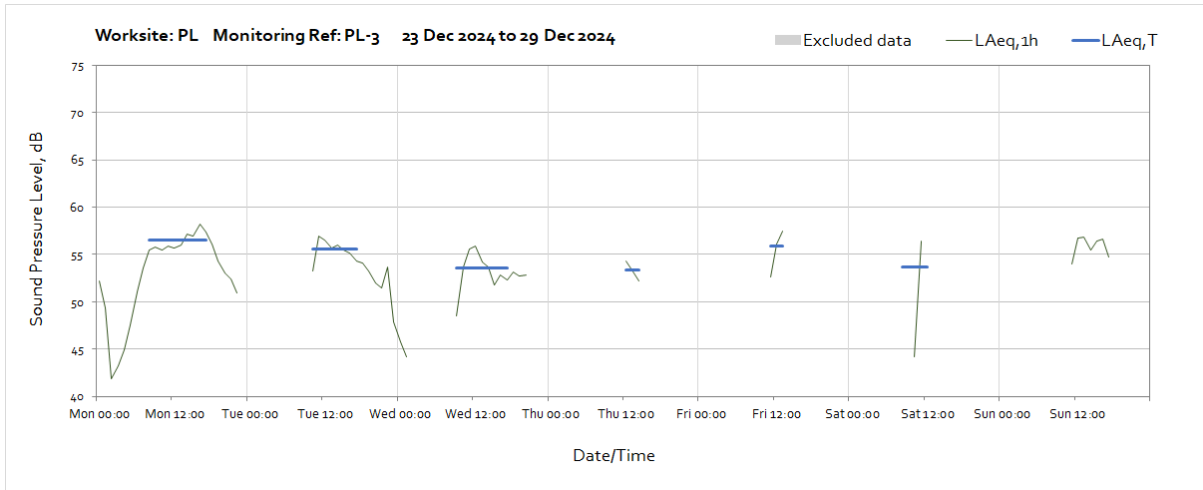
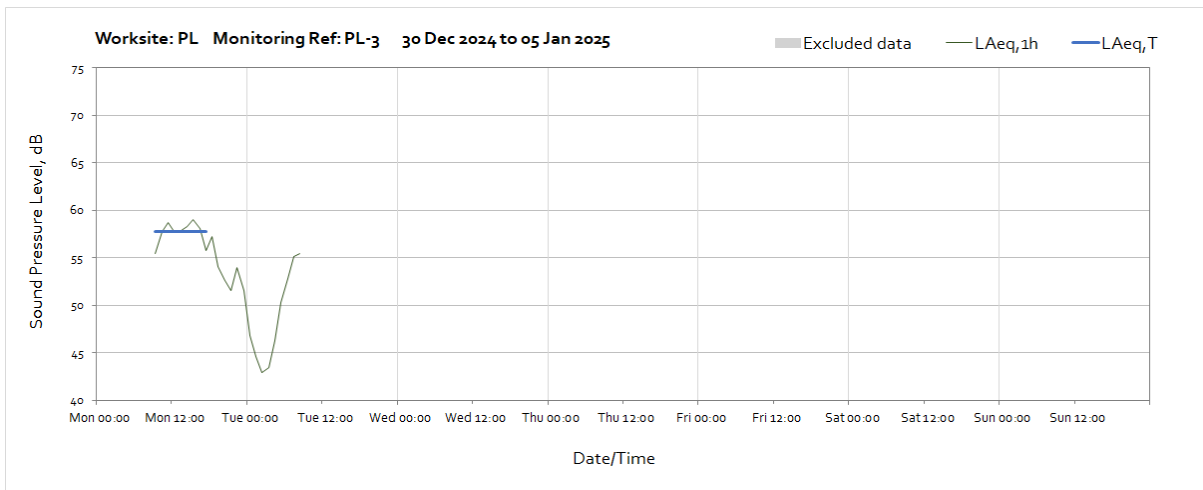
### Worksite: PL – Monitoring Ref: PL-3

Note: Missing data throughout the month was due to poor solar conditions impacting power supply to the monitoring station.

Note: Missing data throughout the month was due to a loss of power to the monitoring station caused by poor weather conditions preventing sufficient light reaching the solar panel.

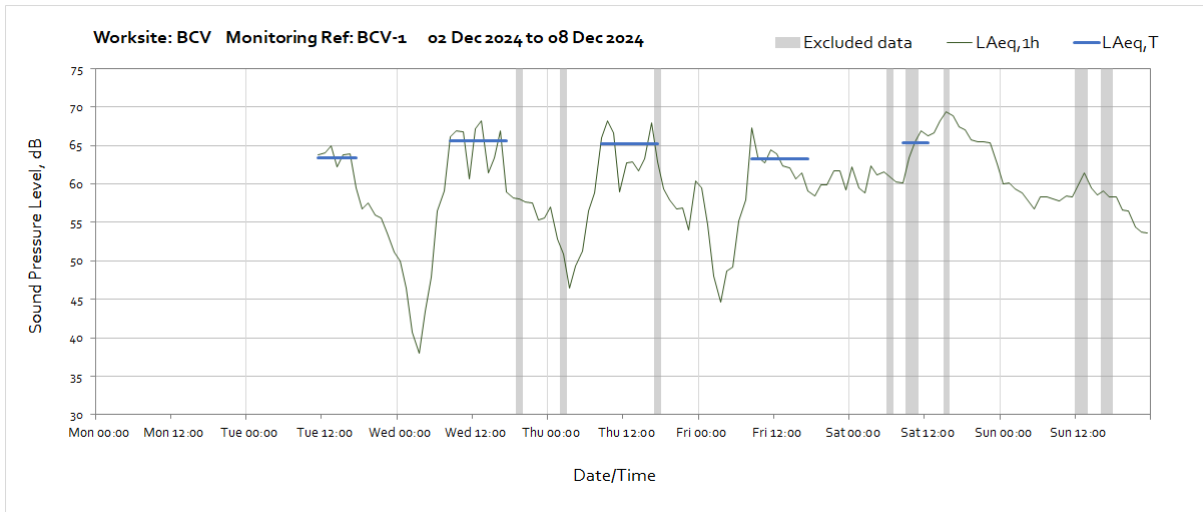
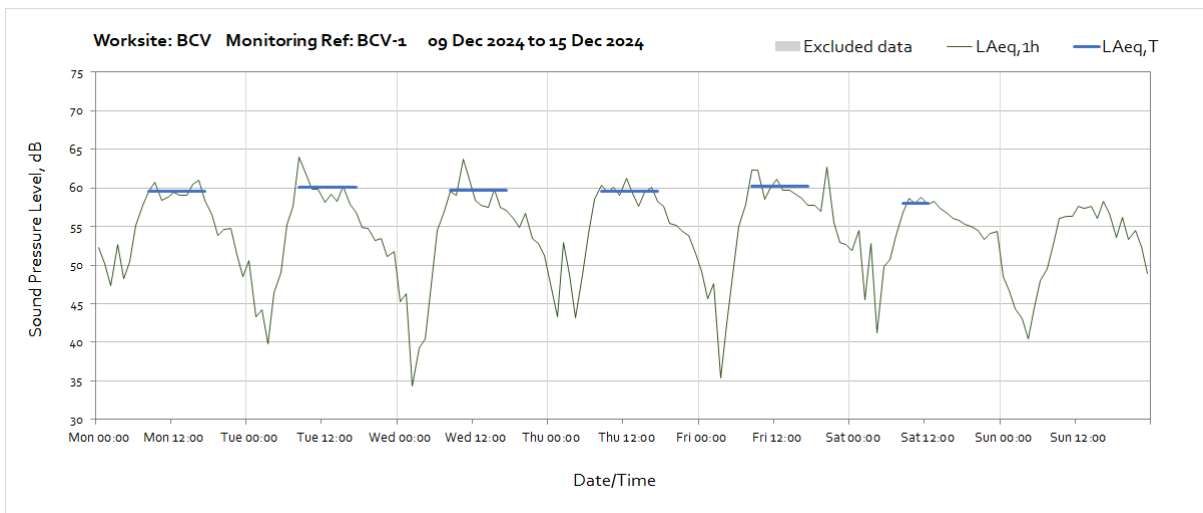
## Worksite: BCV – Monitoring Ref: BCV-1

Note: Missing data from the beginning of December until 11:00 on Tuesday 3<sup>rd</sup> December was due to a loss of power to the monitoring station caused by poor weather conditions preventing sufficient light reaching the solar panel.

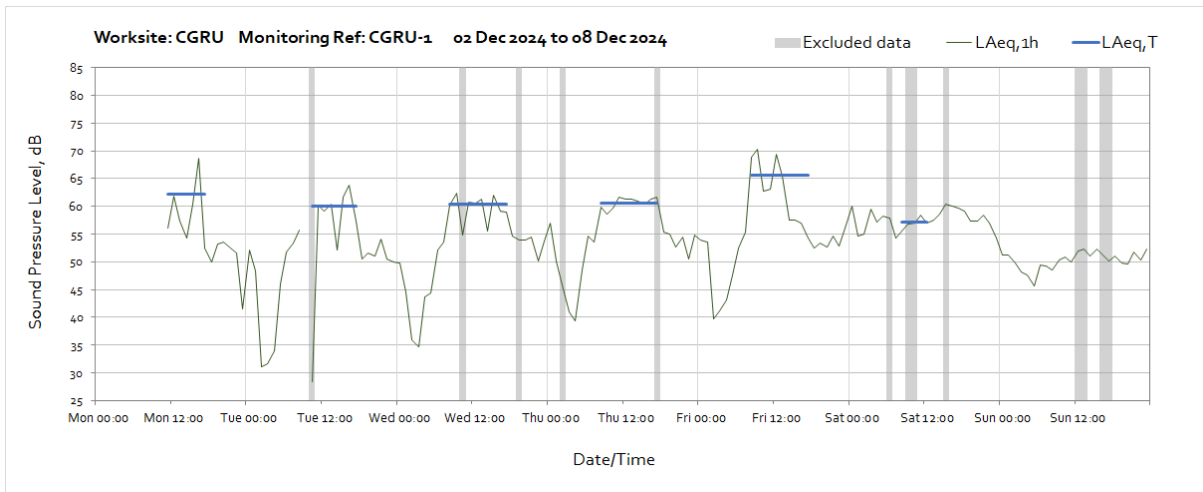
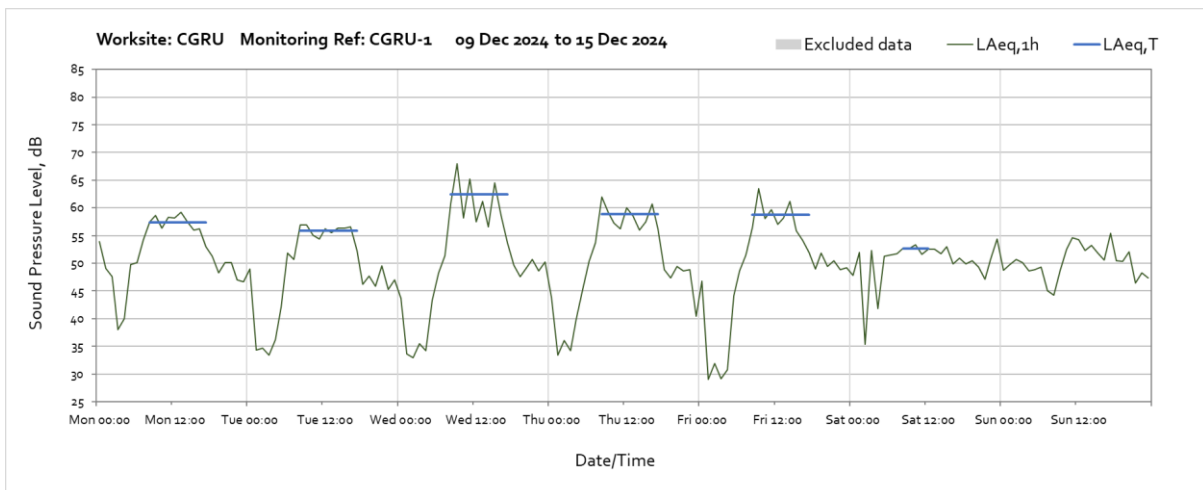
## Worksite: CGRU- Monitoring Ref: CGRU-1

Note: Missing data from the beginning of December until 11:00 on Tuesday 3<sup>rd</sup> December and between 09:00 and 10:00 on Tuesday 3<sup>rd</sup> December was due to a system error causing loss of power to the monitoring station.

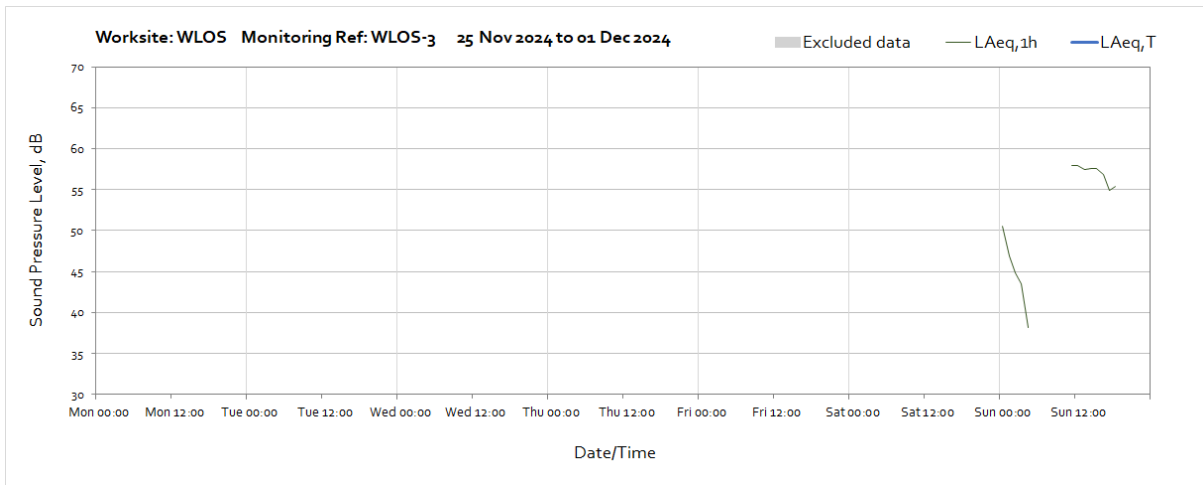
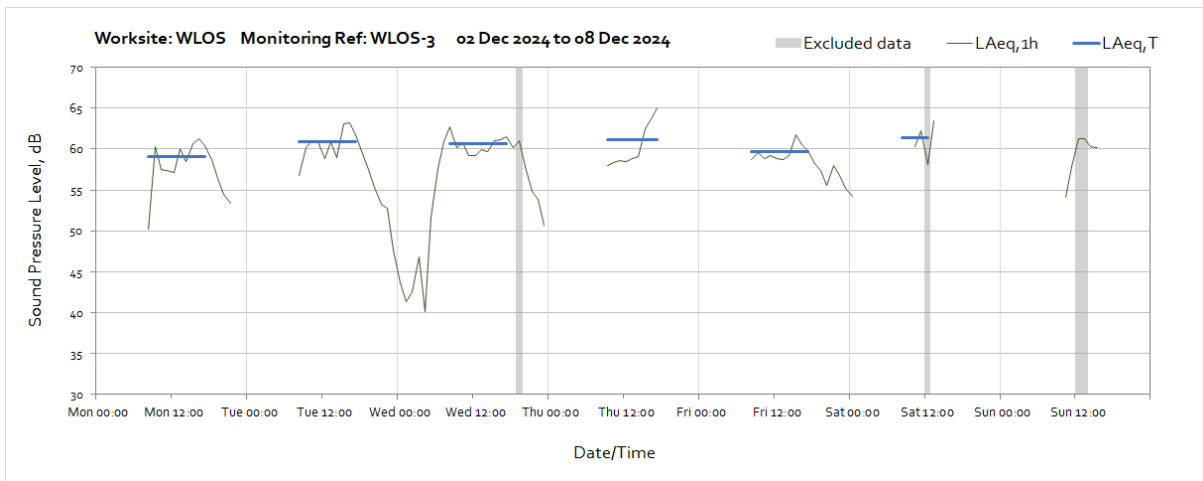
## Worksite: WLOS - Monitoring Ref: WLOS-3

Note: Missing data throughout the month was due to a loss of power to the monitoring station caused by poor weather conditions preventing sufficient light reaching the solar panel.

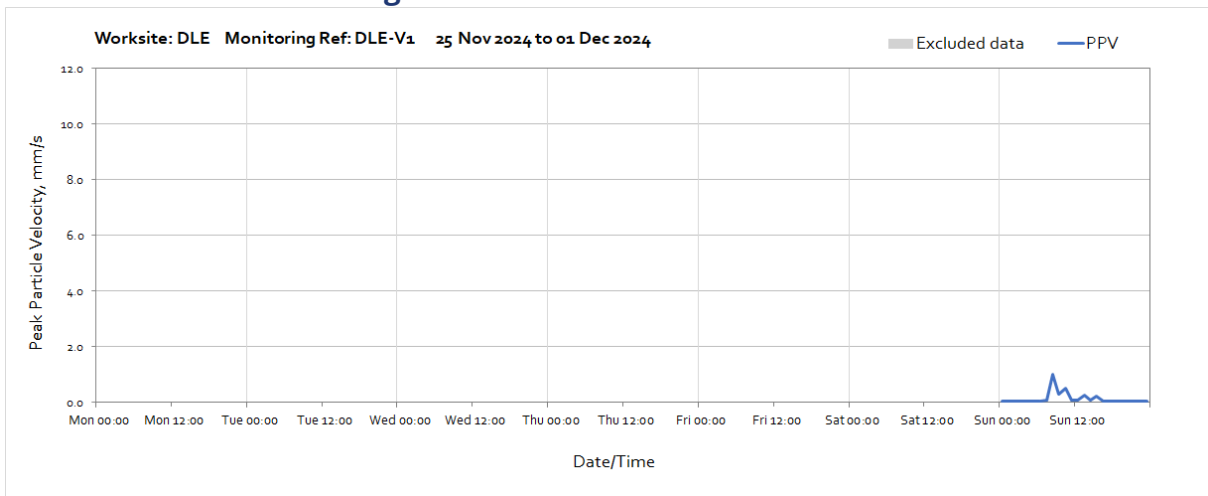
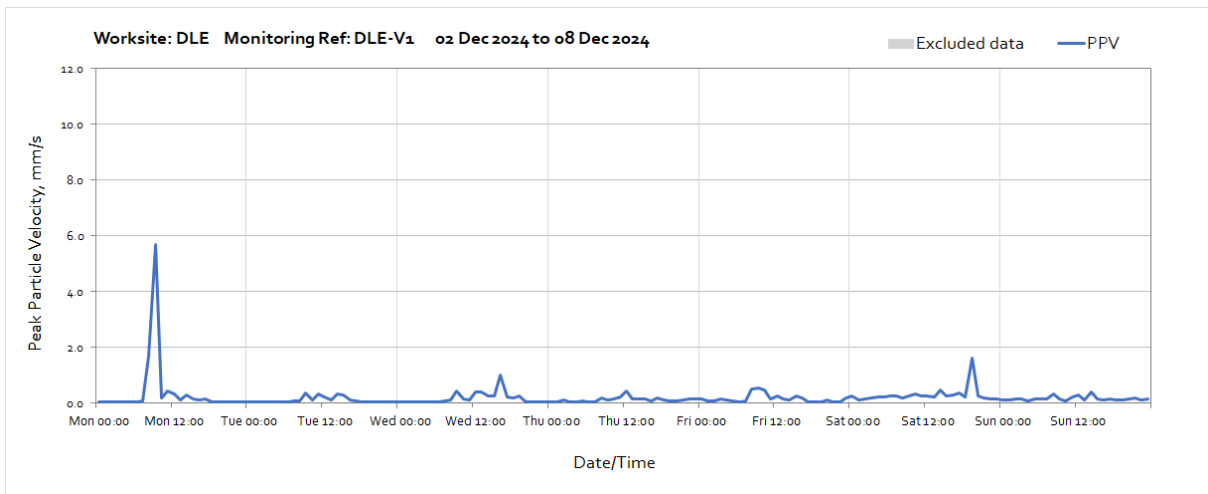
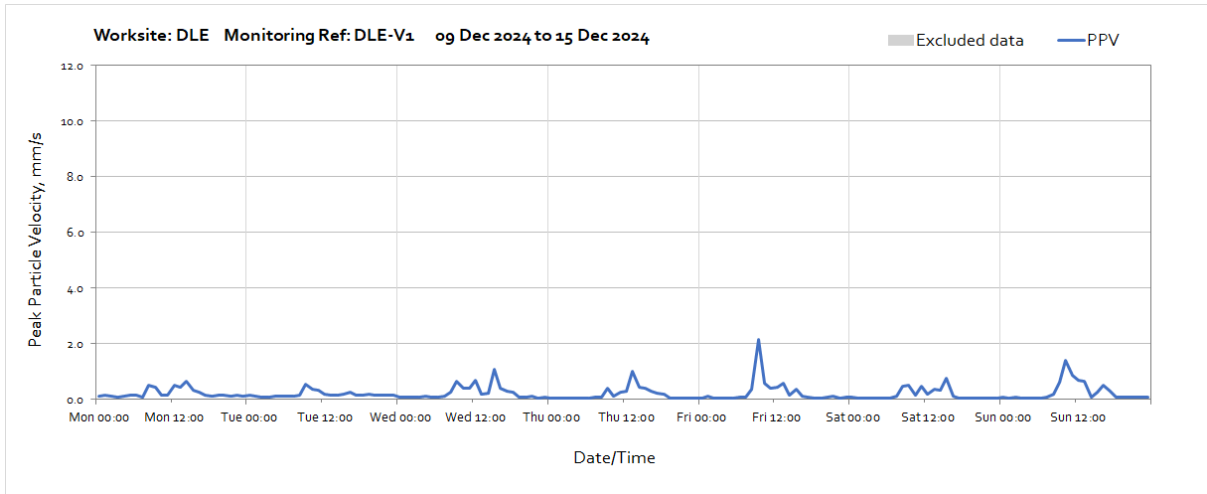
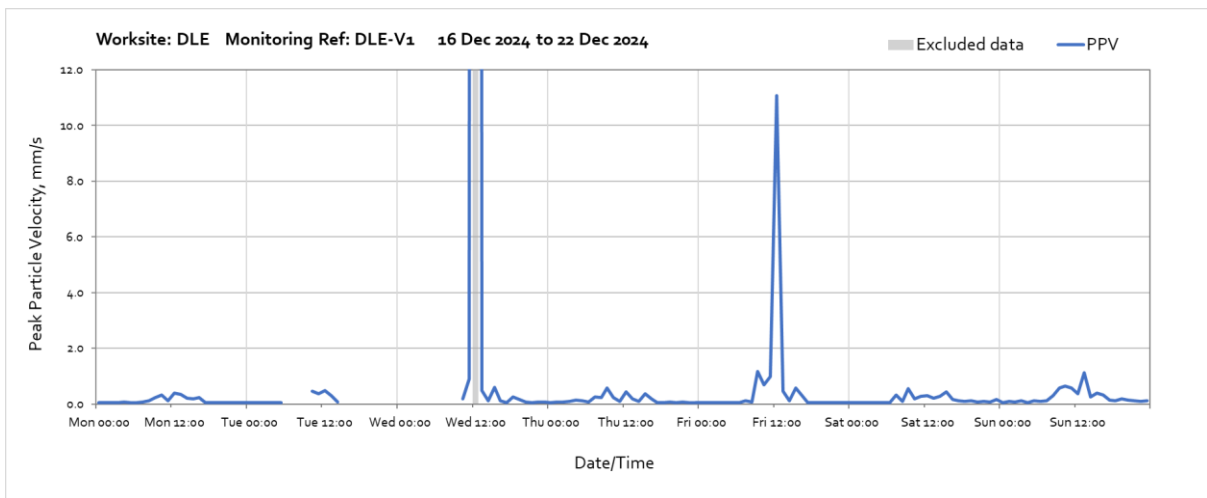
**Worksite: DLE - Monitoring Ref: DLE-V1**

The following graphs show the hourly measured peak particle velocity PPV recorded during the monitoring period. The graphs show the highest PPV of the three orthogonal axes x, y and z. Periods where PPV values have been affected by local interference with the vibration monitor or only measured for part of the period, which are not representative of HS2 construction works, have been greyed out and excluded when calculating values in of the main report.

Note: Missing data between 06:00 and 10:00 on Tuesday 17<sup>th</sup> December and between 15:00 on Tuesday 17<sup>th</sup> and 10:00 on Wednesday 18<sup>th</sup> December was due to poor solar conditions impacting power supply to the monitoring station.

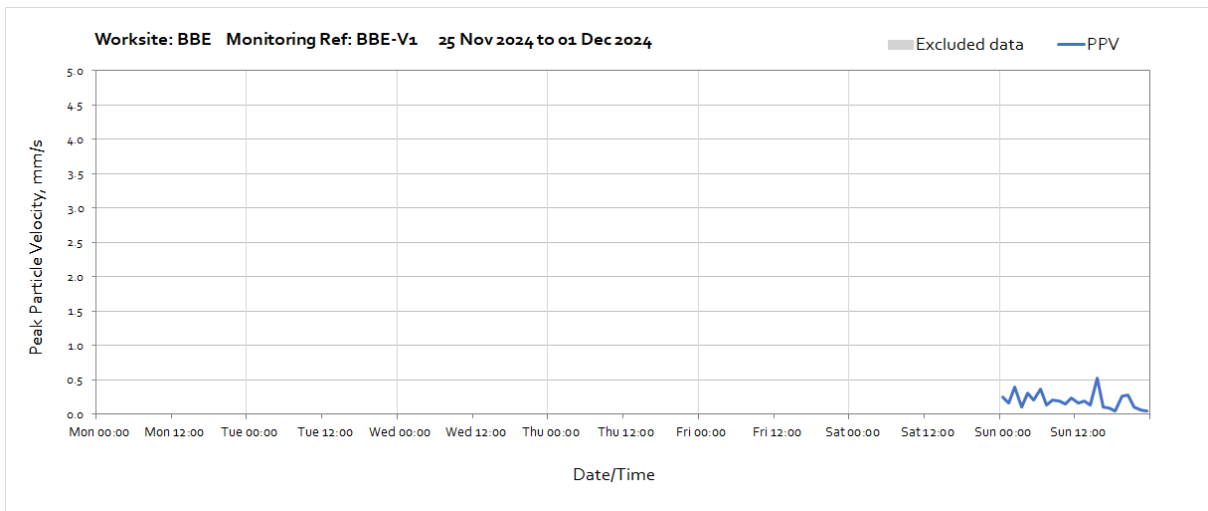
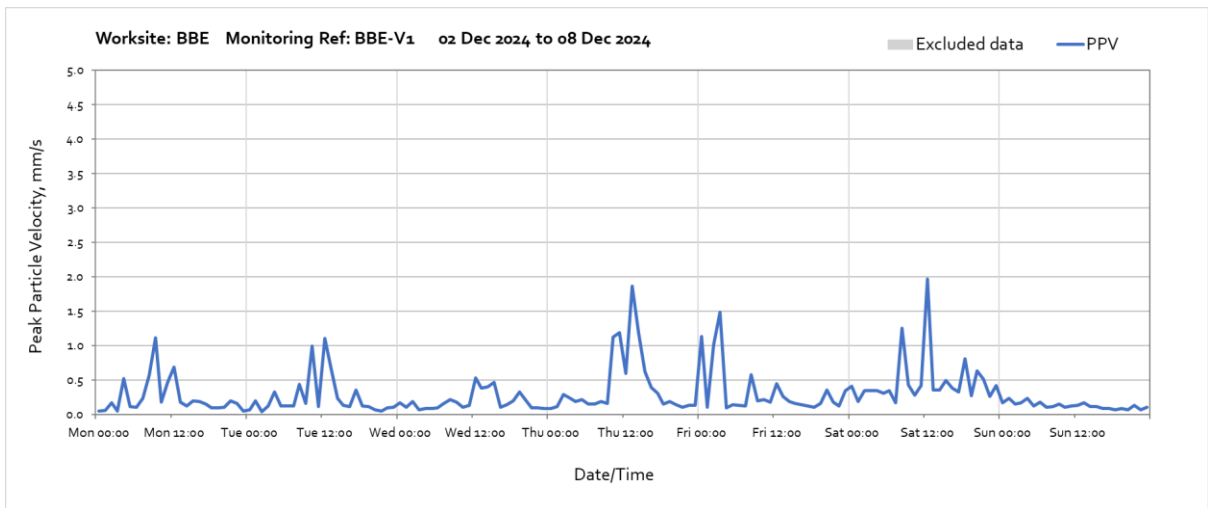
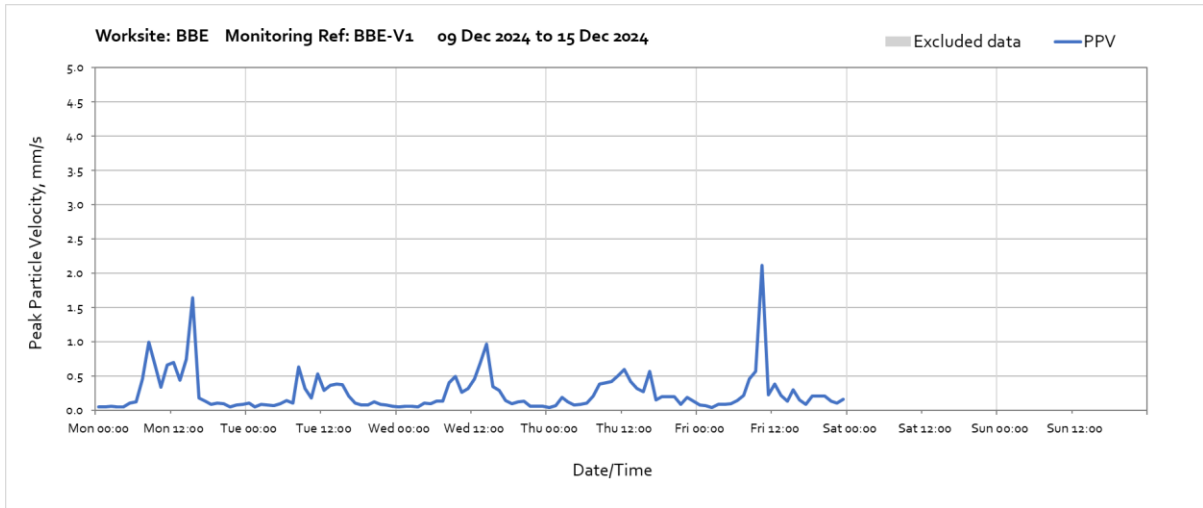
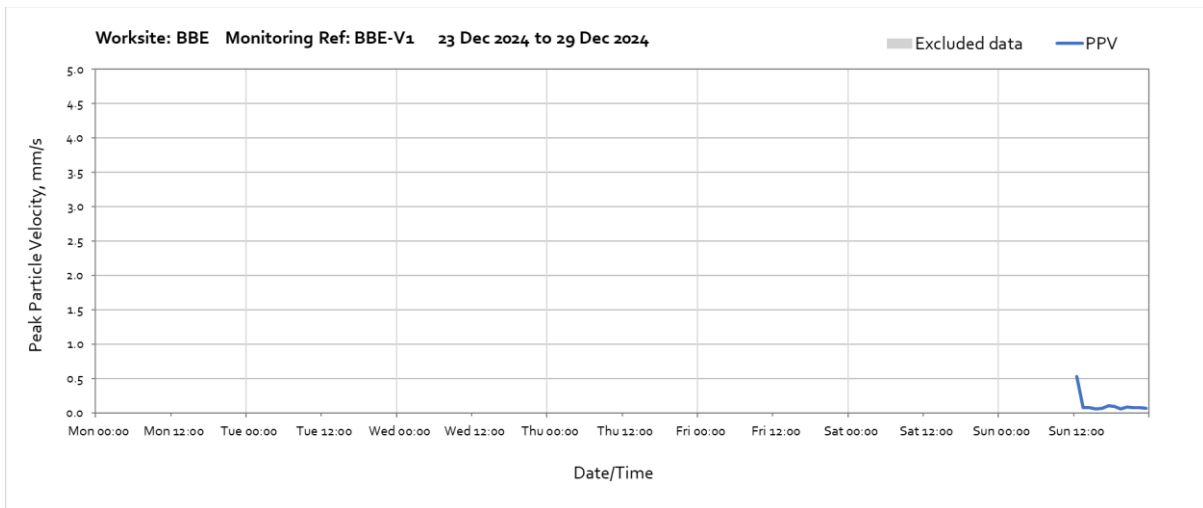
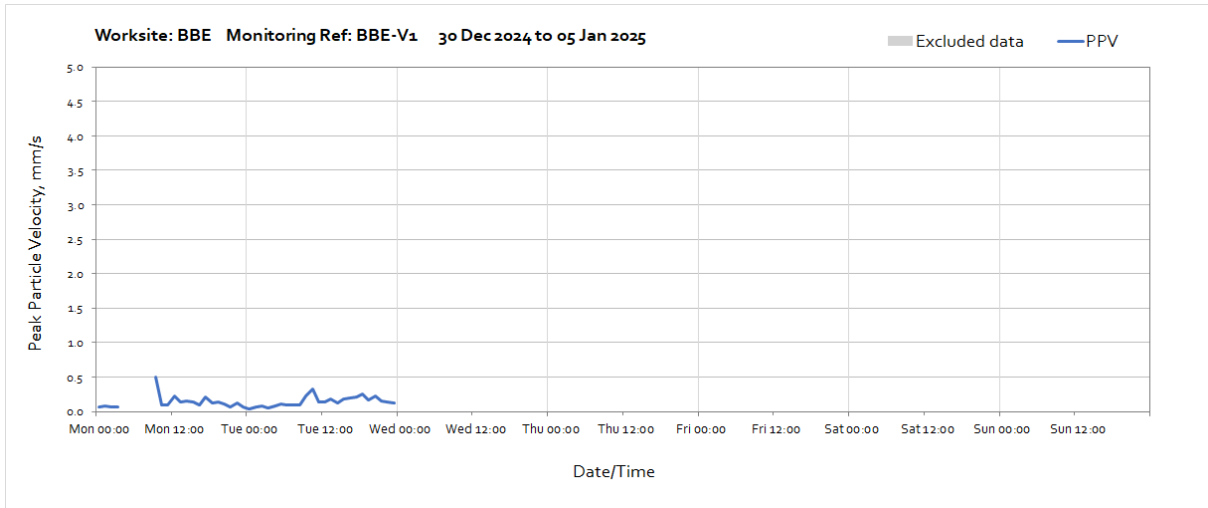
**Worksite: BBE - Monitoring Ref: BBE-V1**

Note: Missing data throughout the month was due to a loss of power to the monitoring station caused by poor weather conditions preventing sufficient light reaching the solar panel.

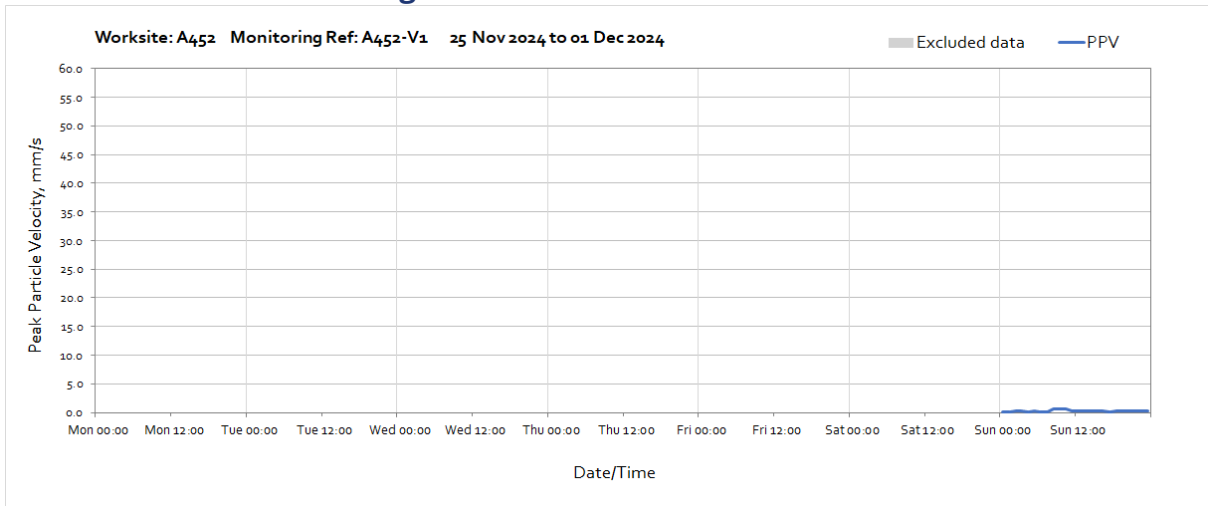
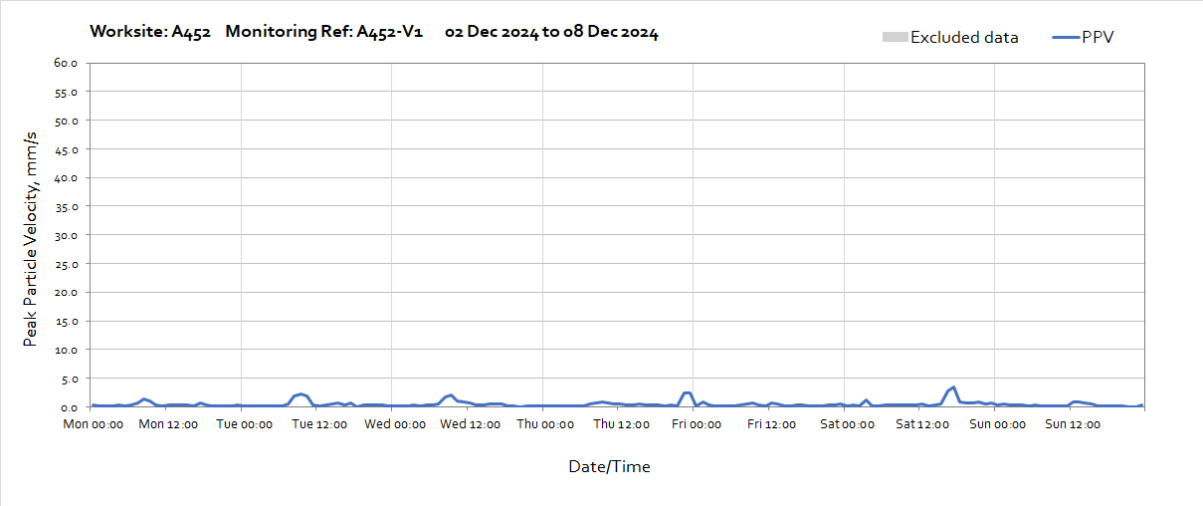
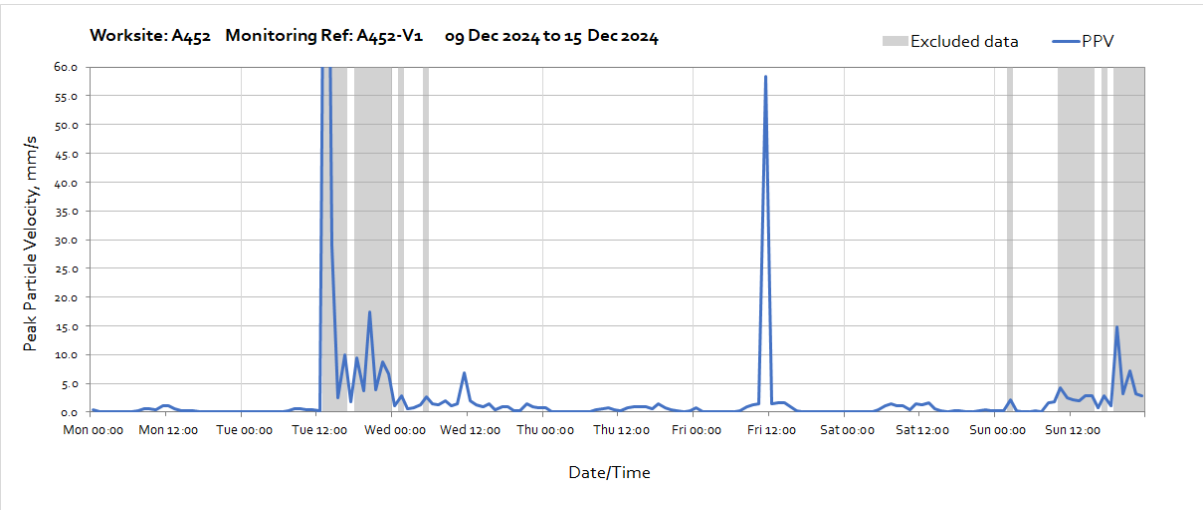
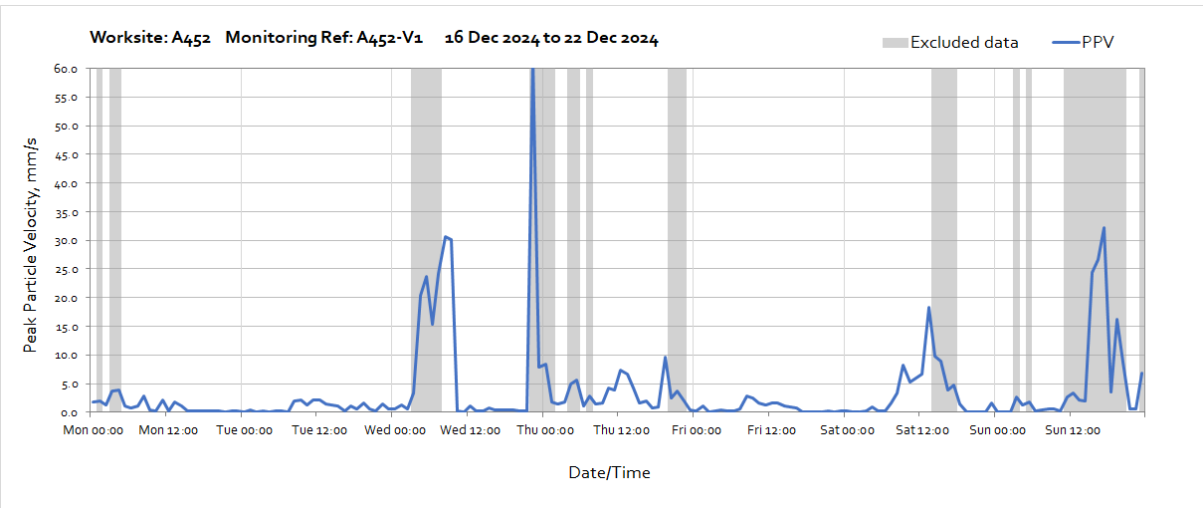
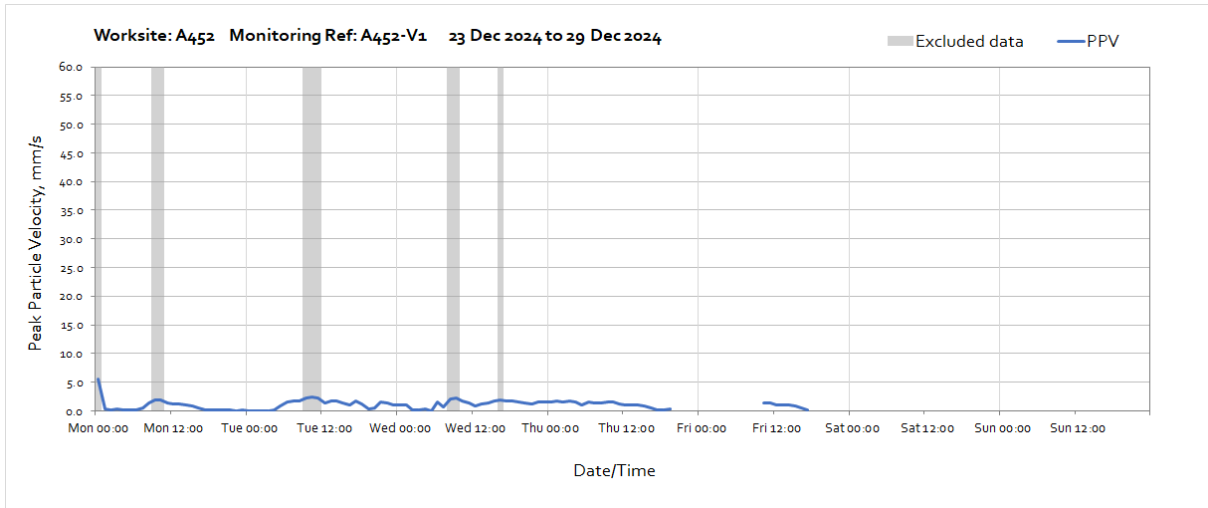
### Worksite: A452 – Monitoring Ref: A452-V1

Note: Missing data between 20:00 on Thursday 26<sup>th</sup> and 10:00 on Friday 27<sup>th</sup> December and from 18:00 on Friday 27<sup>th</sup> December until the end of the month was due to poor solar conditions impacting power supply to the monitoring station.
