## **Construction Noise and Vibration Monthly Report – December 2024**

**Solihull Metropolitan Borough Council**

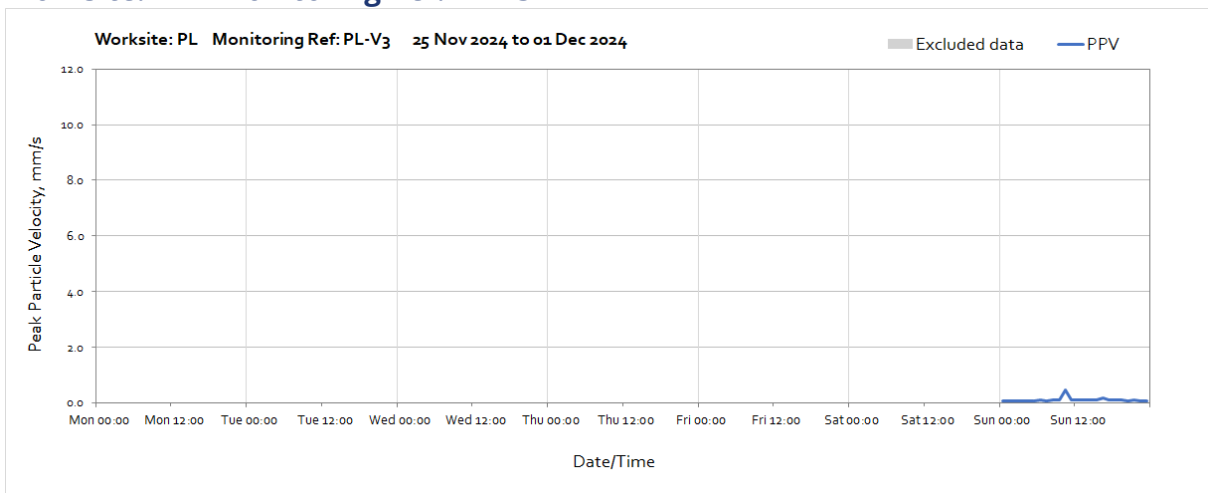
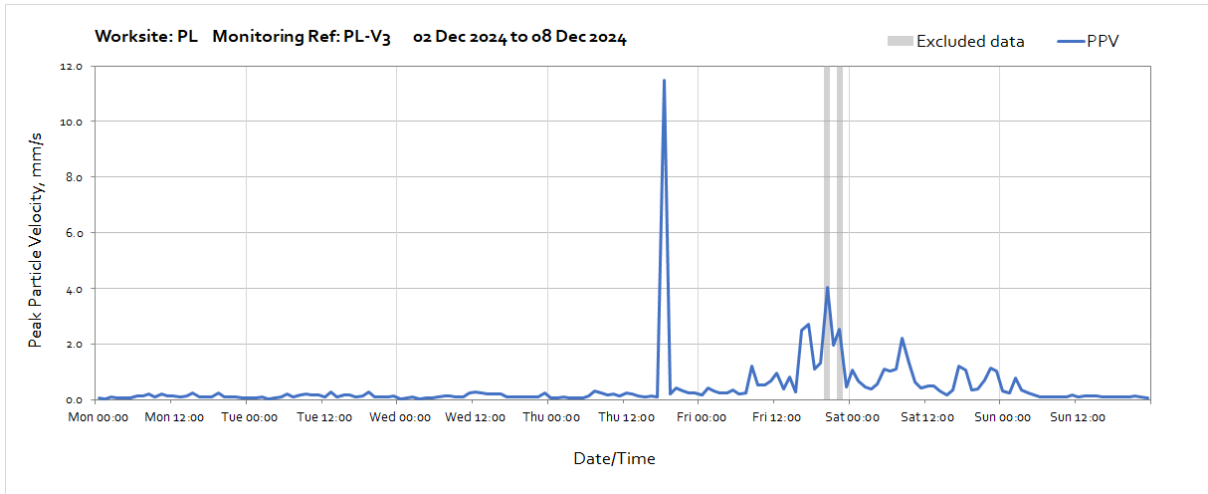
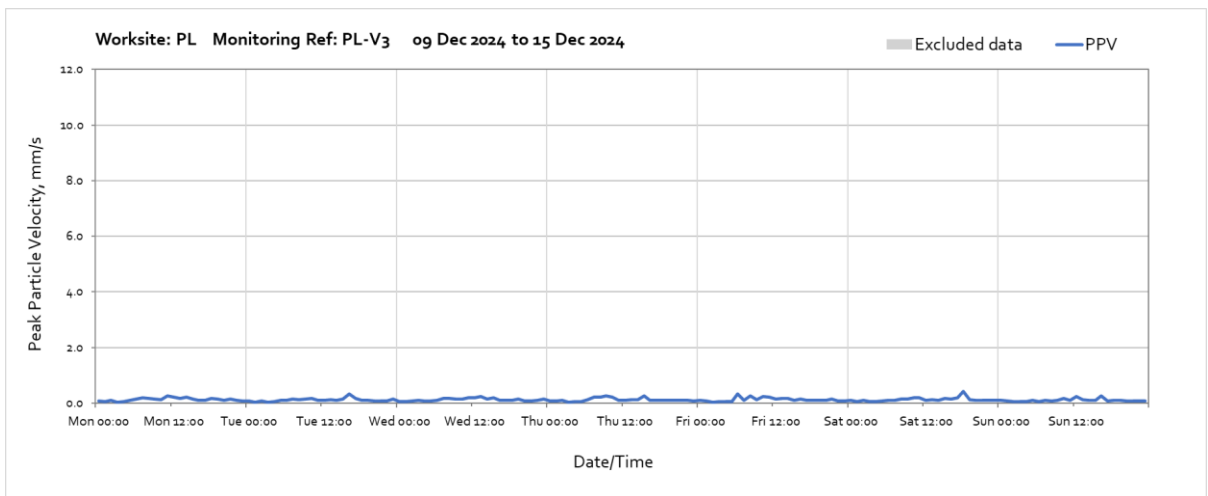
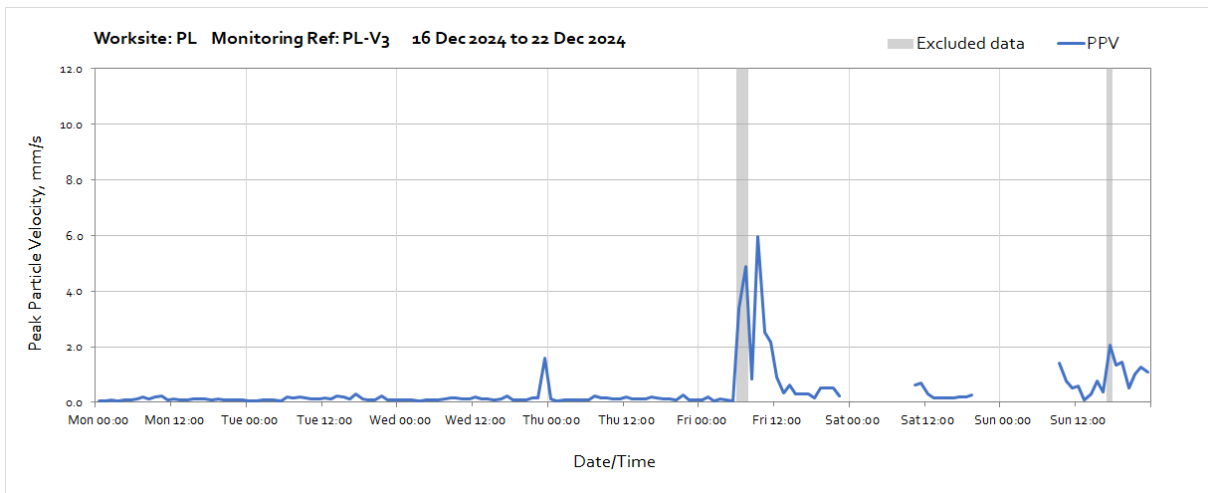
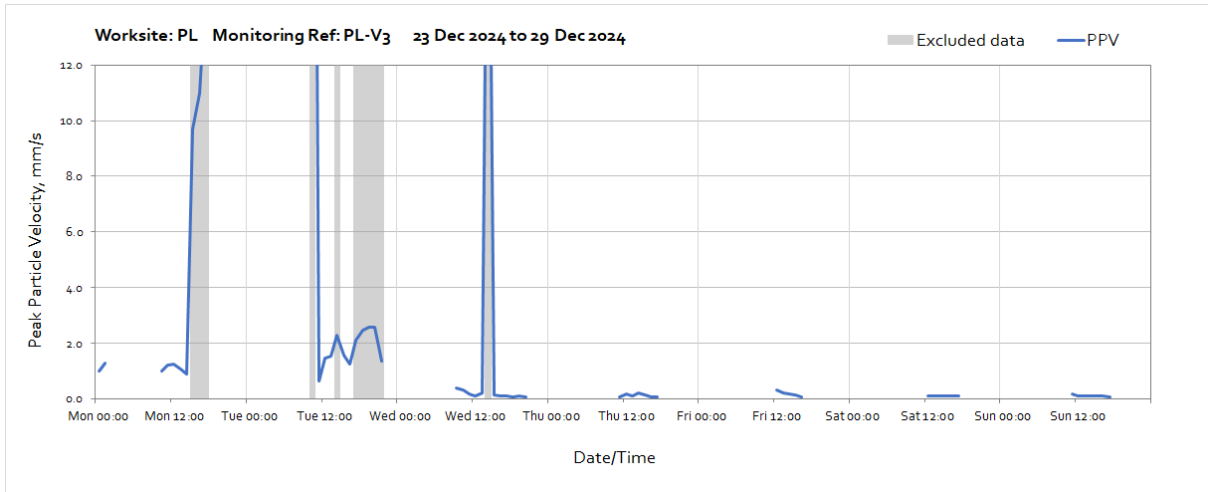
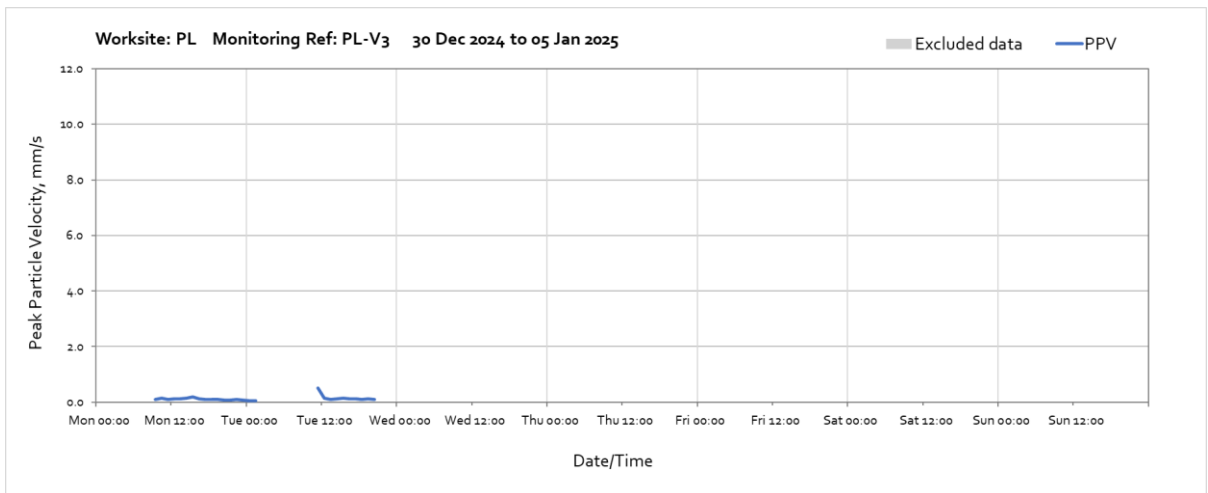
### Worksite: PL - Monitoring Ref: PL-V3

The following graphs show the hourly measured peak particle velocity PPV recorded during the monitoring period. The graphs show the highest PPV of the three orthogonal axes x, y and z. Periods where PPV values have been affected by local interference with the vibration monitor or only measured for part of the period, which are not representative of HS2 construction works, have been greyed out and excluded when calculating values in of the main report.

Note: Missing data throughout the month was due to a loss of power to the monitoring station caused by poor weather conditions preventing sufficient light reaching the solar panel.
