Infrastructure
and Projects
Authority

Asset Condition Playbook
Associated Document No.4

Example Condition Report

Reporting to
Cabinet Office
and HM Treasury

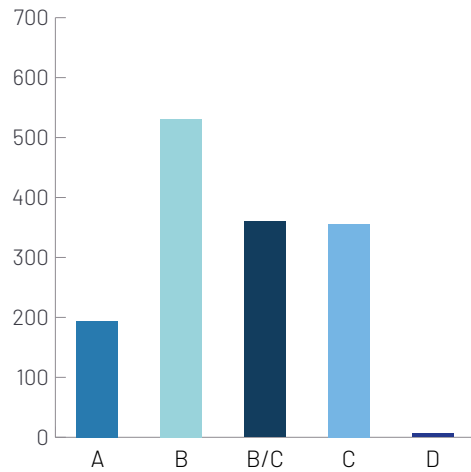
Condition rating (Industry)

Condition assessment	Actions (industry condition rating)
A	194
B	531
B/C	360
C	356
D	6
Grand total	1447

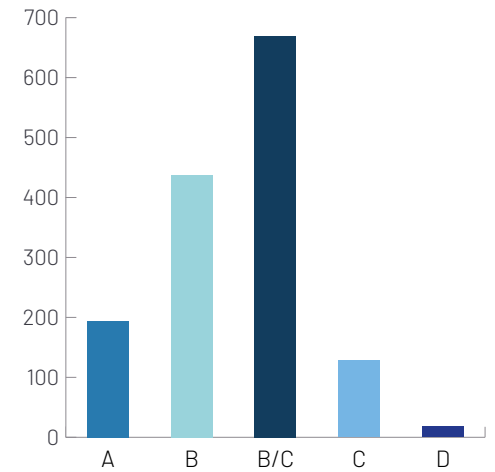
Condition rating (Specific)

Condition assessment	Actions (project-specific rating)
A	194
B	438
B/C	669
C	128
D	18
Grand total	1447
