January 2025

# HS2

Air Quality and Dust Monitoring Monthly Report - January 2025 **Buckinghamshire** Council

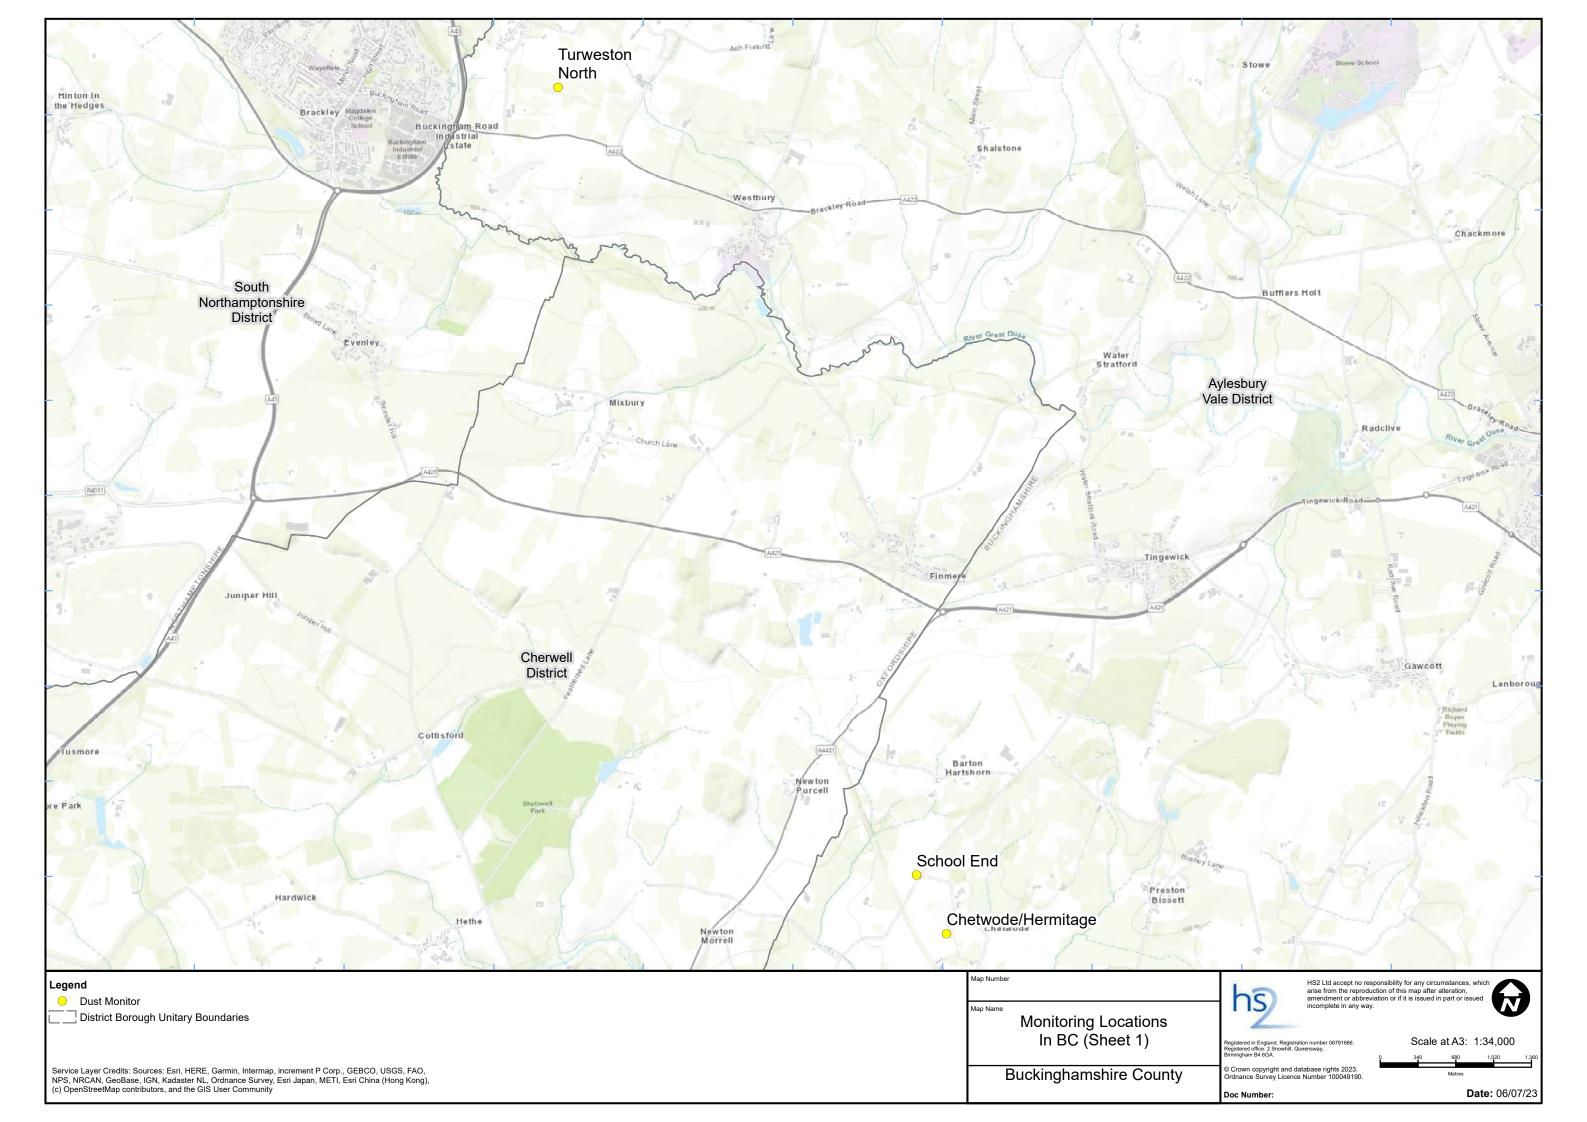
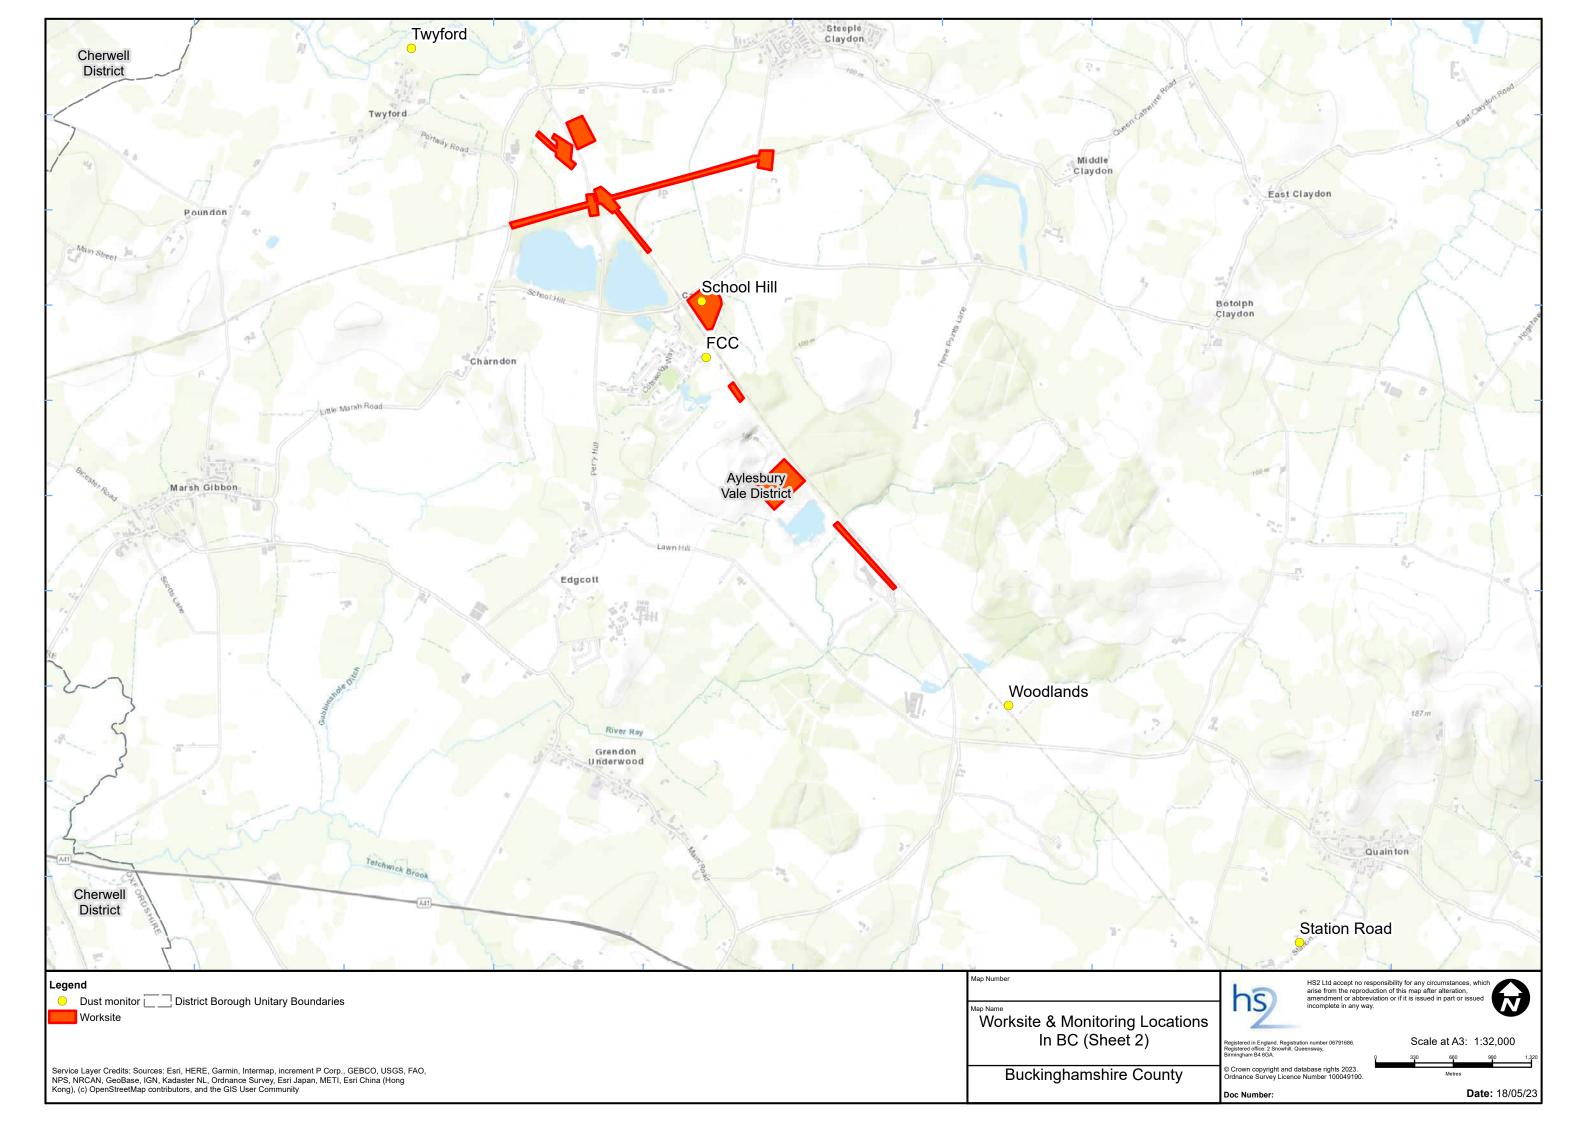
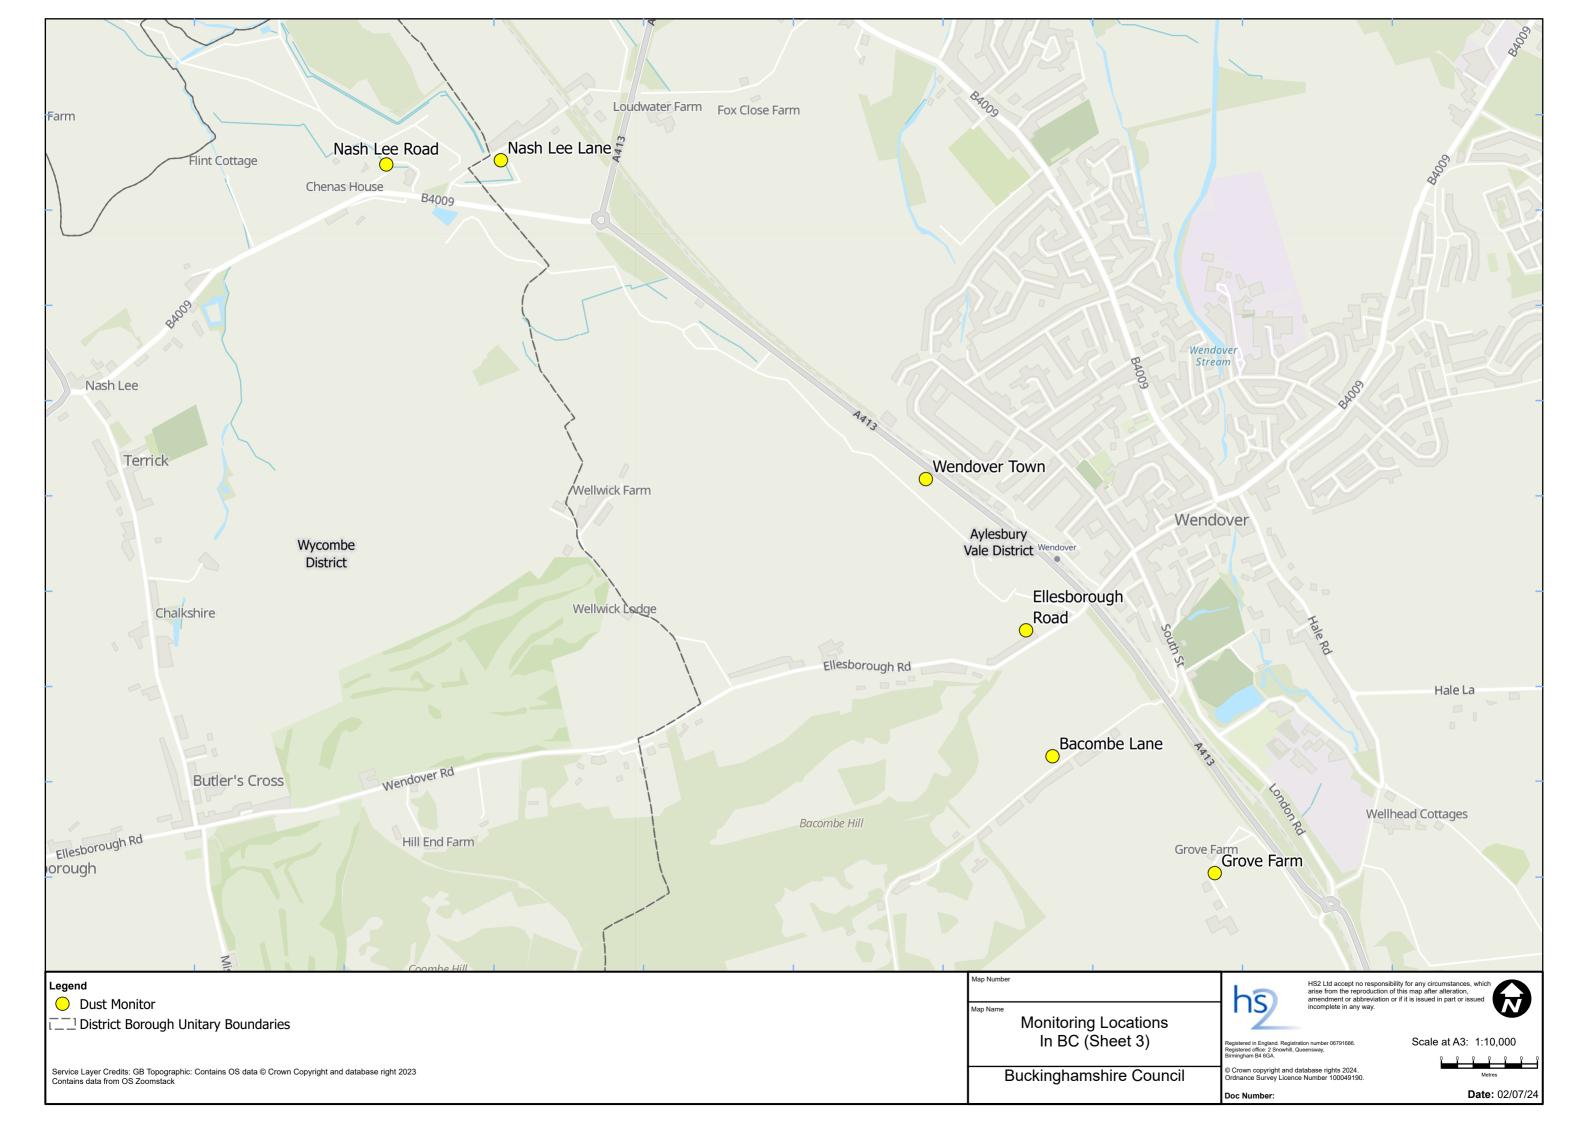
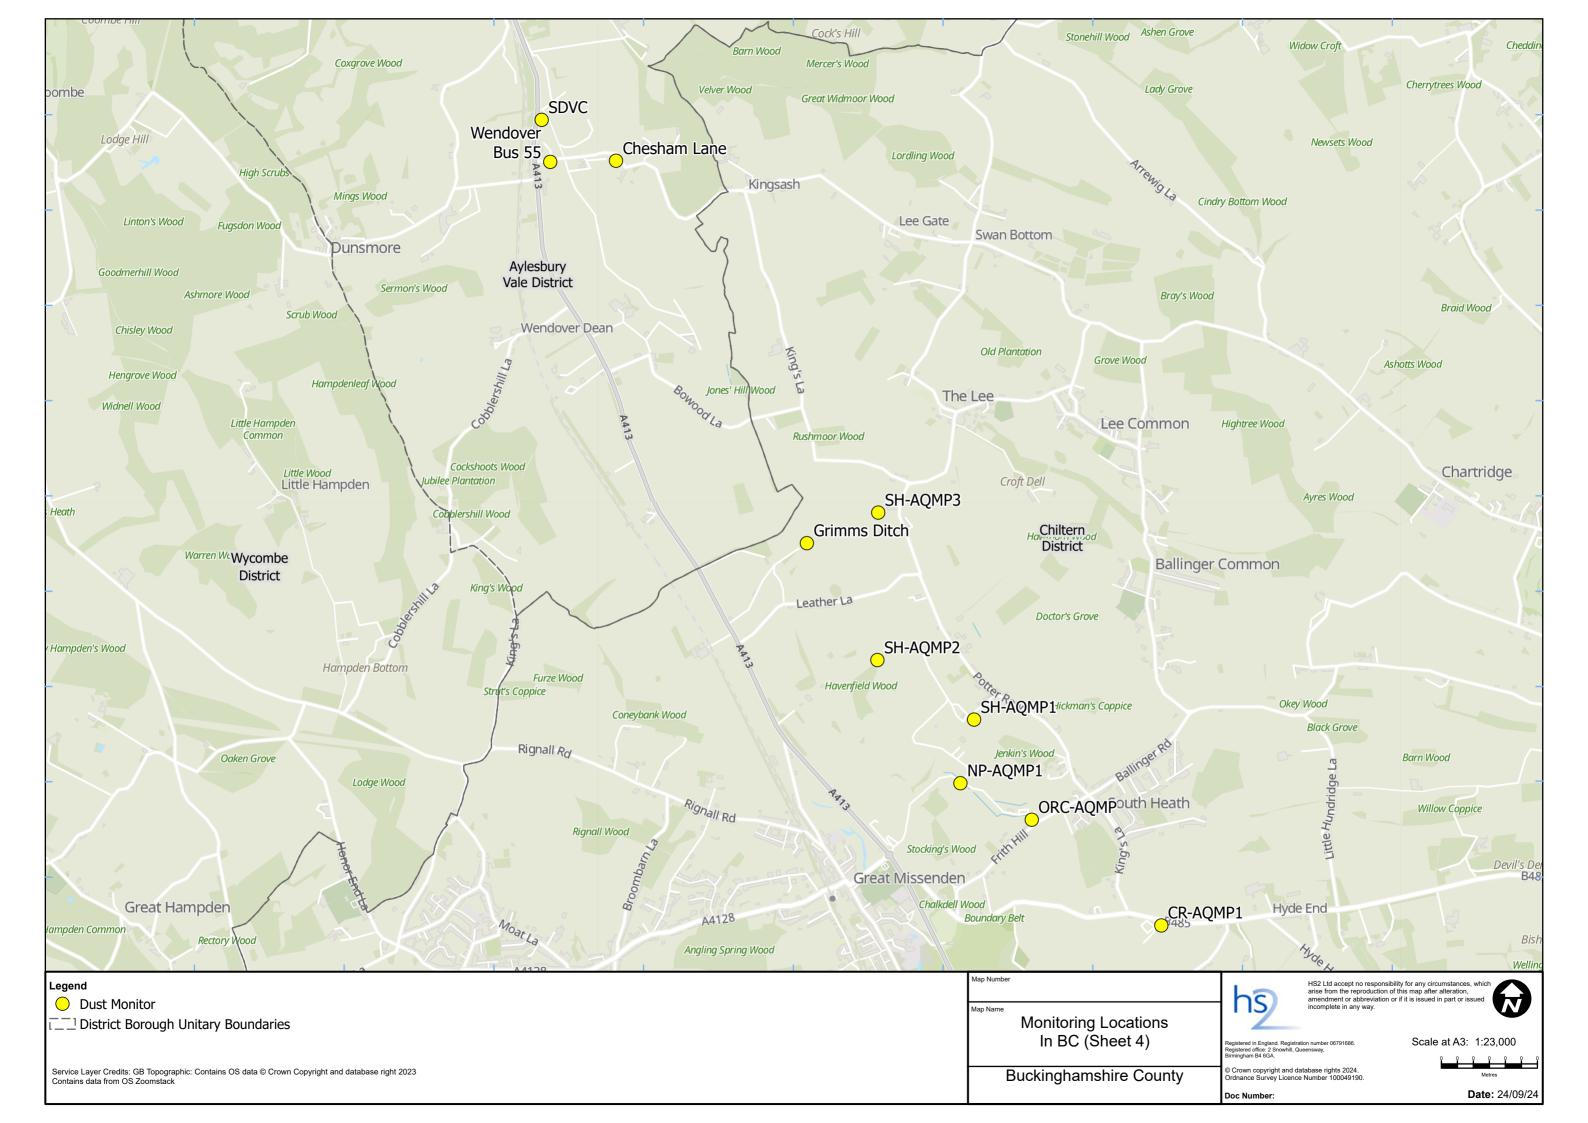
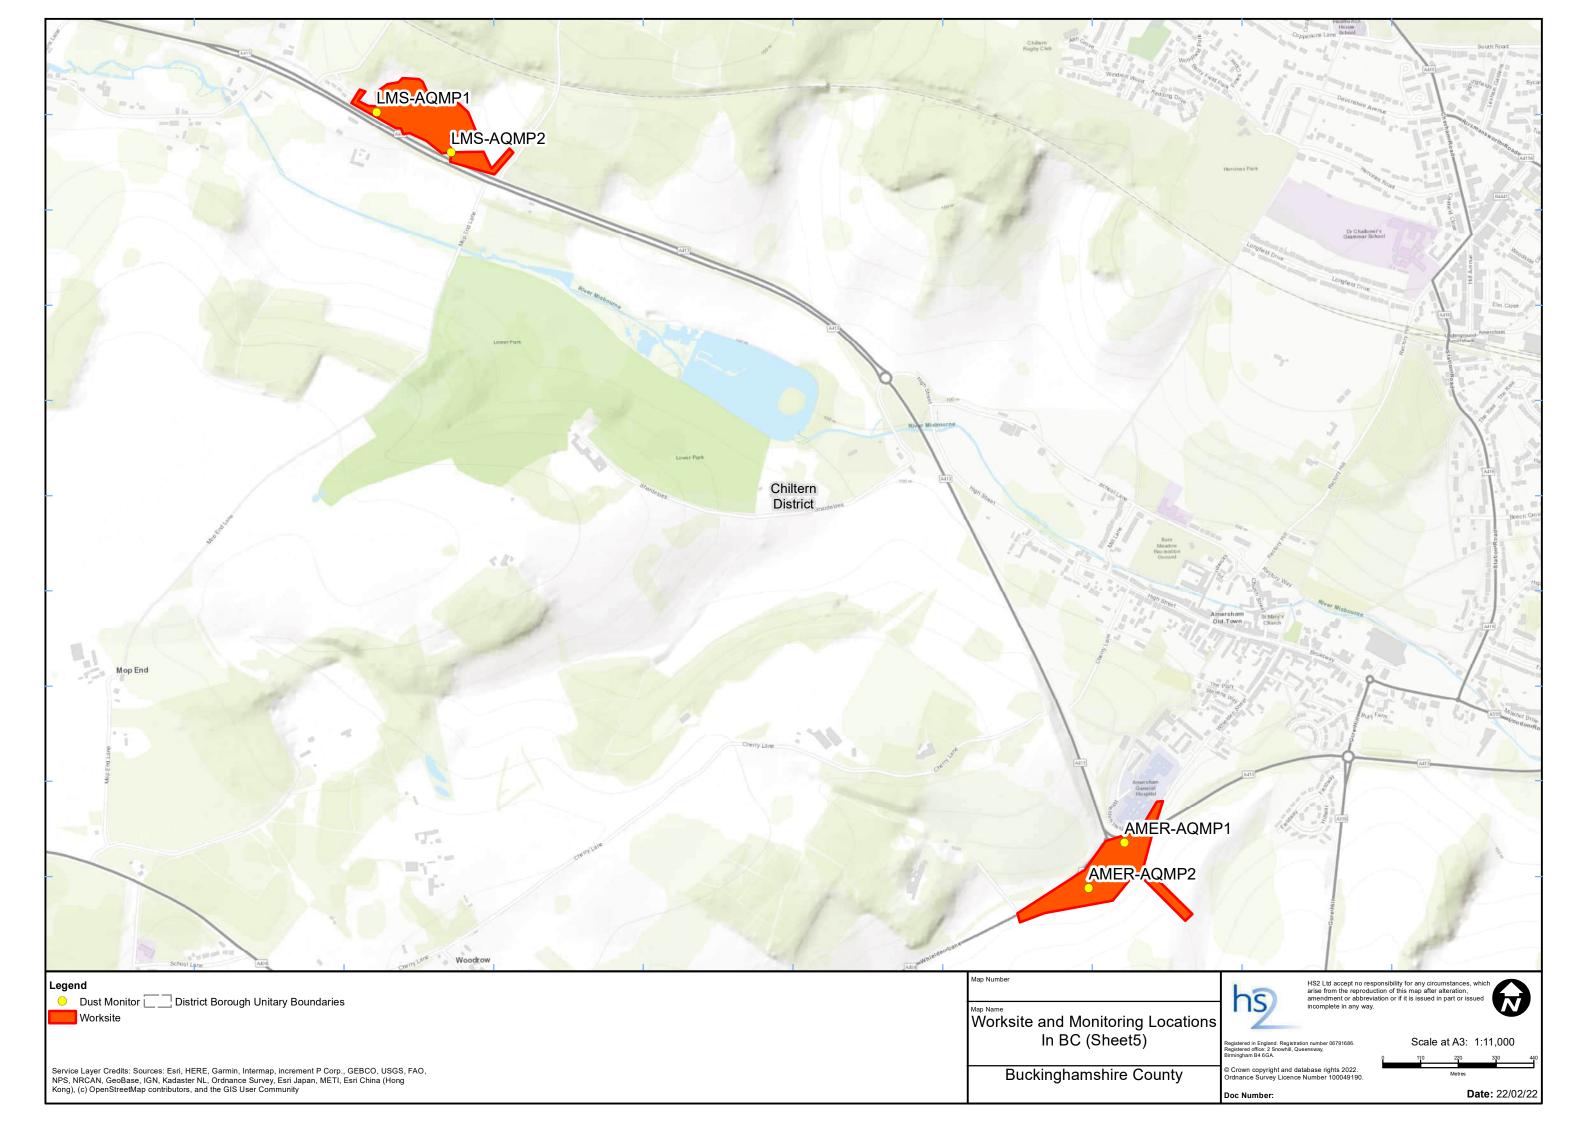
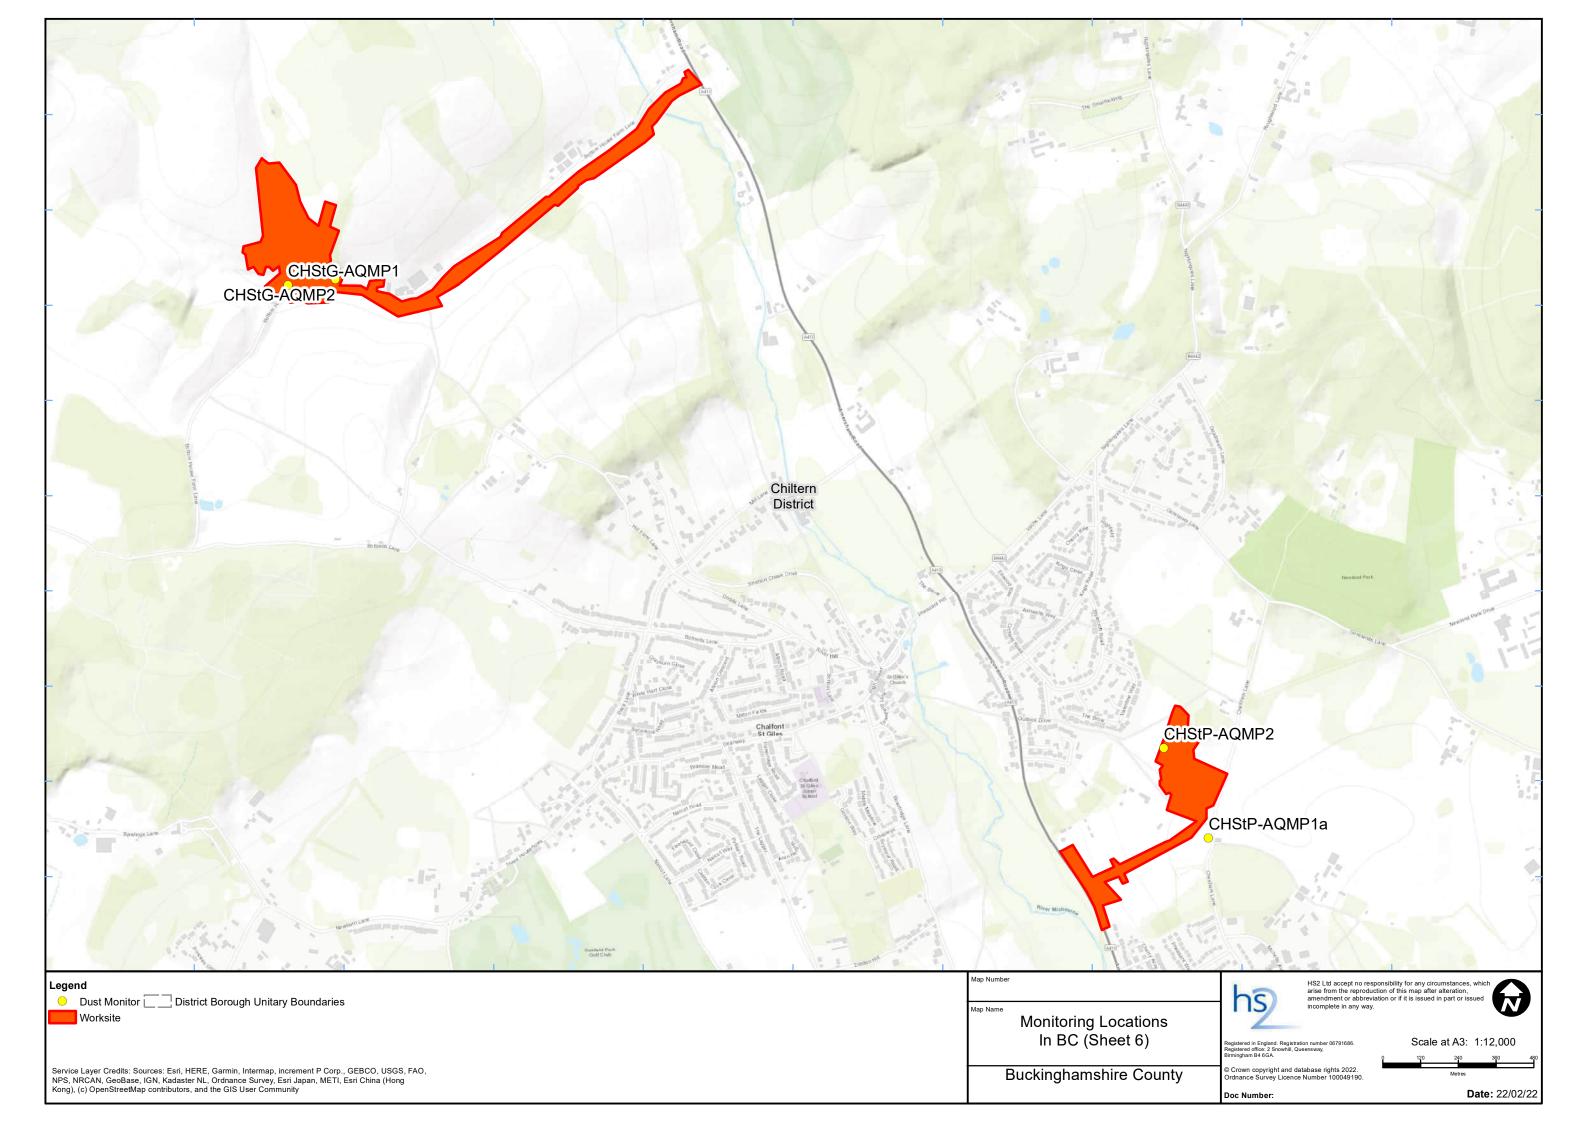
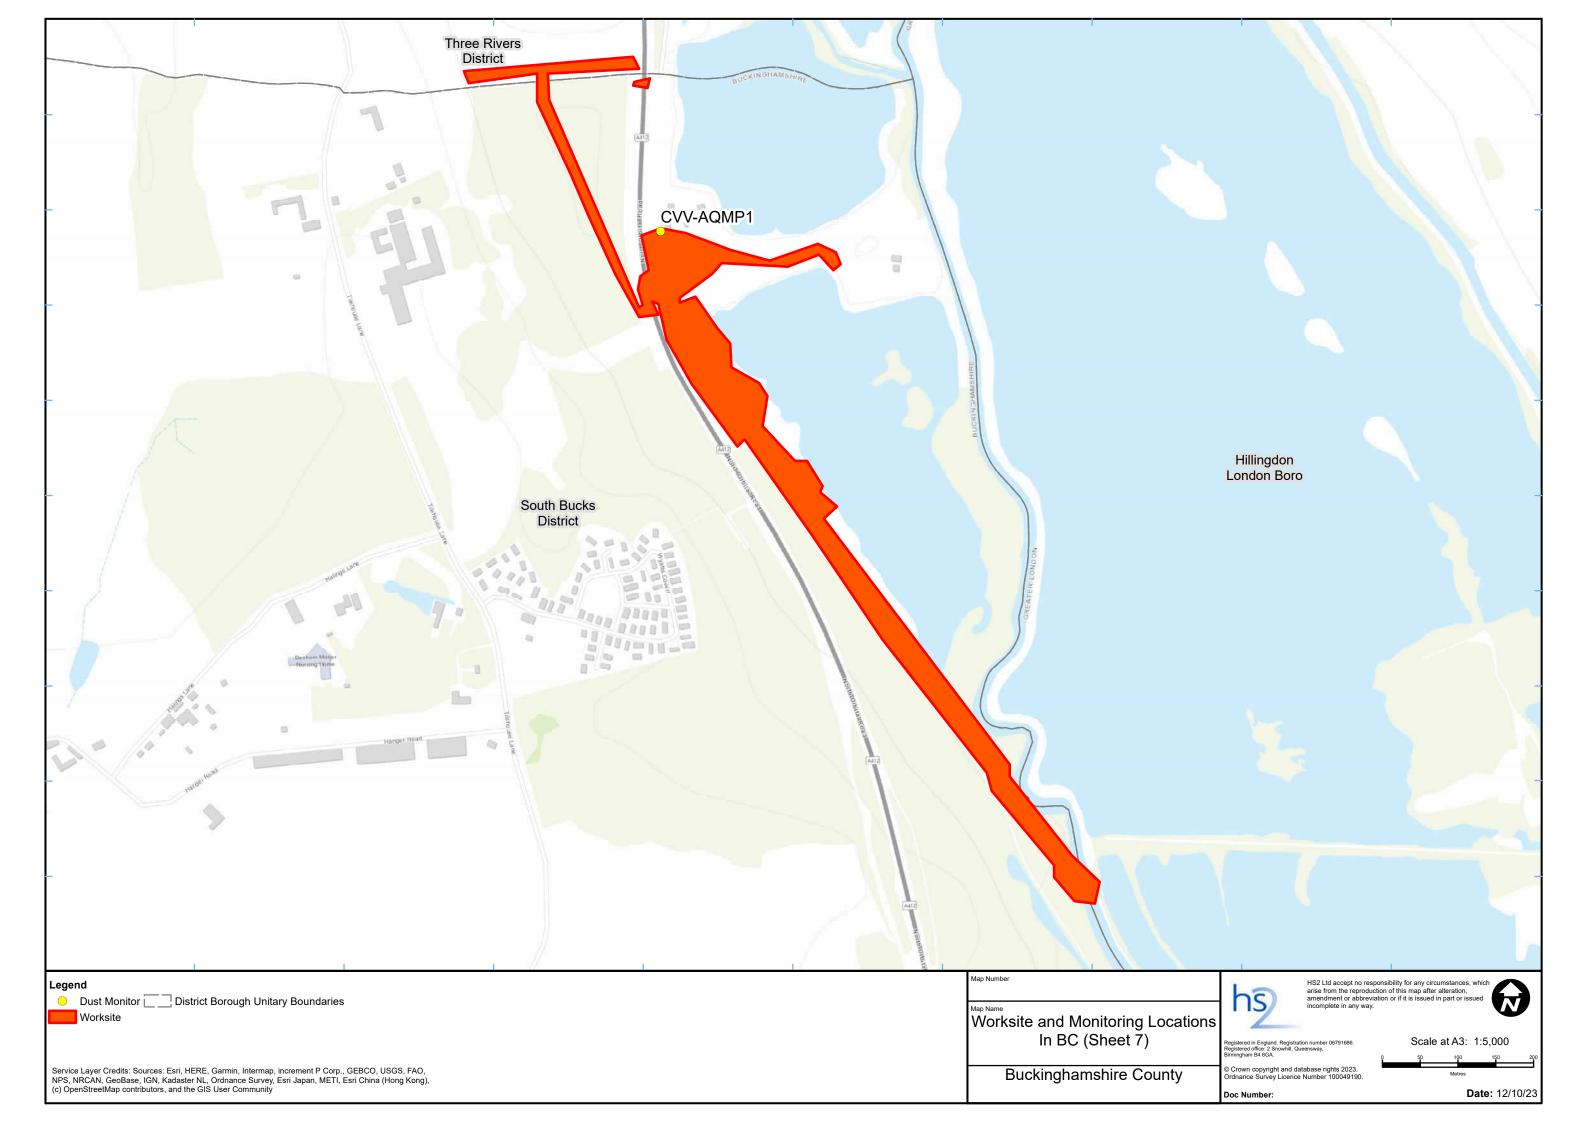
Figures 1-7: Worksite and Monitoring locations within BC

- 1.1.2 Figures 1-7 in Appendix A present the current worksites together with the dust monitoring locations.
- 1.1.3 This summary should be read in conjunction with the overview monitoring report available from <a href="www.gov.uk/government/collections/monitoring-the-environmental-effects-of-hs2">www.gov.uk/government/collections/monitoring-the-environmental-effects-of-hs2</a>, which highlights the applicable standards and guidance, as well as the air quality and dust monitoring methodologies to be implemented by nominated undertakers throughout construction.

- 1.1.4 The current worksites, as presented in Appendix A, Figures 1-7, include:

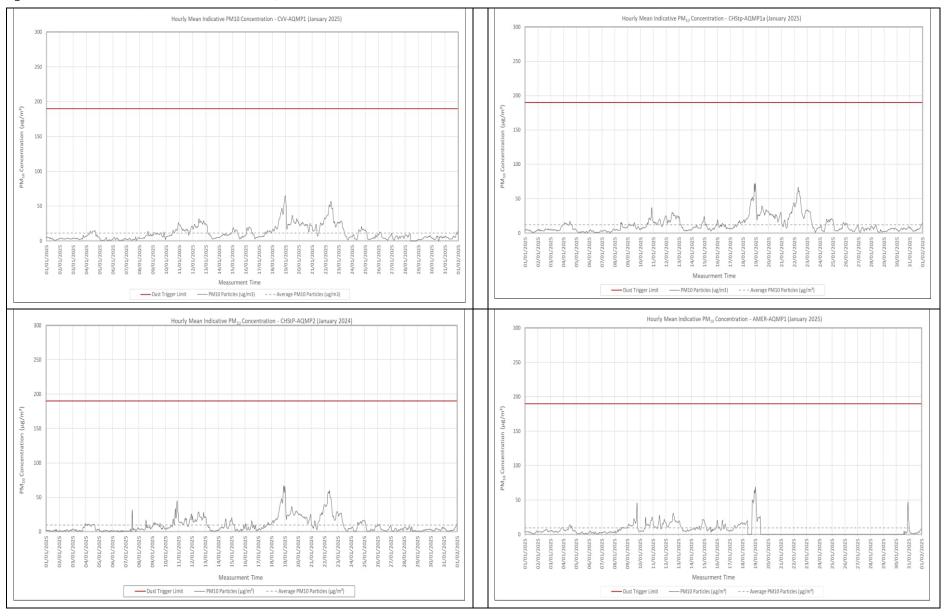
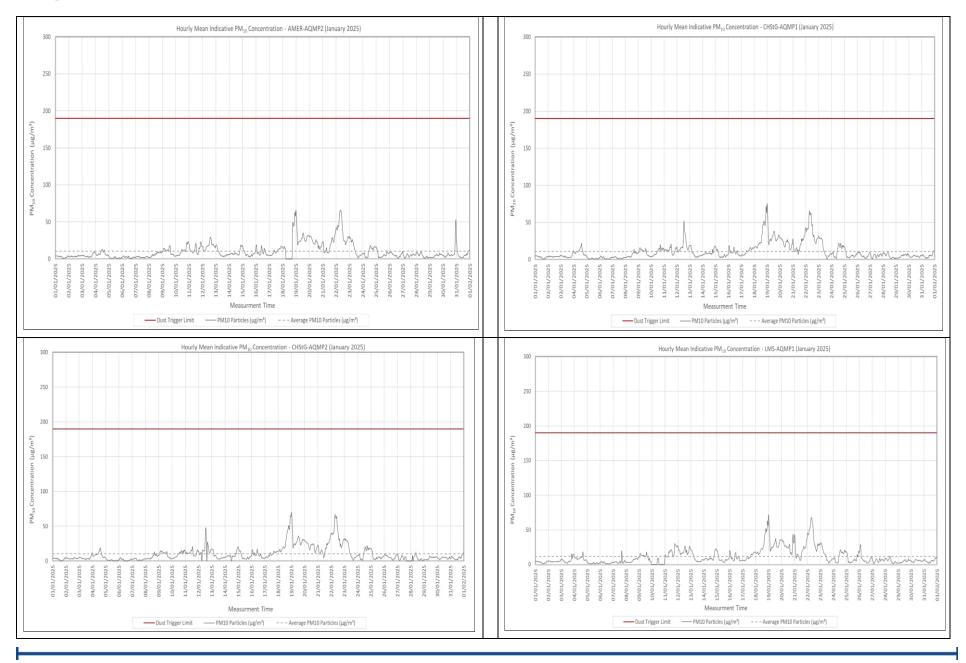
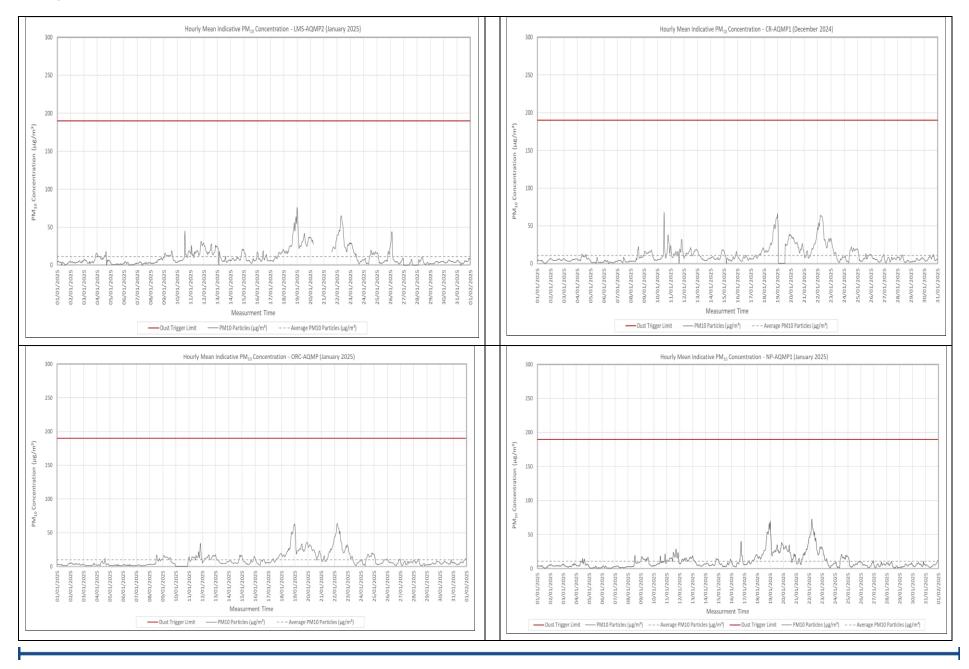
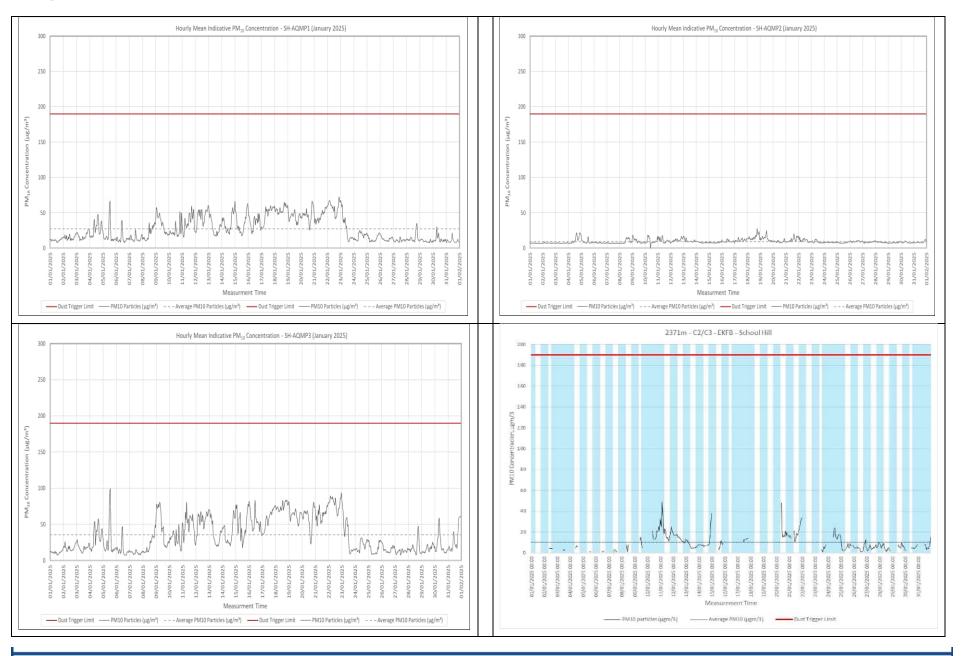
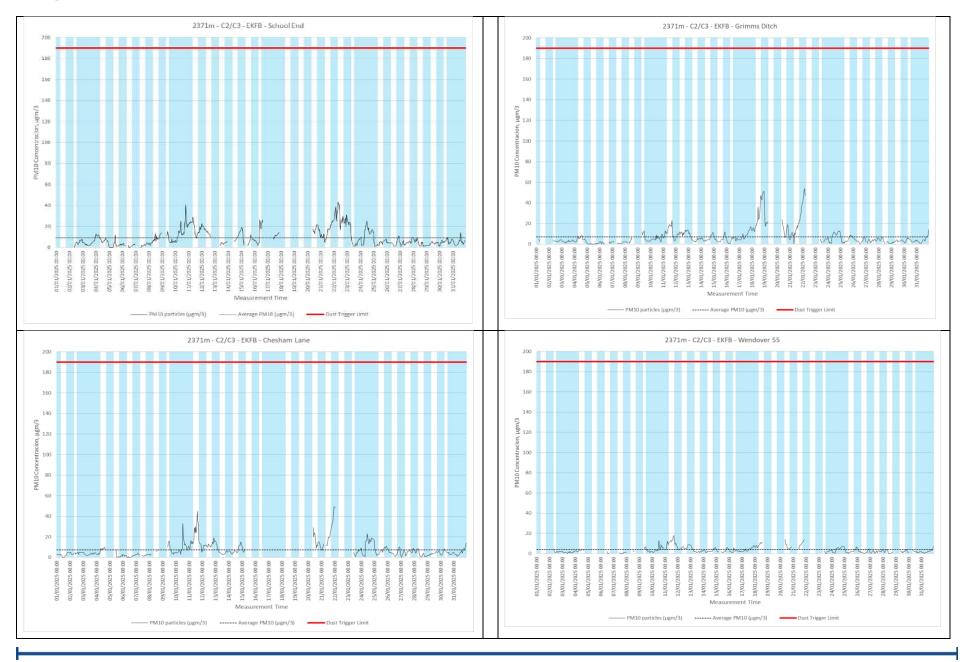
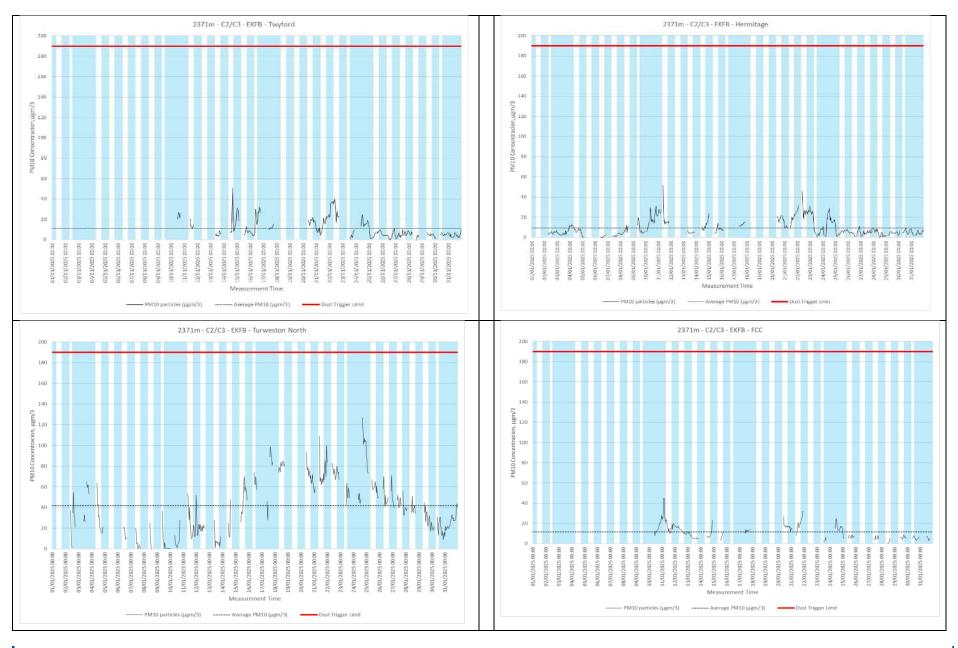
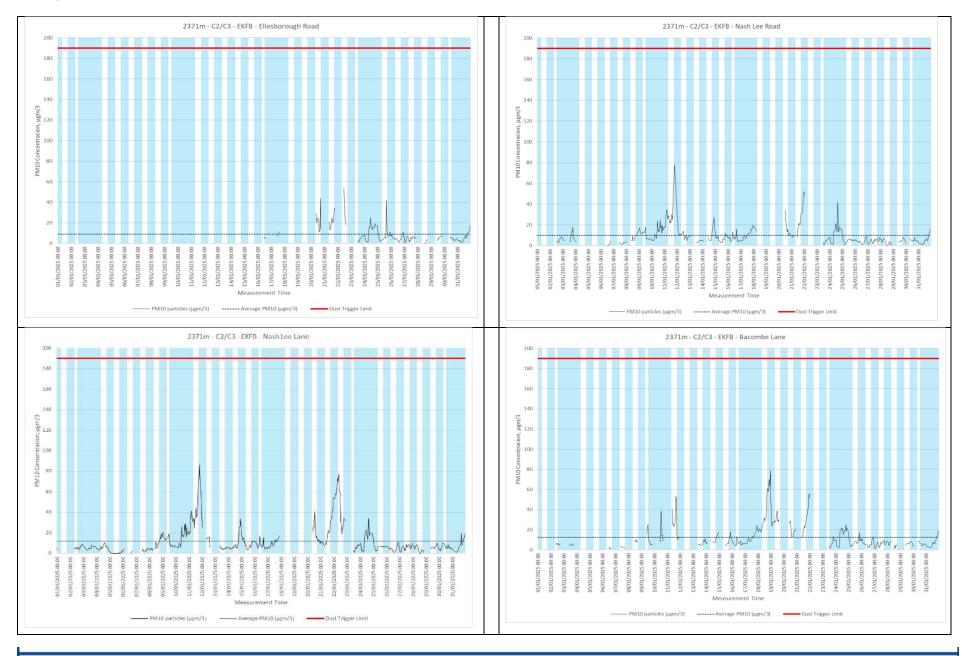
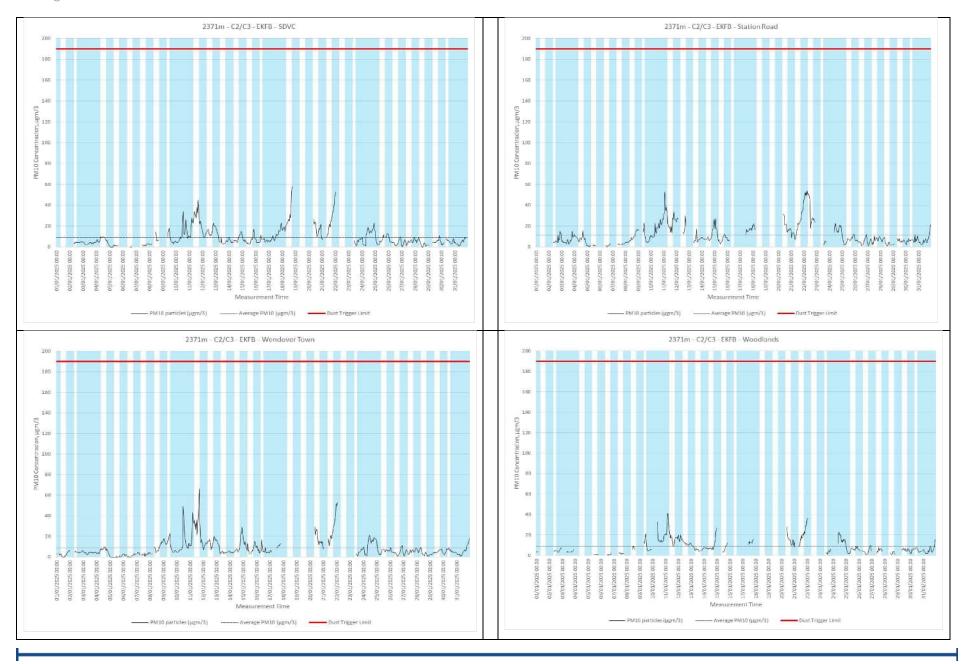
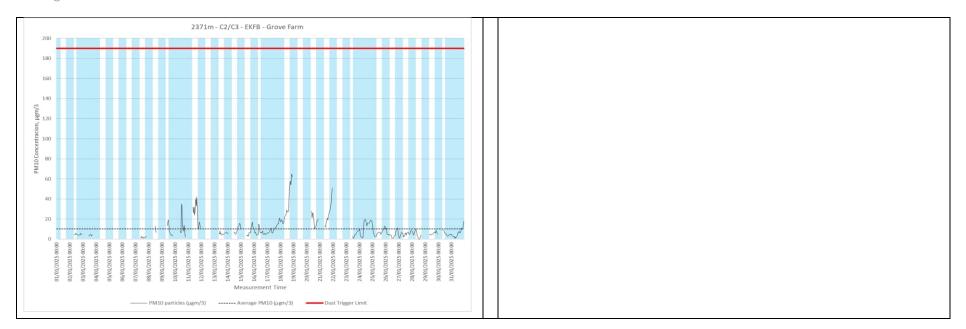
Figure 8: Continuous dust 1-hour mean indicative PM<sub>10</sub> concentration for all dust monitors

- KIS utility works.
- 1.1.5 Thirty-three (33) dust monitors are installed around these worksites, where works are underway. These sites returned a medium dust risk rating.
- 1.1.6 Dust monitoring locations and results are presented in Appendix B, Table 1, together with line charts of monthly data from each dust monitor presented in Figure 8. All continuous dust monitoring is undertaken using indicative monitors. Despite being Environment Agency (MCERTS) certified, indicative monitors carry a higher level of uncertainty than reference monitors, and therefore cannot be strictly compared with Air Quality Standards for human health and the environment. The purpose of the monitoring undertaken is to ensure the effectiveness of the on-site mitigation.

- 1.1.7 The trigger level for  $PM_{10}$  concentrations of 190  $\mu$ g/m³, measured as a 1-hour mean, in accordance with the updated guidance document 'Guidance on Monitoring in the Vicinity of Demolition and Construction Sites (December 2018)' has been applied.

- 1.1.8 No (0) dust trigger alerts were recorded during the monitoring period (January 2025).
- 1.1.9 Data capture was below 90% for multiple monitors due to:
