Air Quality and Dust Monitoring Monthly Report - January 2025

Warwick District Council

Appendix A - Worksites and Monitoring Locations

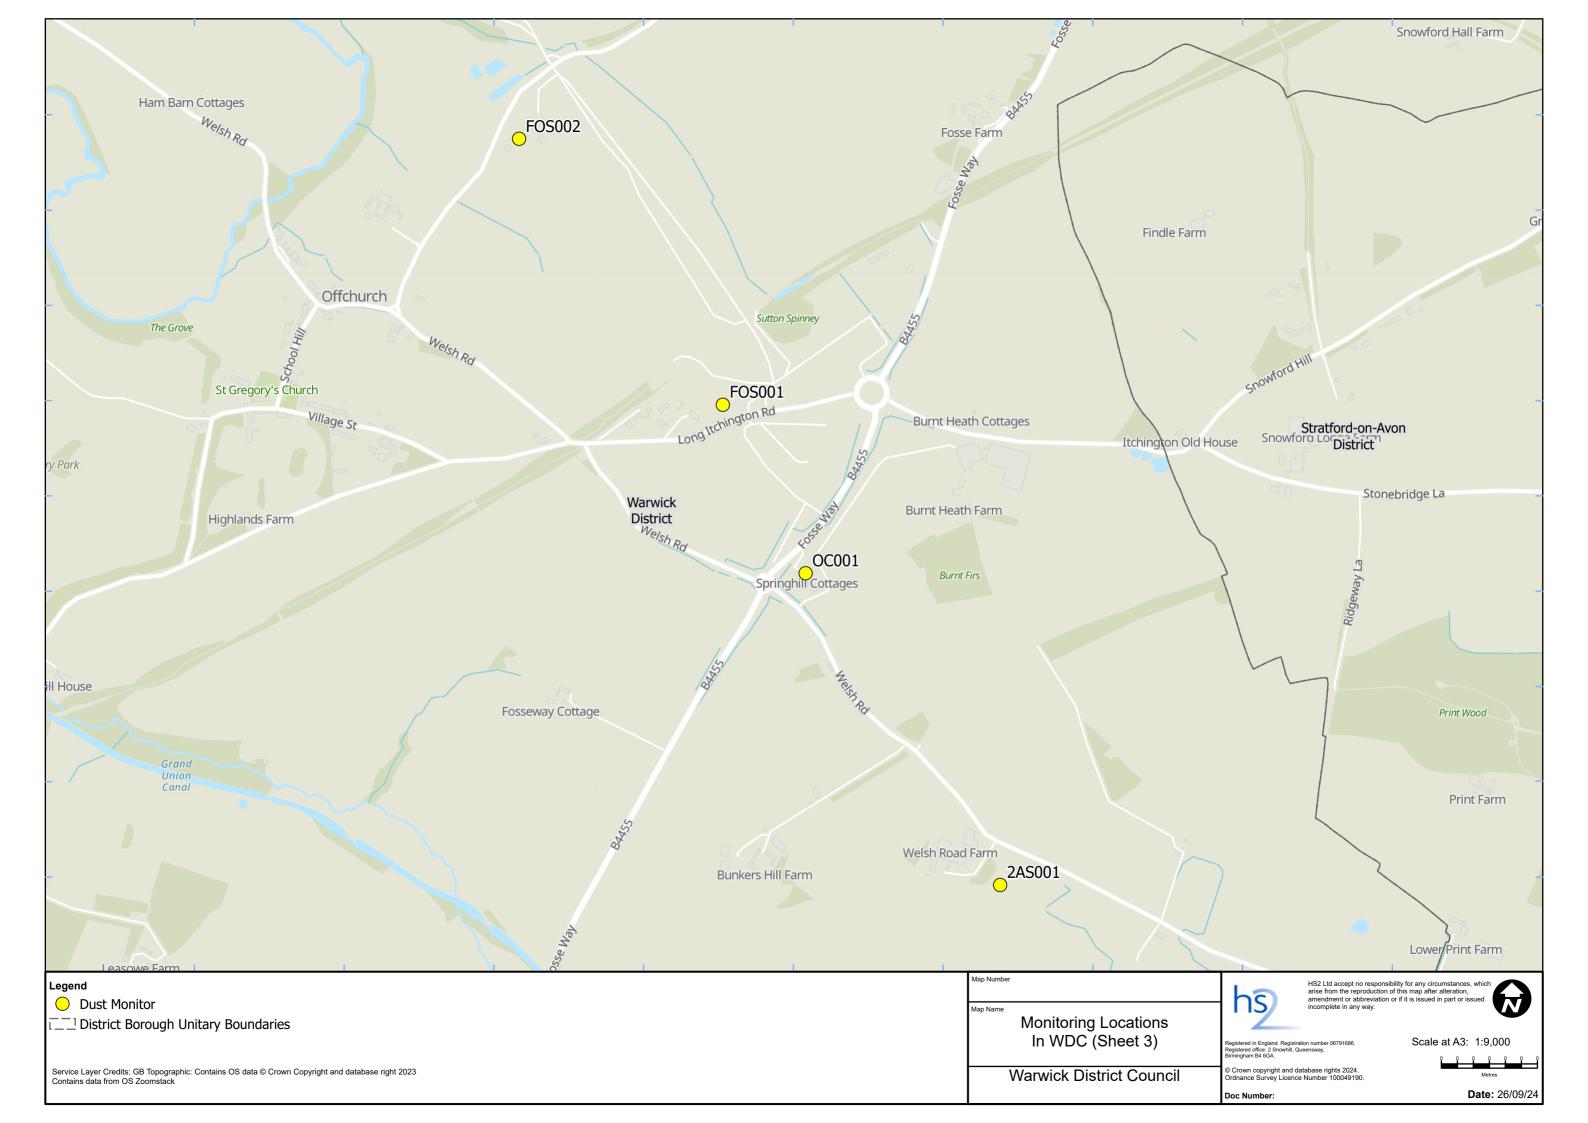
Figures 1-3: Worksites and Monitoring Locations within WDC

- 1.1.2 Figures 1 to Figure 3 in Appendix A present the current worksites together with the dust monitoring locations.
- 1.1.3 This summary should be read in conjunction with the overview monitoring report monthly available from www.gov.uk/government/collections/monitoring-the-environmental-effects-of-hs2, which highlights: the applicable standards and guidance, as well as the air quality and dust monitoring methodologies to be implemented by nominated undertakers throughout construction.

- 1.1.4 The current worksites, as presented in Appendix A, Figures 1 to 3, include:

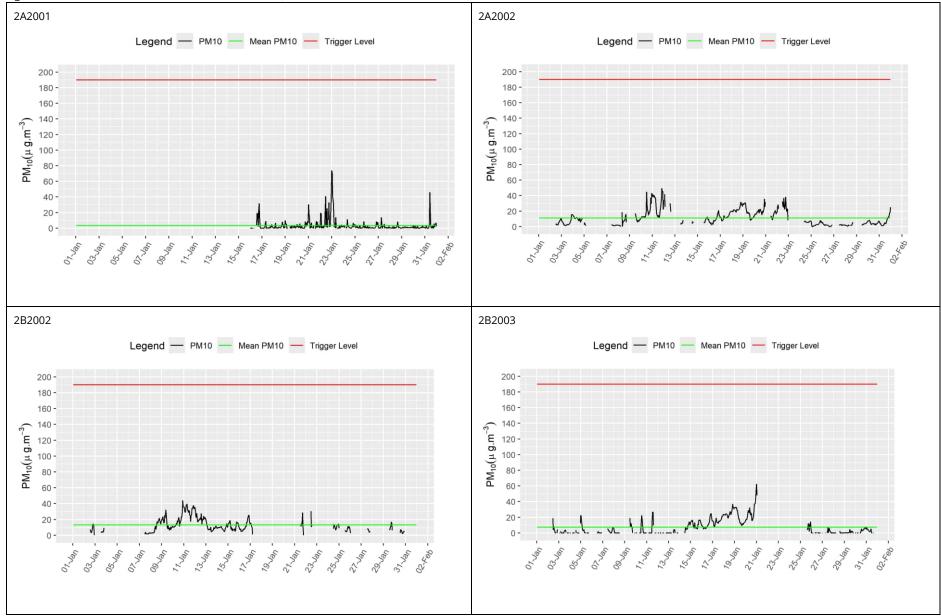
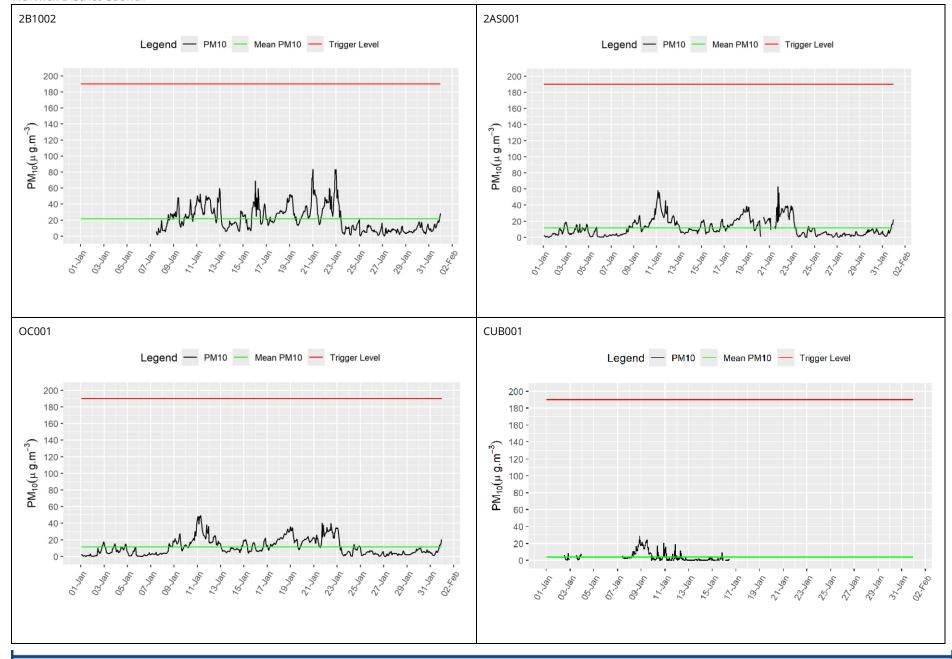
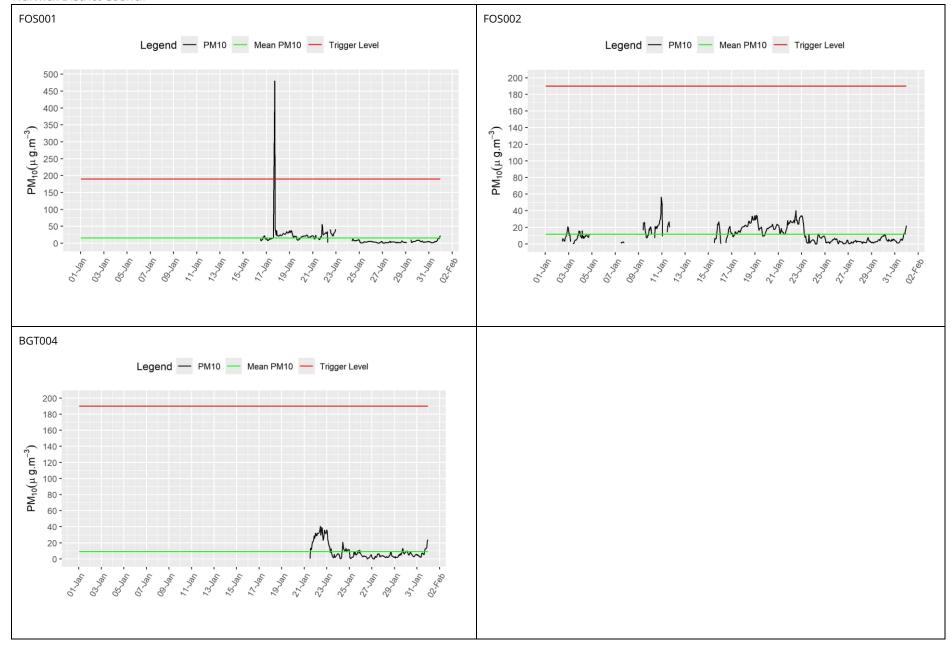
Figure 4: Construction dust 1-hour mean indicative PM₁₀ concentration for all dust monitors

- 1.1.6 Dust monitoring locations and results are presented in Appendix B, Table 1, together with line charts of monthly data from each dust monitor, presented in Figure 4. All continuous dust monitoring is undertaken using indicative monitors. Despite being Environment Agency (MCERTS) certified, indicative monitors carry a higher level of uncertainty than reference monitors, and therefore cannot be strictly compared with Air Quality Standards for human health and the environment. The purpose of the monitoring undertaken is to ensure the effectiveness of the on-site mitigation.

- 1.1.7 The trigger level for PM_{10} concentrations of 190 $\mu g/m^3$, over a 1-hour period, in accordance with the updated guidance document 'Guidance on Monitoring in the Vicinity of Demolition and Construction Sites (October 2018)' has been applied.

Monitoring Site ID	Period of trigger alert &	Investigation	Outcomes / Resolution / Remedial measures		
	Concentration recorded		implemented		
FOS001	17/01/25: 15:01 - 16:00; 297.2 μg m ³ 16:01 - 17:00; 480.3 μg m ³	No relevant site activities occurred near the monitor at the times of the exceedances, so these exceedances are not thought to be associated with current HS2 construction works.	N/A
