Construction Noise and Vibration Monthly Report – January 2025

Lichfield District Council

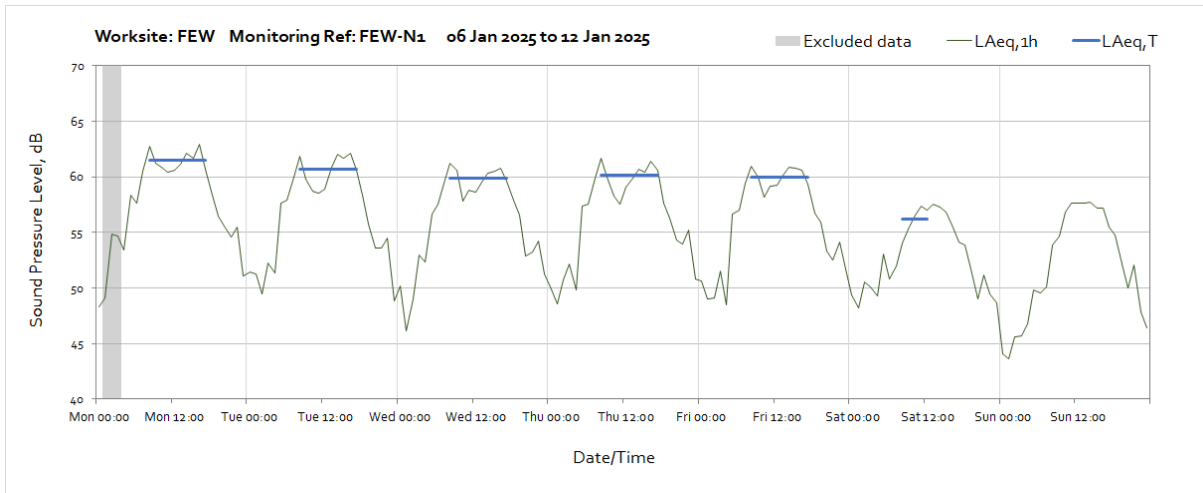
Worksite:FEW – Monitoring Ref: FEW-N1

The following graphs show the hourly measured ambient noise level $L_{Aeq,1h}$ and, where relevant, the averaged noise level $L_{Aeq,T}$ values, where the time period T is as specified in Table 1 of HS2 Information Paper E23. Periods where noise levels are adversely affected by weather or only measured for part of the period, which are not representative of HS2 construction works, have been greyed out and excluded from the calculation of the $L_{Aeq,T}$ values in Table 3 of the main report.

Note: Missing data between 19:00 on Sunday 19th January and 10:00 on Tuesday 21st January was due to a system error at the monitoring station.
