## **Construction Noise and Vibration Monthly Report – January 2025**

**Solihull Metropolitan Borough Council**

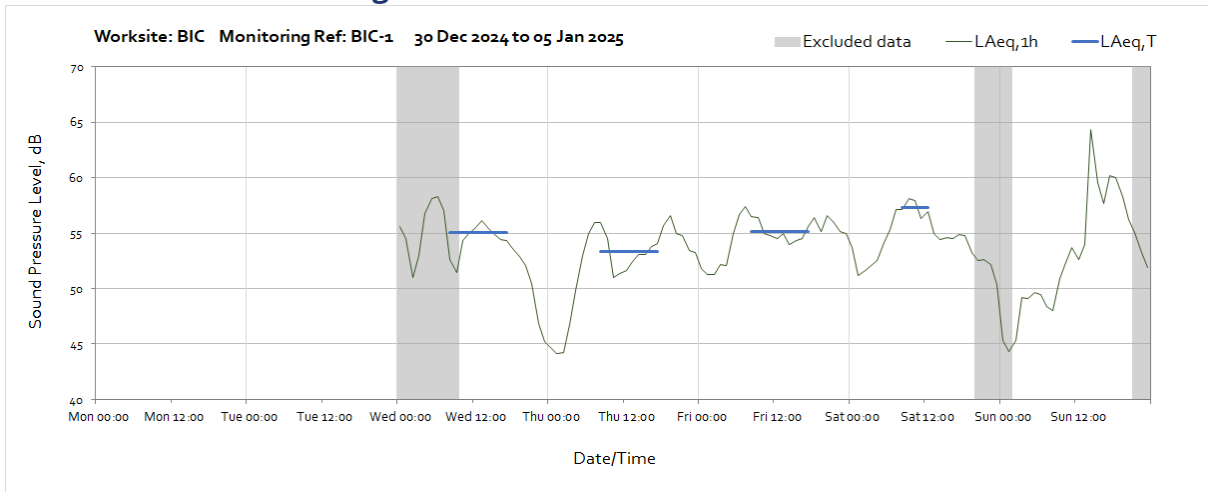
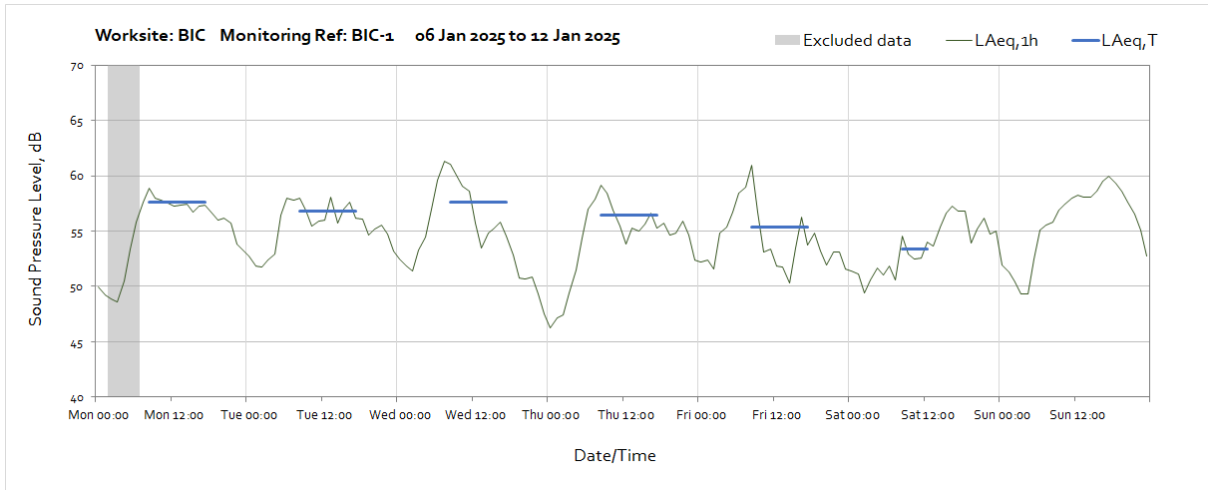
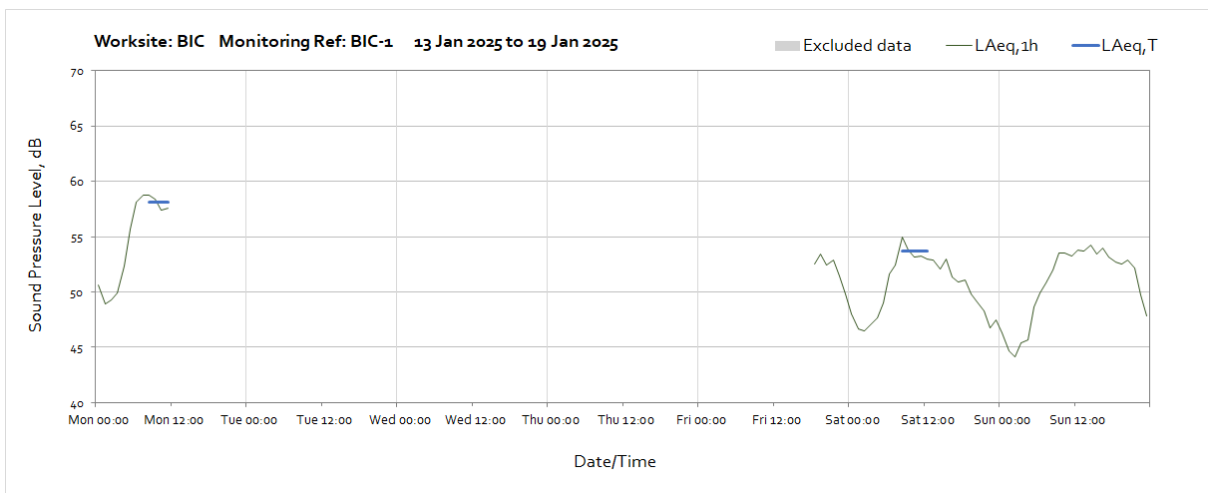
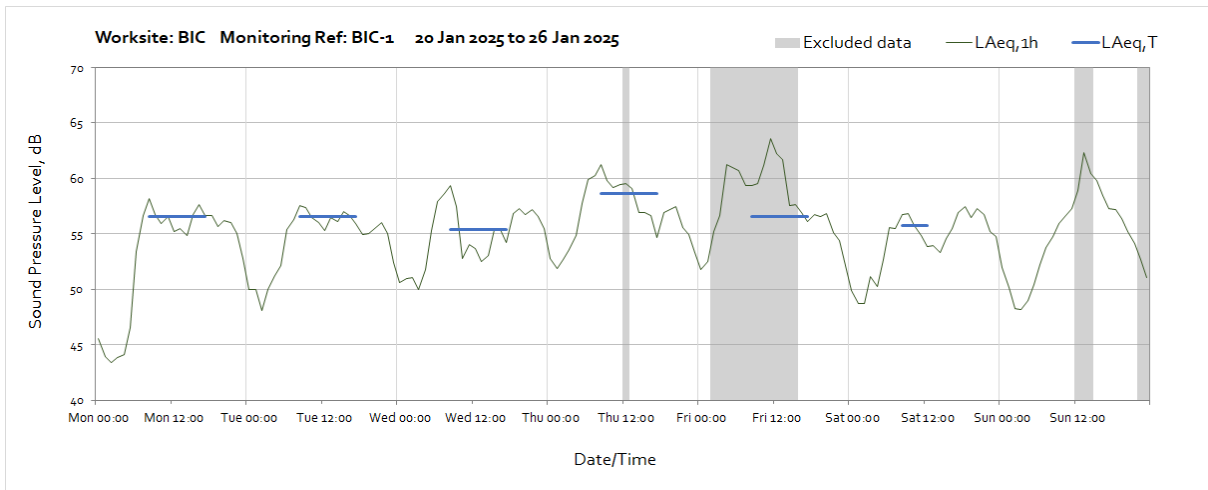
**Worksite: BIC - Monitoring Ref: BIC-1**

Note: Missing data between 11:00 on Monday 13<sup>th</sup> and 18:00 on Friday 17<sup>th</sup> January was due to monitor retrieval for recalibration.

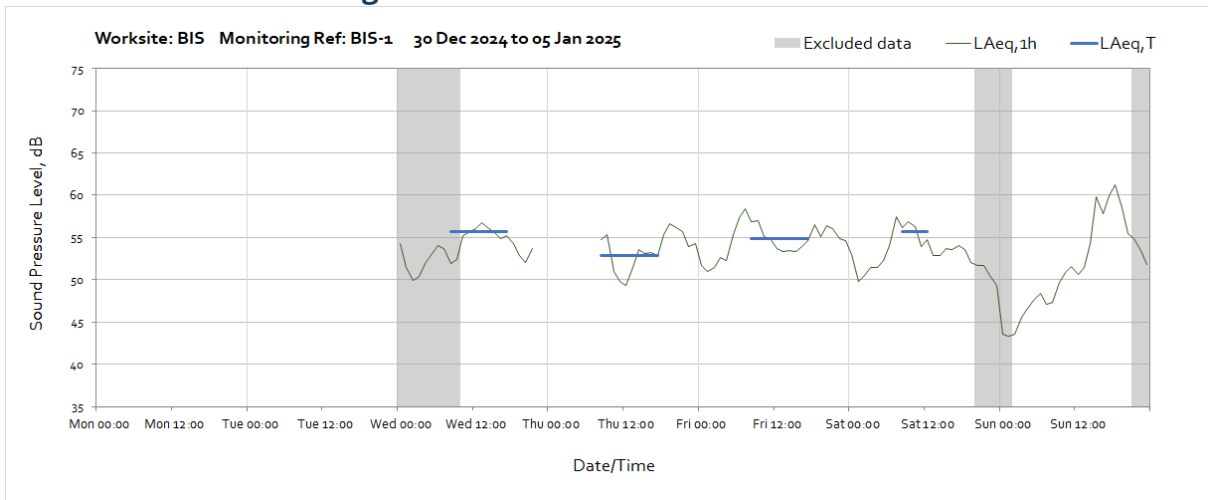
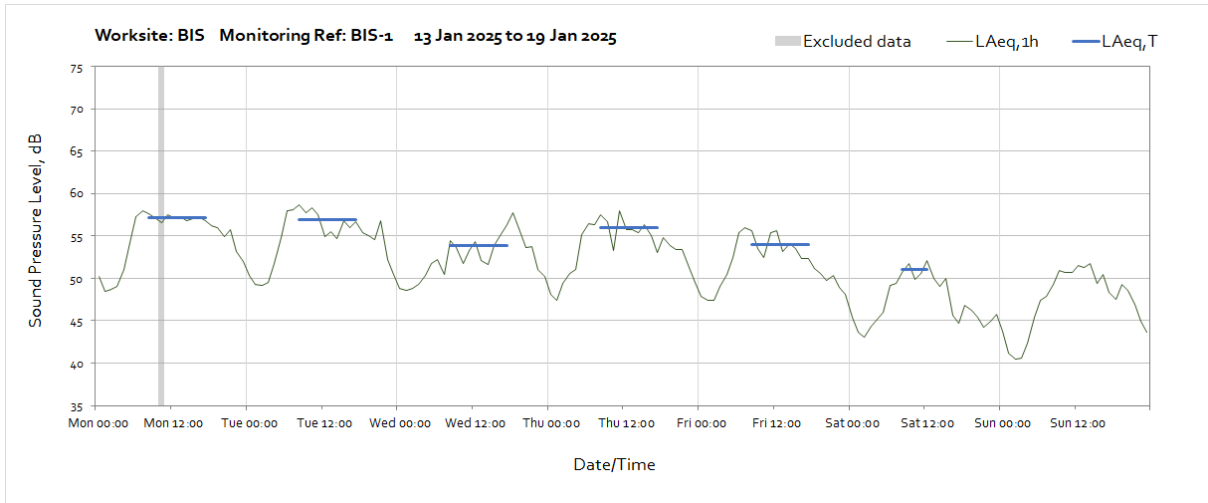
**Worksite: BIS- Monitoring Ref: BIS-1**

Note: Missing data between 22:00 on Wednesday 1<sup>st</sup> and 08:00 on Thursday 2<sup>nd</sup> January was due to a fault at the monitoring station.

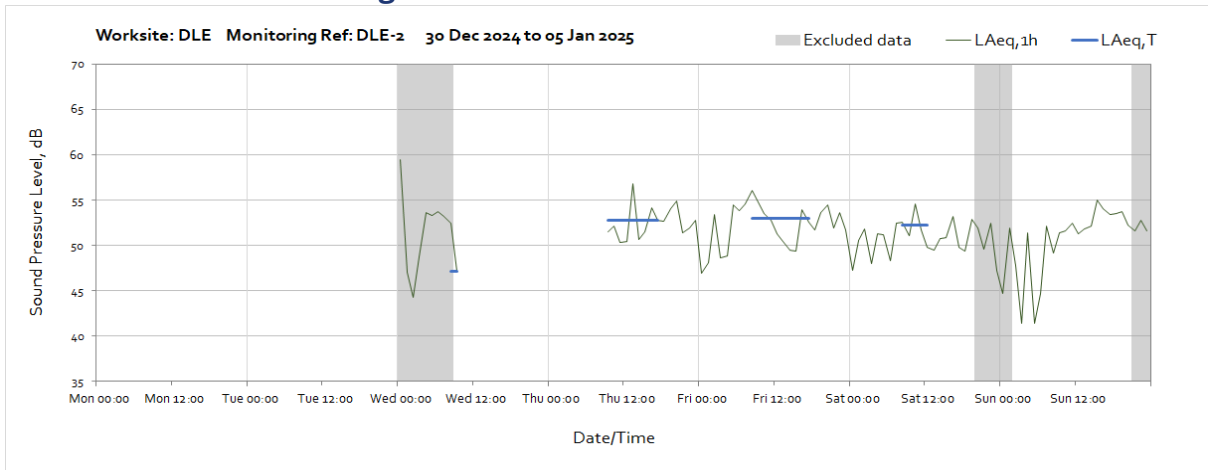
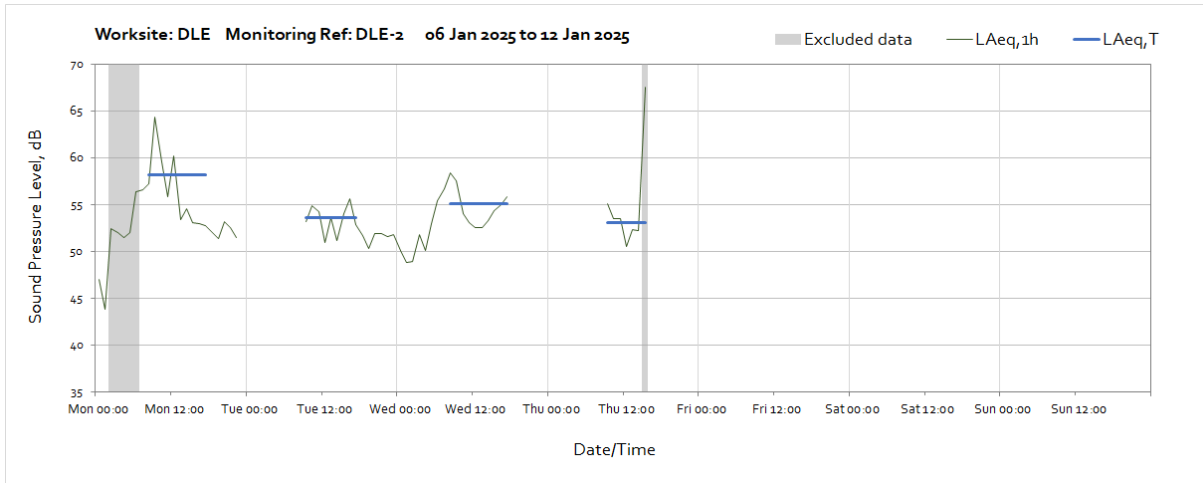
**Worksite: DLE - Monitoring Ref: DLE-2**

Note: Missing data between 10:00 on Wednesday 1<sup>st</sup> and 09:00 on Thursday 2<sup>nd</sup> January was due to a loss of power to the monitoring station caused by poor weather conditions preventing sufficient light reaching the solar panel.

Note: Missing data throughout the week was due to a loss of power to the monitoring station caused by poor weather conditions preventing sufficient light reaching the solar panel.

Note: Missing data between 16:00 on Thursday 9<sup>th</sup> and 09:00 on Tuesday 14<sup>th</sup> January was due to a loss of power to the monitoring station caused by poor weather conditions preventing sufficient light reaching the solar panel.

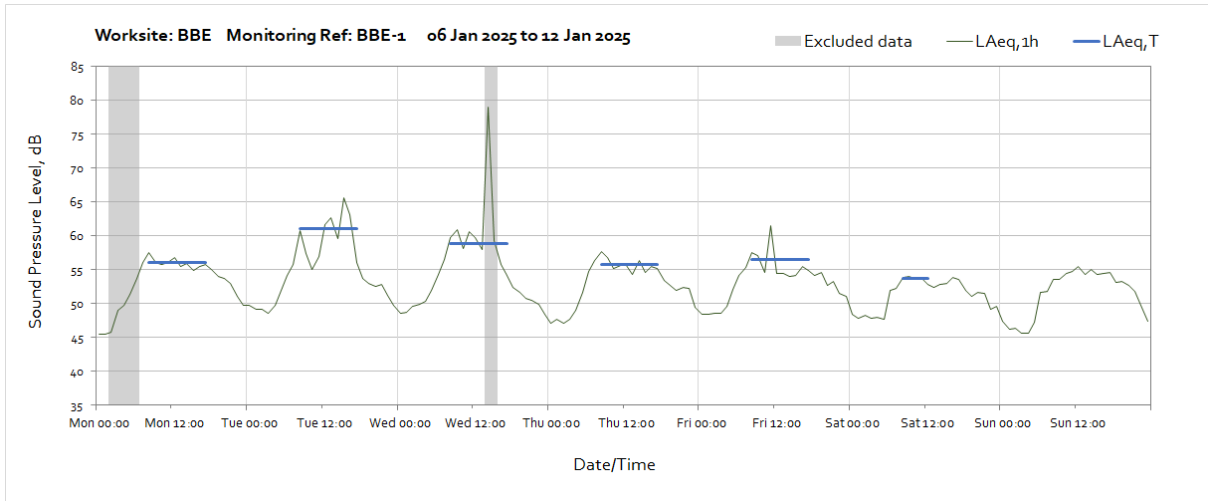
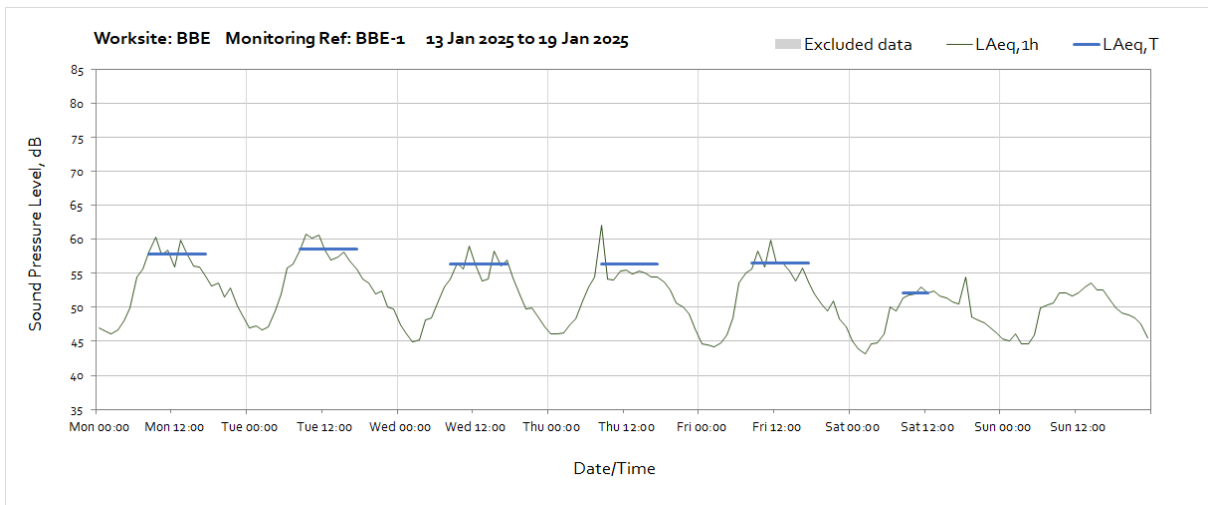
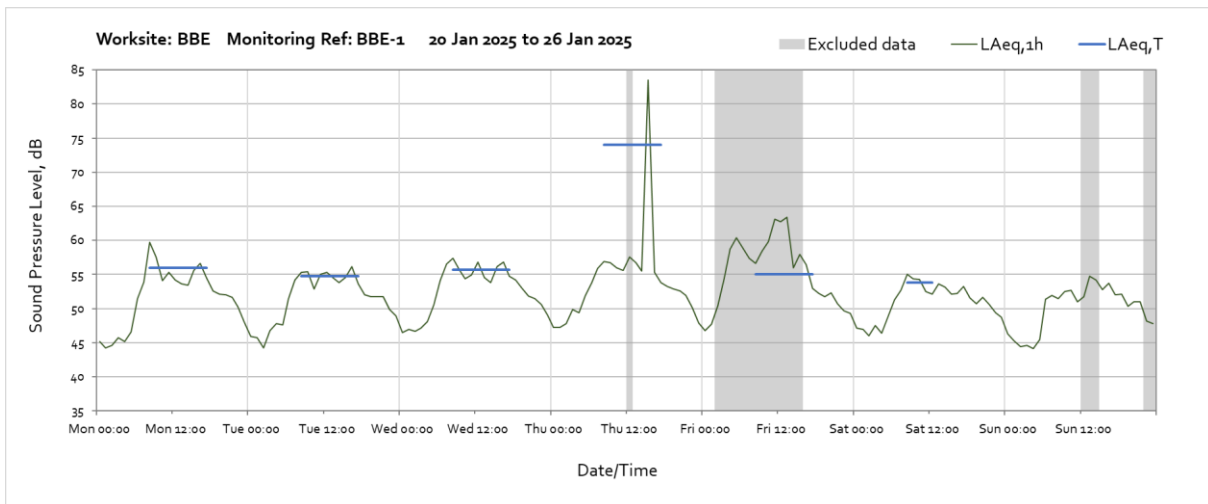
**Worksite: BBE – Monitoring Ref: BBE-1**

Note: Missing data between 04:00 on Wednesday 1<sup>st</sup> and 09:00 on Thursday 2<sup>nd</sup> January was due to a loss of power to the monitoring station caused by poor weather conditions preventing sufficient light reaching the solar panel.

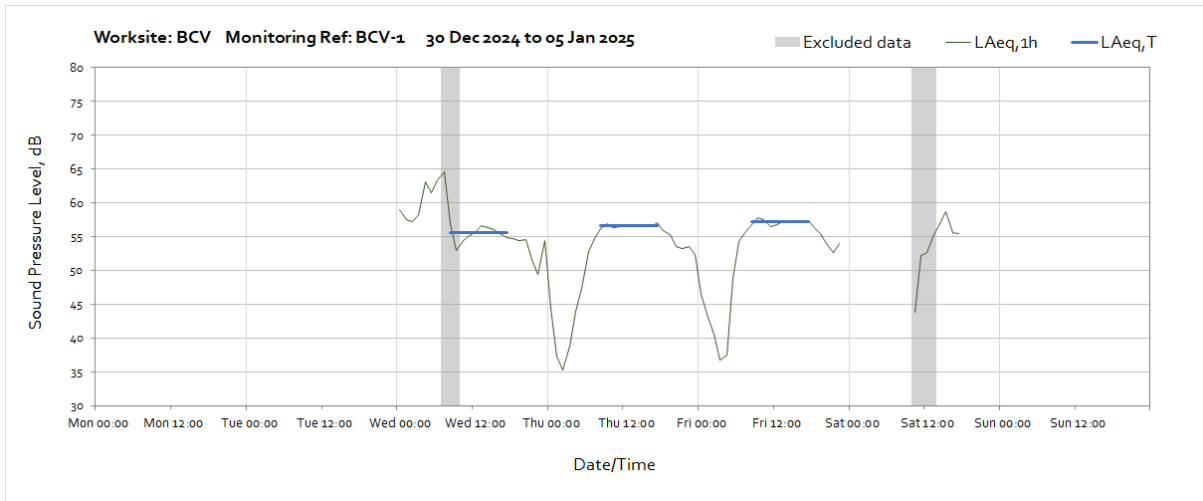
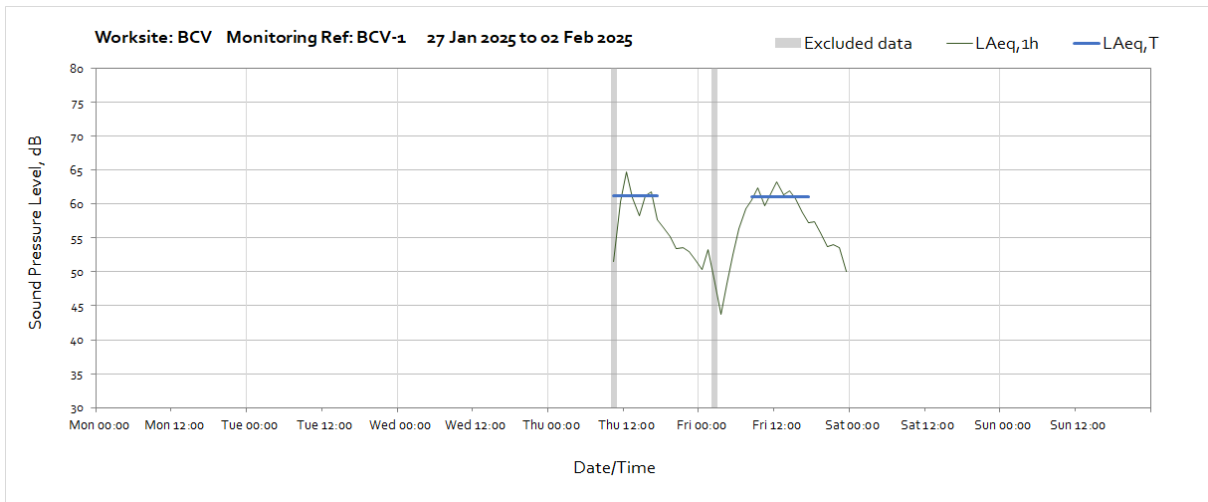
## Worksite: BCV – Monitoring Ref: BCV-1

Note: Missing data throughout the month was due to a loss of power to the monitoring station caused by poor weather conditions preventing sufficient light reaching the solar panel.

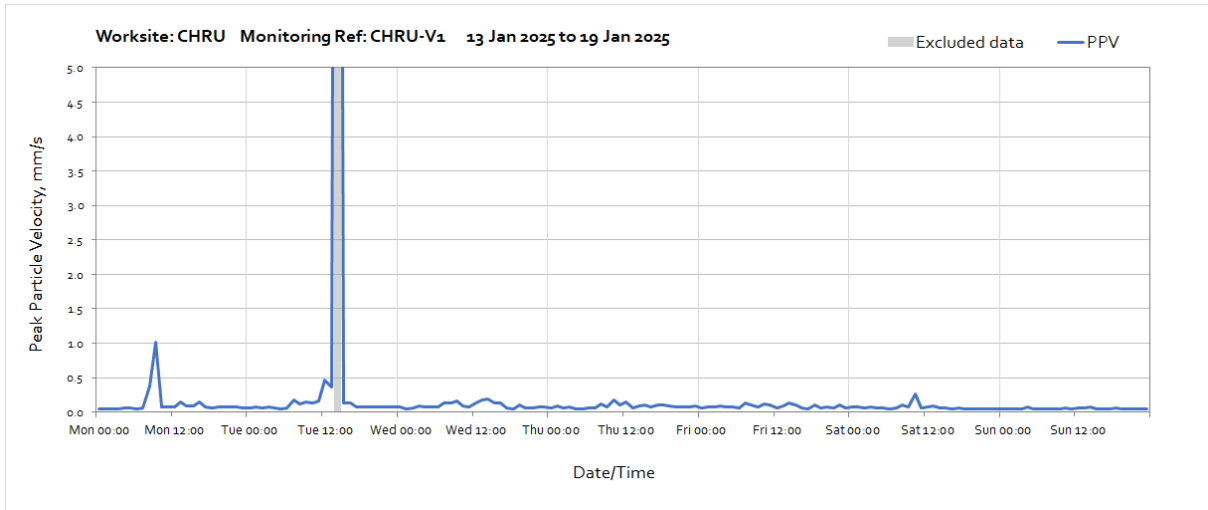
## Worksite: CHR – Monitoring Ref: CHR-U-V1

The following graphs show the hourly measured peak particle velocity PPV recorded during the monitoring period. The graphs show the highest PPV of the three orthogonal axes x, y and z. Periods where PPV values have been affected by local interference with the vibration monitor or only measured for part of the period, which are not representative of HS2 construction works, have been greyed out and excluded when calculating values in of the main report.

Note: Missing data between 11:00 and 12:00 on Tuesday 28<sup>th</sup> January was due to monitoring station relocation.

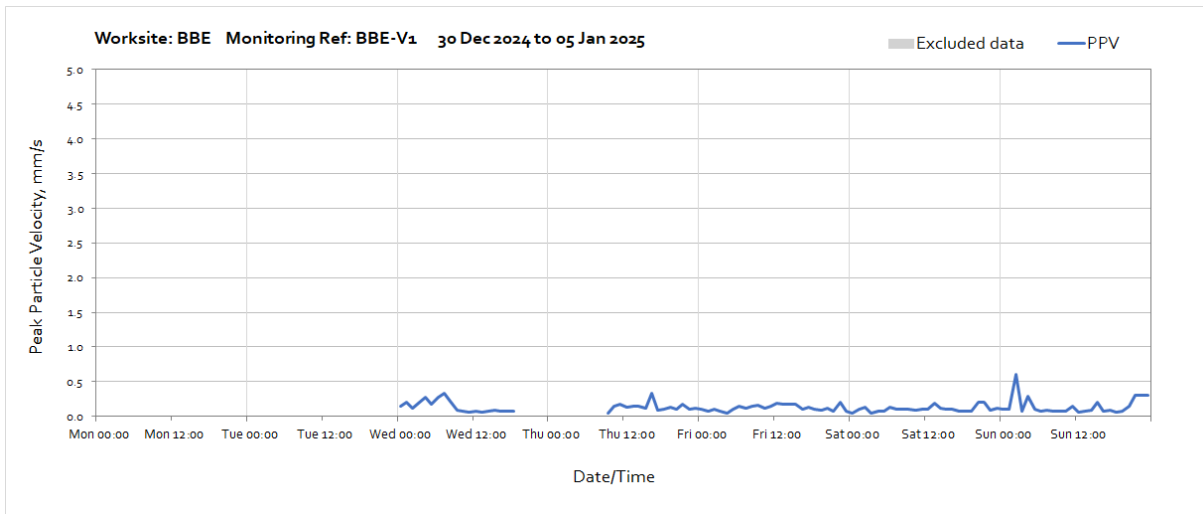
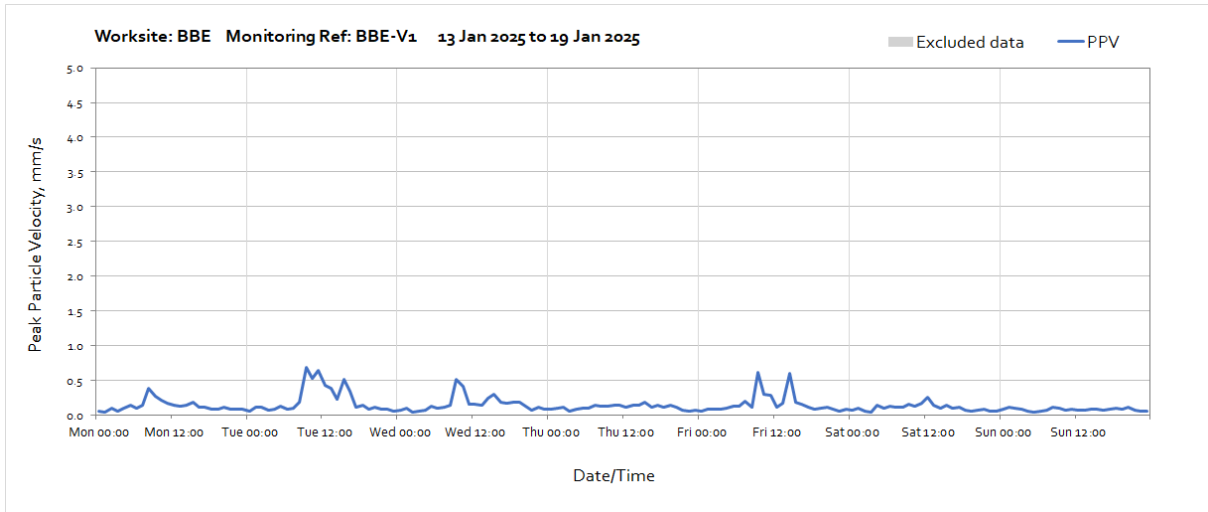
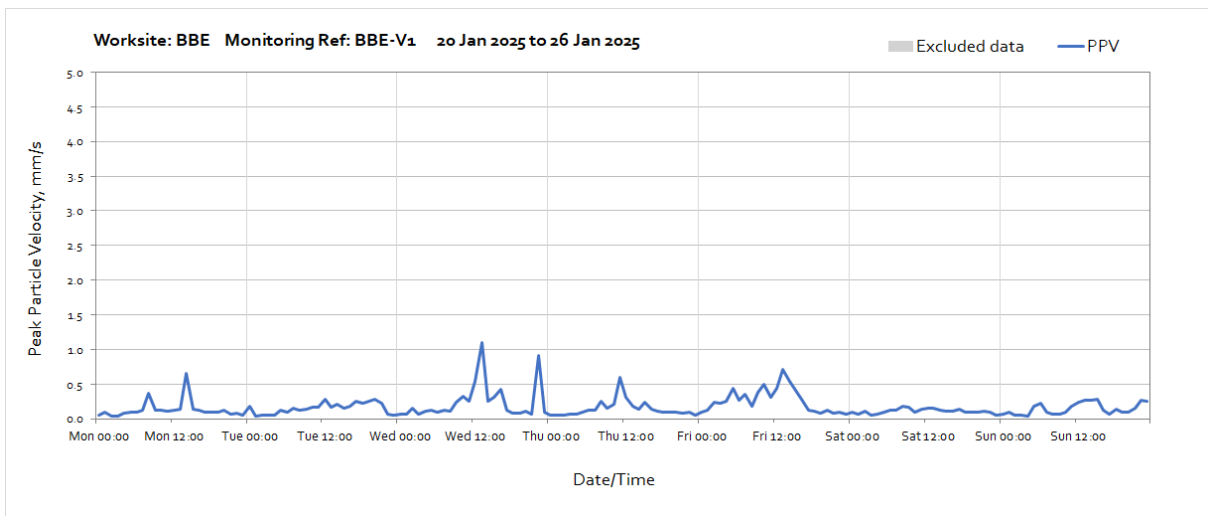
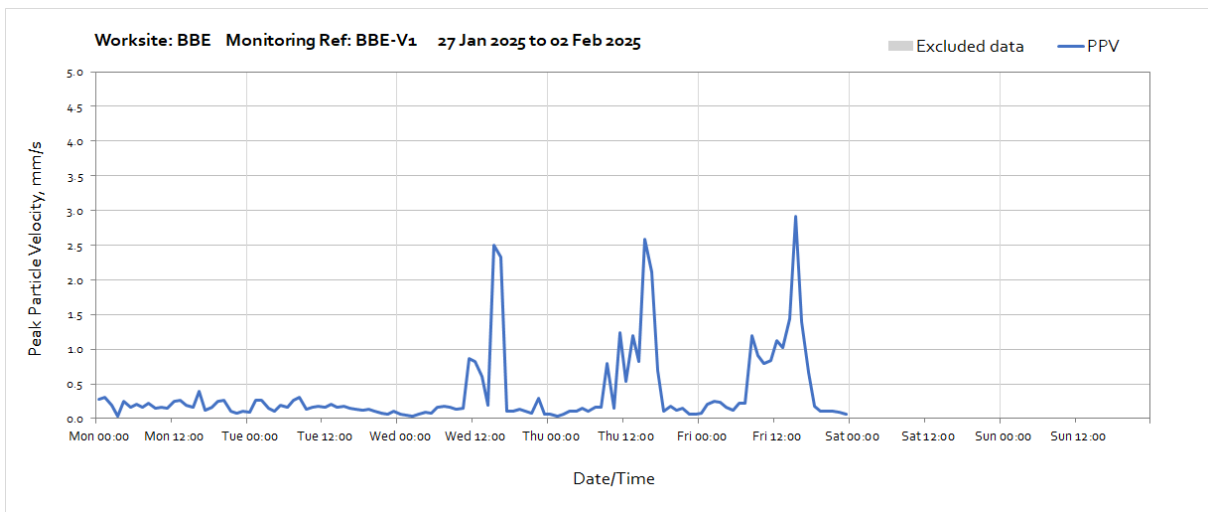
## Worksite: BBE – Monitoring Ref: BBE-V1

Note: Missing data between 19:00 on Wednesday 1<sup>st</sup> and 09:00 on Thursday 2<sup>nd</sup> January was due to a loss of power to the monitoring station caused by poor weather conditions preventing sufficient light reaching the solar panel.

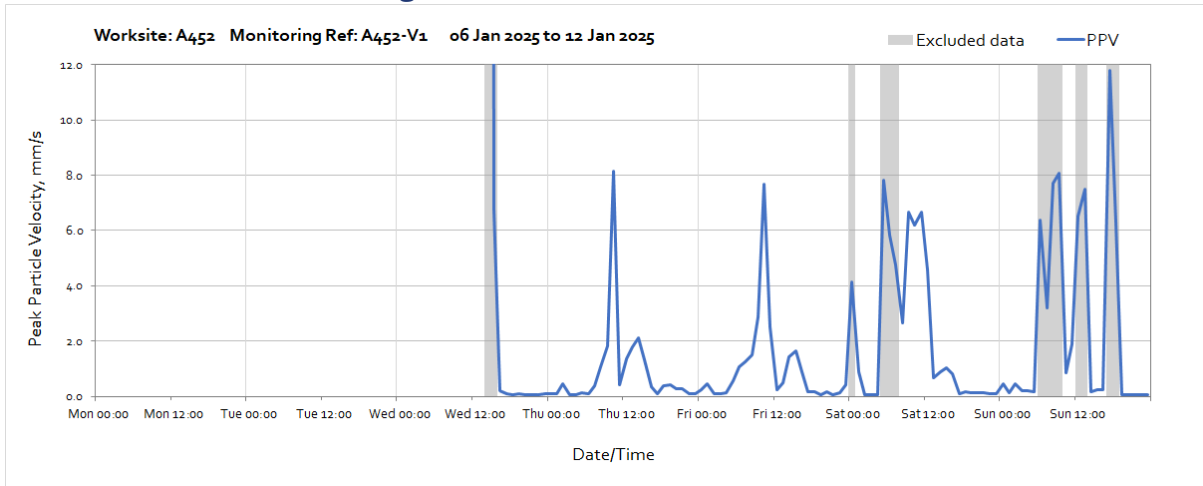
## Worksite: A452 – Monitoring Ref: A452-V1

Note: Missing data from the beginning of the month until 14:00 on Wednesday 1<sup>st</sup> January was due to a loss of power to the monitoring station caused by poor weather conditions preventing sufficient light reaching the solar panel.

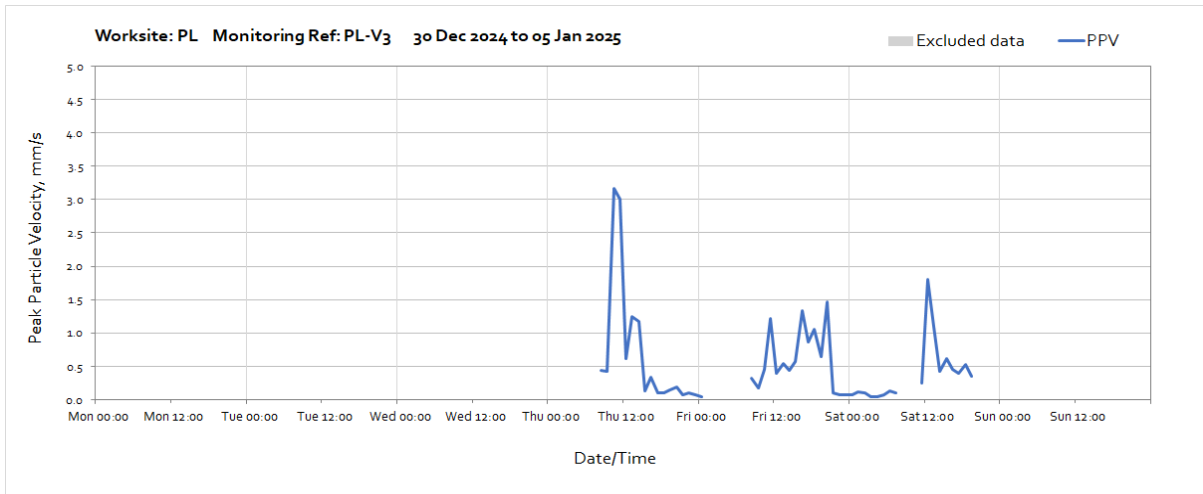
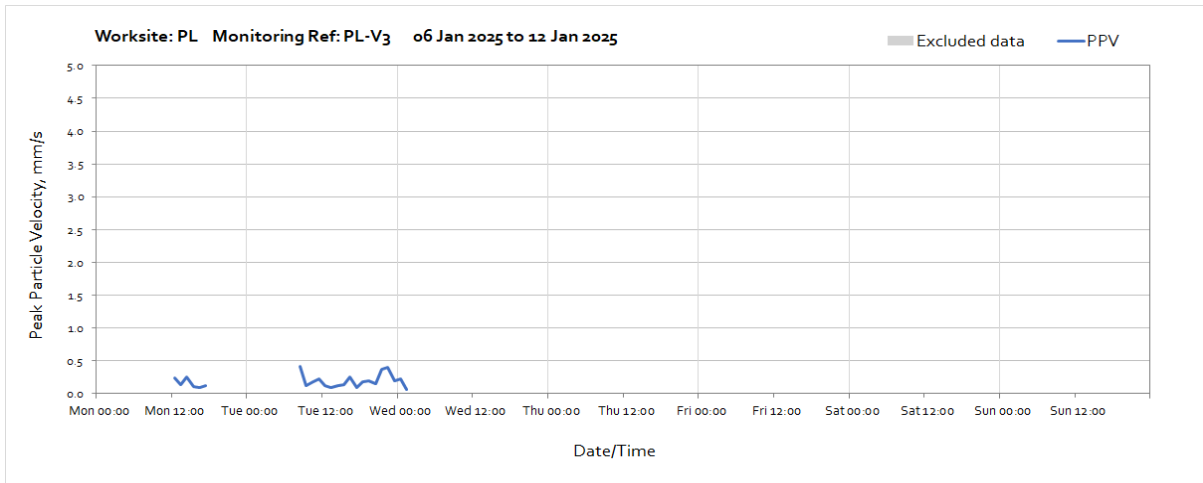
## Worksite: PL – Monitoring Ref: PL-V3

Note: Missing data throughout the month was due to a loss of power to the monitoring station caused by poor weather conditions preventing sufficient light reaching the solar panel.

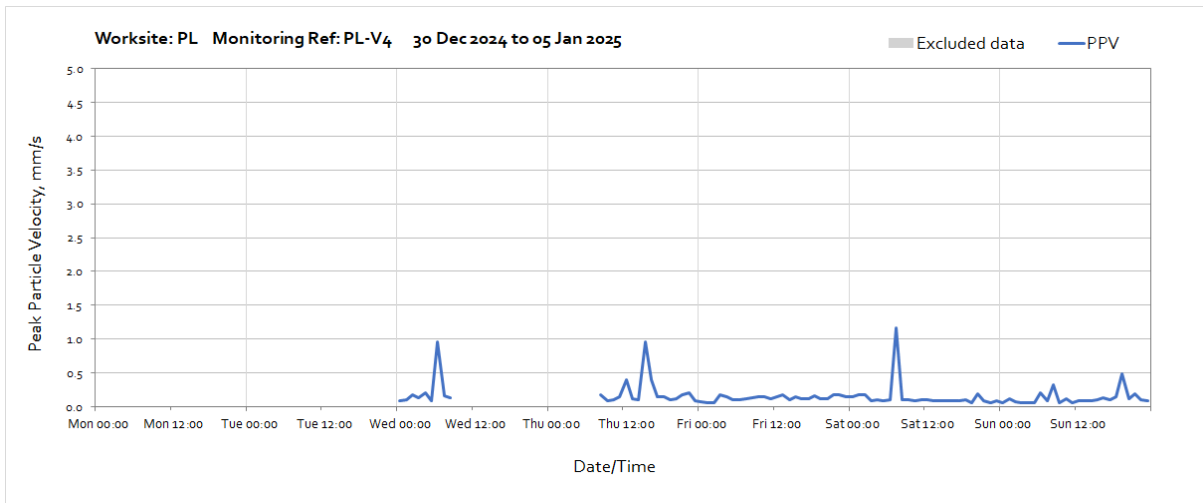
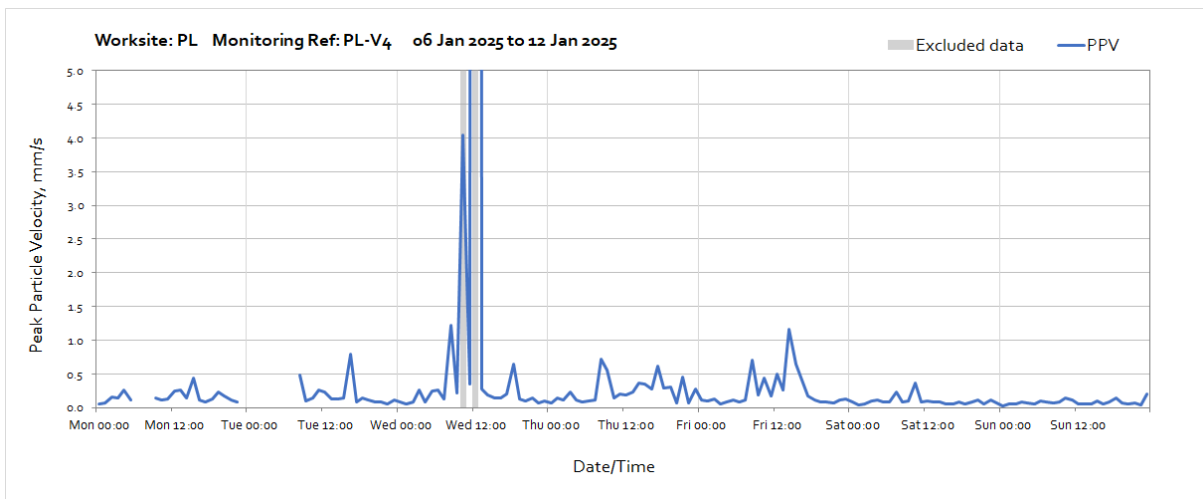
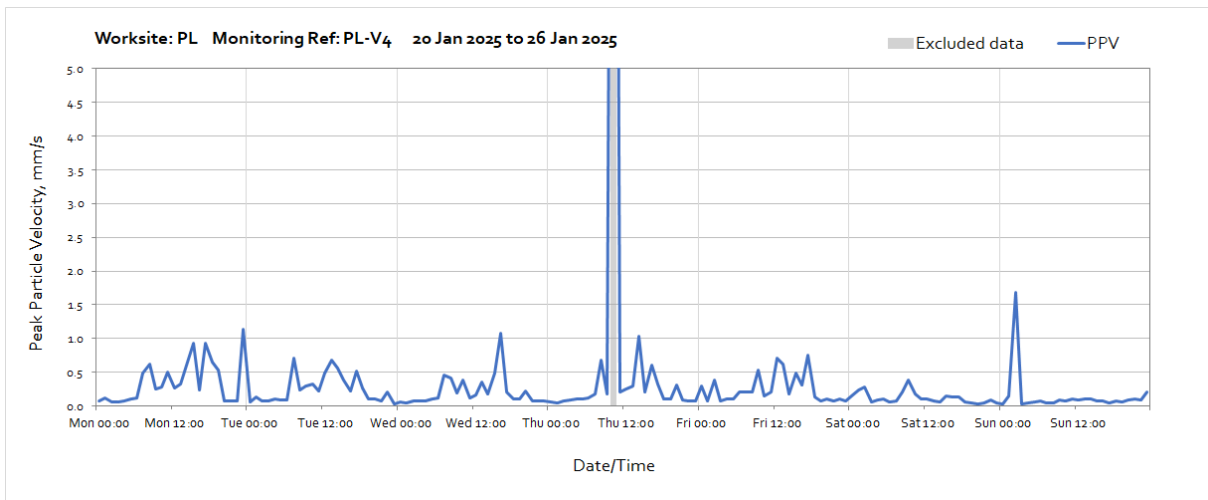
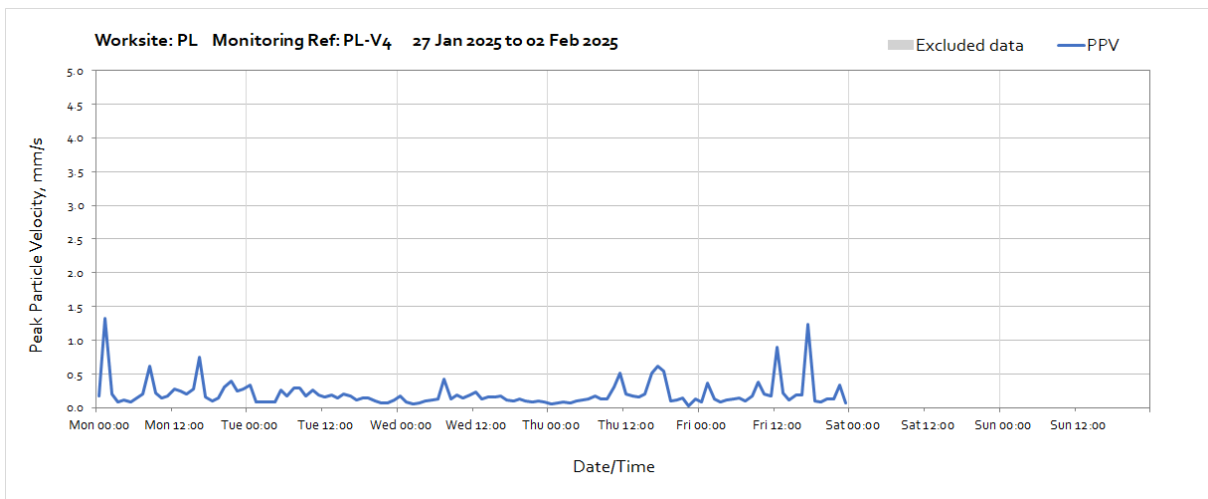
## Worksite: PL – Monitoring Ref: PL-V4

Note: Missing data between 09:00 on Wednesday 1<sup>st</sup> and 08:00 on Thursday 2<sup>nd</sup> January was due to a loss of power to the monitoring station caused by poor weather conditions preventing sufficient light reaching the solar panel.

Note: Missing data between 05:00 and 09:00 on Monday 6<sup>th</sup> and between 23:00 on Monday 6<sup>th</sup> and 08:00 on Tuesday 7<sup>th</sup> January was due to a loss of power to the monitoring station caused by poor weather conditions preventing sufficient light reaching the solar panel.
