## **Construction Noise and Vibration Monthly Report – January 2025**

**Warwick District Council**

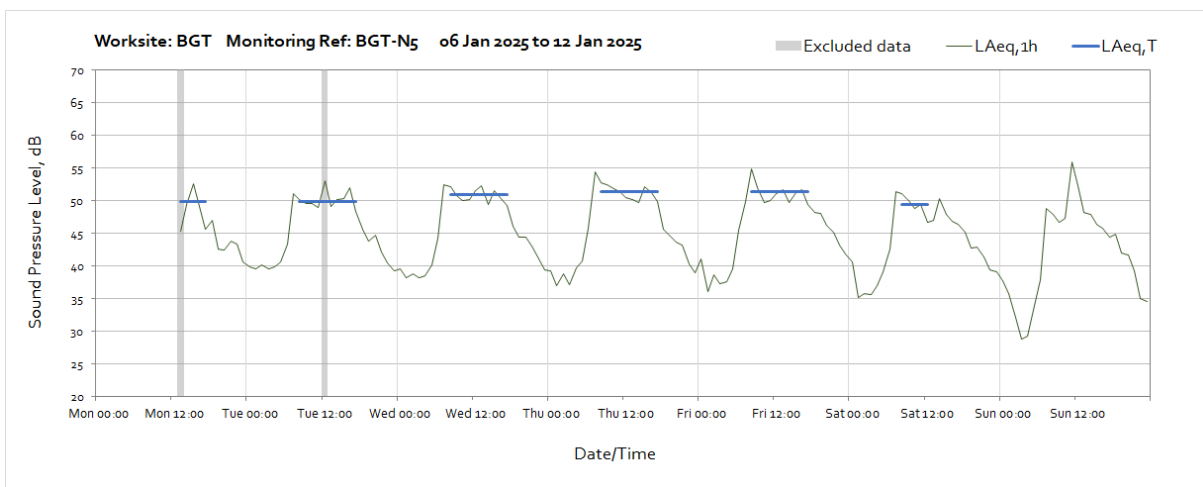
### Worksite: BGT – Monitoring Ref: BGT-N5

Note: Missing data between the start of the month and 12:00 on Monday 6<sup>th</sup> of January was due to a loss of power at the monitoring station.

The following graphs show the hourly measured ambient noise level  $L_{Aeq,1h}$  and, where relevant, the averaged noise level  $L_{Aeq,T}$  values, where the time period T is as specified in Table 1 of HS2 Information Paper E23. Periods where noise levels are adversely affected by weather or only measured for part of the period, which are not representative of HS2 construction works, have been greyed out and excluded from the calculation of the  $L_{Aeq,T}$  values in in Table 3 of the main report.

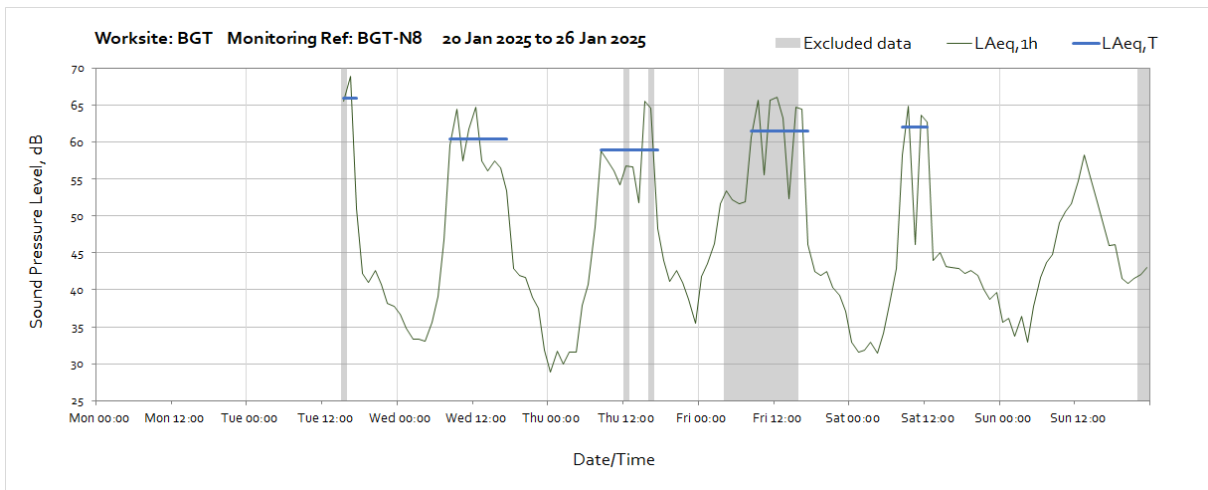
### Worksite: BGT - Monitoring Ref: BGT-N8

Note: Missing data between the start of the month and 14:00 on Tuesday 21<sup>st</sup> January was due to a loss of power to the monitoring station caused by poor weather conditions preventing sufficient light reach the solar panel.

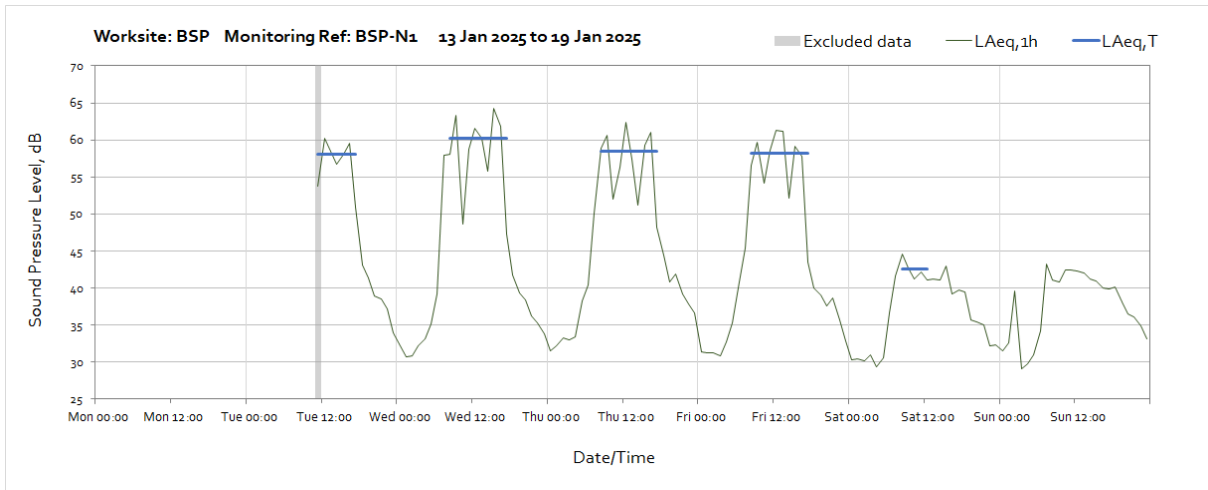
**Worksite: BSP – Monitoring Ref: BSP-N1**

Note: Missing data between the start of the month and 10:00 on Tuesday 14<sup>th</sup> January was due to a loss of power to the monitoring station caused by poor weather conditions preventing sufficient light reach the solar panel.

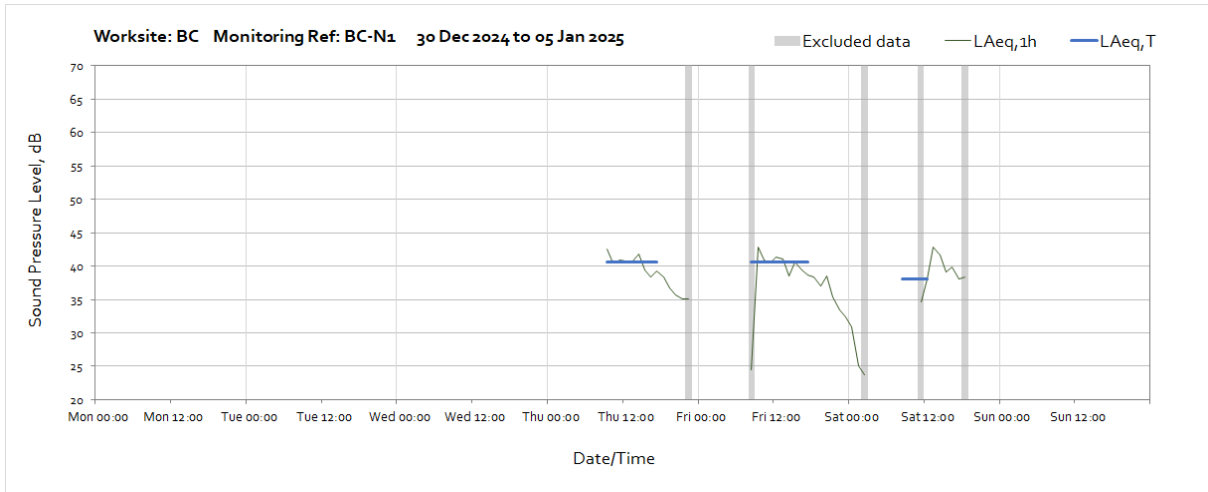
**Worksite: BC – Monitoring Ref: BC-N1**

Note: Missing data throughout the month was due to a loss of power to the monitoring station caused by poor weather conditions preventing sufficient light reach the solar panel.

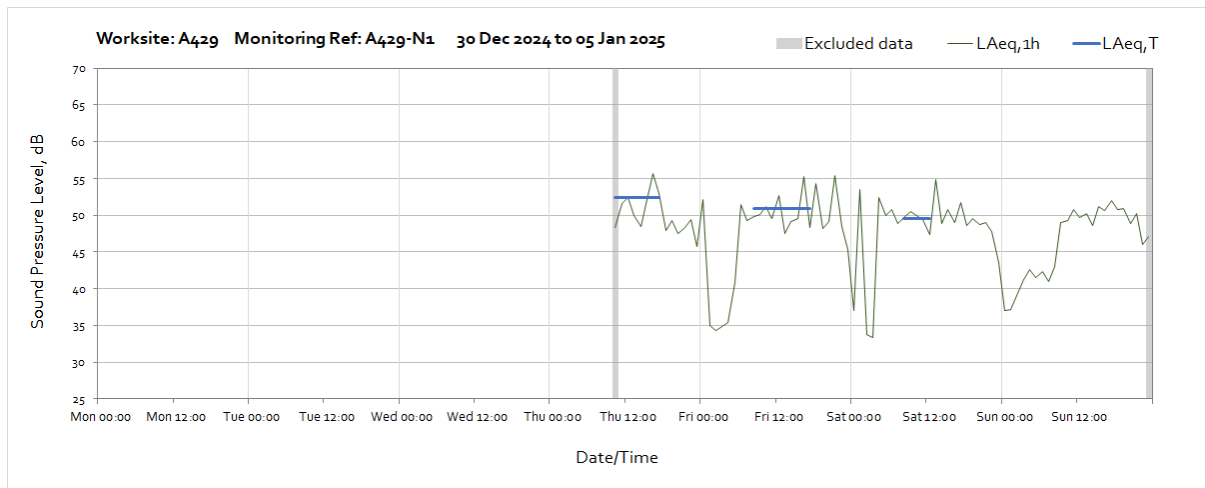
## Worksite: A429 – Monitoring Ref: A429-N1

Note: Missing data between the start of the month and 09:00 on Thursday 2<sup>nd</sup> January was due to a loss of power to the monitoring station caused by poor weather conditions preventing sufficient light reach the solar panel.

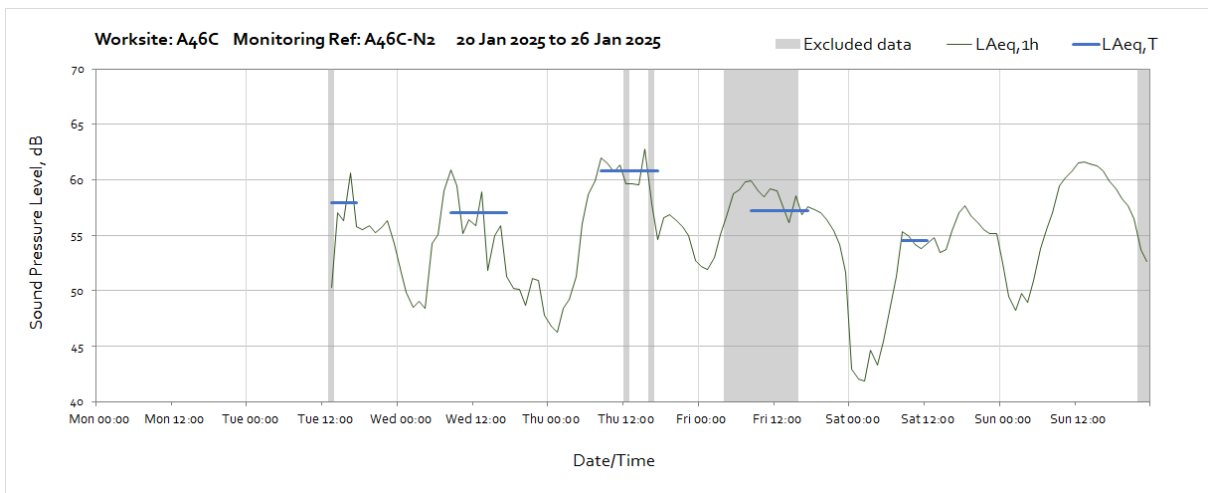
### Worksite: A46C – Monitoring Ref: A46C-N2

Note: Missing data between the start of the month and 12:00 on Tuesday 21<sup>st</sup> January was due to a loss of power to the monitoring station caused by poor weather conditions preventing sufficient light reach the solar panel.

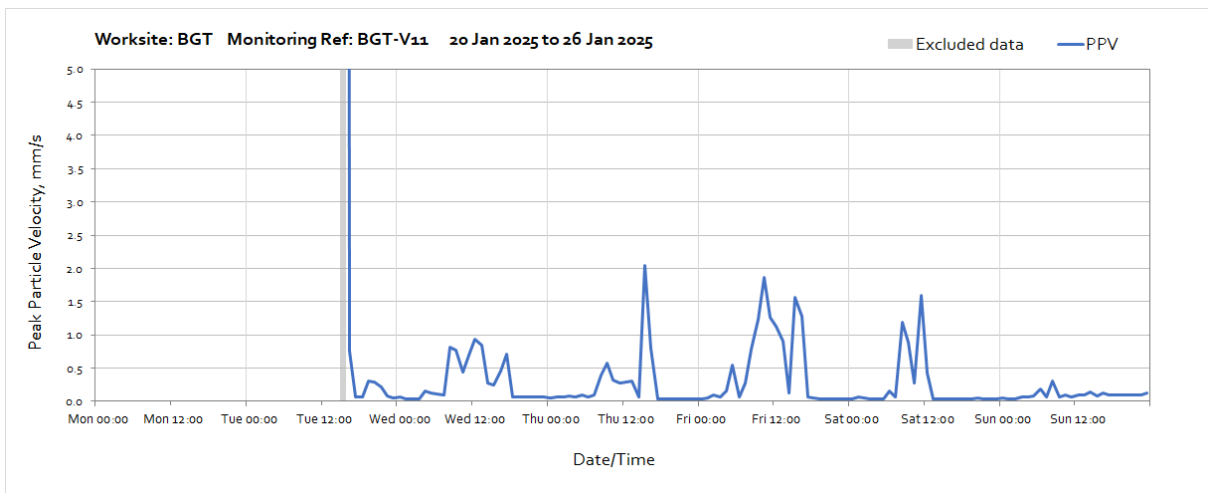
### Worksite: BGT - Monitoring Ref: BGT-V11

Note: Missing data between the start of the month and 14:00 on Tuesday 21<sup>st</sup> January was due to a loss of power to the monitoring station caused by poor weather conditions preventing sufficient light reach the solar panel.
