Construction Noise and Vibration Monthly Report – January 2025

Warwick District Council

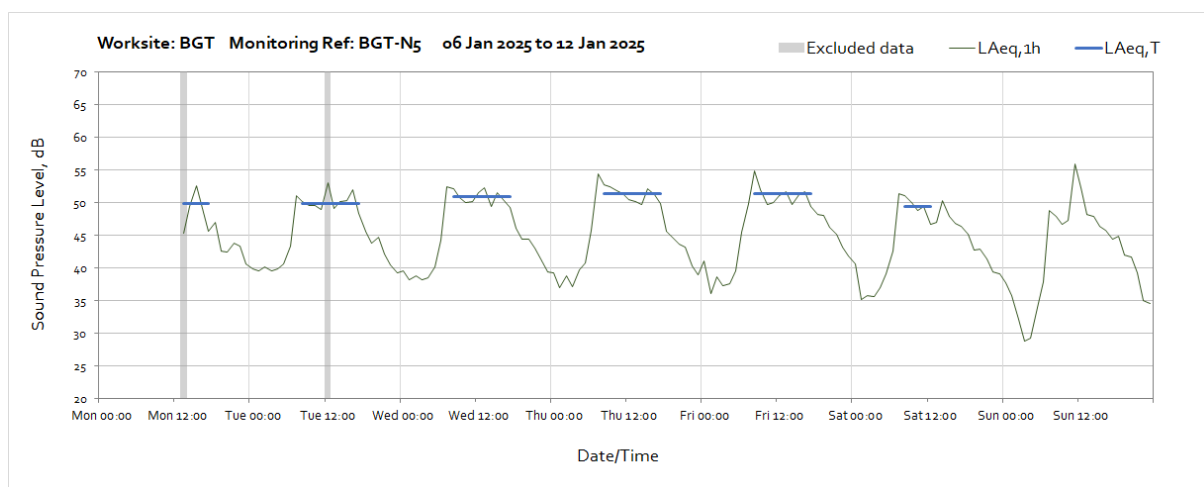
Worksite: BGT – Monitoring Ref: BGT-N5

Note: Missing data between the start of the month and 12:00 on Monday 6th of January was due to a loss of power at the monitoring station.

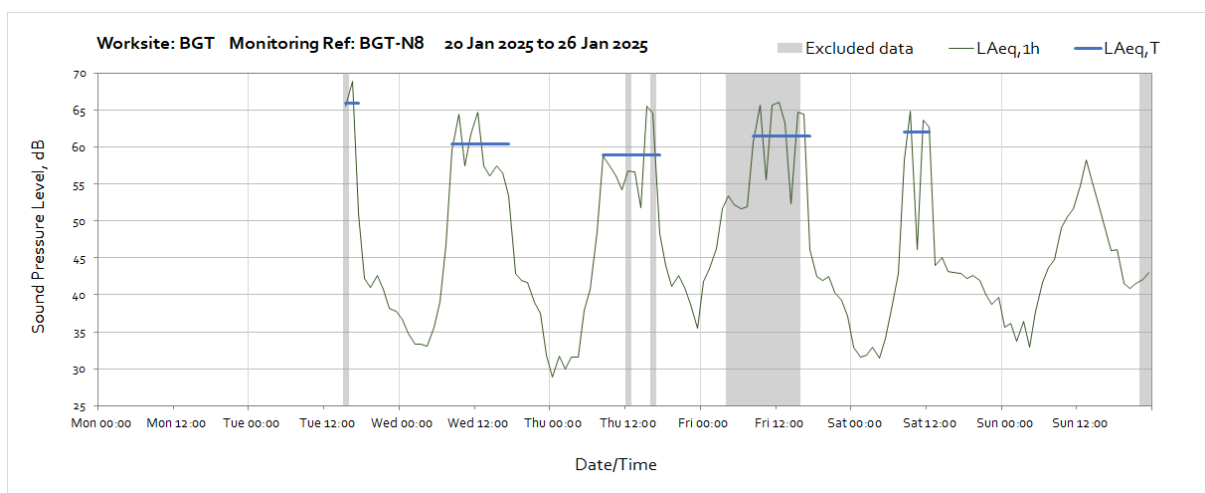
Worksite: BGT – Monitoring Ref: BGT-N8

Note: Missing data between the start of the month and 14:00 on Tuesday 21st January was due to a loss of power to the monitoring station caused by poor weather conditions preventing sufficient light reach the solar panel.

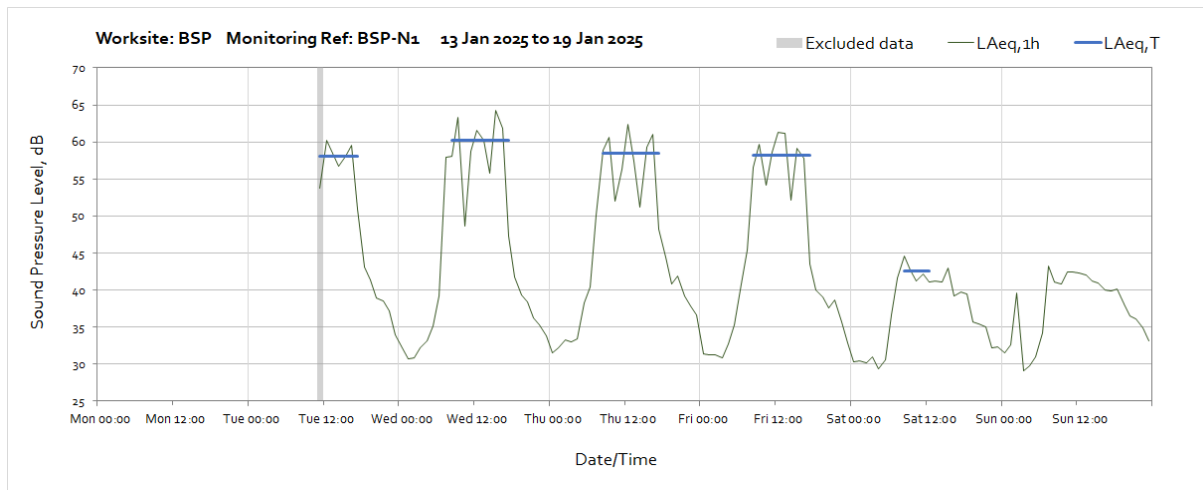
Worksite: BSP – Monitoring Ref: BSP-N1

Note: Missing data between the start of the month and 10:00 on Tuesday 14th January was due to a loss of power to the monitoring station caused by poor weather conditions preventing sufficient light reach the solar panel.

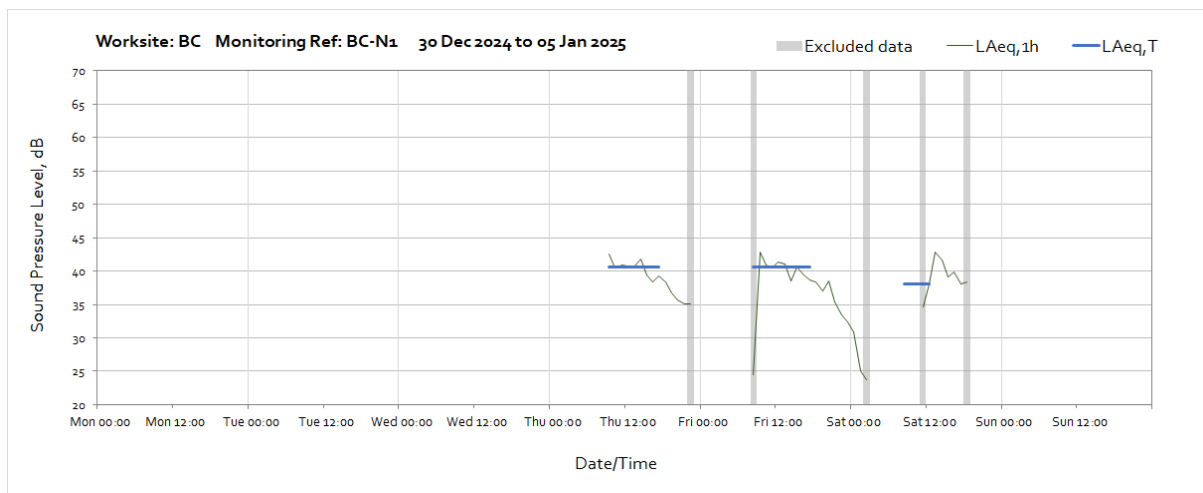
Worksite: BC – Monitoring Ref: BC-N1

Note: Missing data throughout the month was due to a loss of power to the monitoring station caused by poor weather conditions preventing sufficient light reach the solar panel.

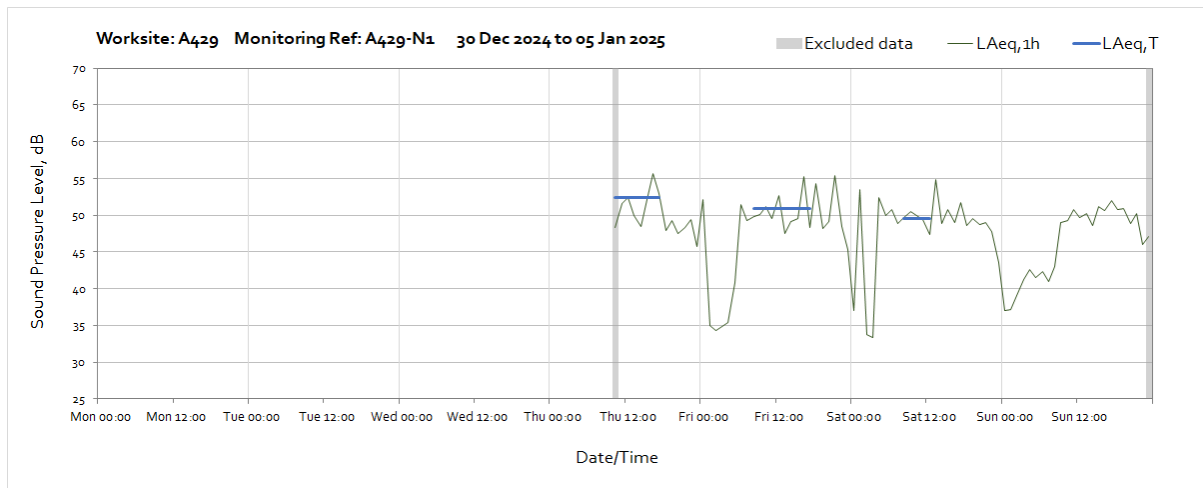
Worksite: A429 – Monitoring Ref: A429-N1

Note: Missing data between the start of the month and 09:00 on Thursday 2nd January was due to a loss of power to the monitoring station caused by poor weather conditions preventing sufficient light reach the solar panel.

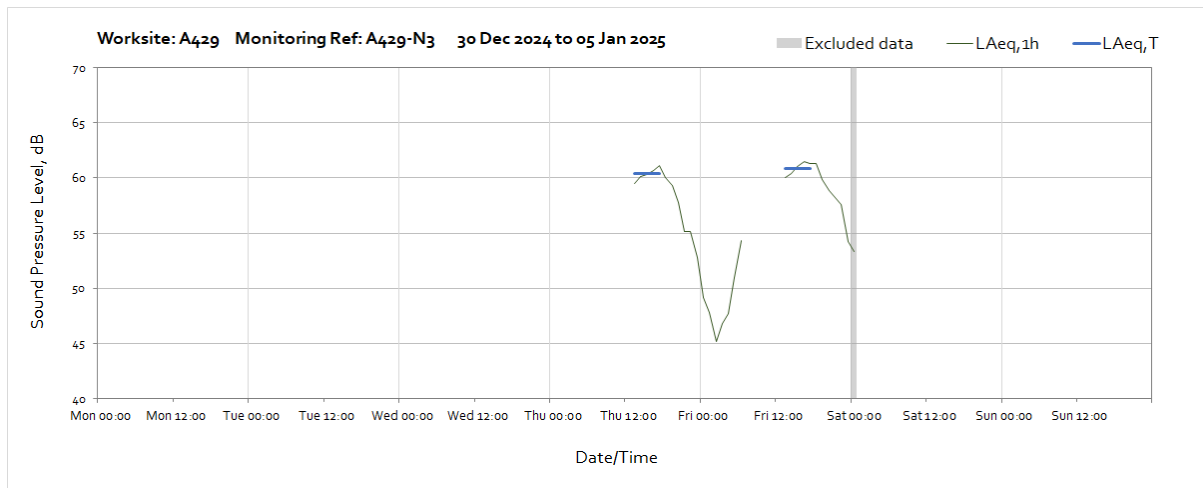
Worksite: A429 – Monitoring Ref: A429-N3

Note: Missing data throughout the month was due to a loss of power to the monitoring station caused by poor weather conditions preventing sufficient light reach the solar panel.

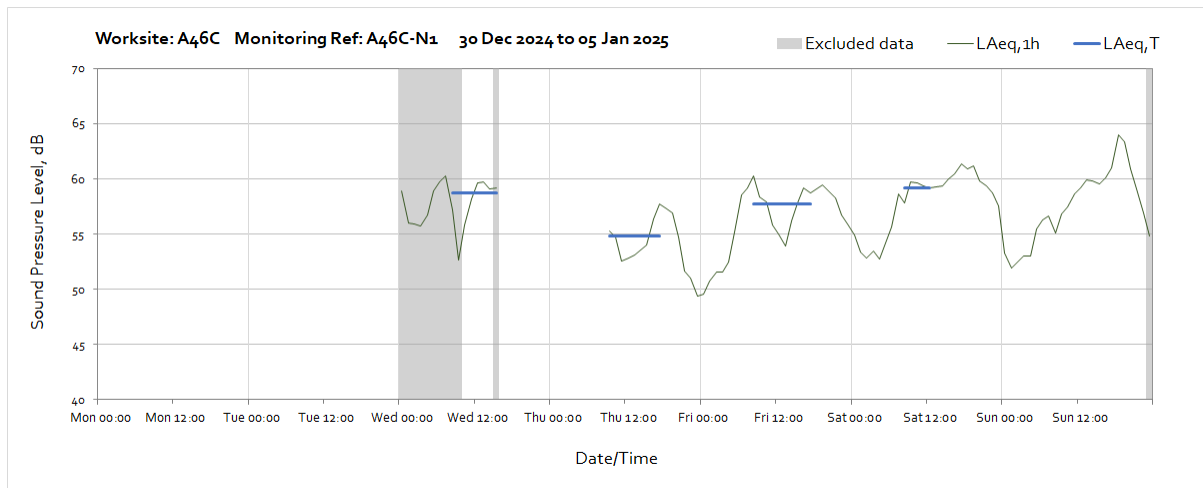
Worksite: A46C – Monitoring Ref: A46C-N1

Note: Missing data between 16:00 on Wednesday 01st January and 08:00 on Thursday 02nd January was due to a loss of power to the monitoring station caused by poor weather conditions preventing sufficient light reach the solar panel.

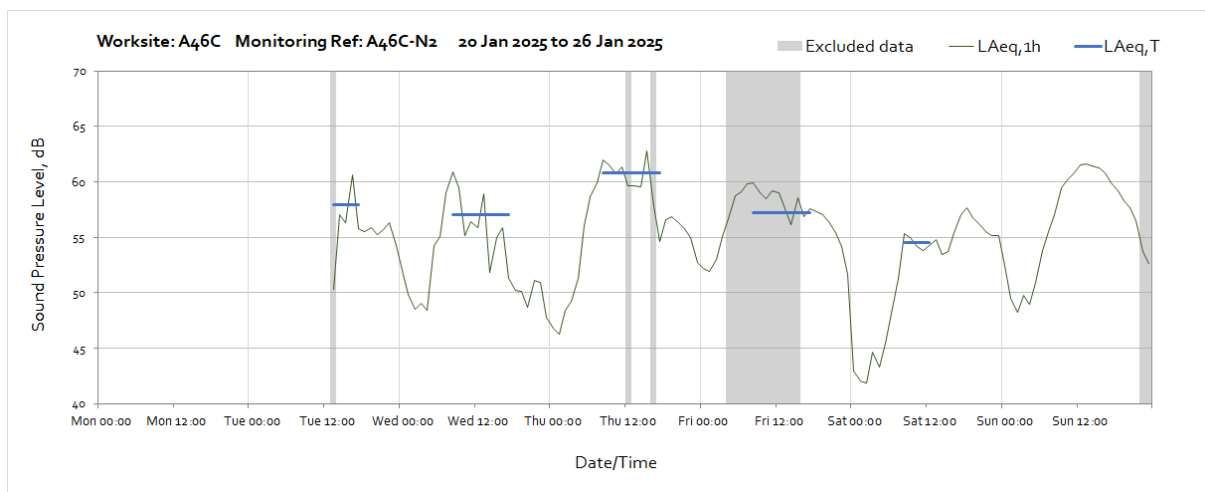
Worksite: A46C – Monitoring Ref: A46C-N2

Note: Missing data between the start of the month and 12:00 on Tuesday 21st January was due to a loss of power to the monitoring station caused by poor weather conditions preventing sufficient light reach the solar panel.

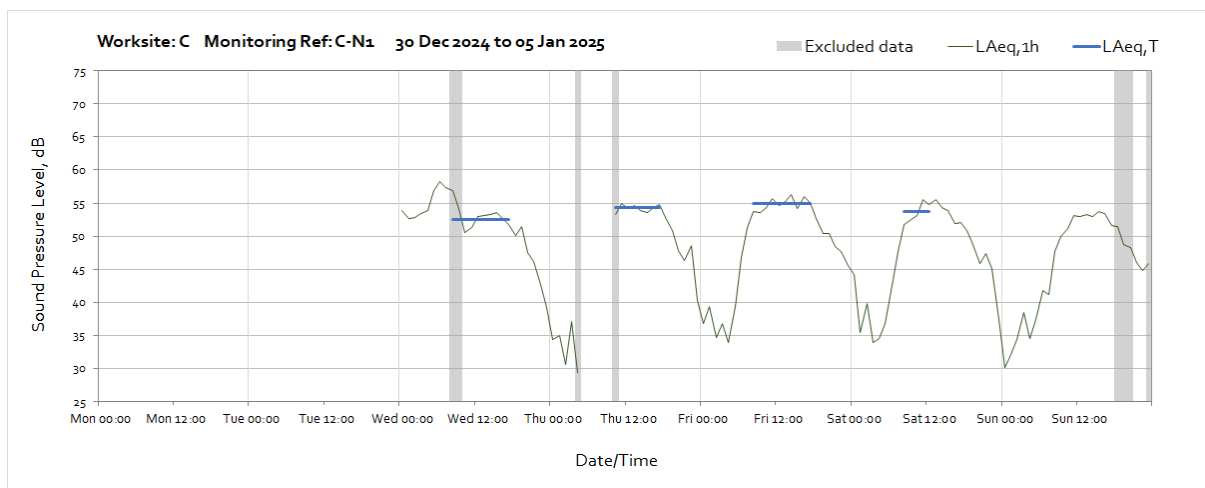
Worksite: C – Monitoring Ref: C-N1

Note: Missing data between 05:00 and 09:00 on Thursday 2nd January was due to a loss of power to the monitoring station caused by poor weather conditions preventing sufficient light reach the solar panel.

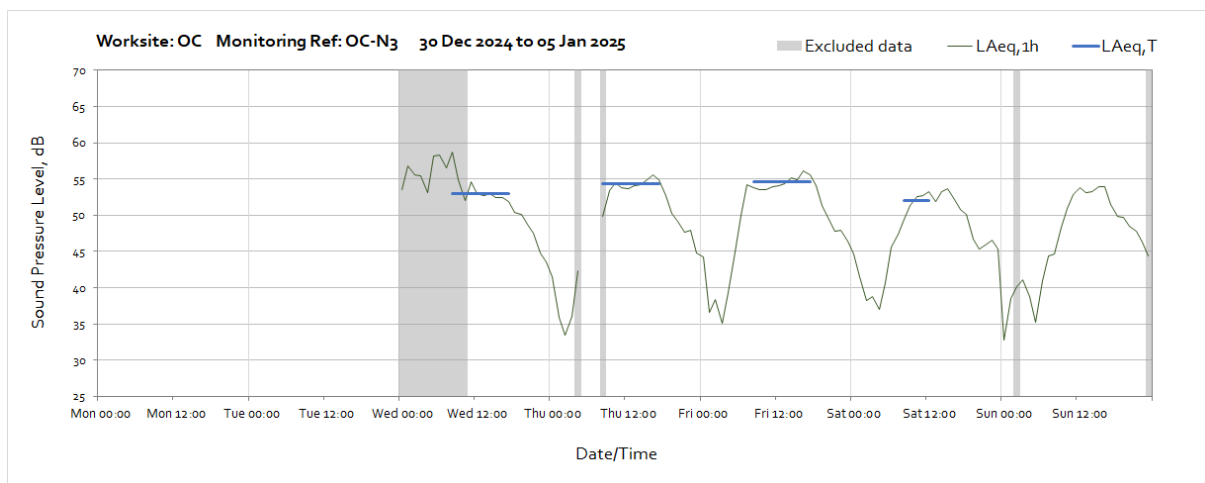
Worksite: OC – Monitoring Ref: OC-N3

Note: Missing data between 05:00 and 07:00 on Thursday 2nd January was due to a loss of power to the monitoring station caused by poor weather conditions preventing sufficient light reach the solar panel.

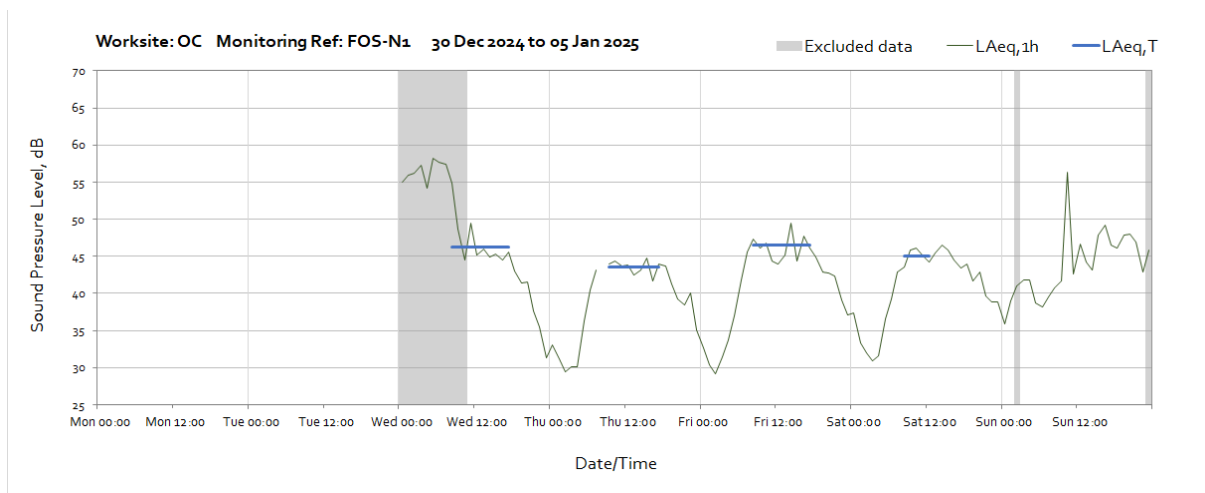
Worksite: OC – Monitoring Ref: FOS-N1

Note: Missing data between 08:00 and 09:00 on Thursday 2nd January was due to a loss of power to the monitoring station caused by poor weather conditions preventing sufficient light reach the solar panel.

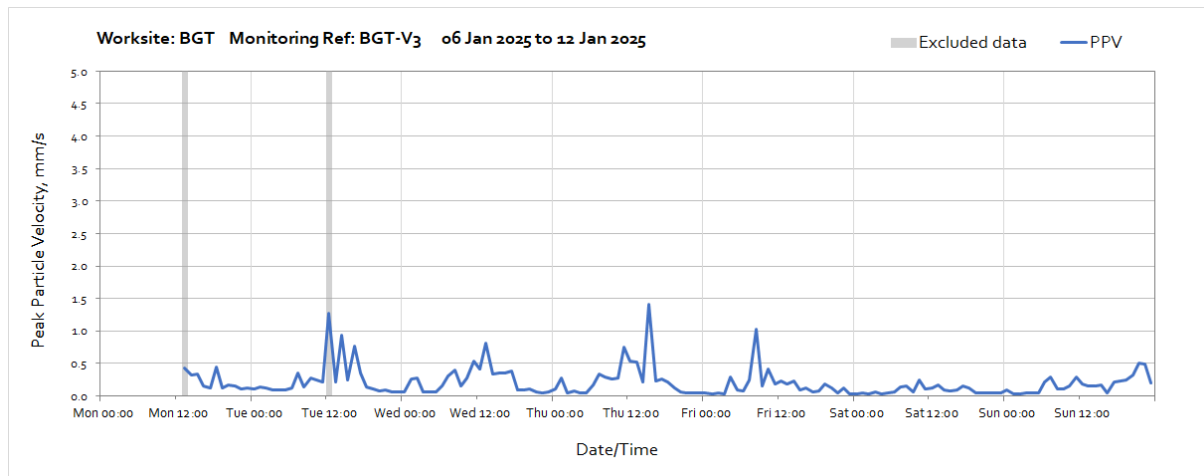
Worksite: BGT – Monitoring Ref: BGT-V3

Note: Missing data between the start of the month and 12:00 on Monday 06th January was due to a loss of power to the monitoring station.

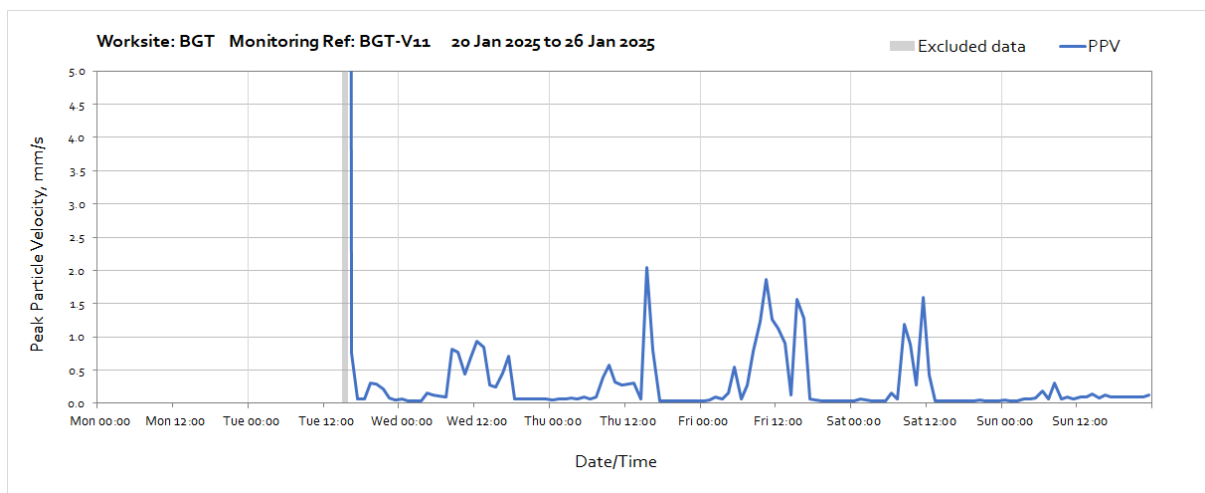
Worksite: BGT – Monitoring Ref: BGT-V11

Note: Missing data between the start of the month and 14:00 on Tuesday 21st January was due to a loss of power to the monitoring station caused by poor weather conditions preventing sufficient light reach the solar panel.

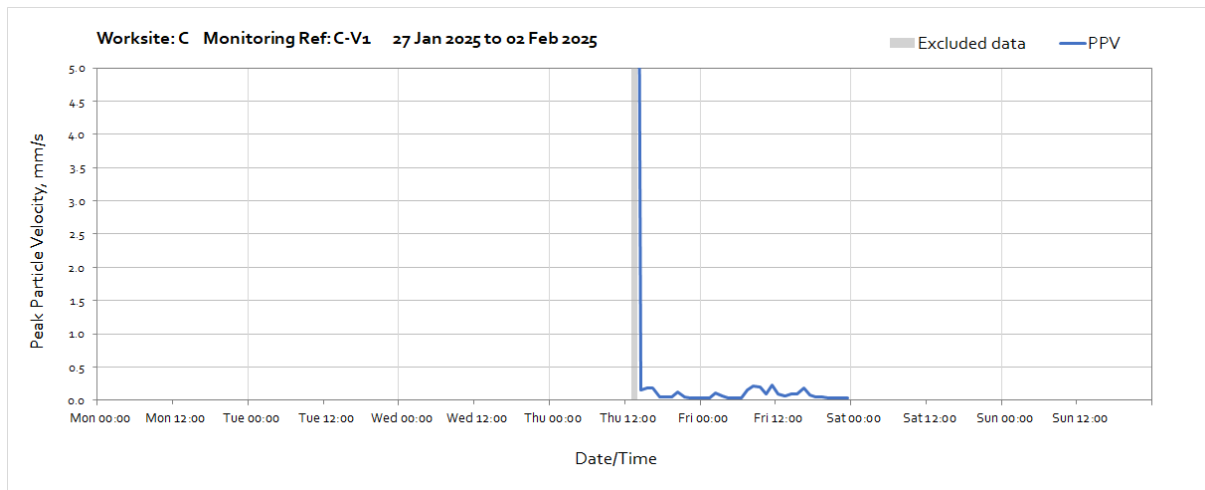
Worksite: C – Monitoring Ref: C-V1

Note: Missing data between the start of the month and 12:00 on Thursday 30th January was due to a communication error between the monitoring station and the server.

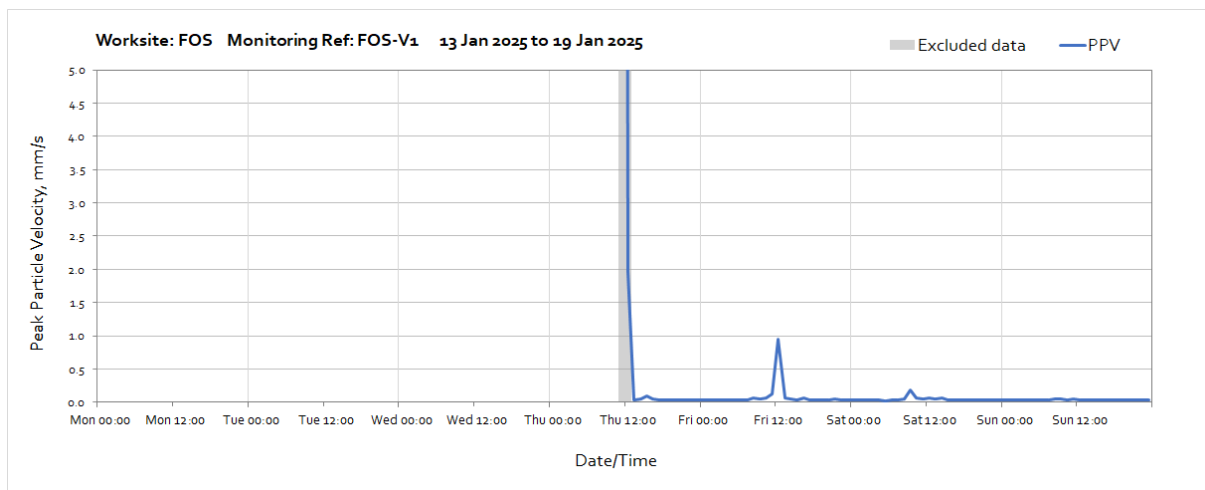
Worksite: OC – Monitoring Ref: FOS-V1

Note: Missing data between the start of the month and 10:00 on Thursday 16th January was due to a loss of power to the monitoring station caused by poor weather conditions preventing sufficient light reach the solar panel.
