February 2025

Air Quality and Dust Monitoring Monthly Report – February 2025 Buckinghamshire Council

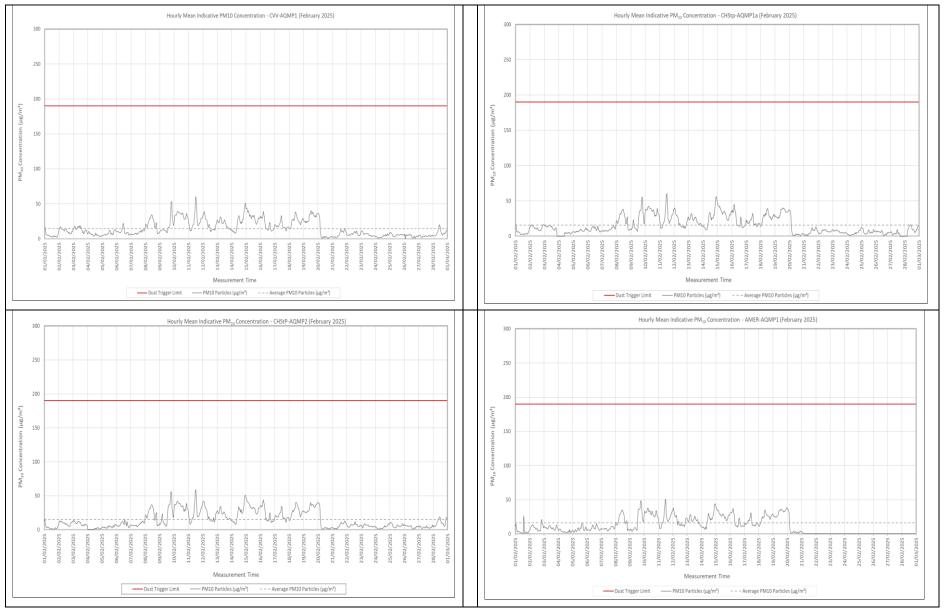
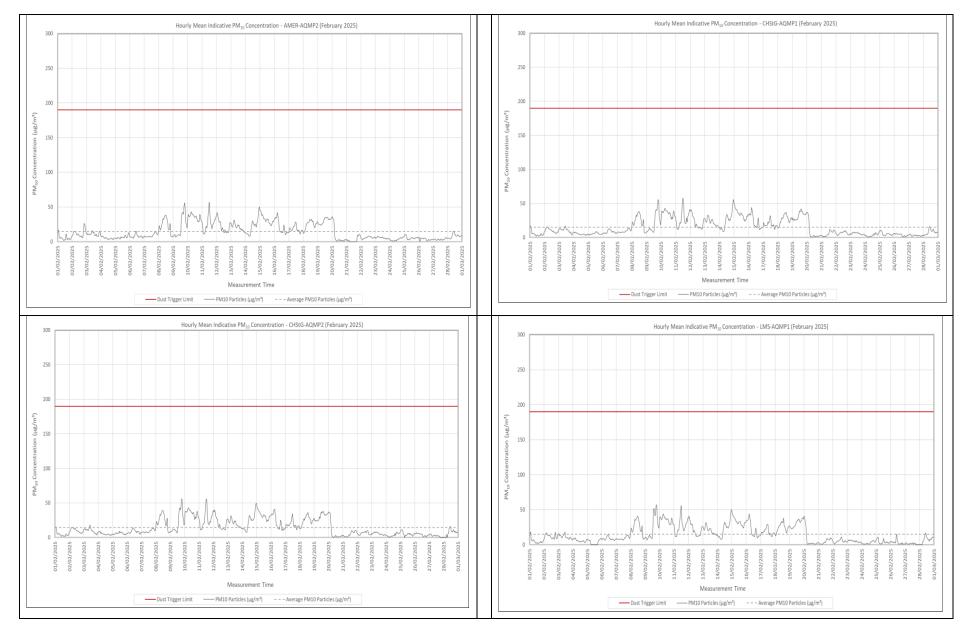
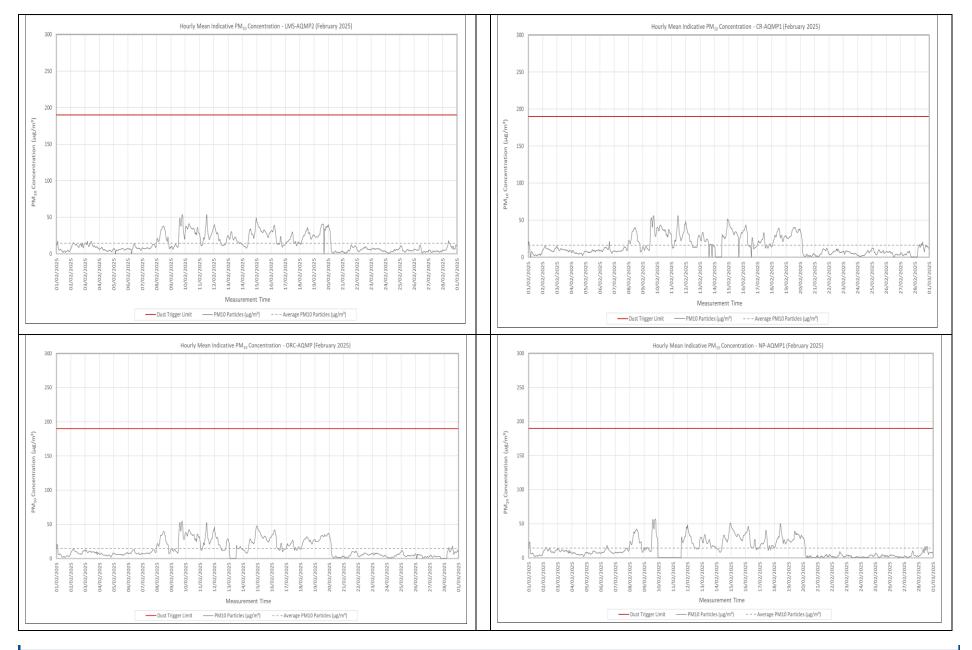
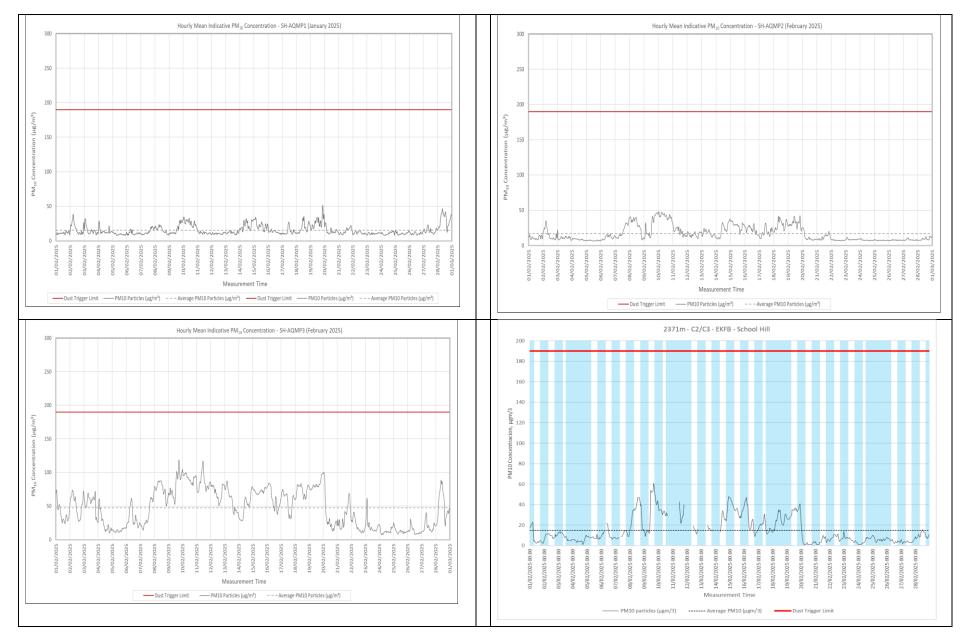
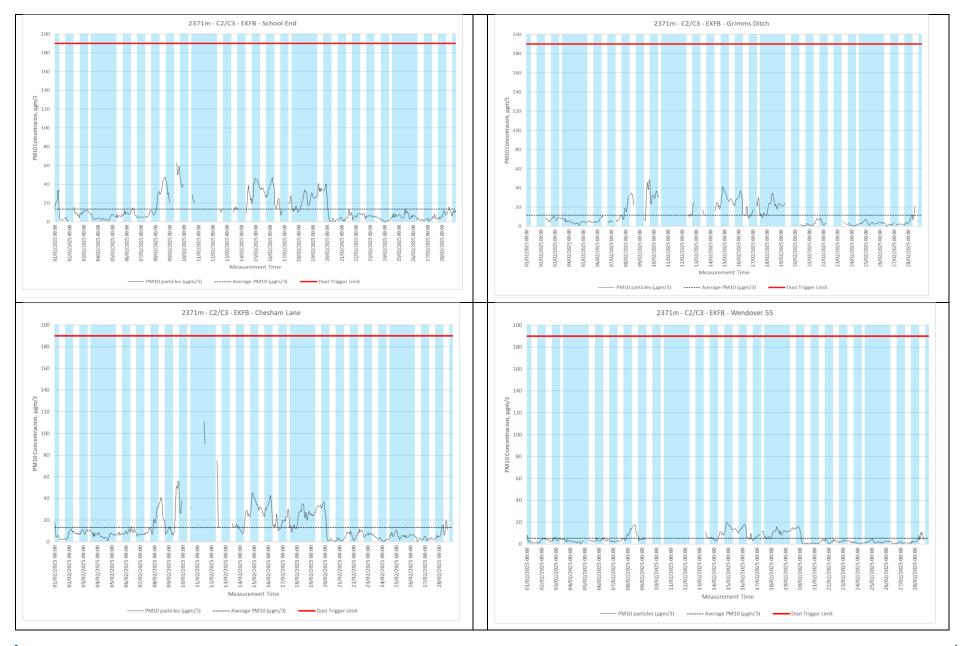
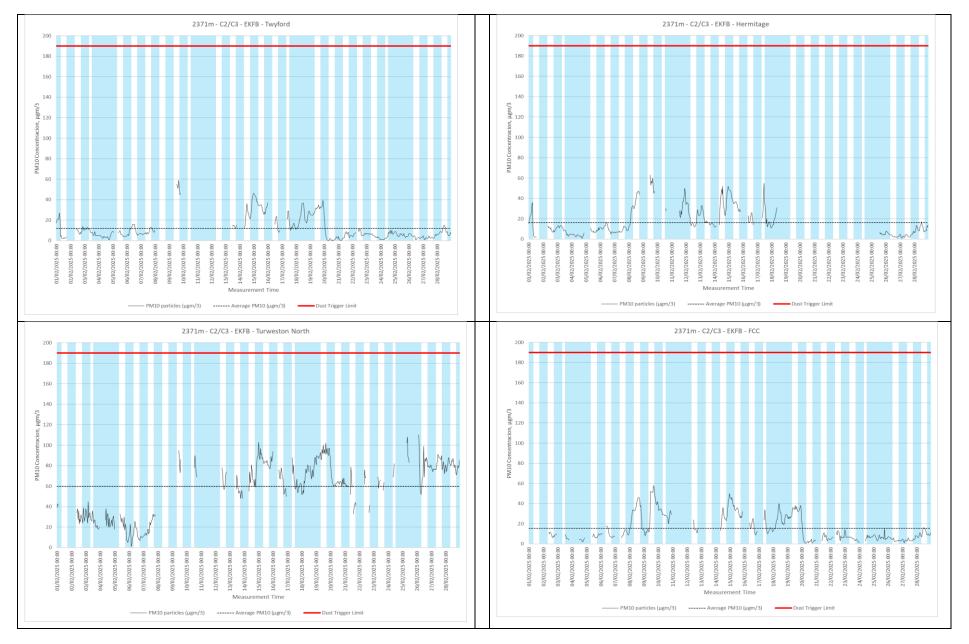
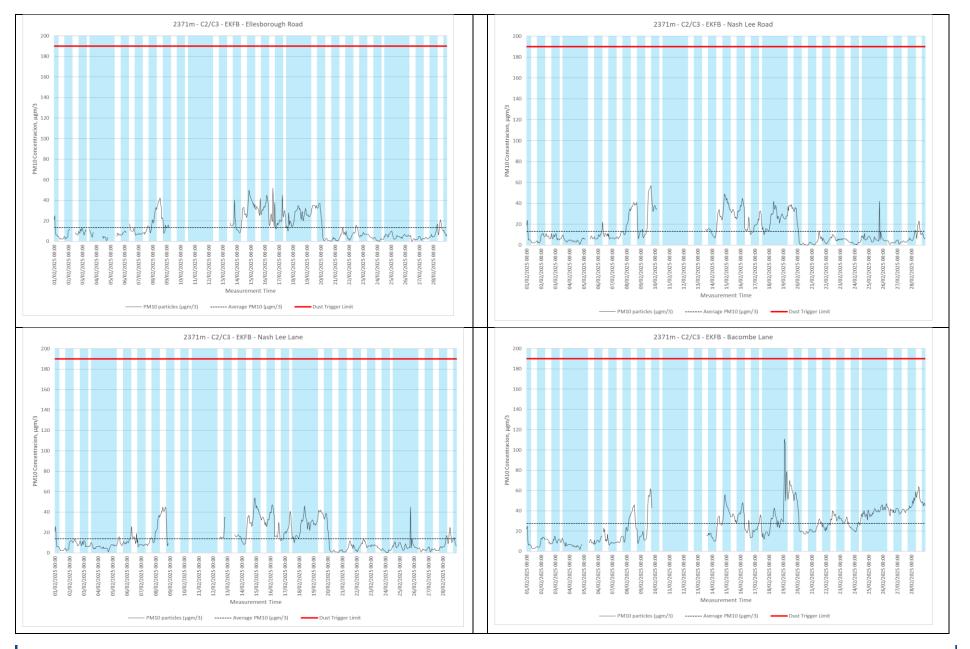
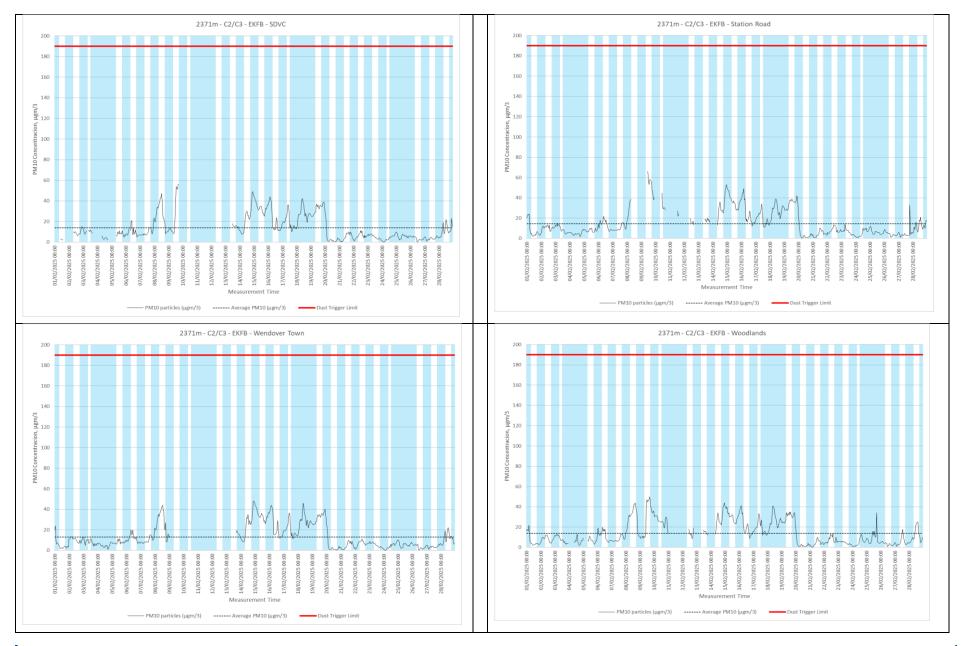
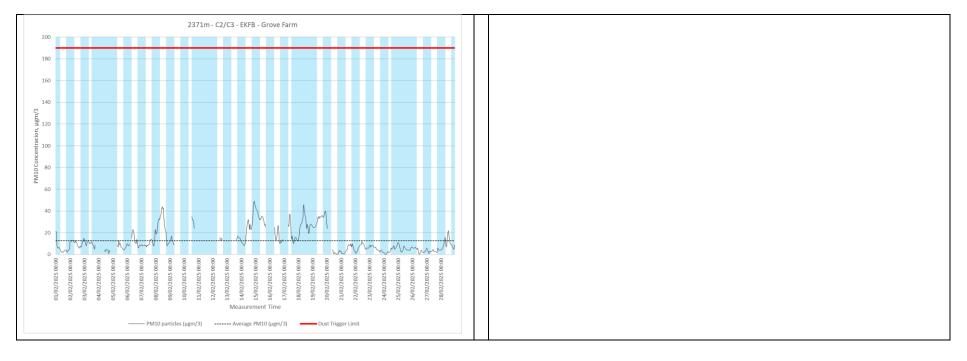
- 1.1.6 Dust monitoring locations and results are presented in Appendix B, Table 1, together with line charts of monthly data from each dust monitor presented in Figure 8. All continuous dust monitoring is undertaken using indicative monitors. Despite being Environment Agency (MCERTS) certified, indicative monitors carry a higher level of uncertainty than reference monitors, and therefore cannot be strictly compared with Air Quality Standards for human health and the environment. The purpose of the monitoring undertaken is to ensure the effectiveness of the on-site mitigation.

- 1.1.7 The trigger level for PM₁₀ concentrations of 190 μg/m³, measured as a 1-hour mean, in accordance with the updated guidance document '*Guidance on Monitoring in the Vicinity of Demolition and Construction Sites (December 2018)*' has been applied.

- 1.1.8 No (0) dust trigger alerts were recorded during the monitoring period (February 2025).
- 1.1.9 Data capture was below 90% for multiple monitors due to:
