## **Construction Noise and Vibration Monthly Report – February 2025**

**Lichfield District Council**

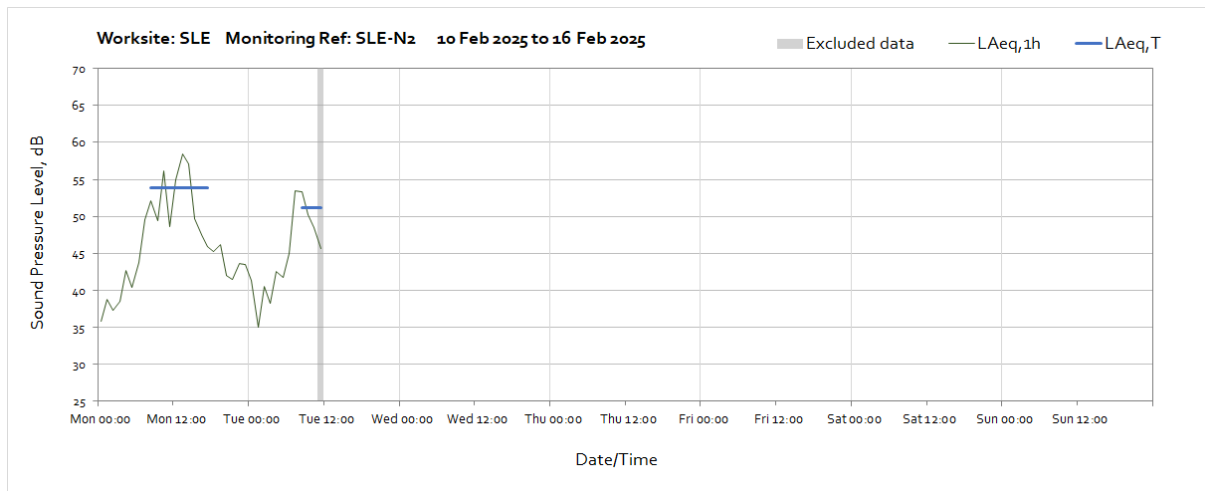
### Worksite:SLE – Monitoring Ref: SLE-N2

Note: Missing data between 12:00 on Tuesday 11<sup>th</sup> February and the end of the month was due to system reset failure following replacement of monitoring equipment for laboratory calibration.

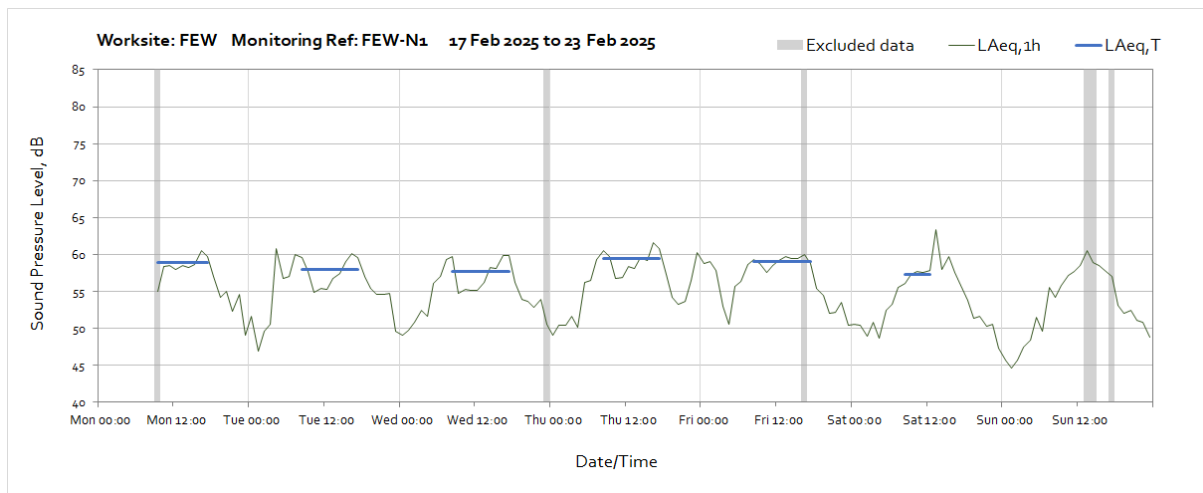
Note: Missing data between 02:00 on Sunday 16<sup>th</sup> February and 09:00 on Monday 17<sup>th</sup> February was due to a clock synchronisation issue at the monitoring station.

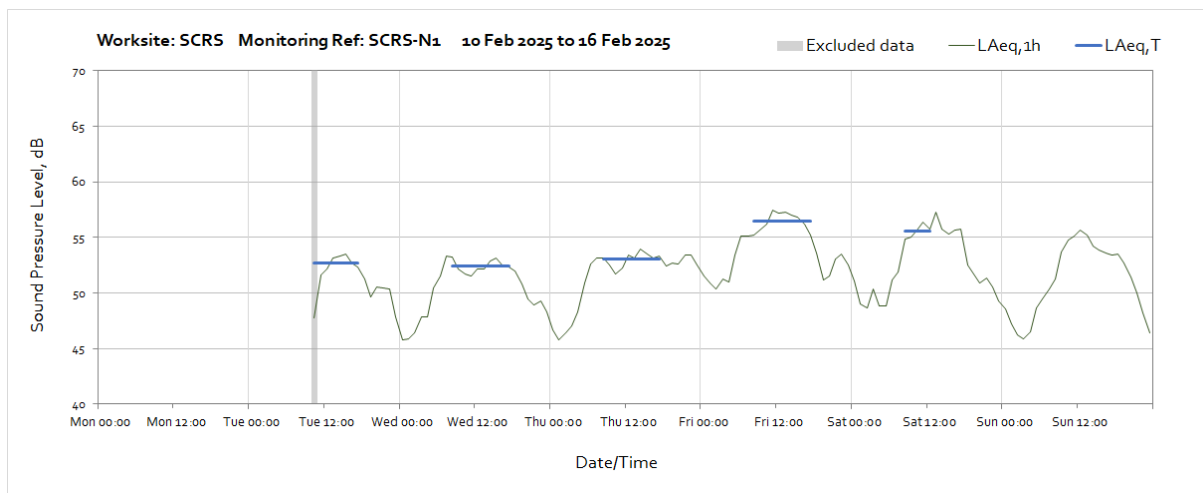
## Worksite:SCRS – Monitoring Ref: SCRS-N1

Note: Missing data between beginning of the month and 10:00 on Tuesday 11<sup>th</sup> February was due to high vegetation restricting the access to the monitoring station and preventing sufficient light reaching the solar panel.
