Construction Noise and Vibration Monthly Report – February 2025

Solihull Metropolitan Borough Council

This Noise and Vibration Monitoring Report fulfils HS2 Limited's commitment detailed in the Environmental Minimum Requirements (EMRs), Annex 1, Code of Construction Practice, to present the results of noise and vibration monitoring carried out within the Solihull Metropolitan Borough Council (SMBC) during the month of February 2025.

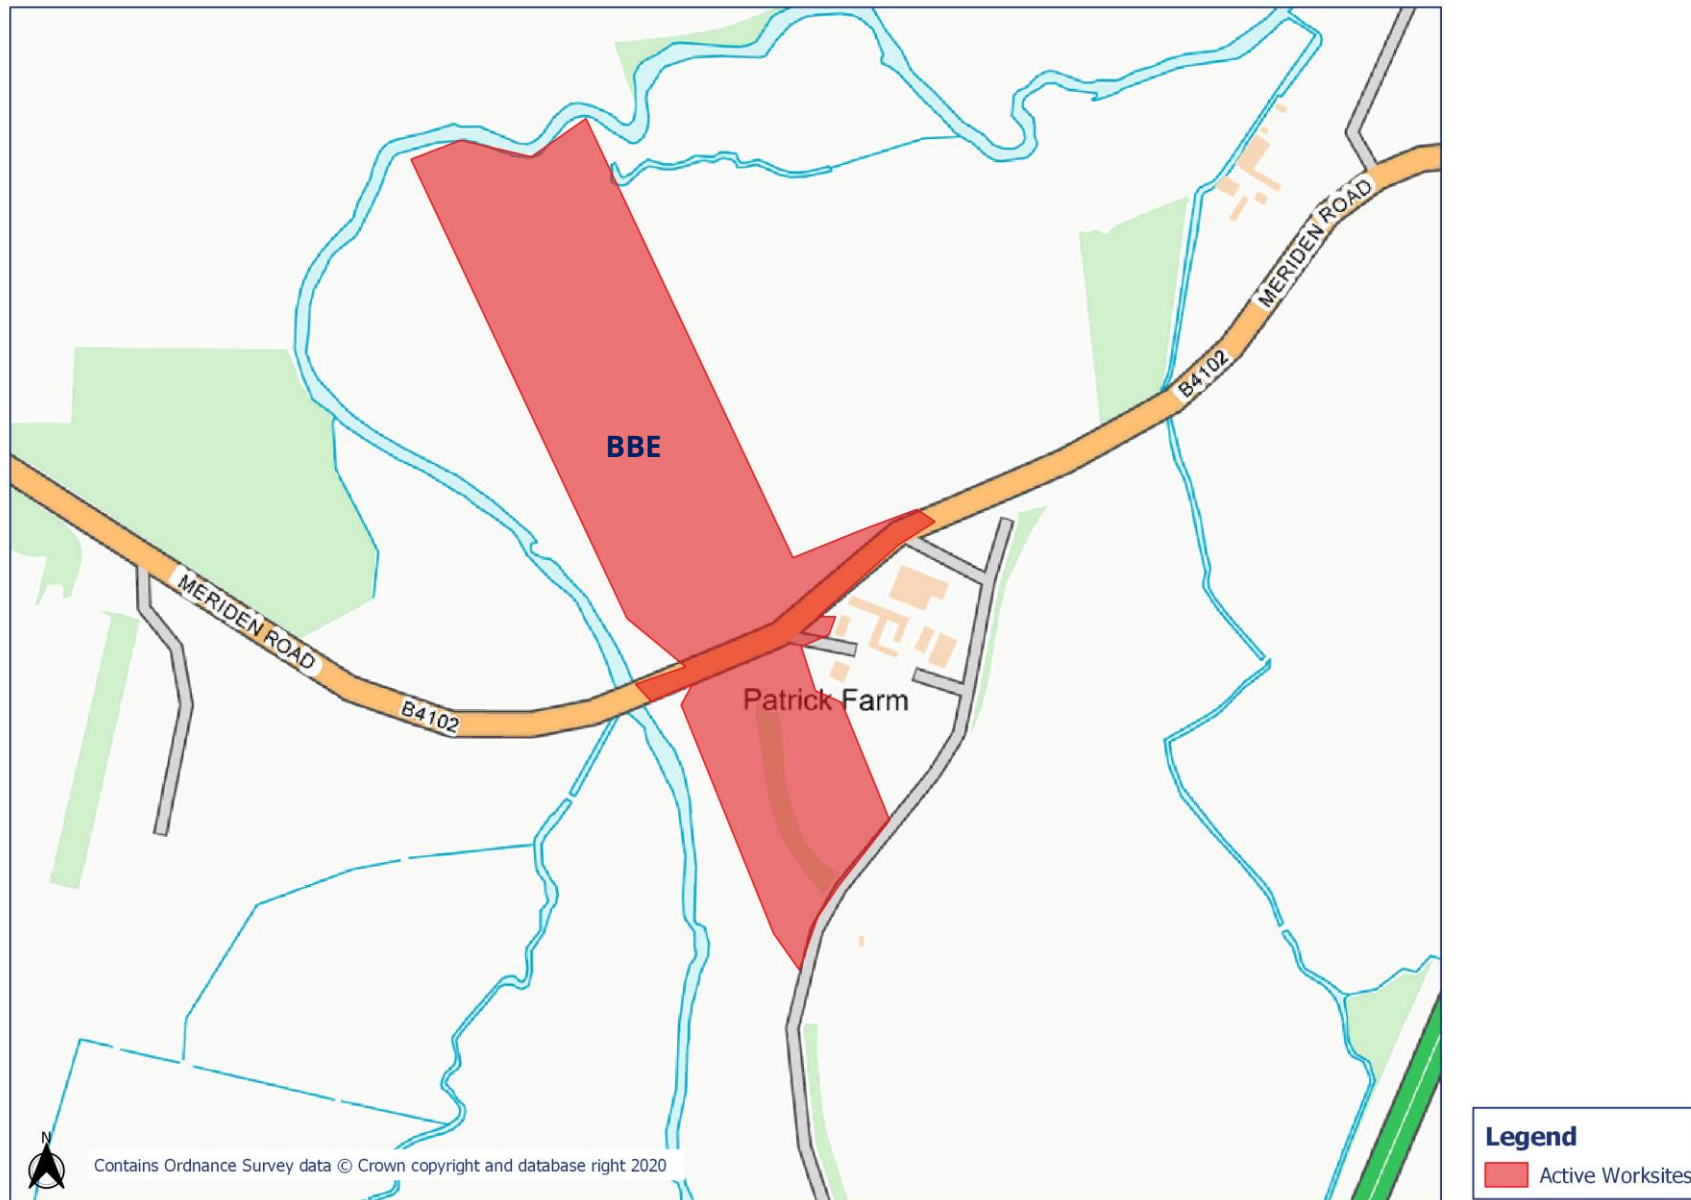
Worksite Identification Plan - 4

- Backfilling.
 - Maintenance works.
 - Installation of soffits.
 - Installation of precast beams.
 - Installation of shutters.
- Blythe Bypass Embankment worksite, reference - BBE (see plan 4 in Appendix A), where works activities included:

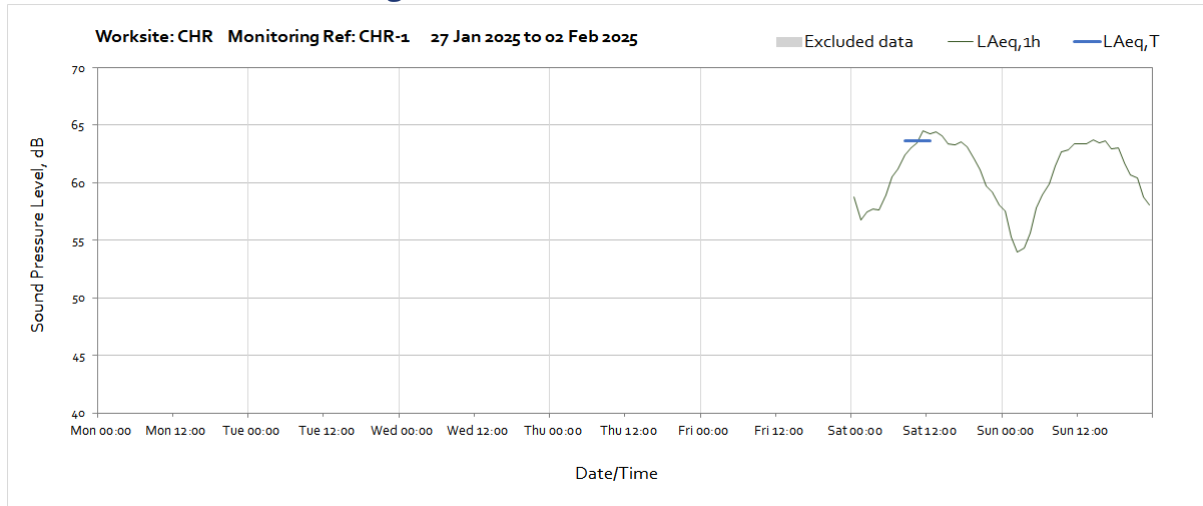
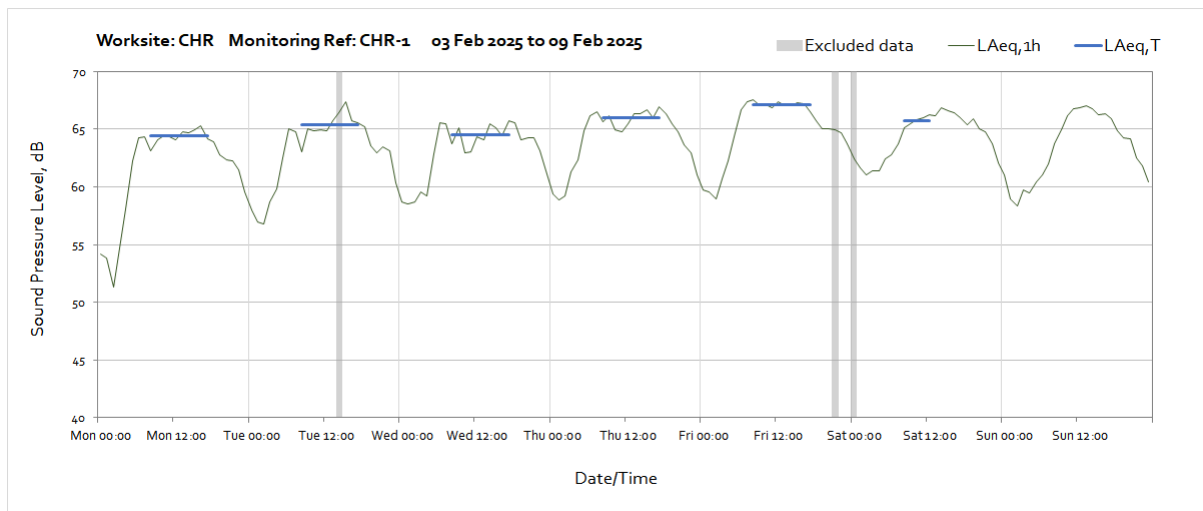
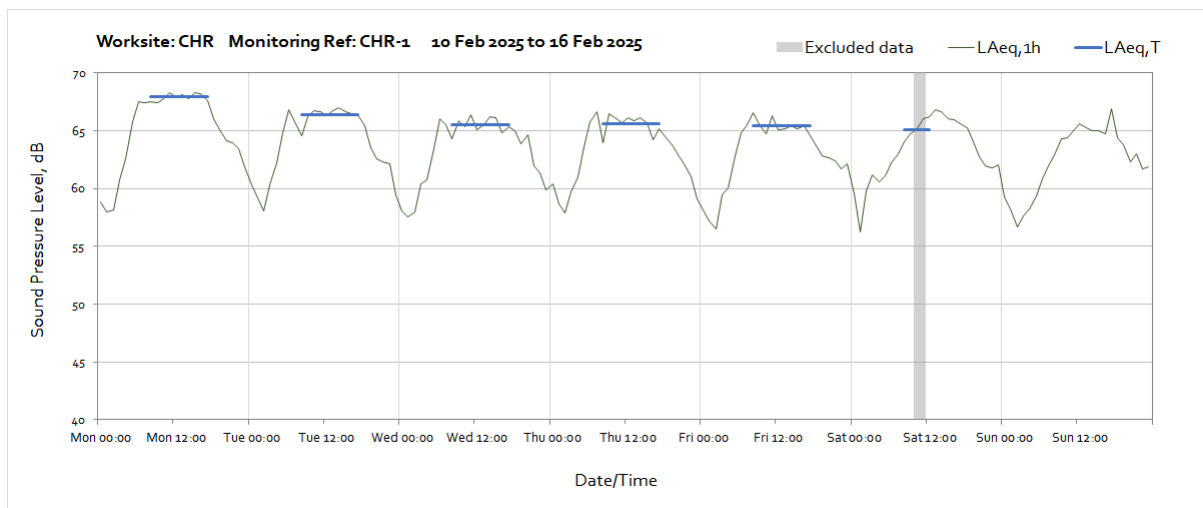
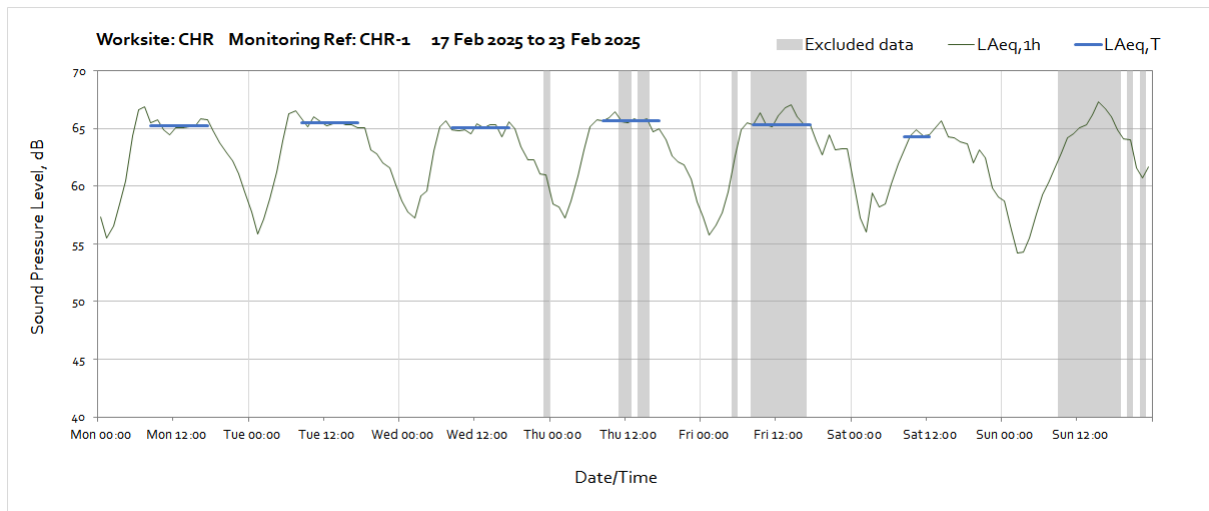
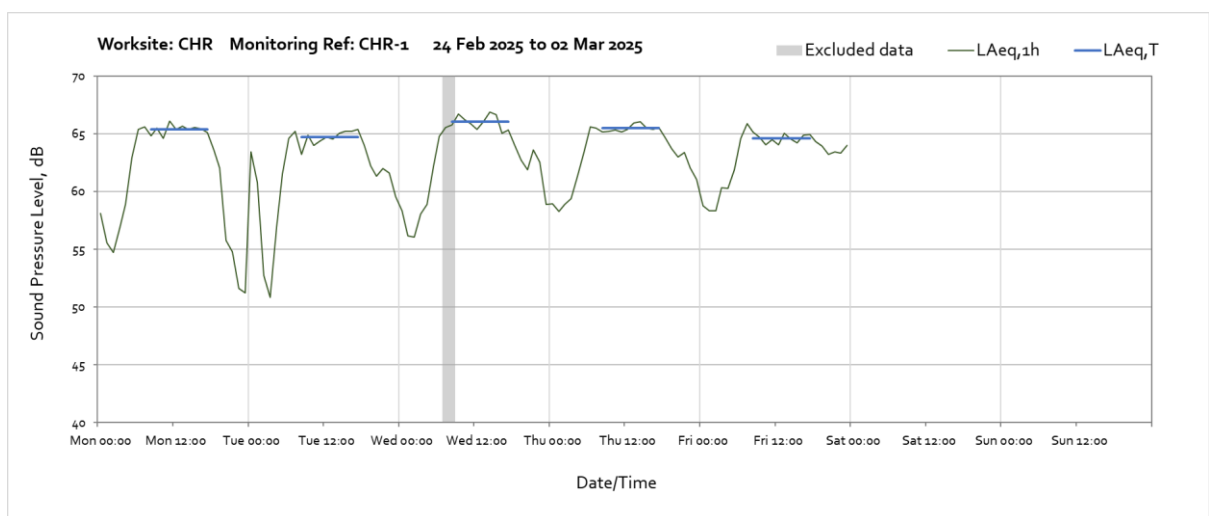
Worksite: CHR - Monitoring Ref: CHR-1

The following graphs show the hourly measured ambient noise level $L_{Aeq,1h}$ and, where relevant, the averaged noise level $L_{Aeq,T}$ values, where the time period T is as specified in Table 1 of HS2 Information Paper E23. Periods where noise levels are adversely affected by weather or only measured for part of the period, which are not representative of HS2 construction works, have been greyed out and excluded from the calculation of the $L_{Aeq,T}$ values in of the main report.
