Construction Noise and Vibration Monthly Report – March 2025

Buckinghamshire

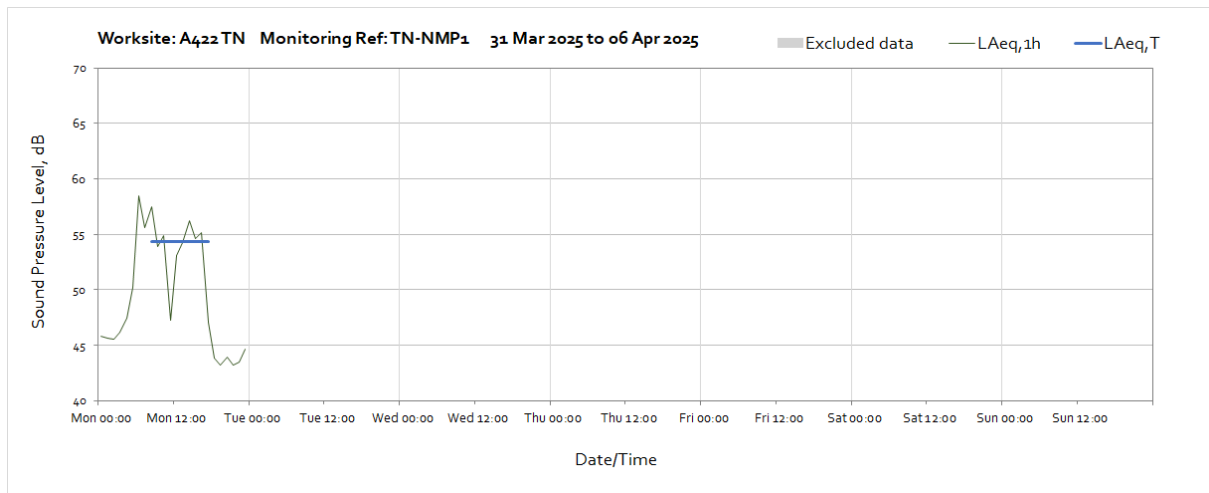
Worksite: A422 TN – Monitoring Ref: TN-NMP1

Note: Missing data between 00:00 and 04:00 on Sunday 30th March was due to a monitor time adjustment at the start of British Summer Time.

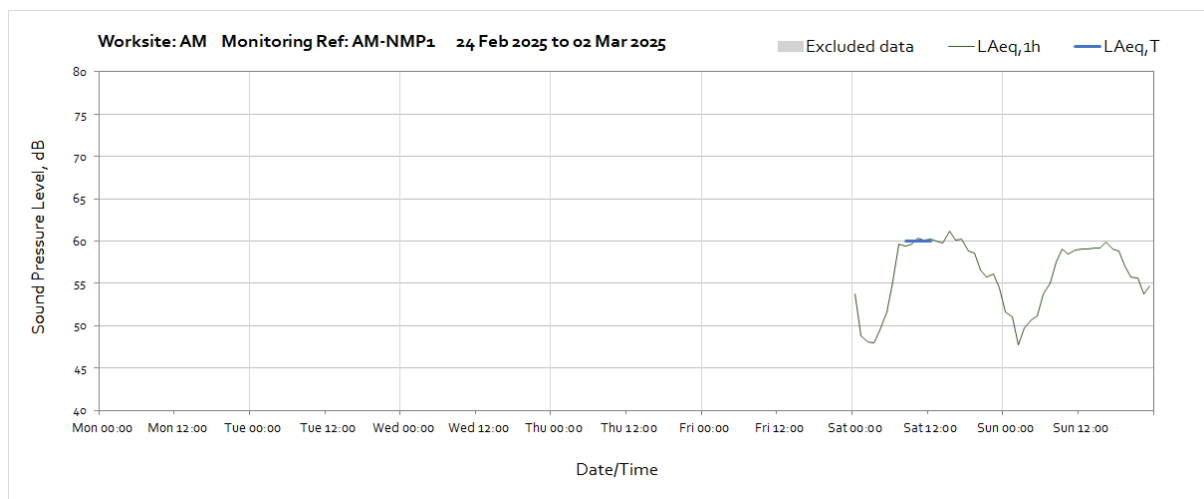
Worksite: AM – Monitoring Ref: AM-NMP1

Note: Missing data between 04:00 on Friday 7th March and 12:00 on Tuesday 18th March was due to a loss of connection to the monitoring station.

Note: Missing data between 01:00 and 03:00 on Sunday 30th March was due to a monitor time adjustment at the start of British Summer Time.
