# HS2

## Construction Noise and Vibration Monthly Report – March 2025

London Borough of Camden

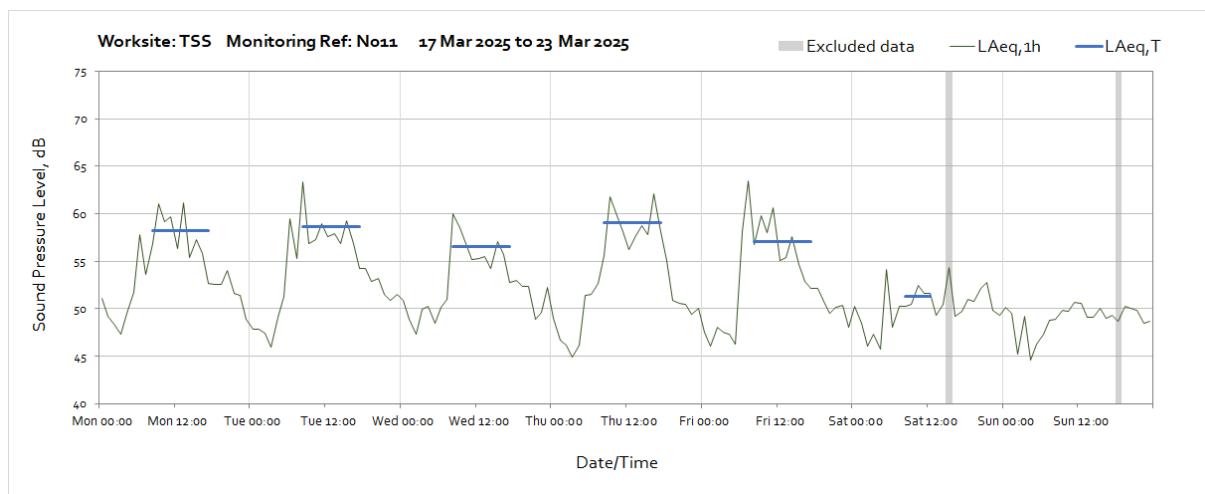
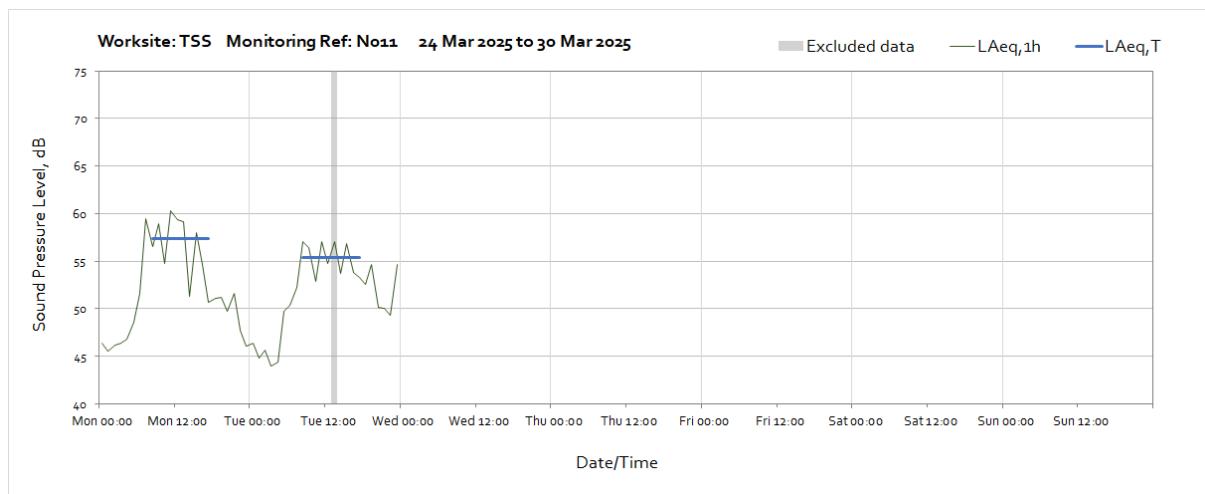
Note: Missing data between 00:00 on Wednesday 26<sup>th</sup> March and 11:00 on Monday 31<sup>st</sup> March was due to loss of power at the monitoring station.
