## UNIVERSAL DESTINATIONS & EXPERIENCES UK PROJECT

Former Kempston Hardwick Brickworks  
and adjoining land, Bedford

**Environmental Statement Volume 3**

**Appendix 6.8 Macrophyte Survey Report**

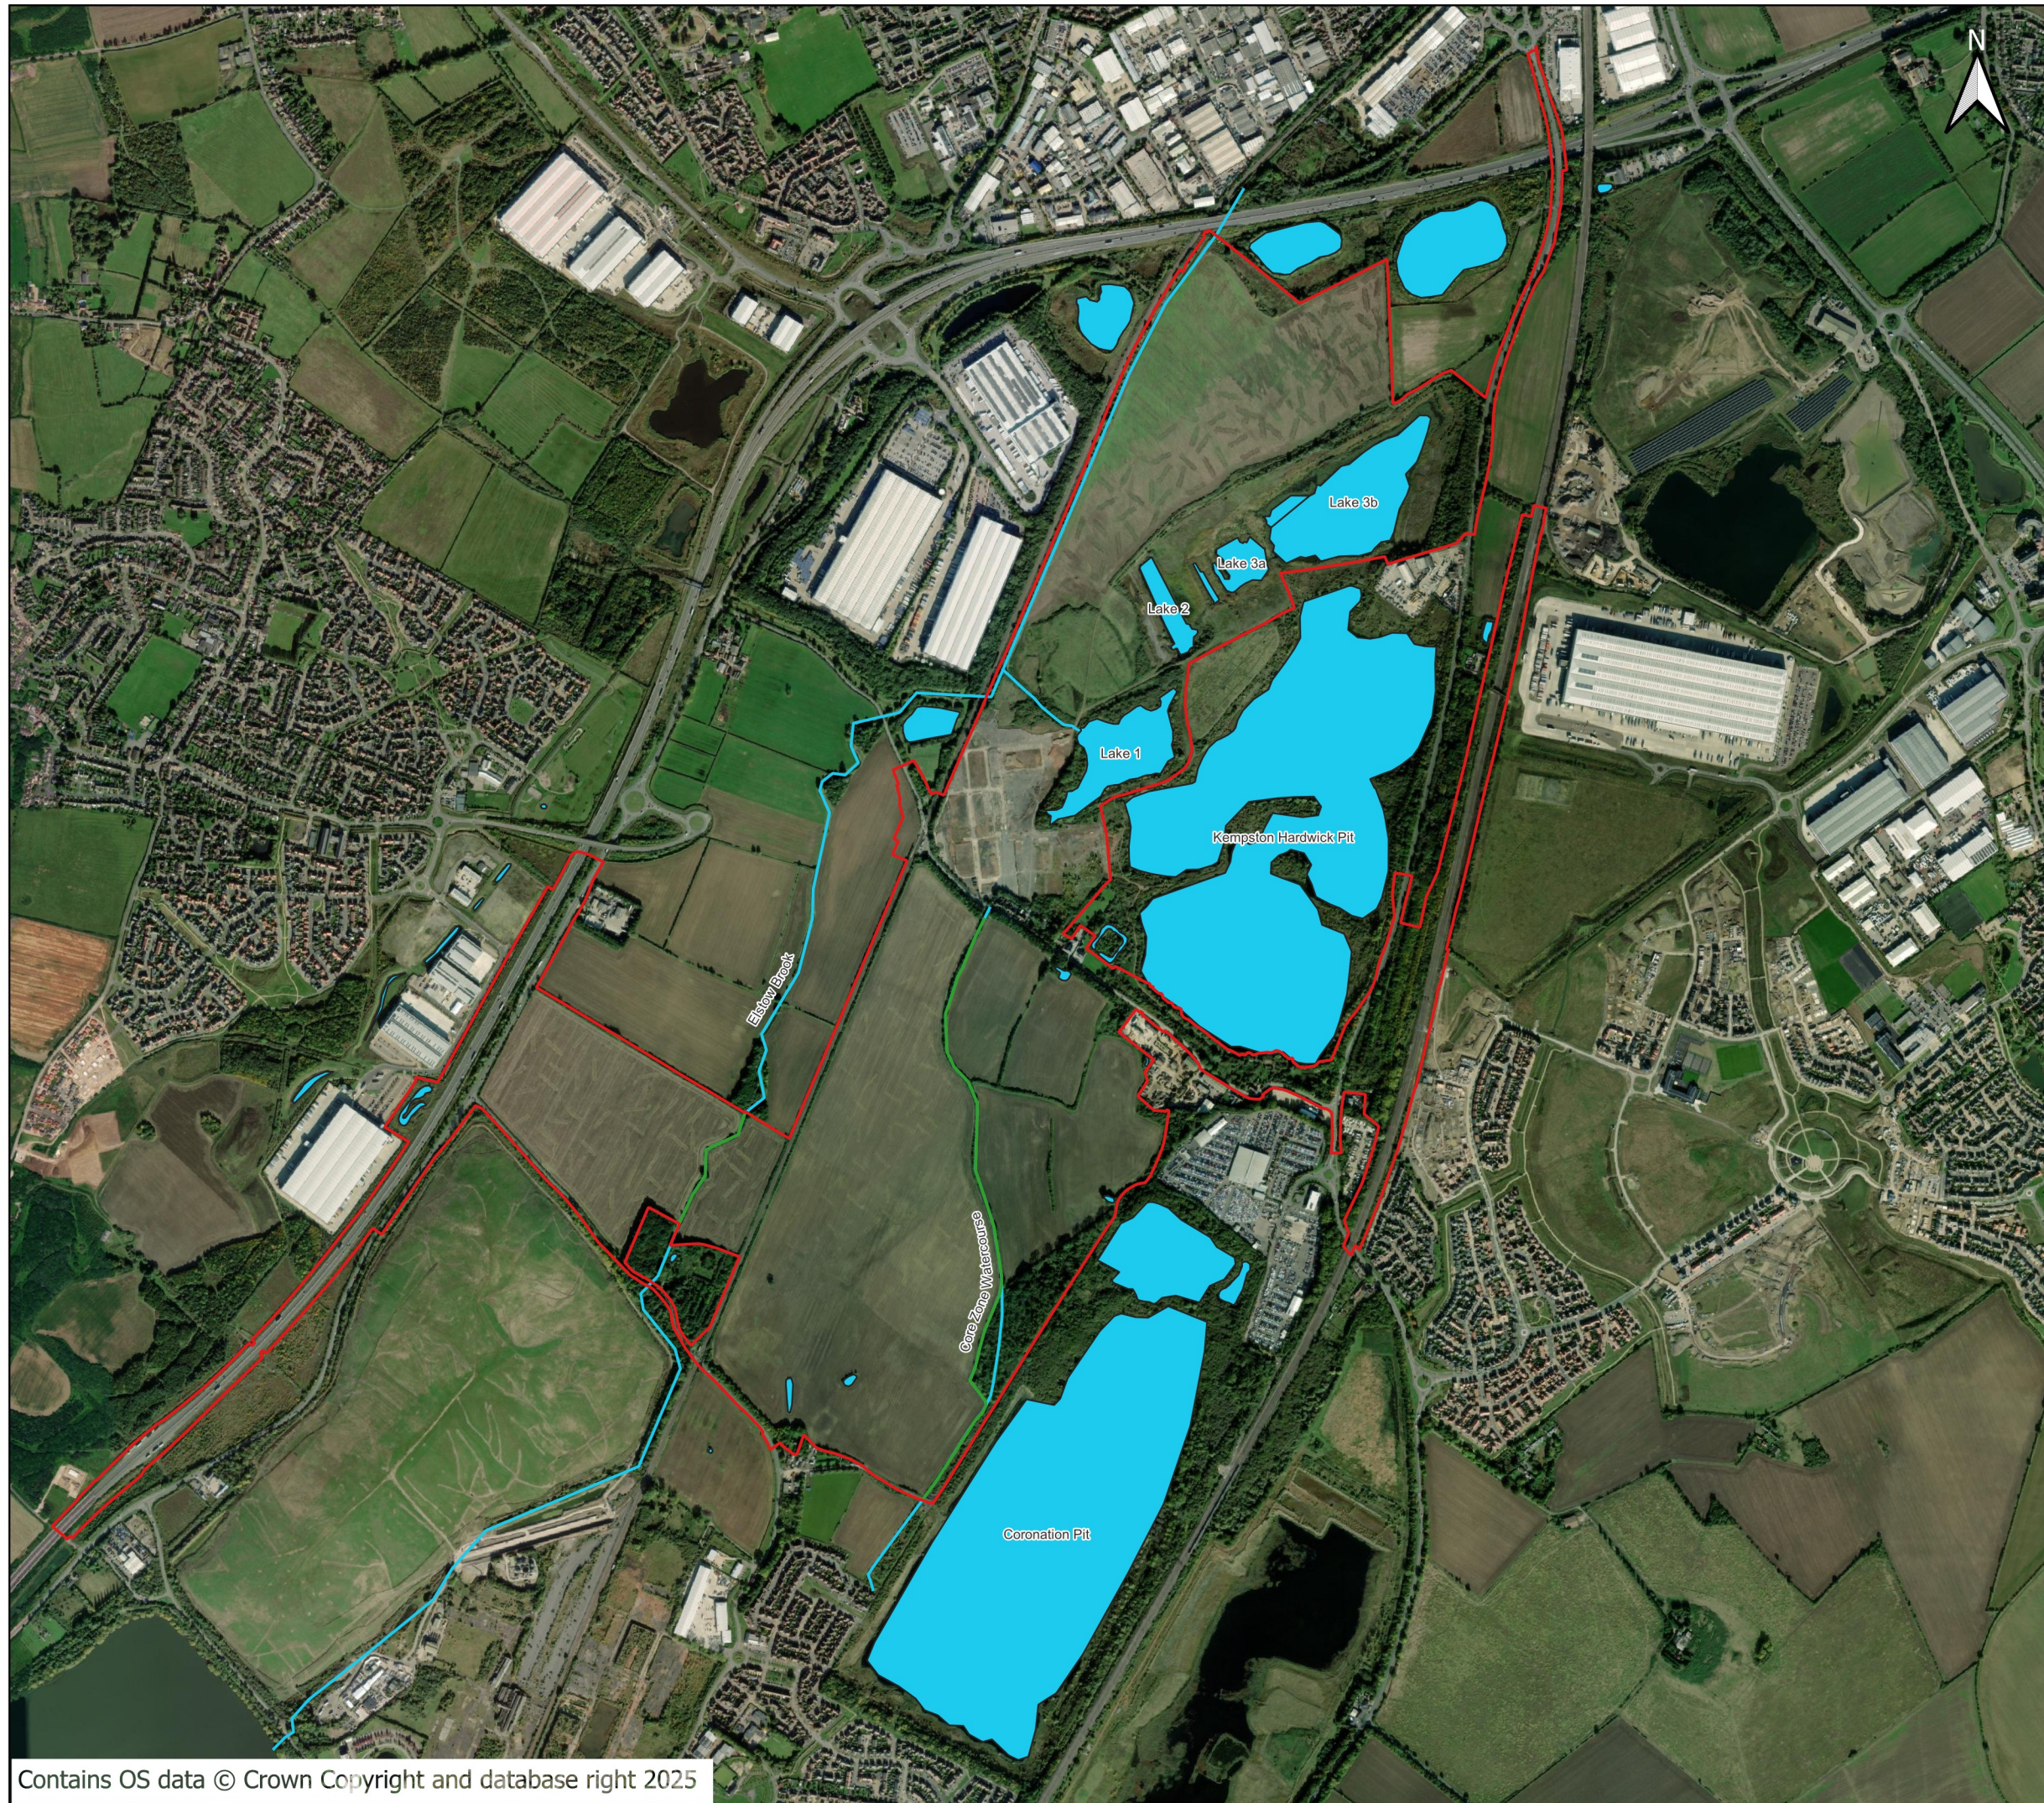
Title:  
Figure 1 - Macrophyte Survey Area

- 3.2.1. Elstow Brook, a tributary of the River Great Ouse, crosses through the West Gateway Zone, flowing under Manor Road, and then follows the Marston Vale Railway Line along the western boundary of the Lake Zone. The total length of the watercourse within the Site is approximately 1.9km (see **Figure 1: Macrophyte Survey Area of Annex 1: Figures**).

- 3.2.6. This is an ordinary watercourse located within the Core Zone, flowing in an approximate south to north direction towards Manor Road. The length of the watercourse within the Site boundary is 1.5km (see **Figure 1: Macrophyte Survey Area of Annex 1: Figures**).

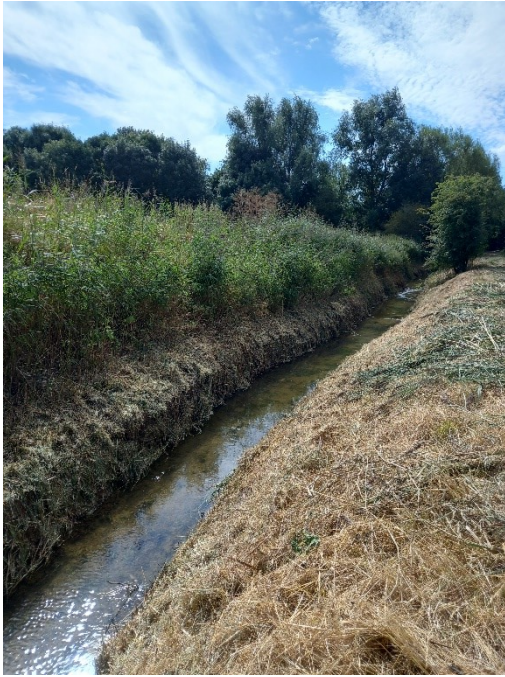
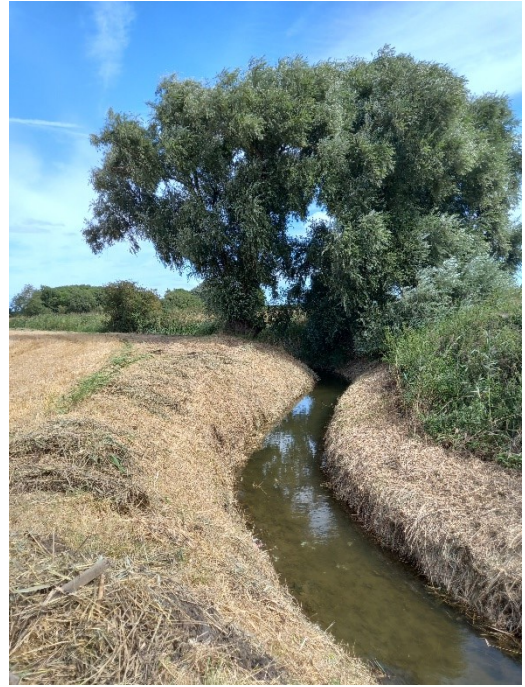
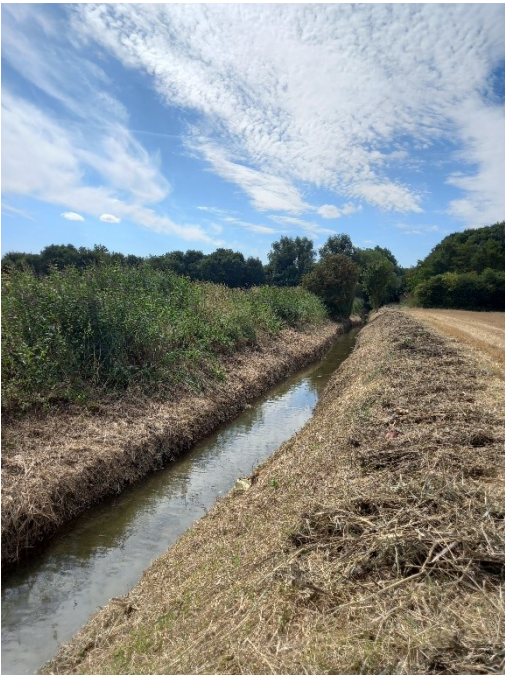
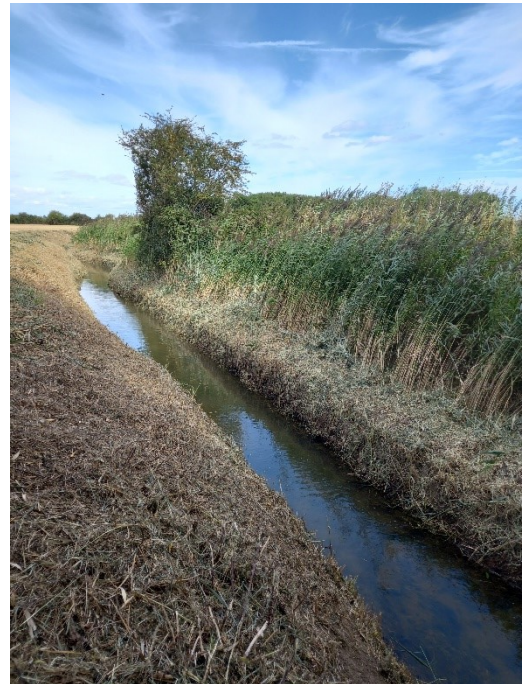
- 3.2.2. No macrophyte species were recorded during the macrophyte survey of Elstow Brook.
- 3.2.3. Within the Site boundary, Elstow Brook was recorded as being a heavily re-shaped and homogenous channel, with steep banks. It was noted that management of the watercourse had been carried out along the full length of the watercourses within the Site boundary, prior to the macrophyte survey, in which the riparian vegetation, including common reed *Phragmites australis*, had been cut back and/or removed.

- 3.2.4. During the macrophyte survey, dried specimens of an invasive waterweed *Elodea* sp., were noted within the spoil, likely from the management of the watercourse, that has been discarded on the bank top.

**Figure 2-1 – Elstow Brook**

**Figure 2-2 – Elstow Brook**

**Figure 2-3 – Elstow Brook**

**Figure 2-4 – Elstow Brook**

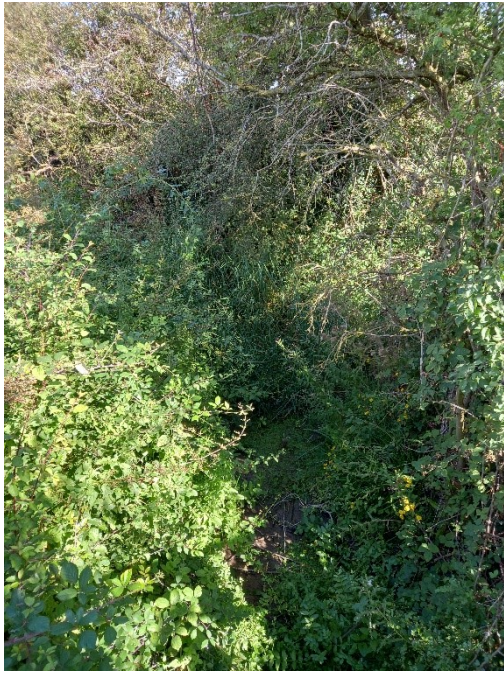
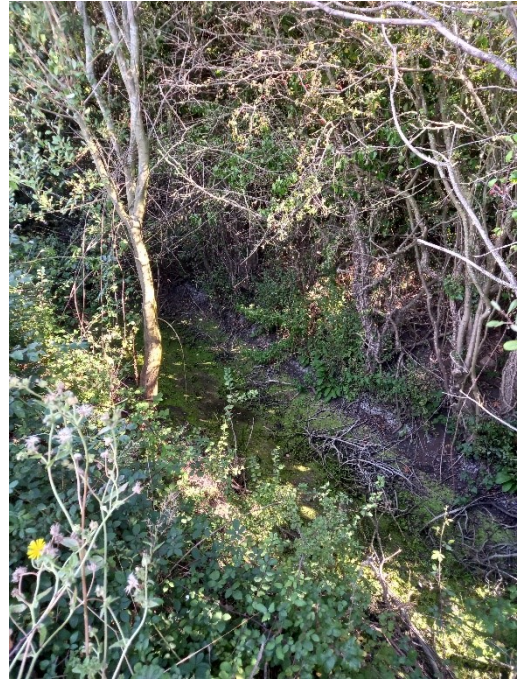
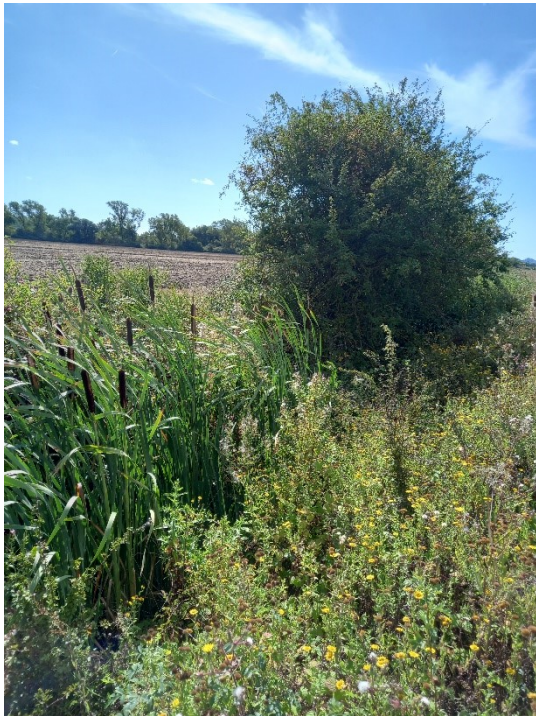
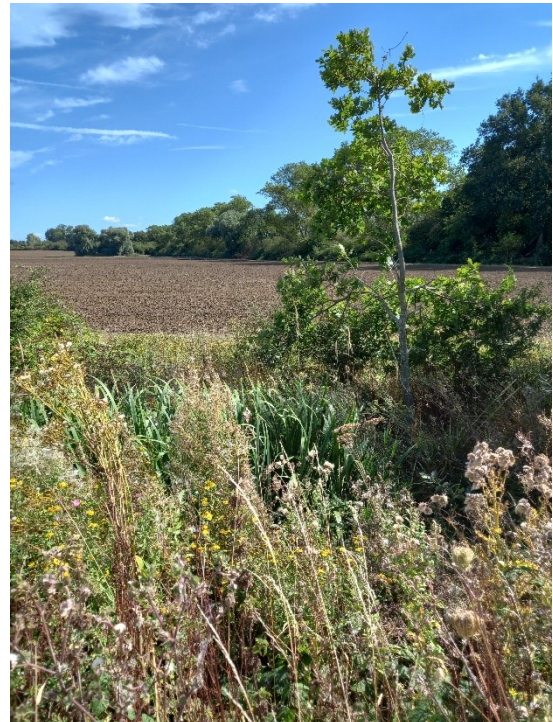
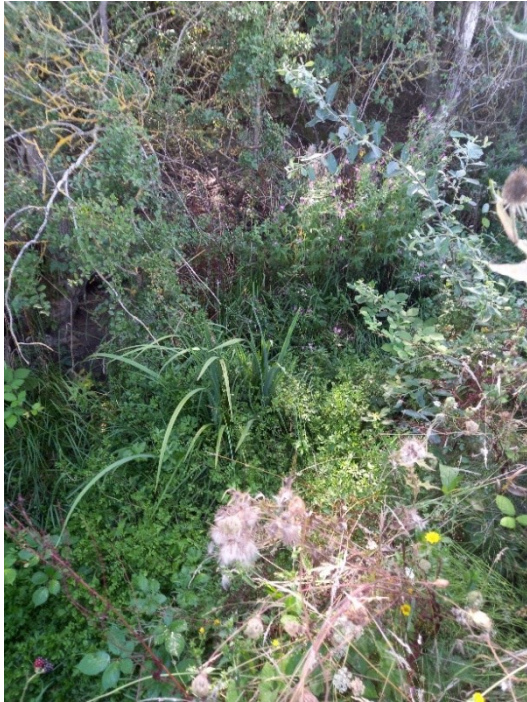
- 3.2.7. During the macrophyte survey, the Core Zone watercourse was noted as dry for much of its length within the Site boundary, with only a few small areas of shallow retained water and damp soil.

**Figure 2-5 – Core Zone Watercourse**

**Figure 2-6 – Core Zone Watercourse**

**Figure 2-7 – Core Zone Watercourse**

**Figure 2-8 – Core Zone Watercourse**

**Figure 2-9 – Core Zone Watercourse**

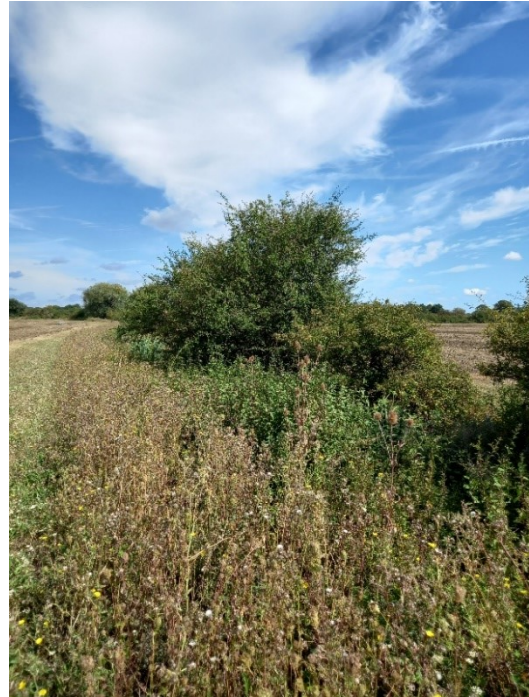
**Figure 2-10 – Core Zone Watercourse Divergence**

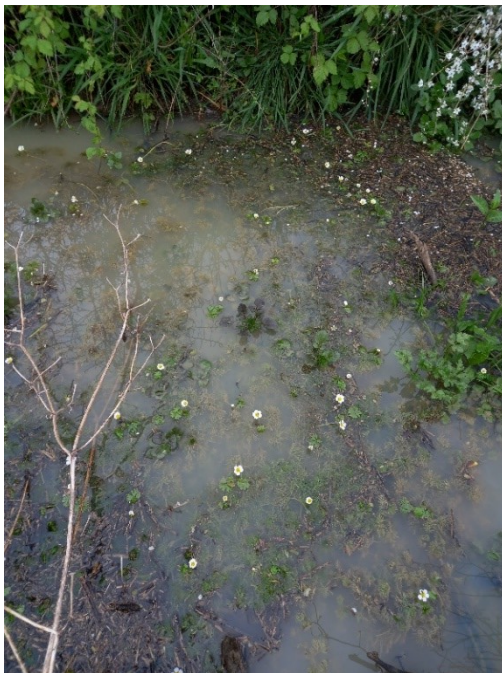
**Figure 2-11 – Core Zone Watercourse Water Crow-Foot (from aquatic habitat scoping assessment)**
