# **Hummingbird Spirit FPSO Sailaway and Riser Disconnection Close Out Report**

| <b>Document ID:</b> | | CHESDC-SPT-F-0000-REP-0018 | |

This document is the close out report for the combined Decommissioning Programmes for the departure of the Sevan Hummingbird<sup>1</sup> floating production storage and offloading vessel, and for the removal of the associated riser systems. One for each set of notices under Section 29 of the Petroleum Act 1998.

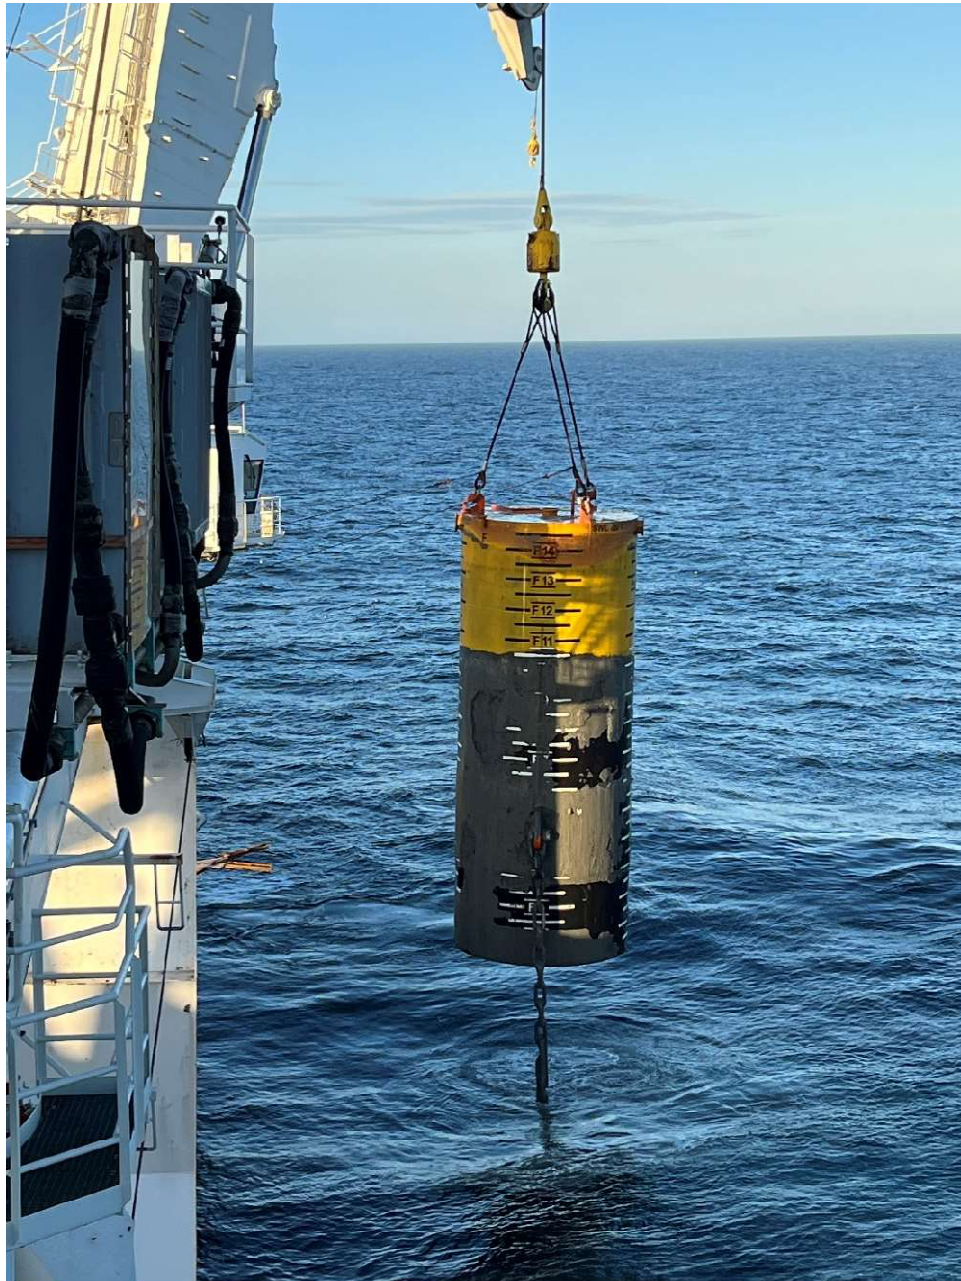
Figure 8.1.2: Suction anchor recovery to vessel

| Table 3.2.1: Platform operations | |
|---|---|
| FPSO Recovery of suction anchors (12x) | 28 Sept – 08 Oct 2022 |

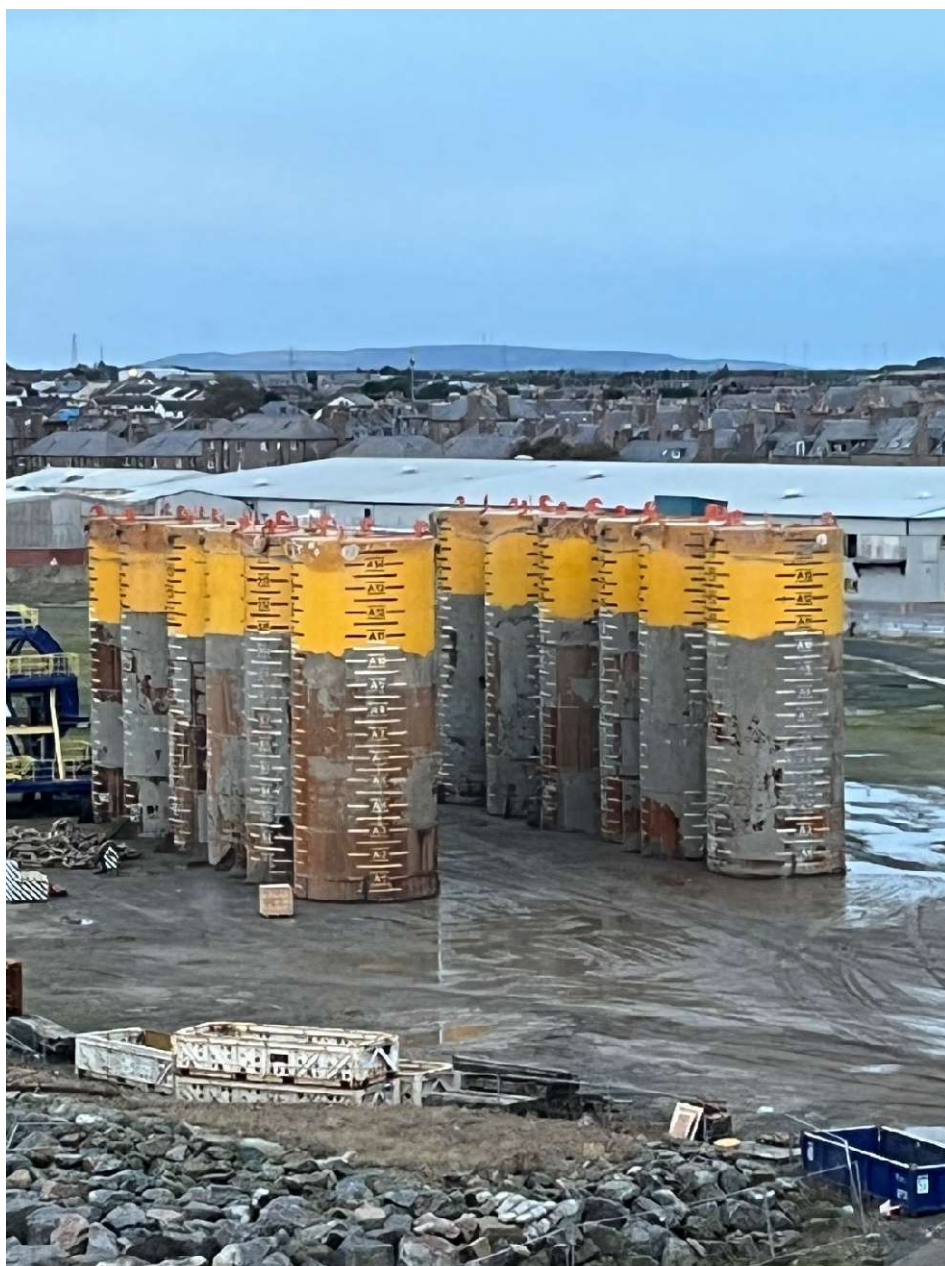
Figure 8.1.3: Sevan Hummingbird FPSO 12x suction anchors

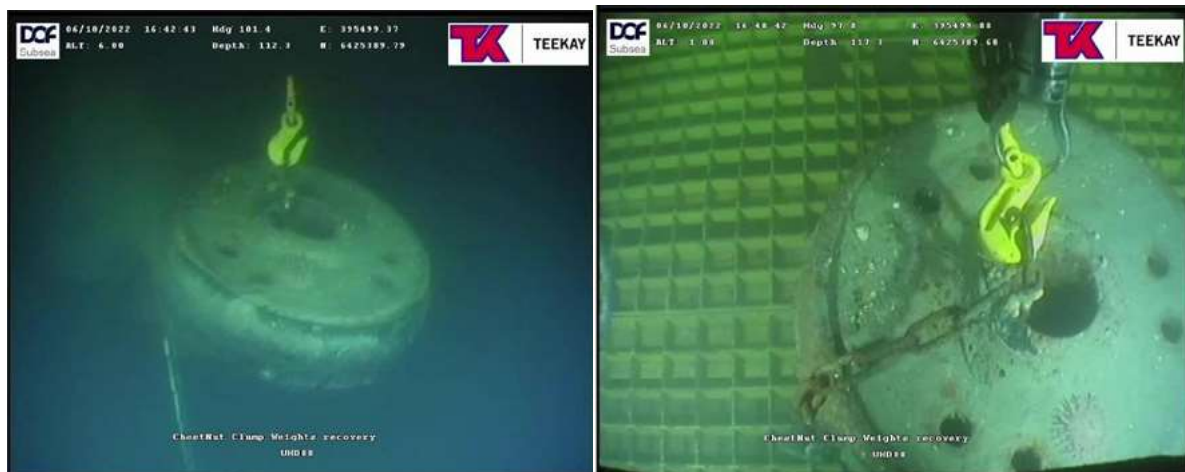
Figure 8.2.1: Wave rider buoy clump weight #3 being recovered

| Table 3.2.1: Platform operations | |
|---|---|
| Recovery of wave rider buoy clump weights | 06 Oct to 07 Oct 2022 |

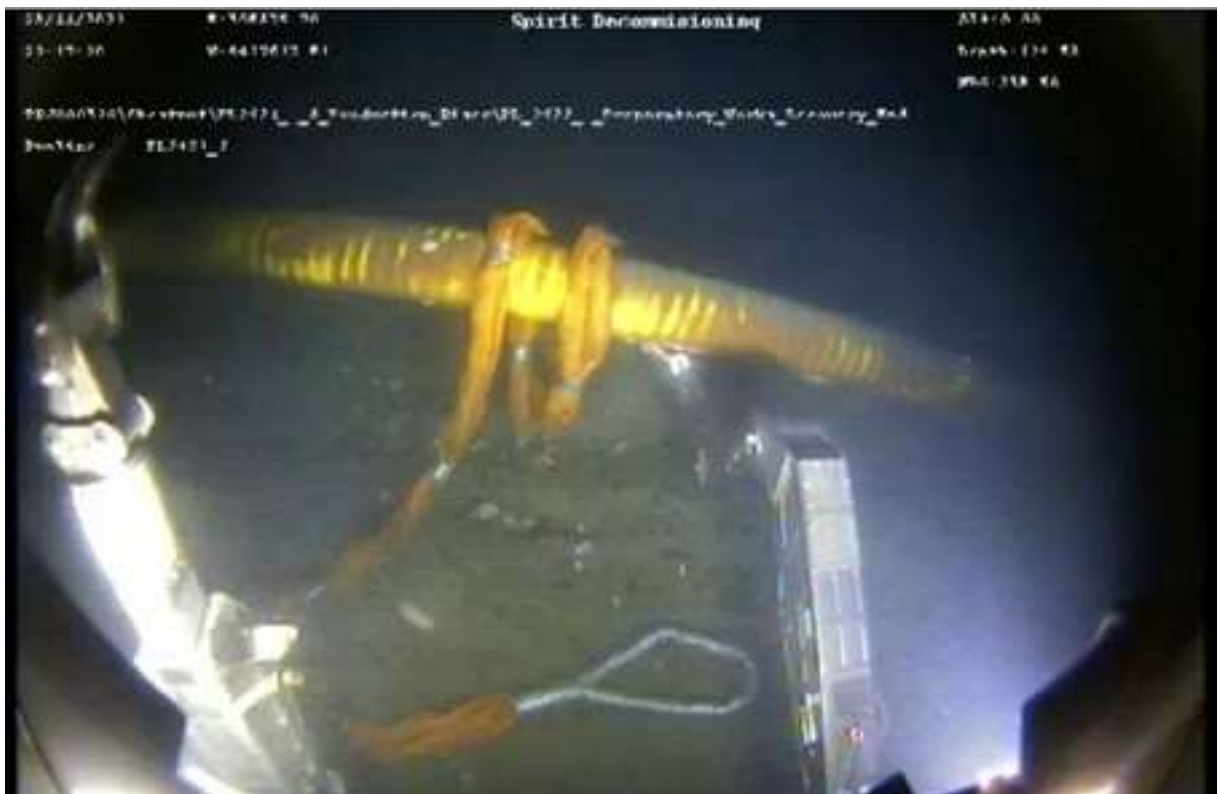
Figure 8.3.2: Typical rigging arrangement for product recovery

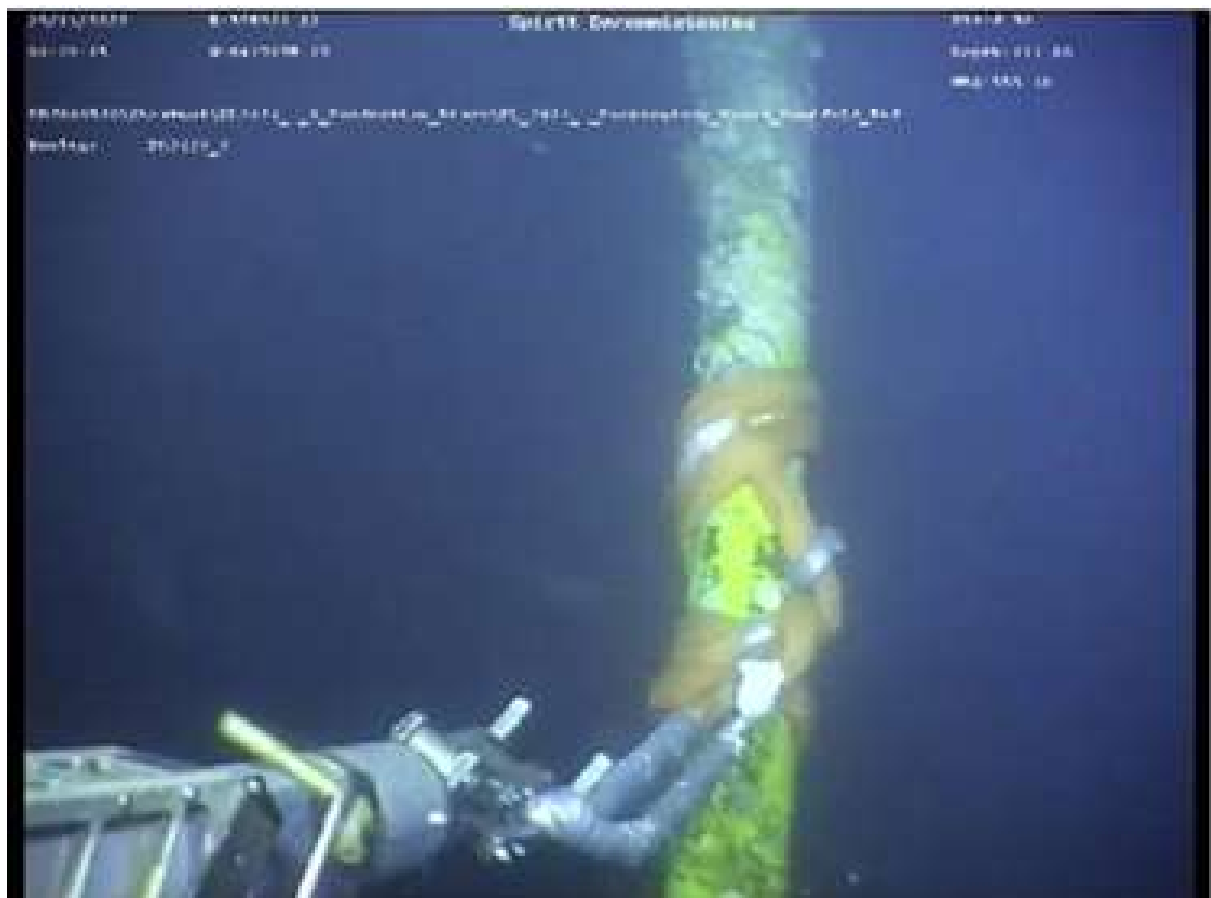
Figure 8.3.3: Typical hold-down rigging arrangement before product recovery

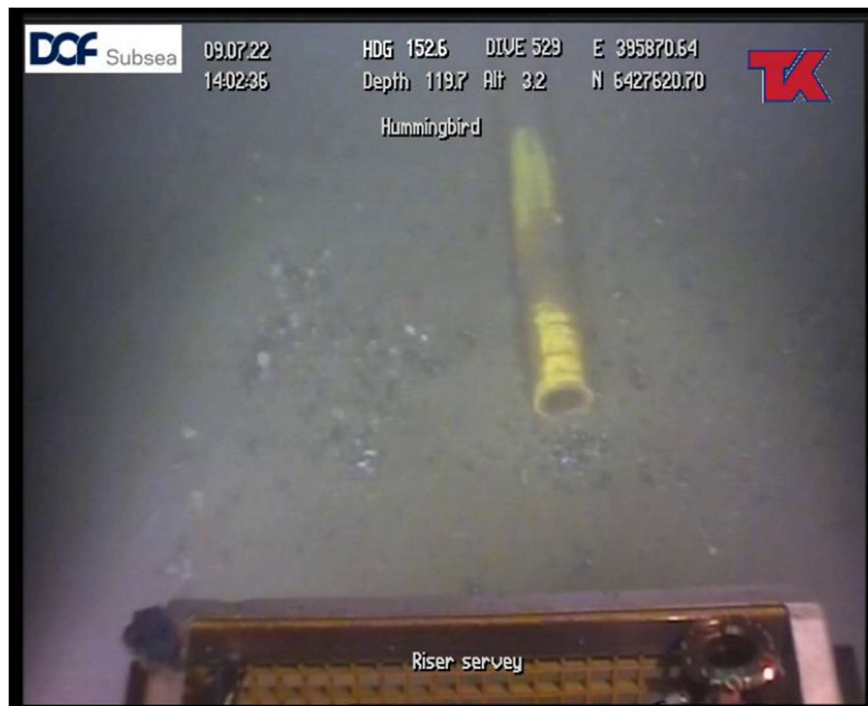
Figure 2: Production riser cut end

Figure 8.4.1: PL2421 production riser cut end before recovery

| Table 2.6.1: Amendments to & deviations from the DP | | |
|---|---|---|
| A 30m section of PL2421 (production riser) and a short stub (~6.5m high) on the riser base have been left on the seabed for recovery as part of Chestnut Phase 2 decommissioning operations. Refer footnote at bottom of table. | Section 2.3, Table 2.3.1. | Operational efficiency |

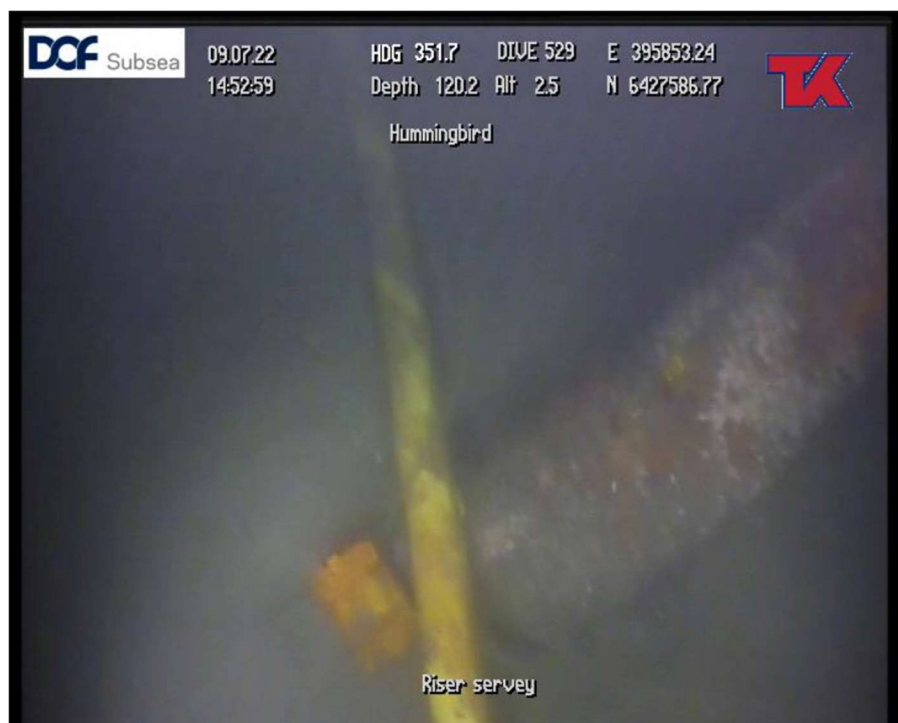
Figure 8: Water injection riser cut end

Figure 8.5.1: PLU2423 water injection riser cut end before recovery

| Table 2.6.1: Amendments to & deviations from the DP | | |
|---|---|---|
| A 30m section of PL2422 (water injection riser) and a short stub (~6.5m high) on the riser base have been left on the seabed for recovery as part of Chestnut Phase 2 decommissioning operations. Refer footnote at bottom of table. | Section 2.3, Table 2.3.1. | Operational efficiency |

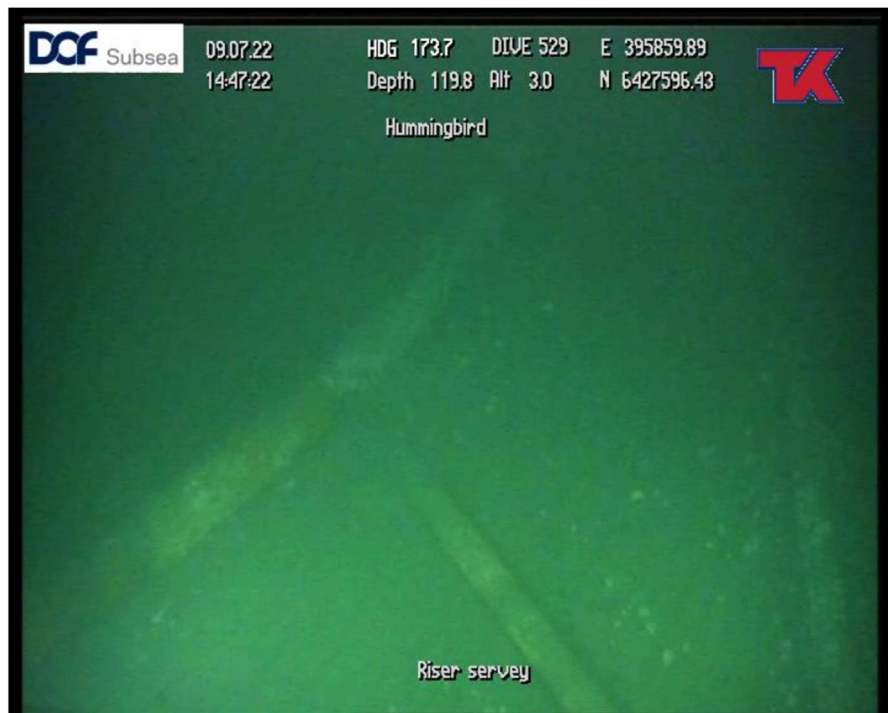
Figure 7: Control umbilical cut end

Figure 8.6.1: PLU2423 umbilical riser cut end before recovery

| Table 2.6.1: Amendments to & deviations from the DP | | |
|---|---|---|
| A 30m section of PLU2423 (umbilical riser) and a short stub (~6m high) on the riser base have been left on the seabed for recovery as part of Chestnut Phase 2 decommissioning operations. Refer footnote at bottom of table. | Section 2.3, Table 2.3.1. | Operational efficiency |

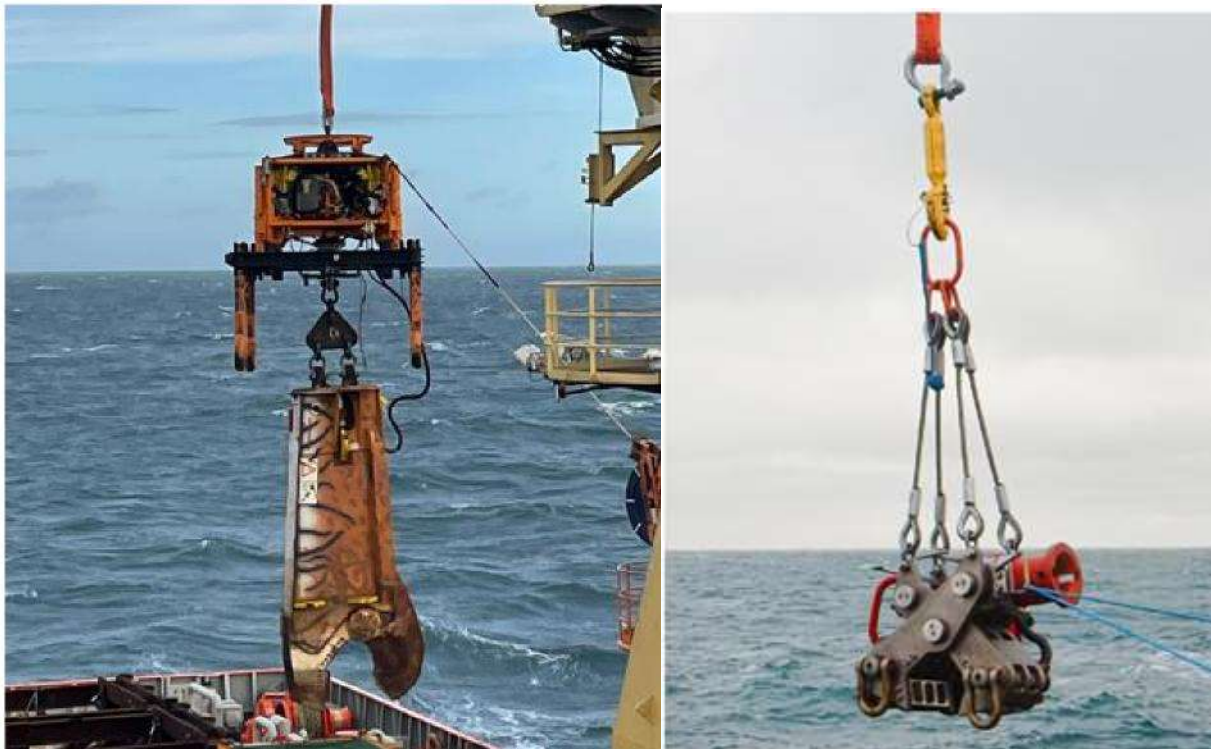
Figure 8.7.1: UTROV™ & shear cutter (left), CRT200 pipe clamp (right)

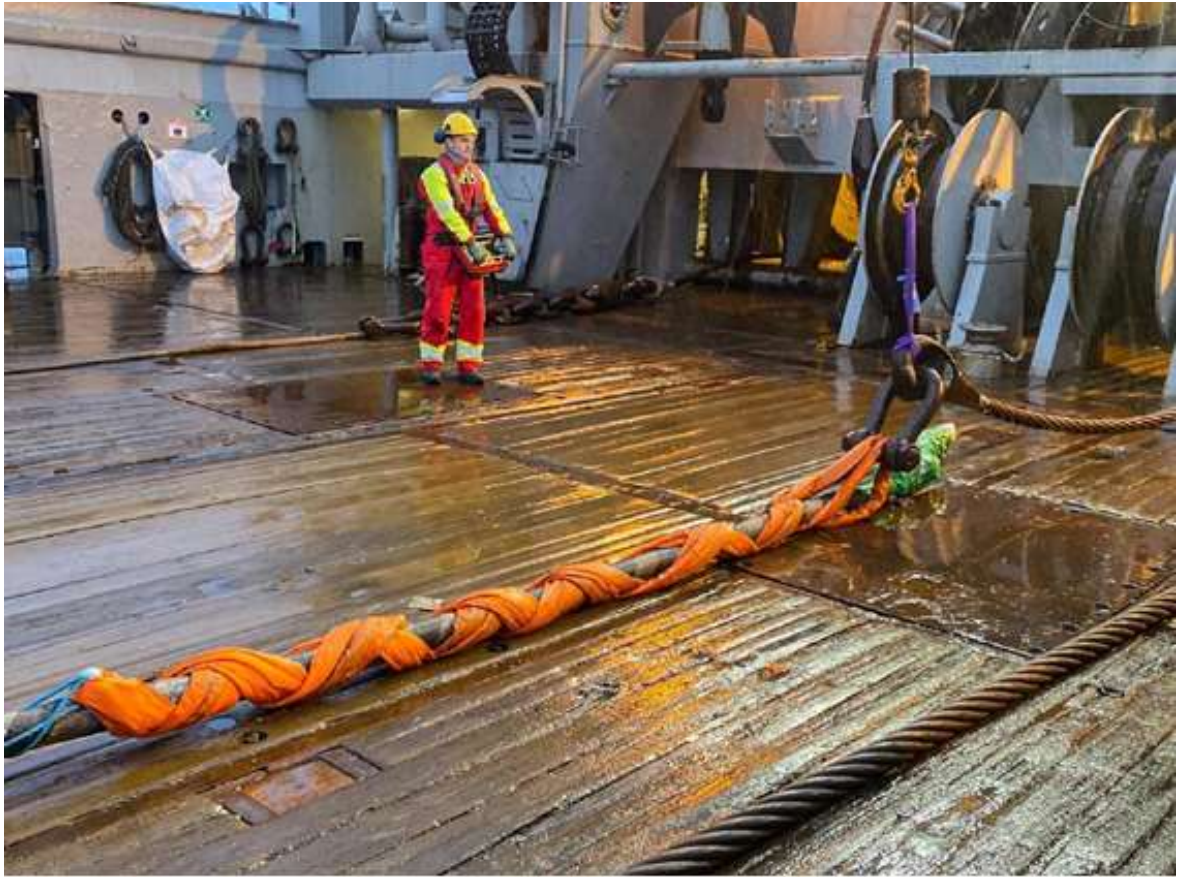
Figure 8.7.2: Chinese finger used to recover flexible risers

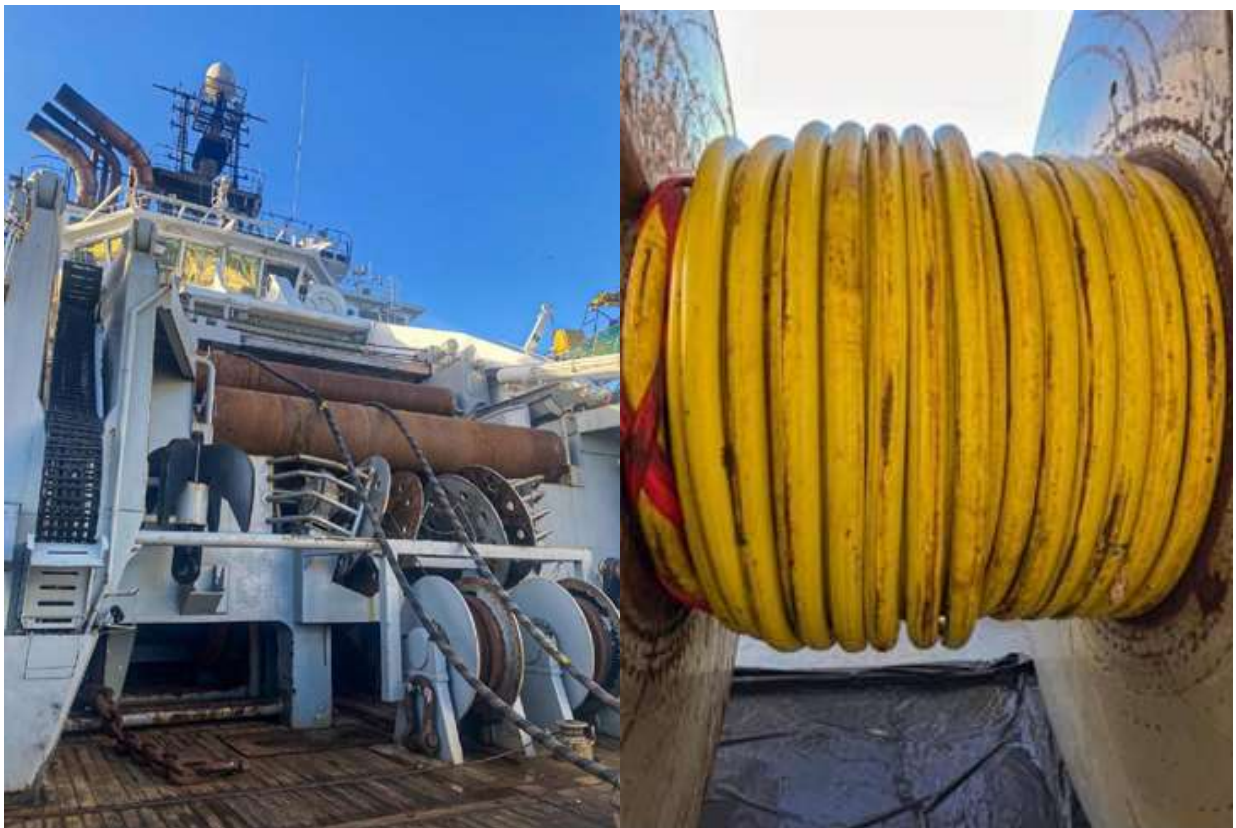
Figure 8.7.3: Product spooling (left) & storage on drum (right)

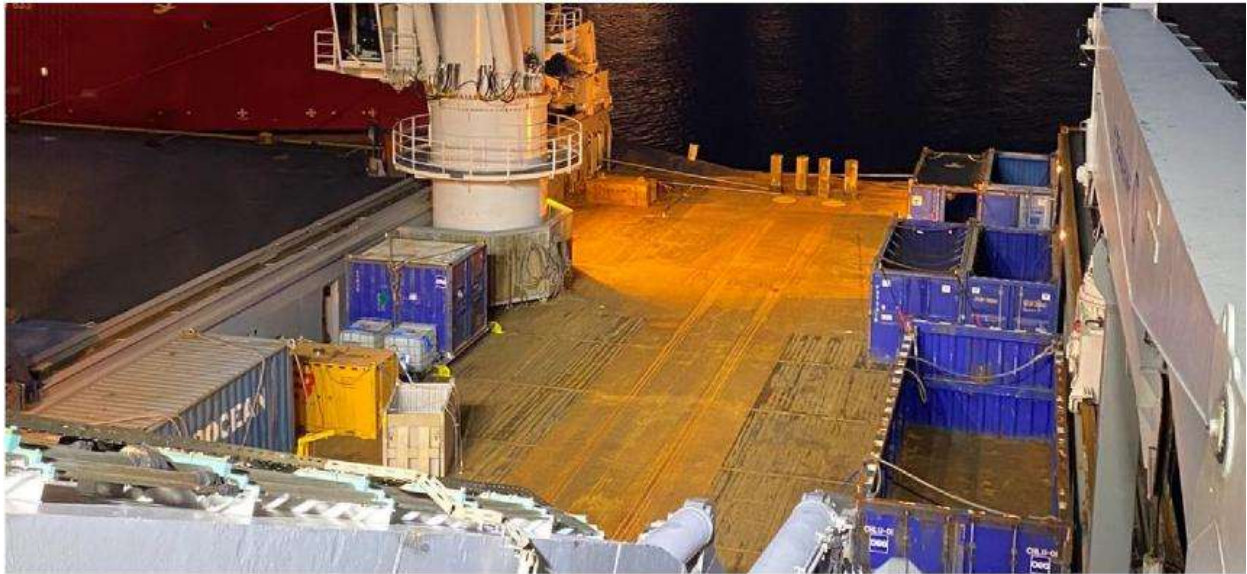
Figure 8.7.4: AHTS / LCV deck layout

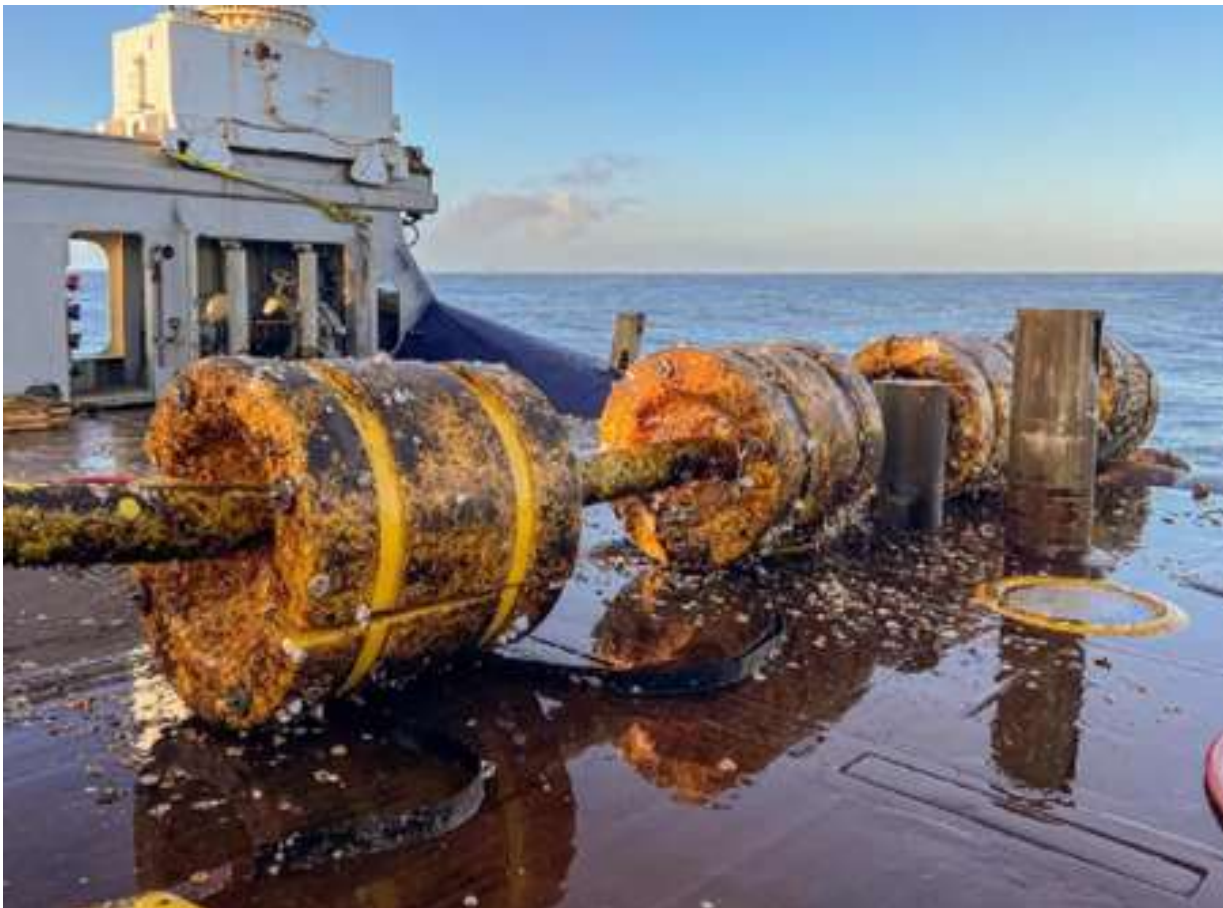
Figure 8.8.1: Buoyancy modules on deck following recovery

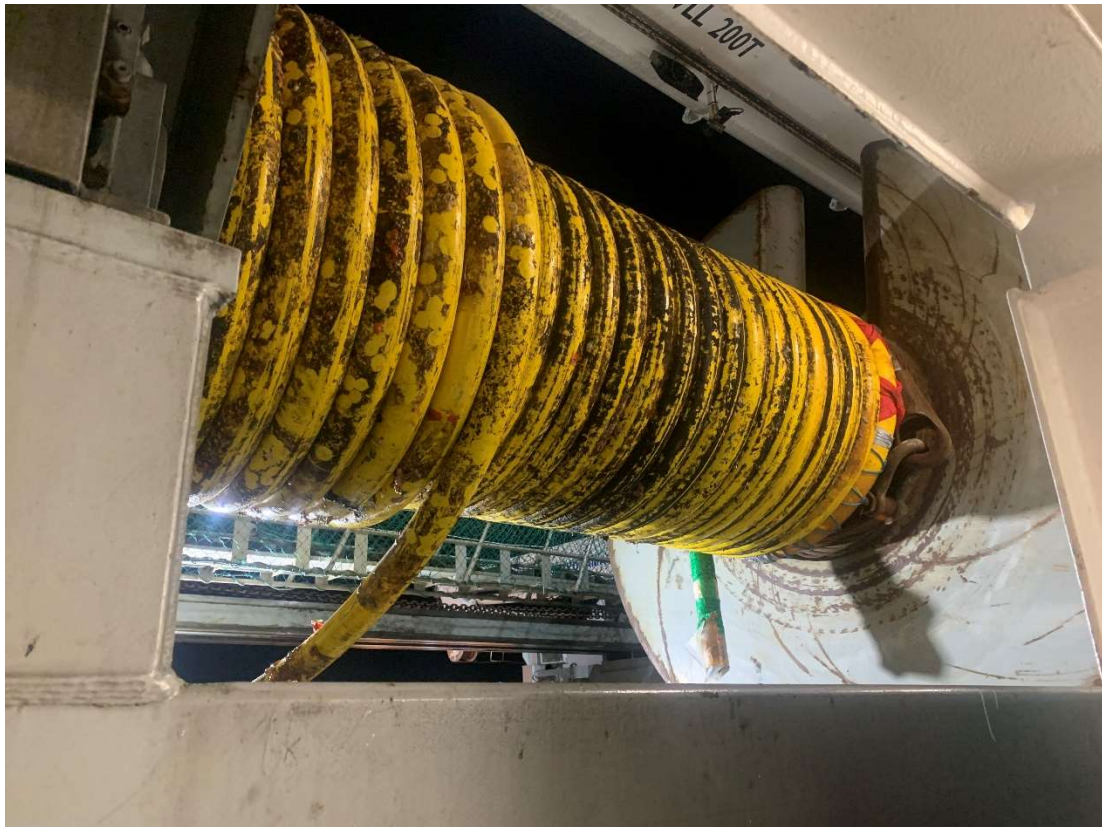
Figure 8.8.3: Riser recovery, drum

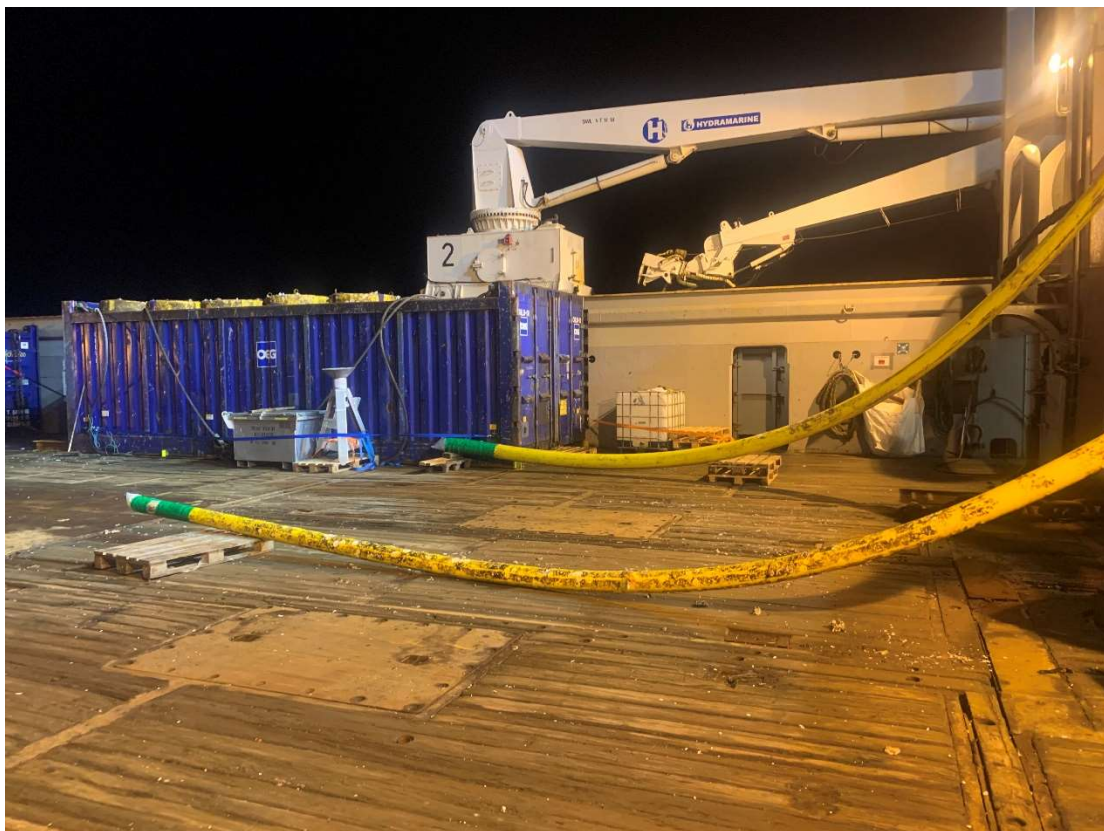
Figure 8.8.4: Riser recovery, tails

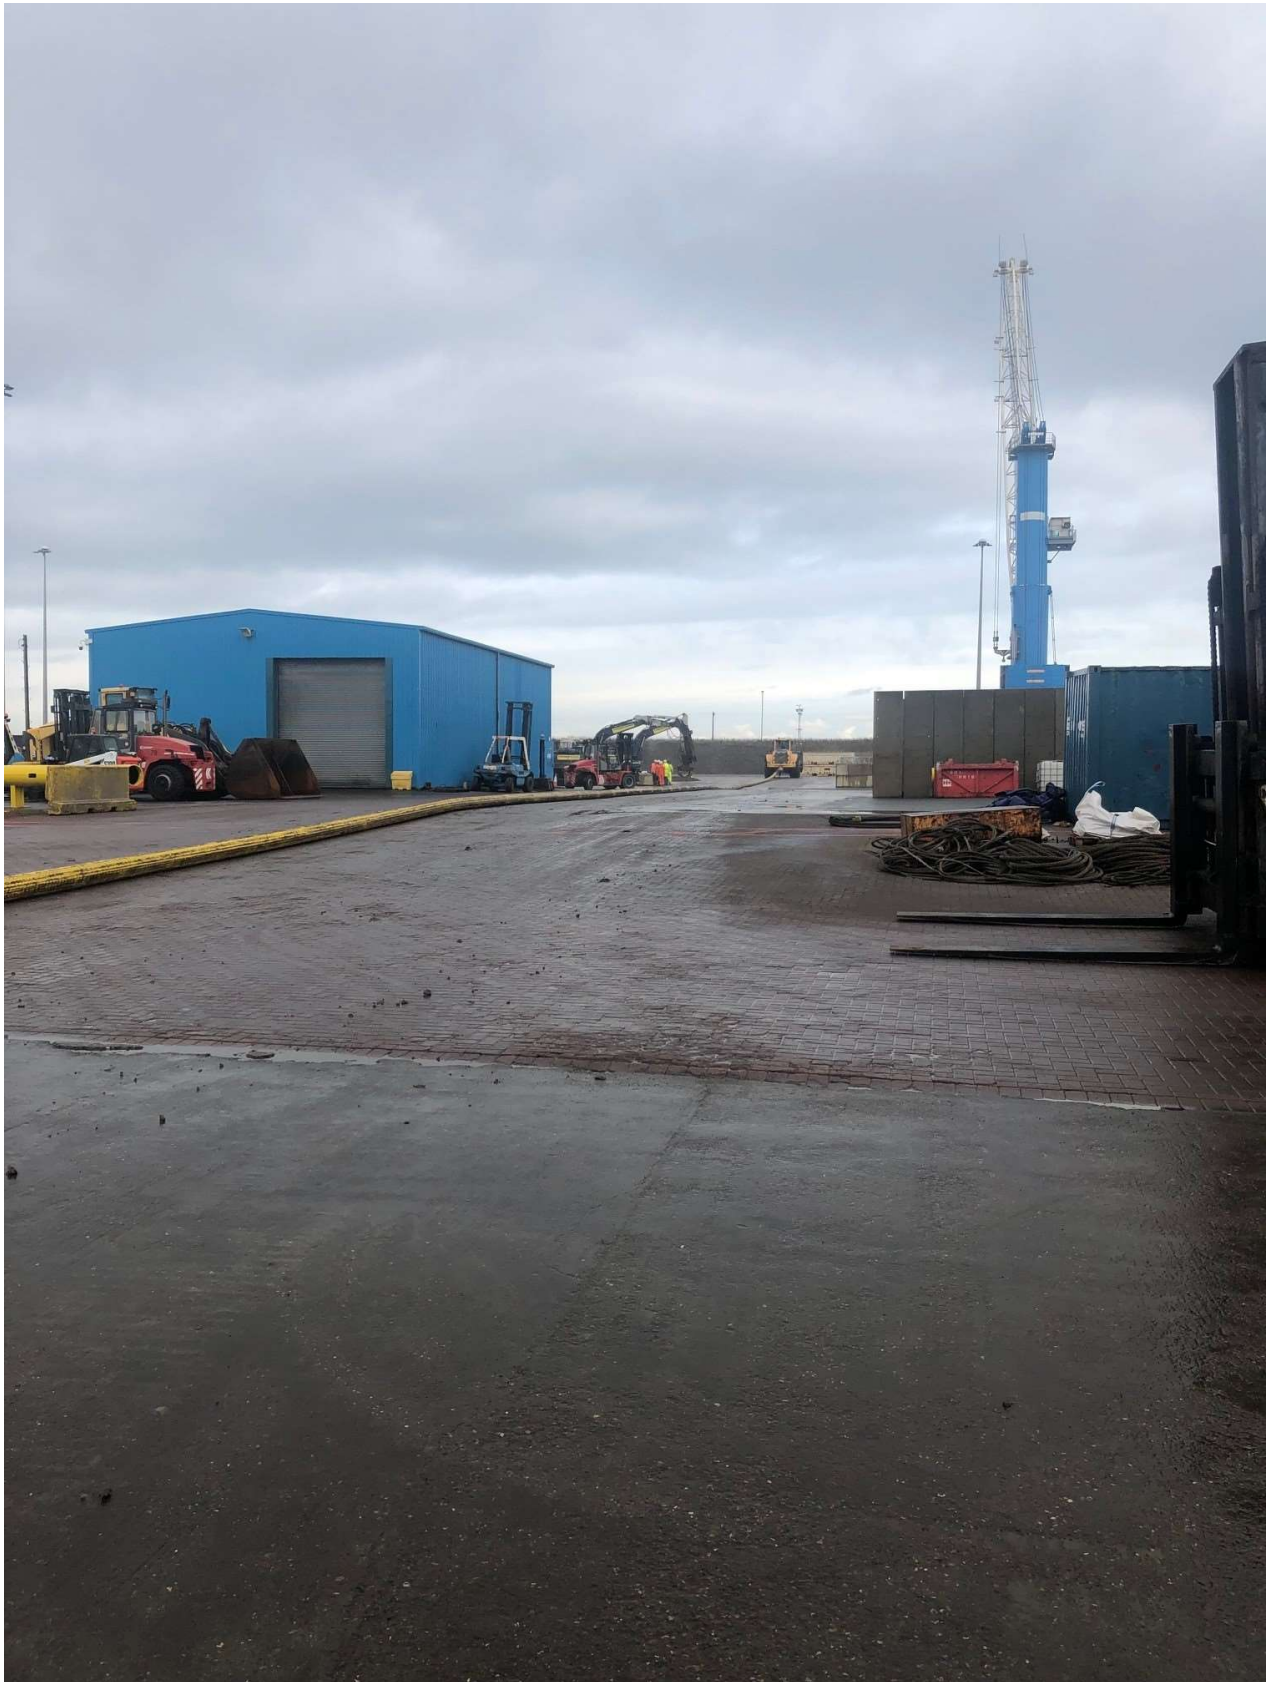
Figure 8.9.1: Riser offloading, quayside set-up I

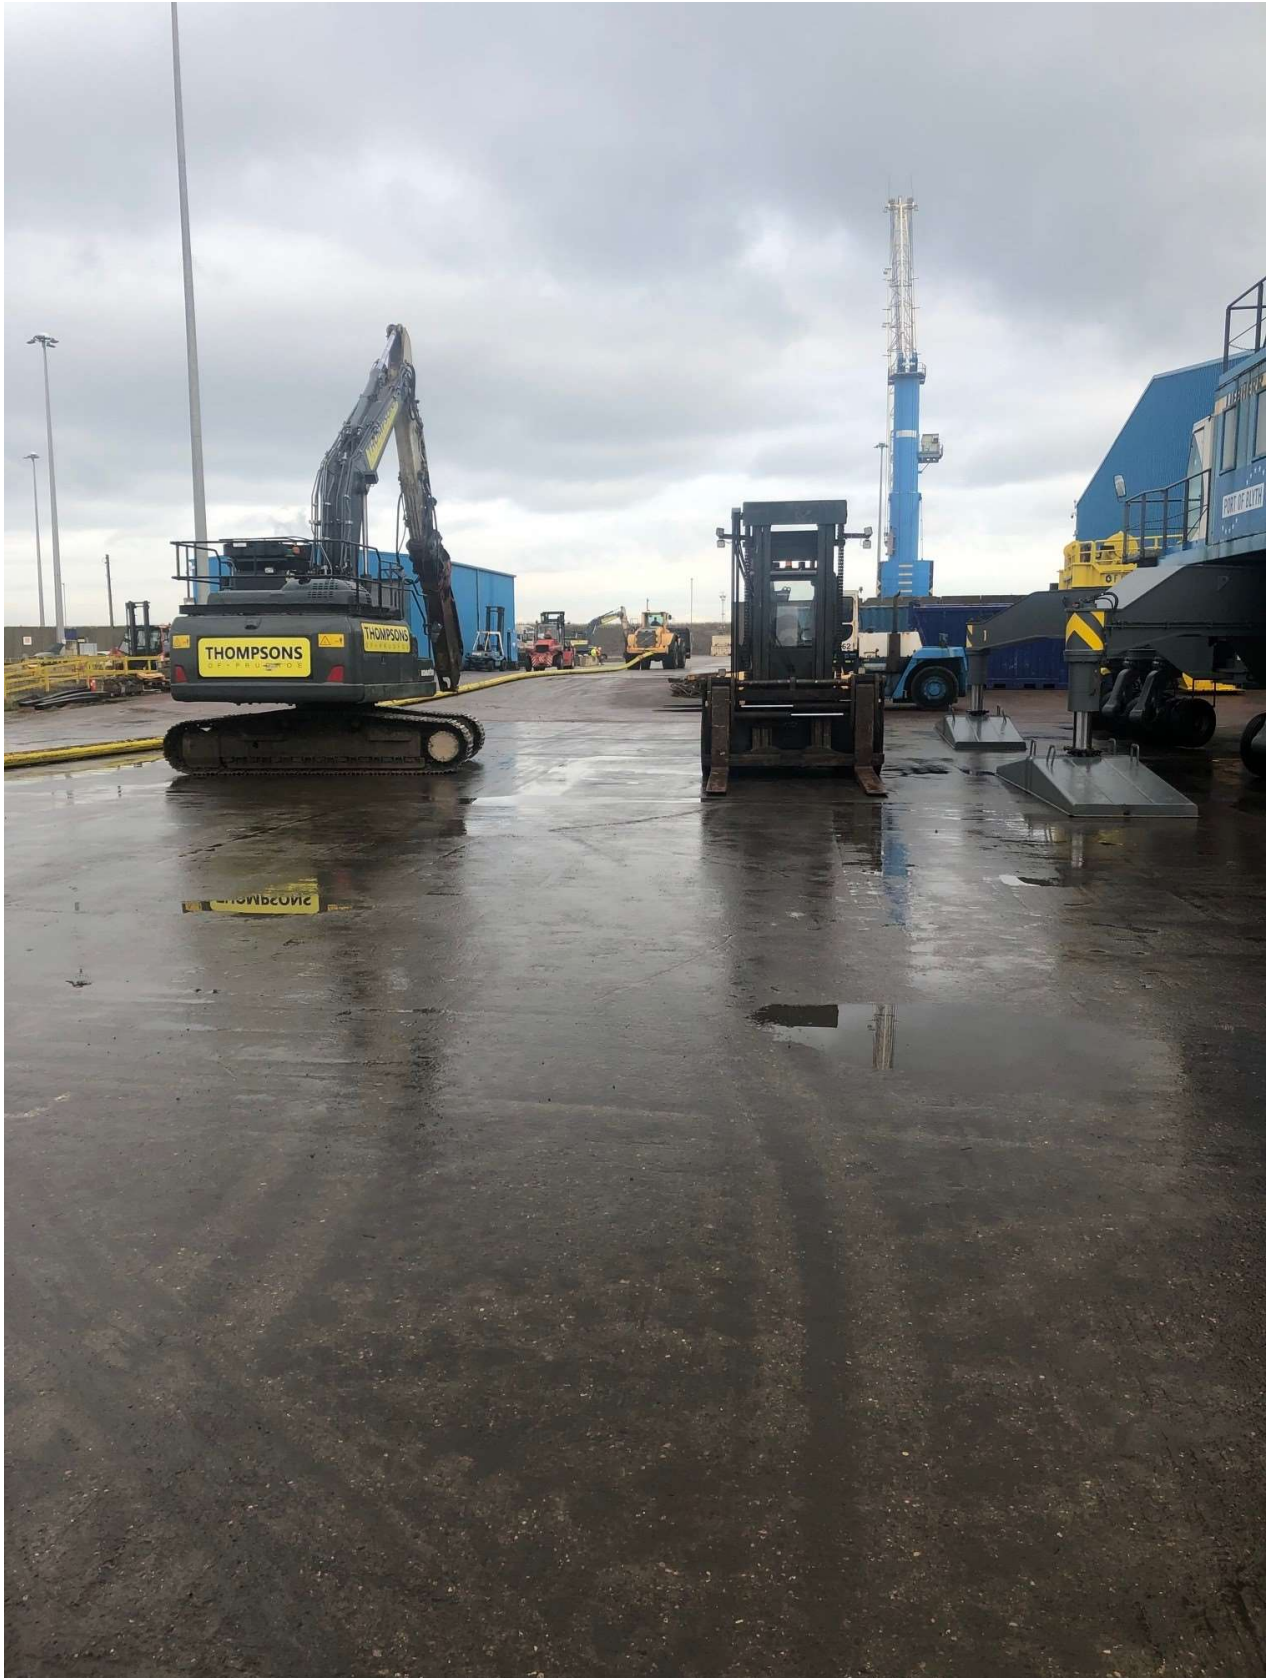
Figure 8.9.2: Riser offloading, quayside set up II

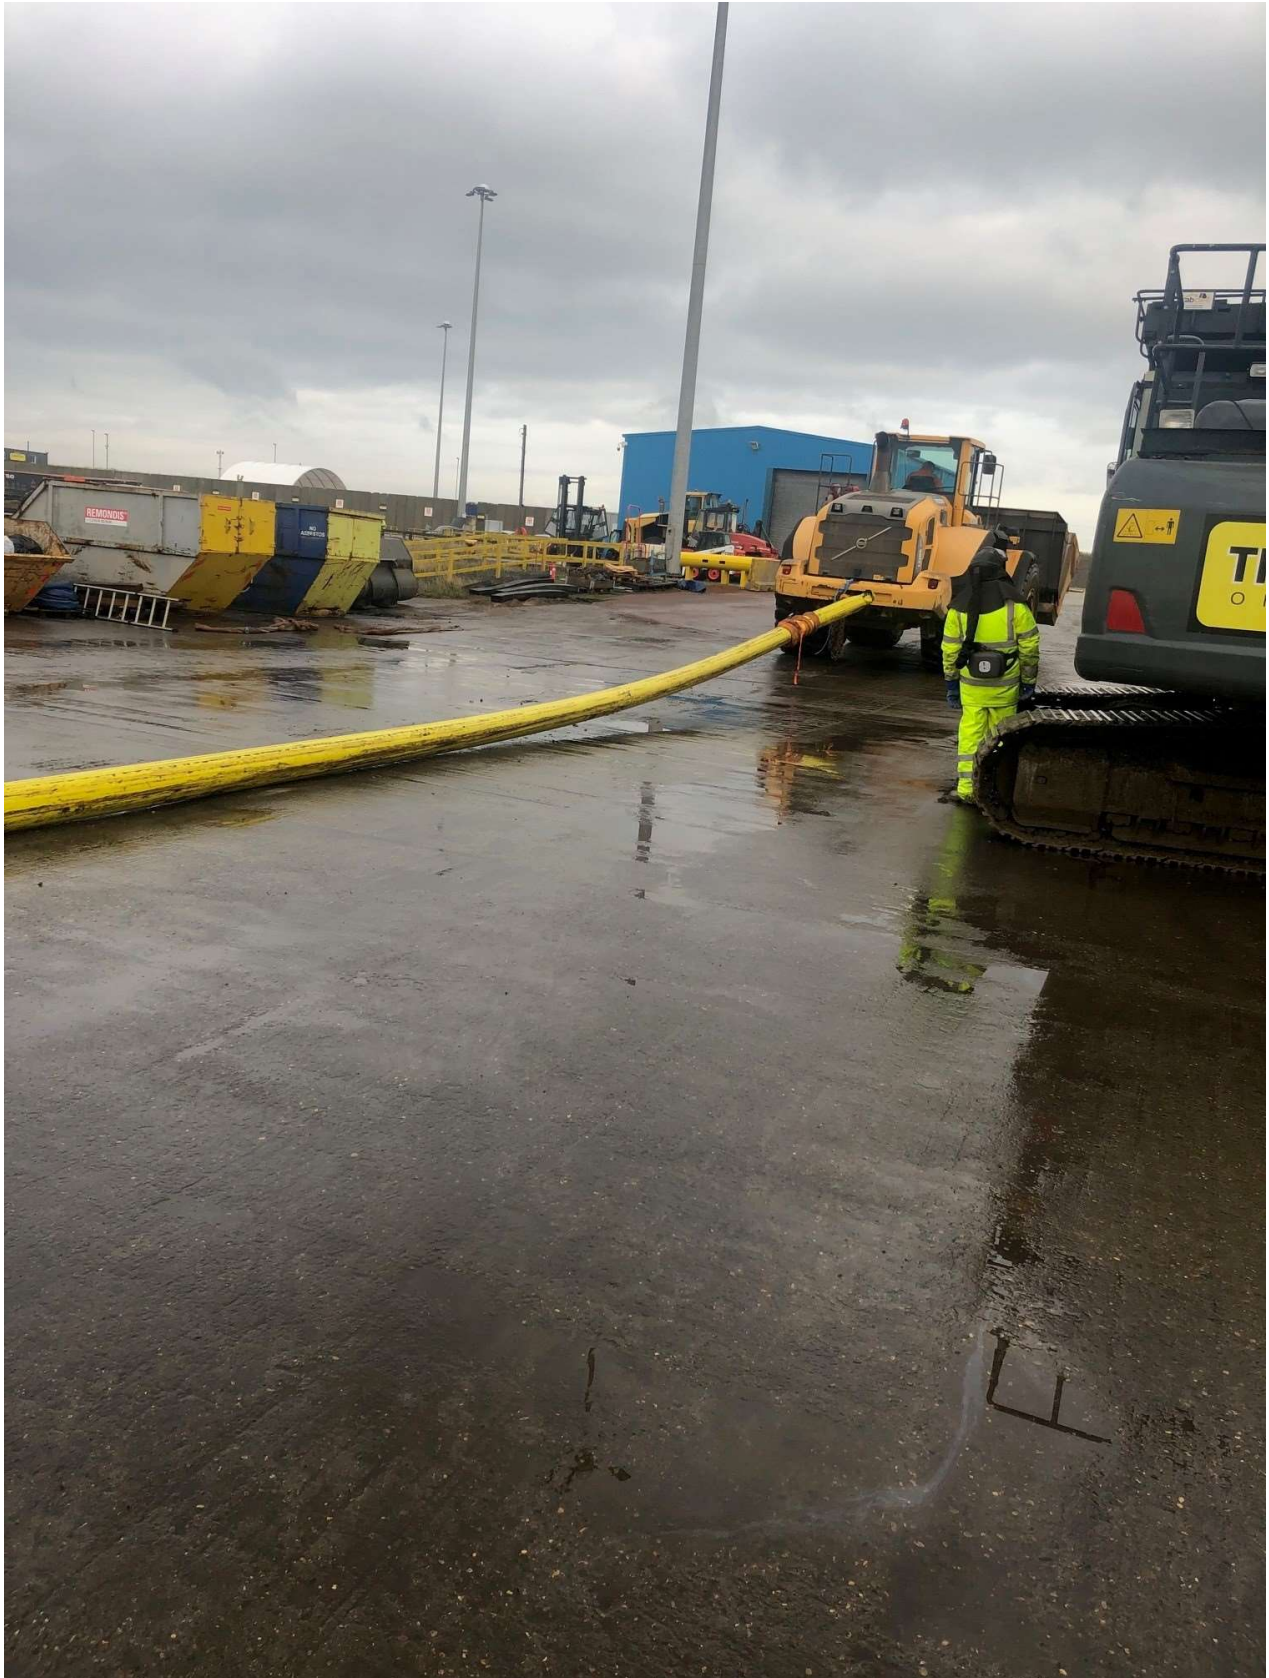
Figure 8.9.3: Riser offloading, towing tractor
