Construction Noise and Vibration Monthly Report – April 2025

Buckinghamshire

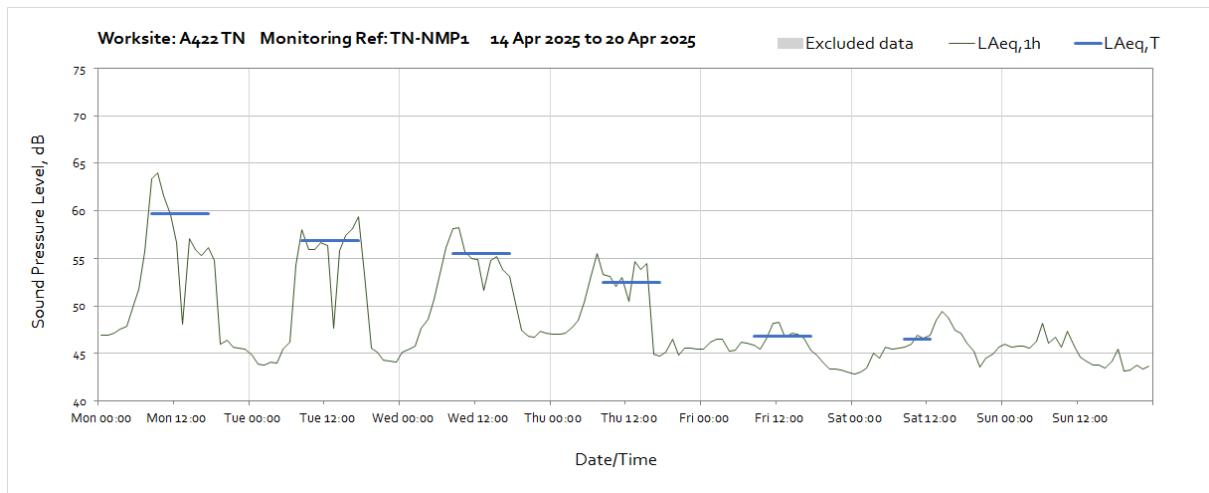
Worksite: A422 TN – Monitoring Ref: TN-NMP1

Note: Missing data between 00:00 and 01:00 on Sunday 6th April is currently under investigation.

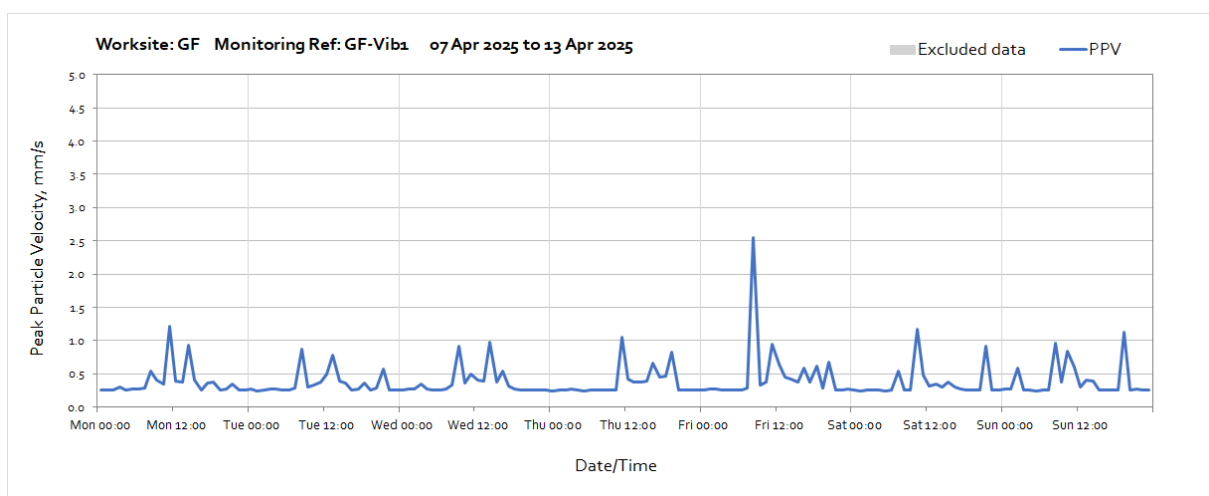
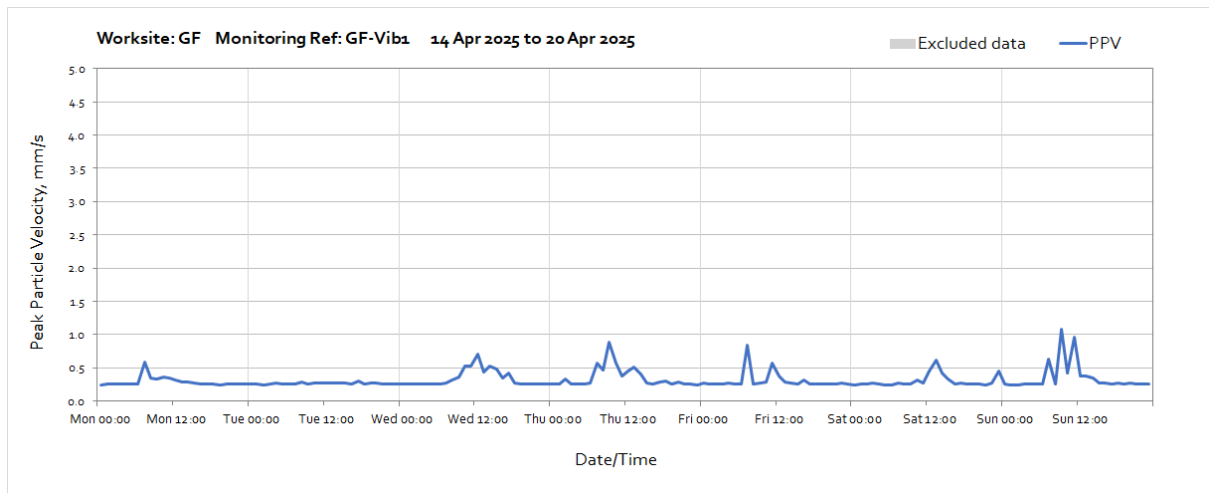
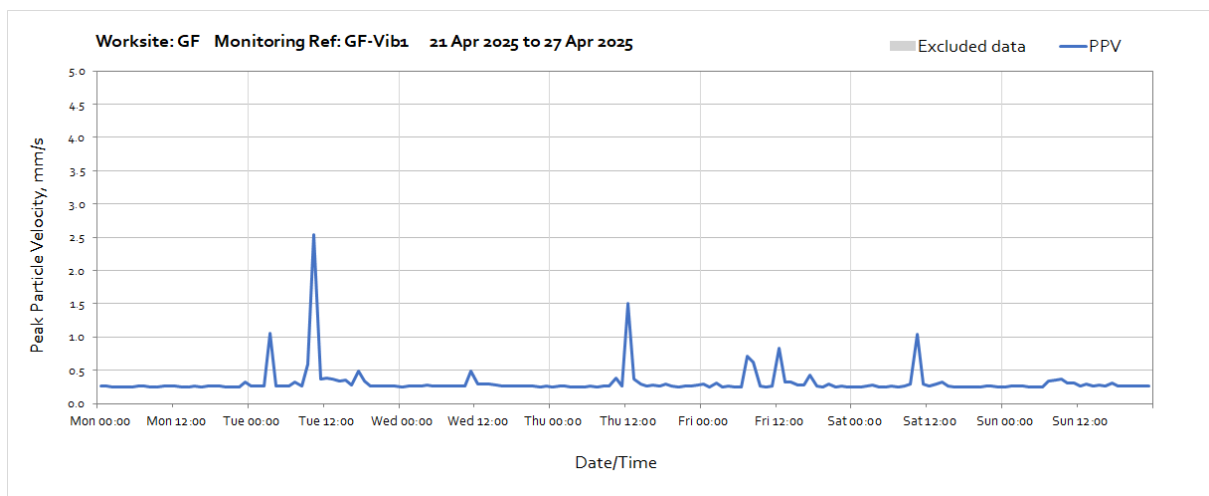
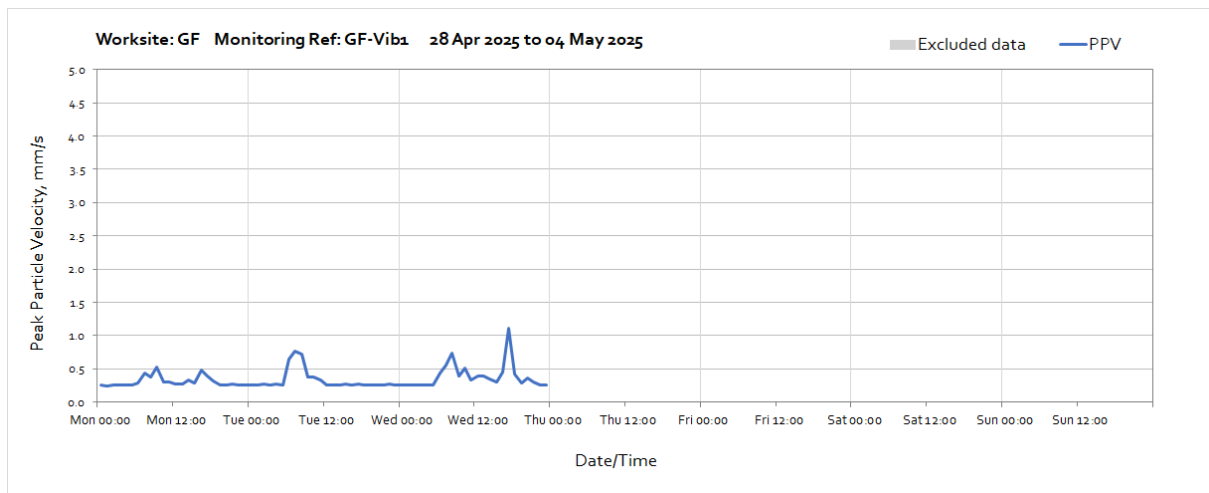
Worksite: GF – Monitoring Ref: GF-Vib1

Note: Missing data between 23:00 on Saturday 5th April and 00:00 on Sunday 6th April was due to synchronisation issues at the monitoring station.
