May 2025

HS2

Air Quality and Dust Monitoring Monthly Report - May 2025 **Buckinghamshire** Council

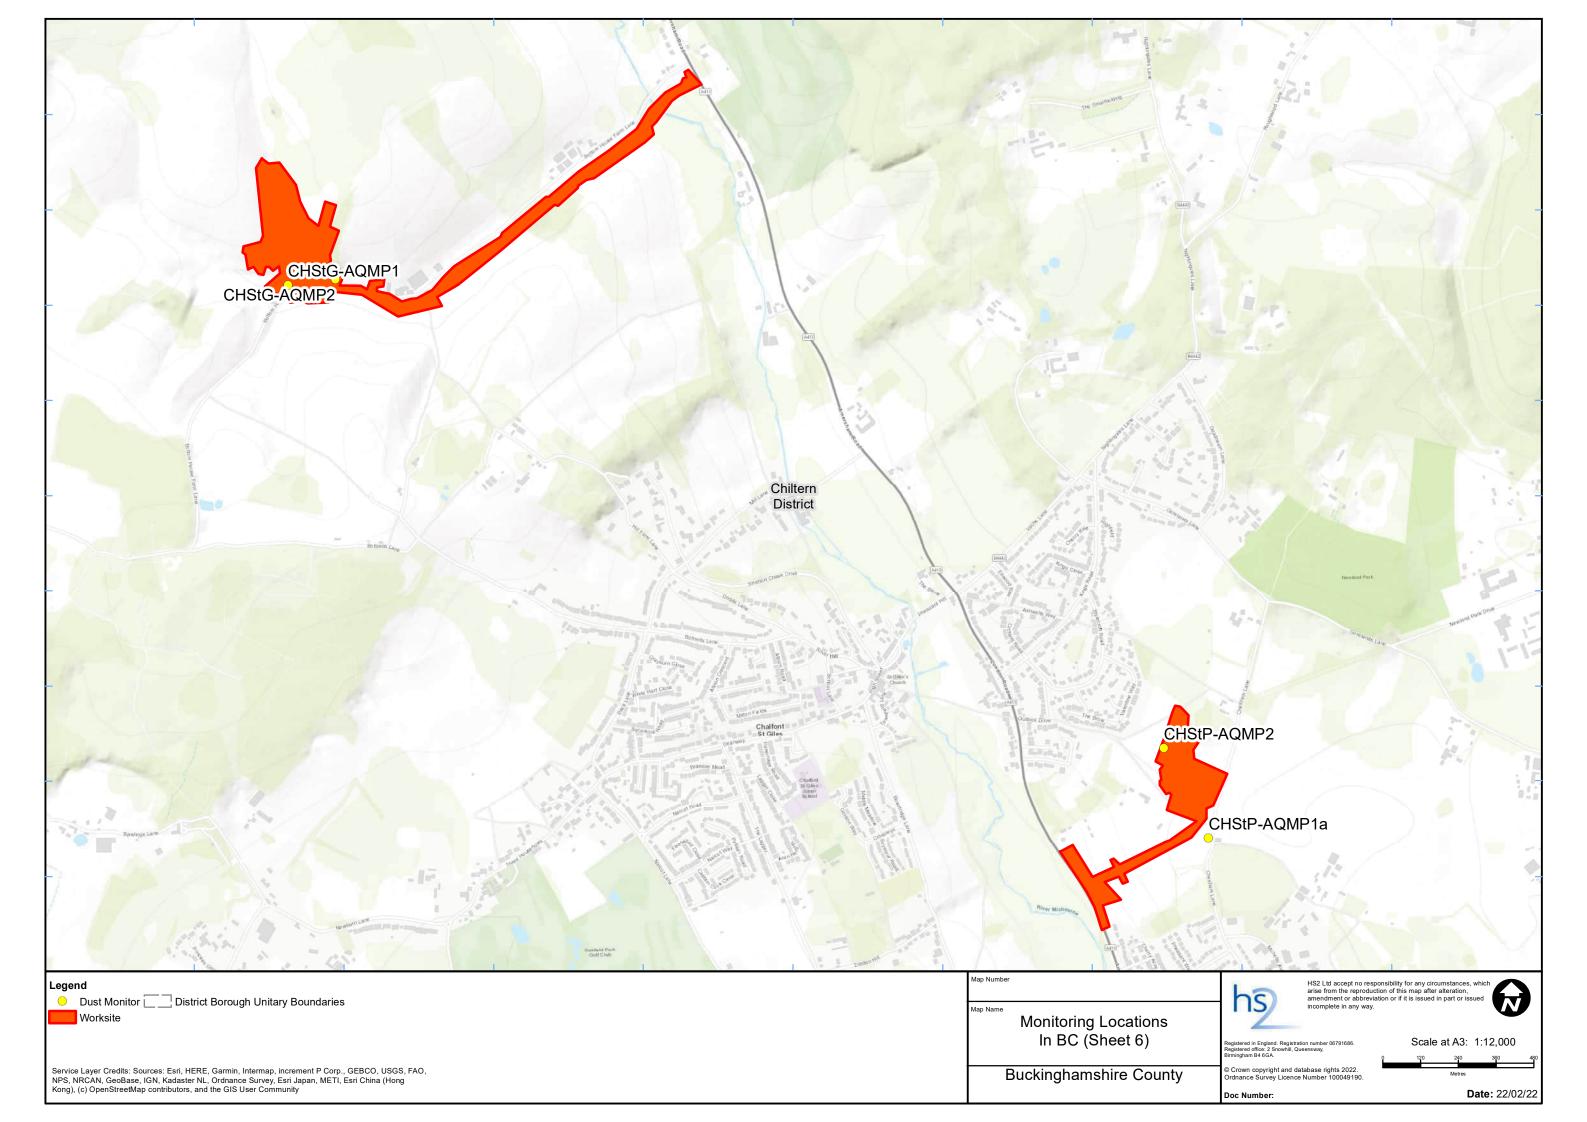
Figures 1-7: Worksite and Monitoring locations within BC

- 1.1.2 Figures 1-7 in Appendix A present the current worksites together with the dust monitoring locations.
- 1.1.3 This summary should be read in conjunction with the overview monitoring report available from <a href="www.gov.uk/government/collections/monitoring-the-environmental-effects-of-hs2">www.gov.uk/government/collections/monitoring-the-environmental-effects-of-hs2</a>, which highlights the applicable standards and guidance, as well as the air quality and dust monitoring methodologies to be implemented by nominated undertakers throughout construction.

- 1.1.4 The current worksites, as presented in Appendix A, Figures 1-7, include:

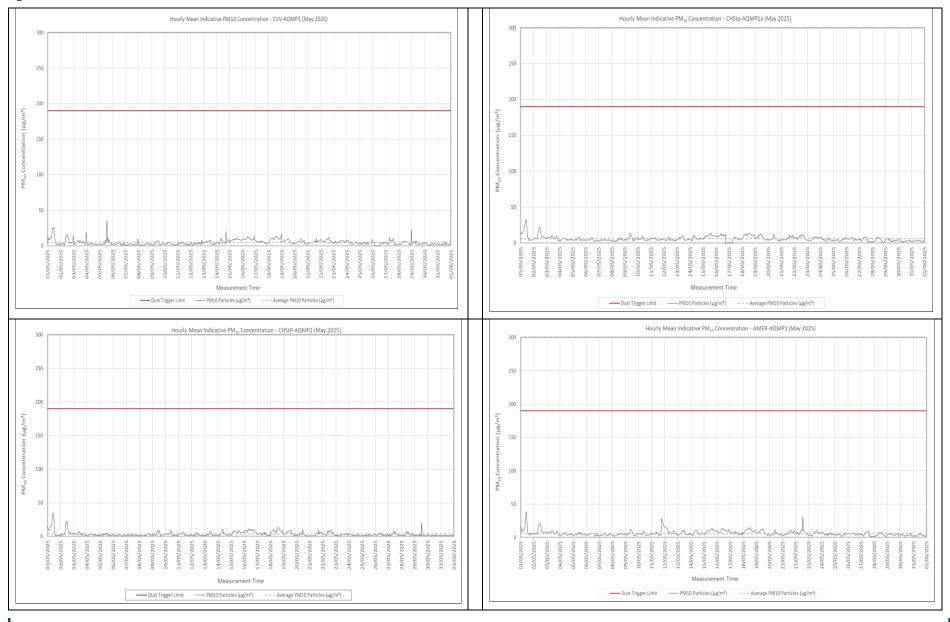
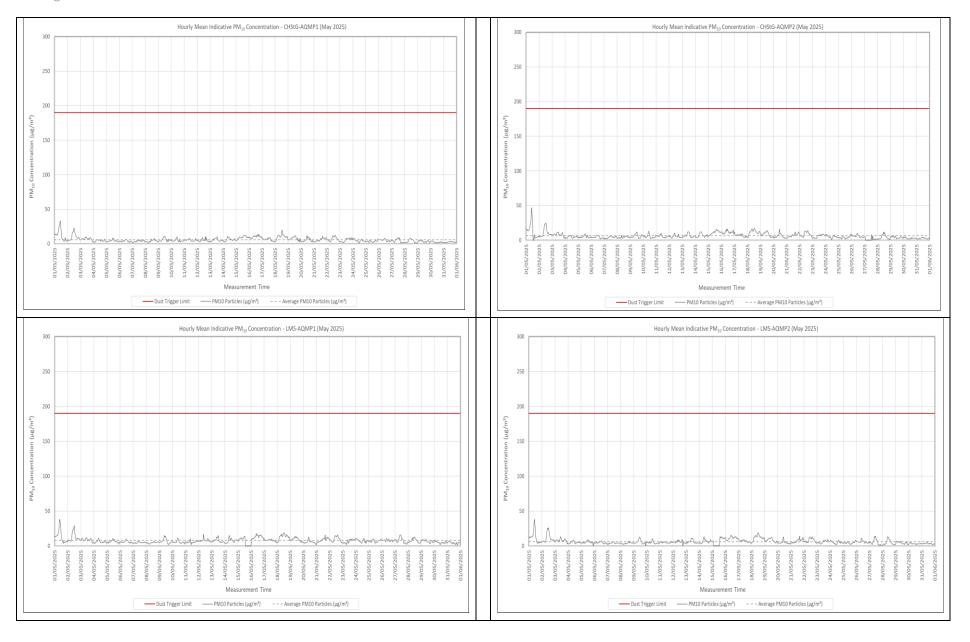
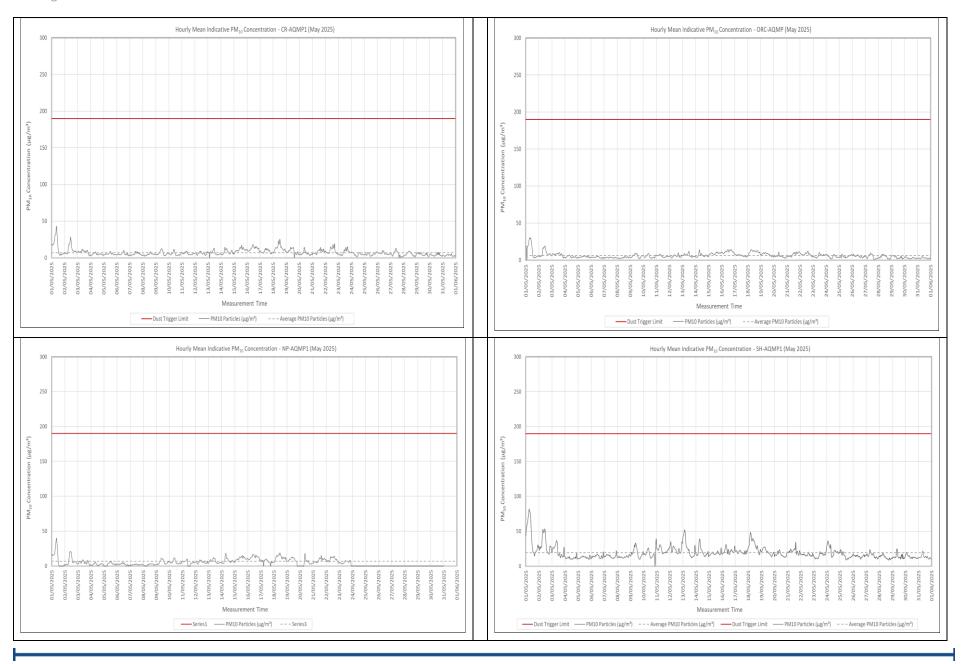
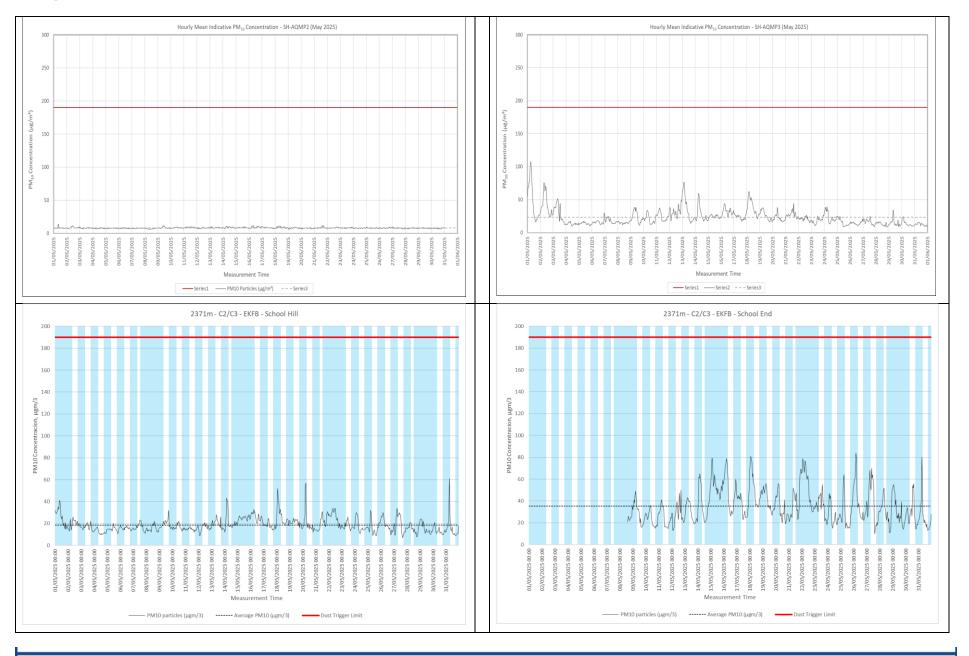
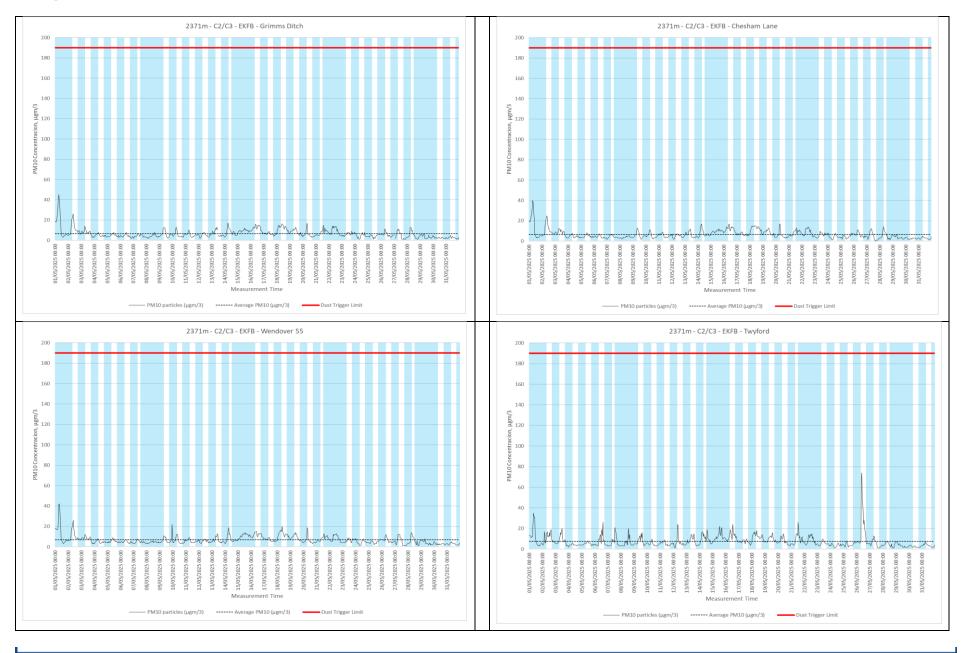
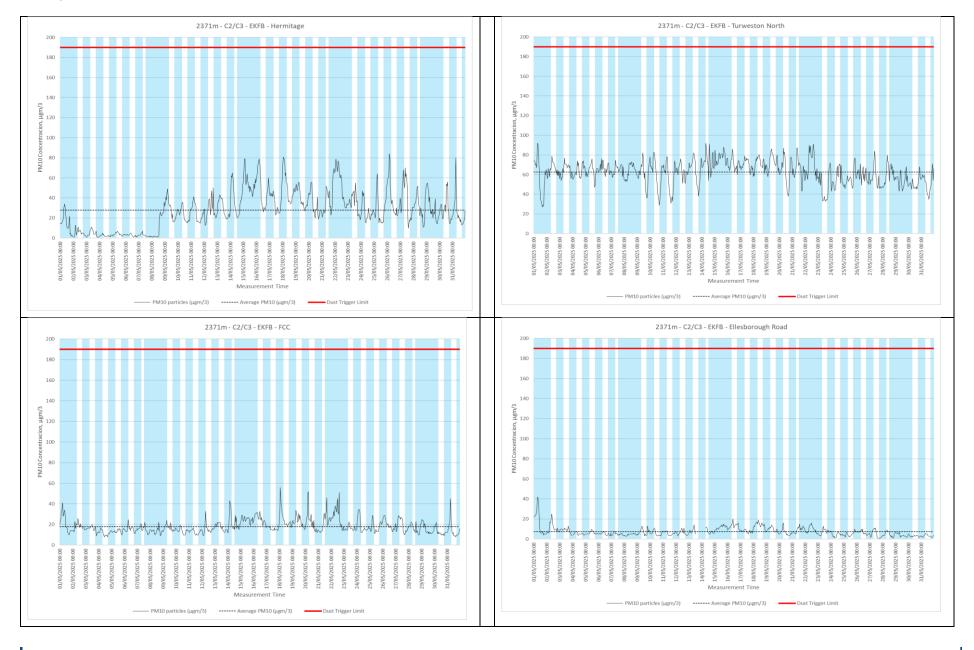
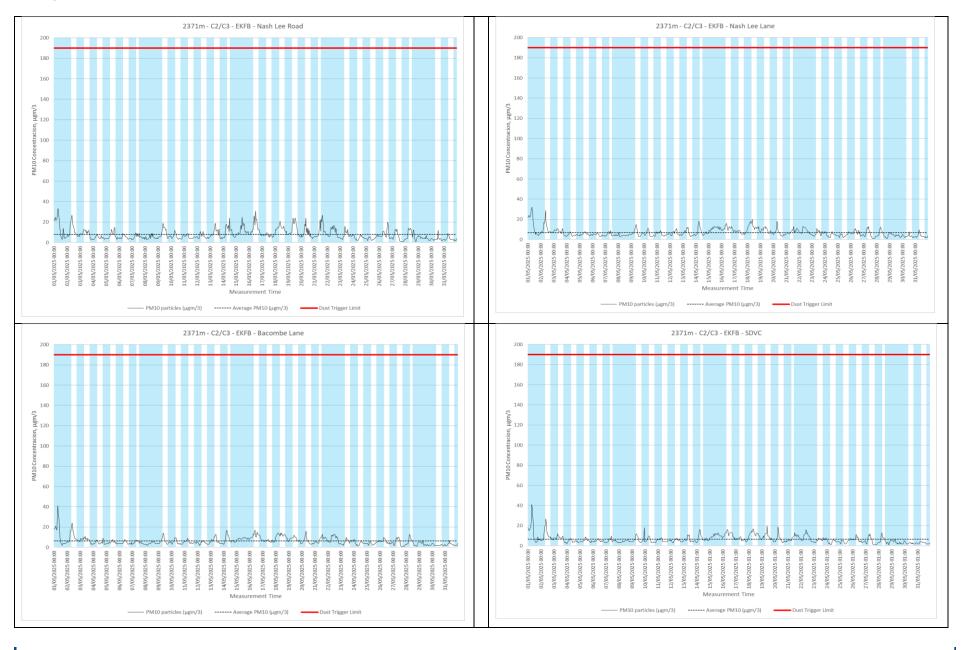
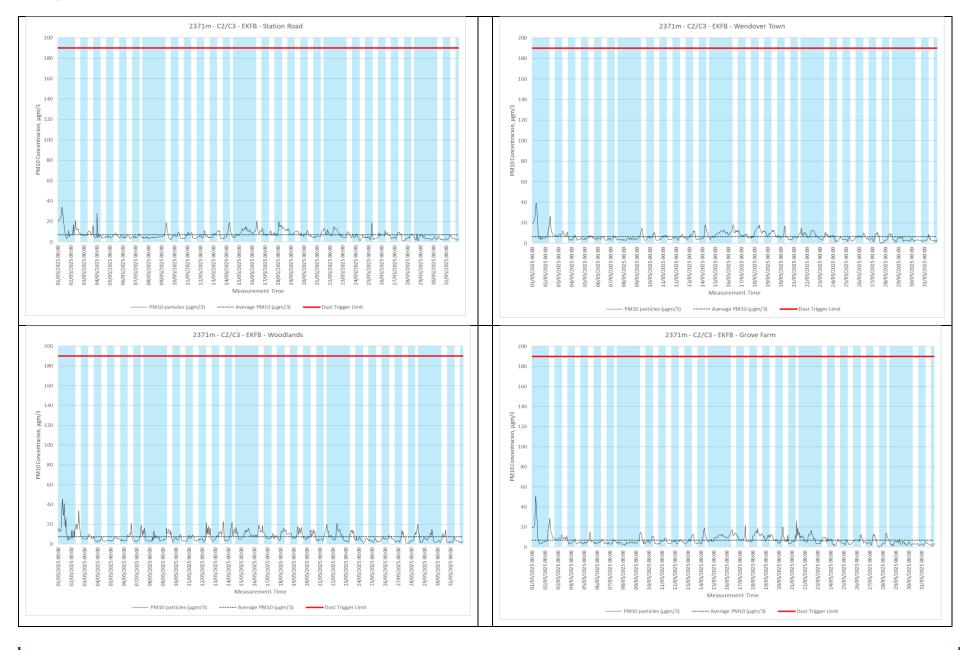
Figure 8: Continuous dust 1-hour mean indicative PM<sub>10</sub> concentration for all dust monitors

- 1.1.6 Dust monitoring locations and results are presented in Appendix B, Table 1, together with line charts of monthly data from each dust monitor presented in Figure 8. All continuous dust monitoring is undertaken using indicative monitors. Despite being Environment Agency (MCERTS) certified, indicative monitors carry a higher level of uncertainty than reference monitors, and therefore cannot be strictly compared with Air Quality Standards for human health and the environment. The purpose of the monitoring undertaken is to ensure the effectiveness of the on-site mitigation.

- 1.1.7 The trigger level for  $PM_{10}$  concentrations of 190  $\mu$ g/m<sup>3</sup>, measured as a 1-hour mean, in accordance with the updated guidance document 'Guidance on Monitoring in the Vicinity of Demolition and Construction Sites (December 2018)' has been applied.
- 1.1.8 No (0) dust trigger alerts were recorded during the monitoring period (May 2025).
- 1.1.9 AMER-AQMP2 was removed on the 14<sup>th</sup> of April and there are currently no plans to relocate this monitor.
- 1.1.10 Data capture was below 90% for multiple monitors due to:
  - School End had no data capture from 1st to 7th May 2025 due to the monitor being retrieved for calibration. New dust monitor installed on 8th May 2025.
  - NP-AQMP1 had the mains power disconnected on the 24th of May and has been fixed on the 2nd of June.
- 1.1.11 There were no (0) complaints received during the reporting period (May 2025).
