May 2025

Air Quality and Dust Monitoring Monthly Report - May 2025

Warwick District Council

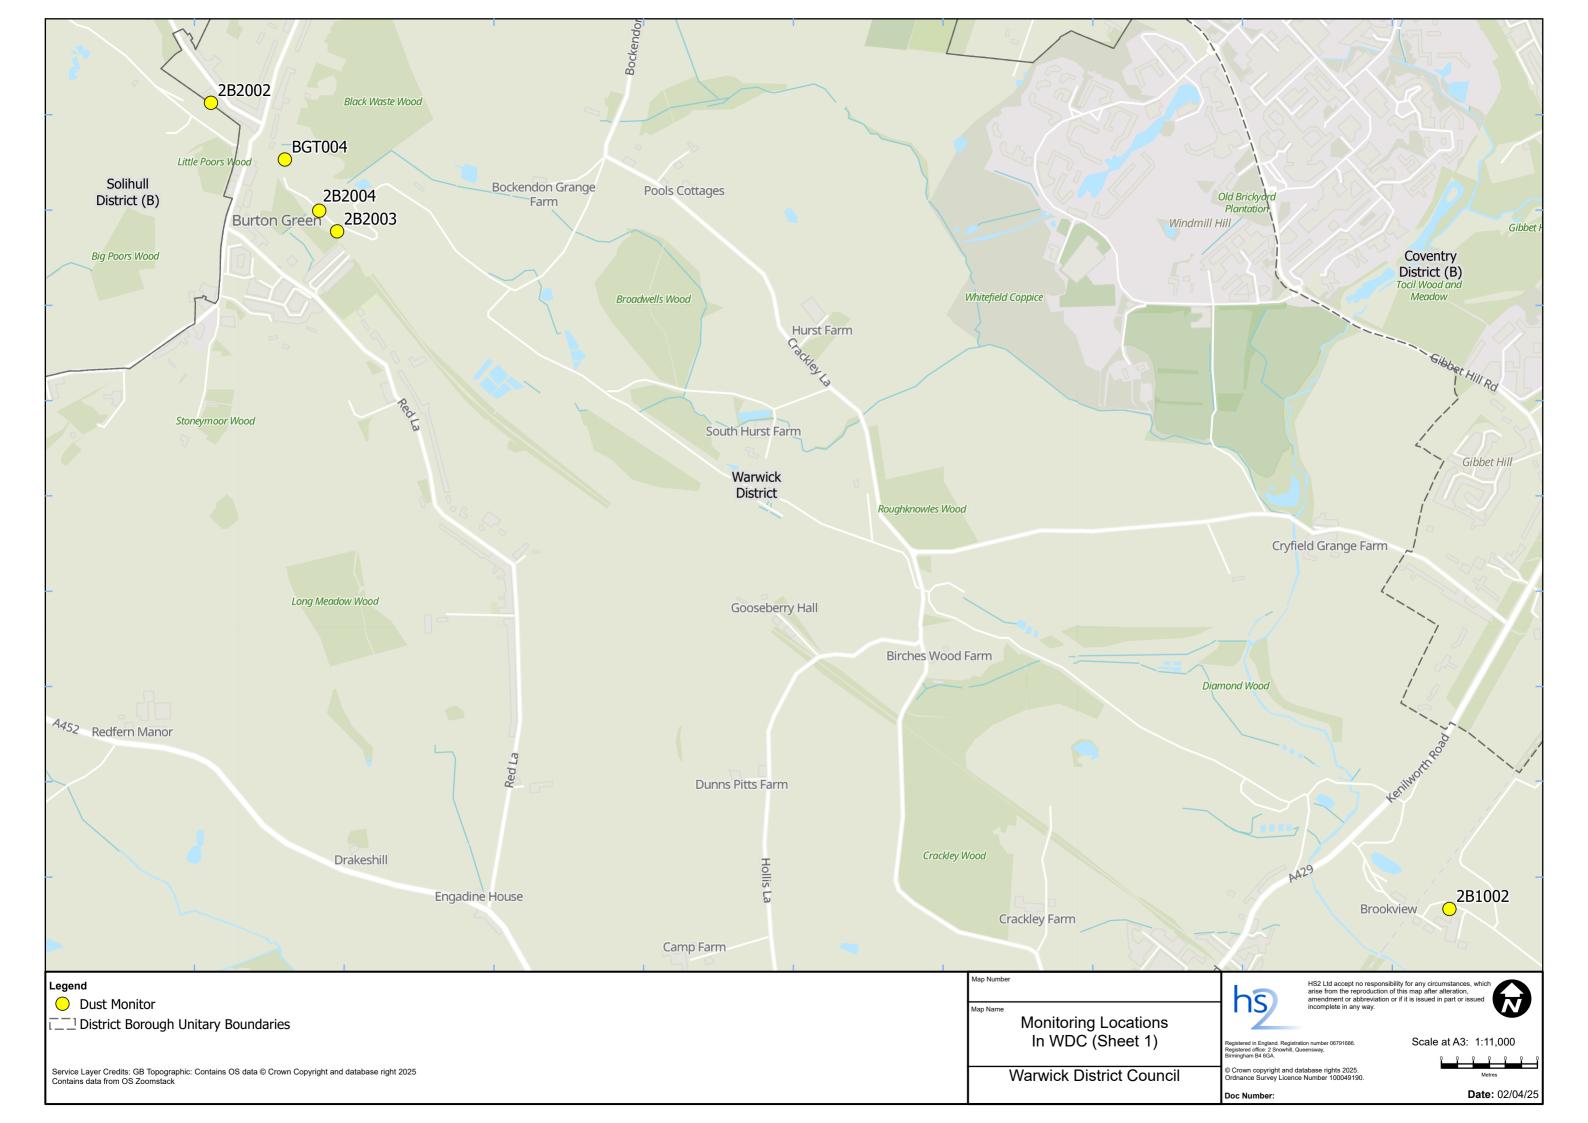
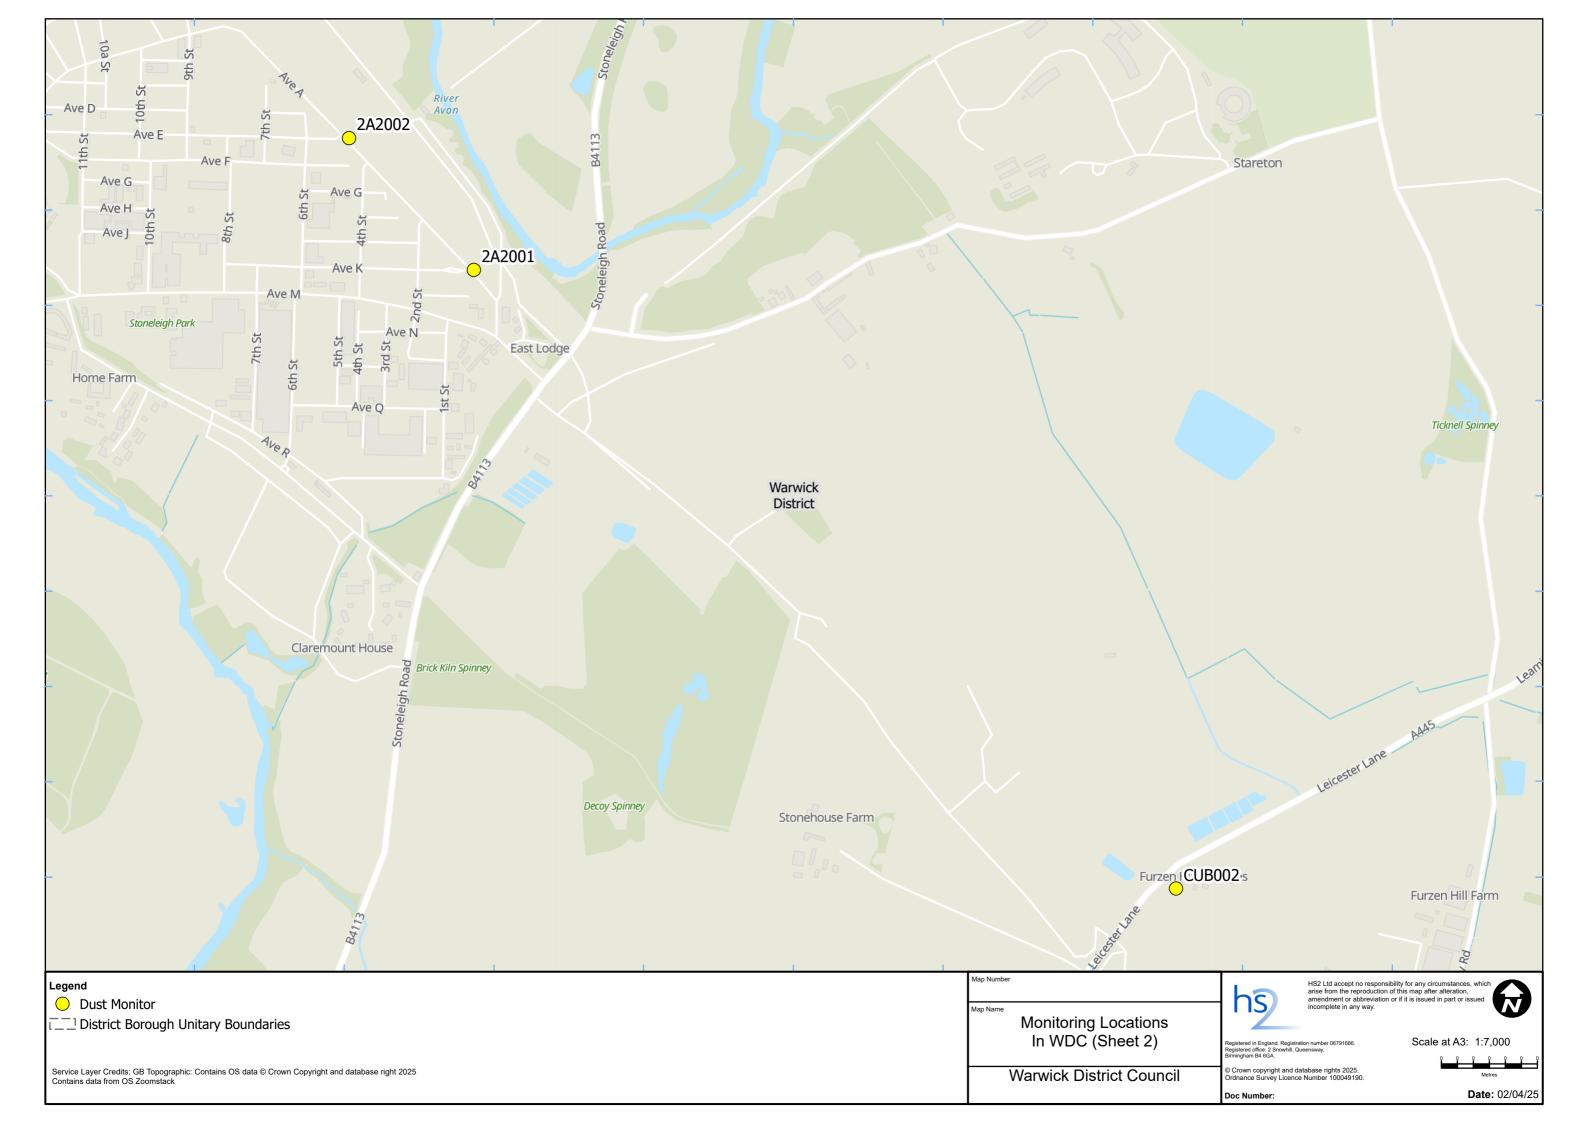
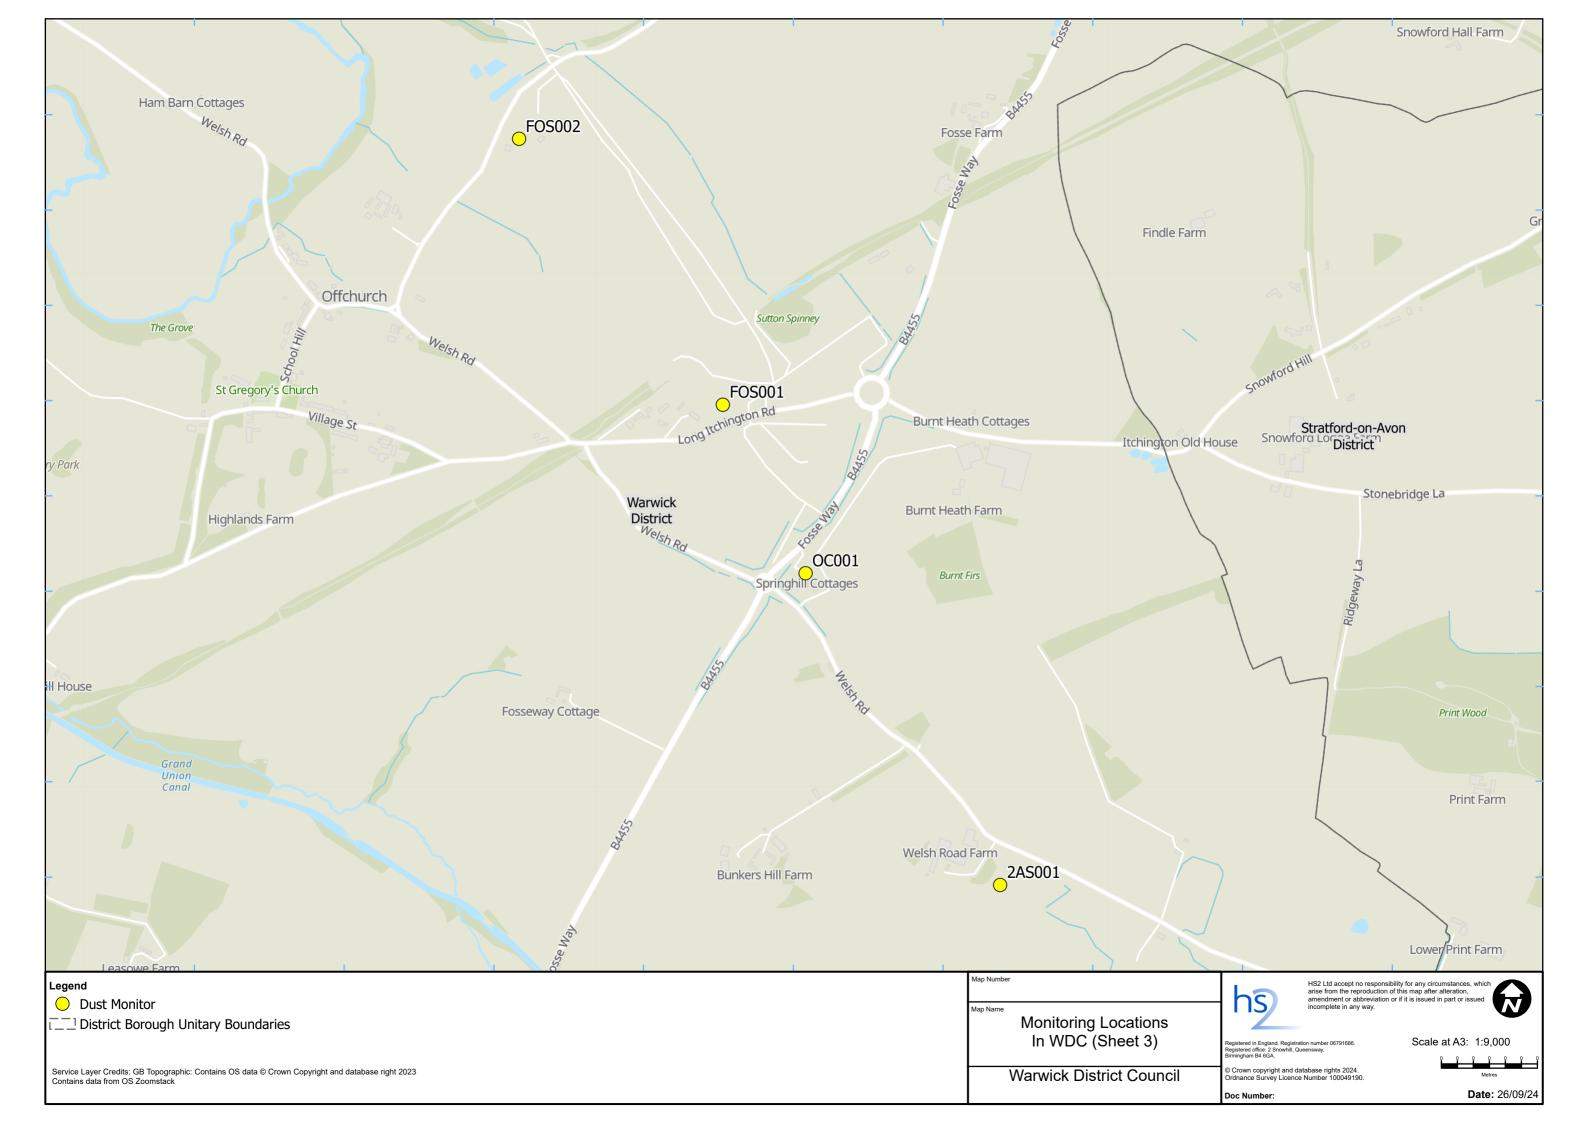
Figures 1-3: Worksites and Monitoring Locations within WDC

- 1.1.2 Figures 1 to Figure 3 in Appendix A present the current worksites together with the dust monitoring locations.
- 1.1.3 This summary should be read in conjunction with the overview monitoring report monthly available from <a href="https://www.gov.uk/government/collections/monitoring-the-environmental-effects-of-hs2">www.gov.uk/government/collections/monitoring-the-environmental-effects-of-hs2</a>, which highlights: the applicable standards and guidance, as well as the air quality and dust monitoring methodologies to be implemented by nominated undertakers throughout construction.

- 1.1.4 The current worksites, as presented in Appendix A, Figures 1 to 3, include:

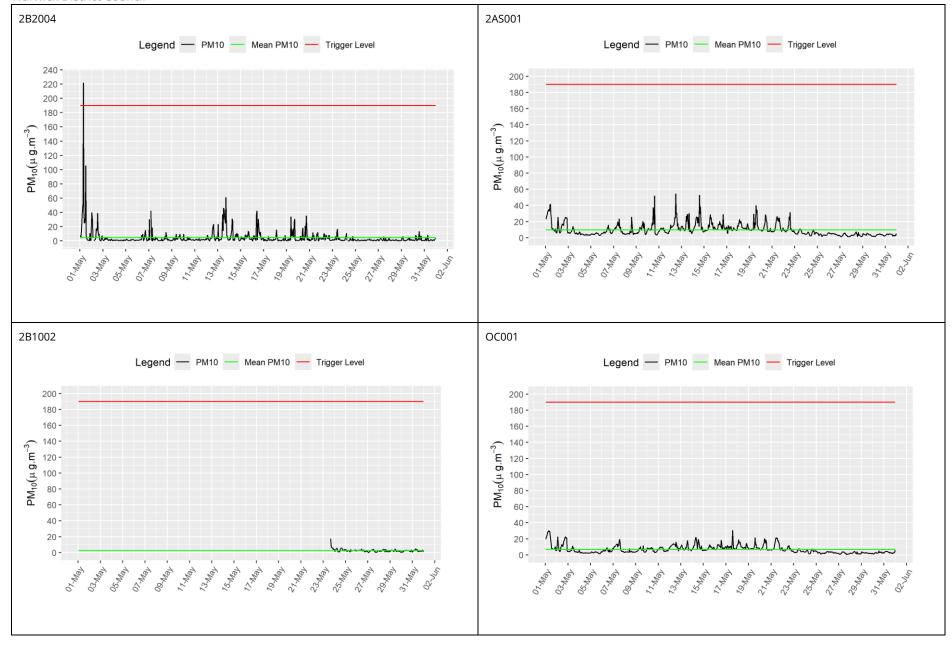
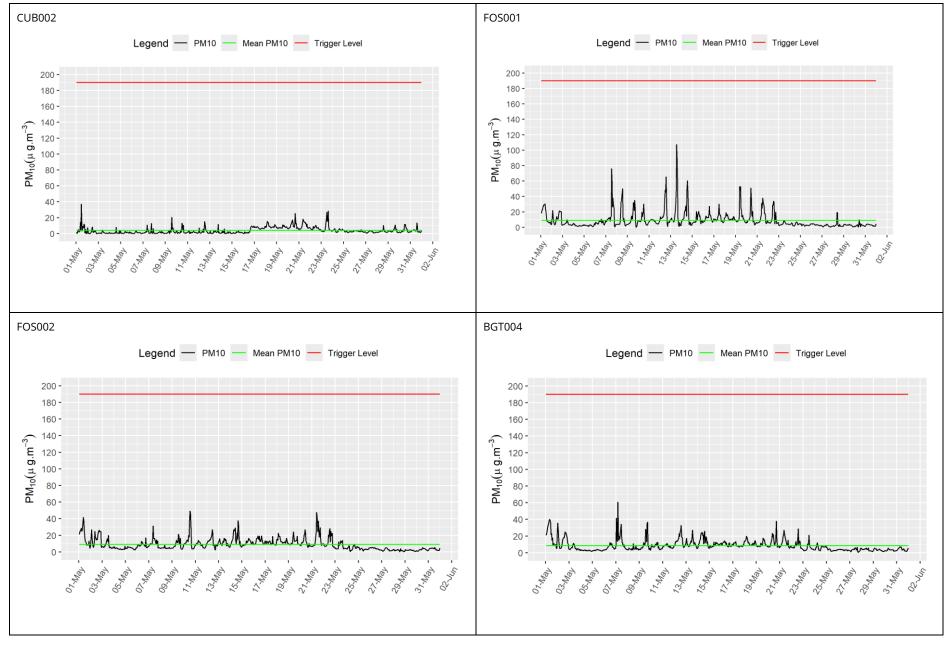
- 1.1.7 The trigger level for  $PM_{10}$  concentrations of 190  $\mu$ g/m<sup>3</sup>, over a 1-hour period, in accordance with the updated guidance document 'Guidance on Monitoring in the Vicinity of Demolition and Construction Sites (October 2018)' has been applied.

Figure 4: Construction dust 1-hour mean indicative PM<sub>10</sub> concentration for all dust monitors 2A2001 2A2002 Legend — PM10 — Mean PM10 — Trigger Level Legend — PM10 — Mean PM10 — Trigger Level 200 -200 -180 -180 -160 -160 -140 -140 - $PM_{10}(\mu \, g.m^{-3})$  $PM_{10}(\mu\,g.m^{-3})$ 120 -120 -100 -100 -80 -80 -60 -60 -40 -40 -20 -20 -2B2002 2B2003 Legend — PM10 — Mean PM10 — Trigger Level Legend — PM10 — Mean PM10 — Trigger Level 200 -200 -180 -180 -160 -160 -PM<sub>10</sub>(µ g.m<sup>-3</sup>) 140 -140 - $PM_{10}(\mu \, g.m^{-3})$ 120 -100 -80 -60 -40 -40 -20 · 20 -

Monitoring Site ID	Period of trigger alert &	Investigation	Outcomes / Resolution / Remedial measures		
	Concentration recorded		implemented		
2B2004	01/05/25: 06:01 - 07:00; 221.7 μg m <sup>-3</sup>	Exceedances occurred outside of working hours on site, so thought to not be a result of site activities.	N/A
