# HS2

June 2025

## **Construction Noise and Vibration Monthly Report – May 2025**

**London Borough of Camden**

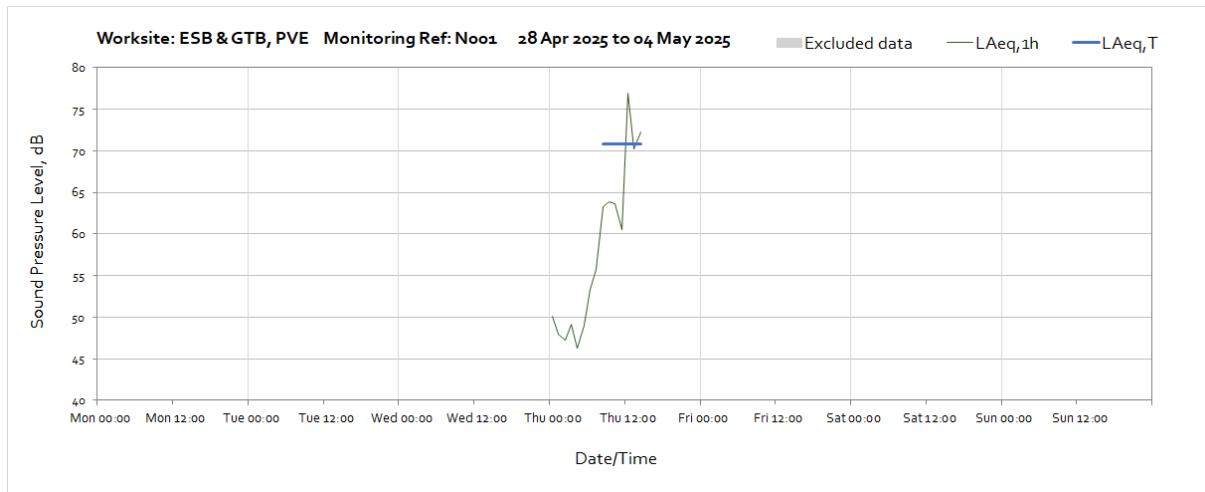
## Worksite: ESB & GTB, PVE – Monitoring Ref: N001

Note: Missing data between the 15:00 and the end of the month was due to loss of power and temporary relocation of the monitoring station.

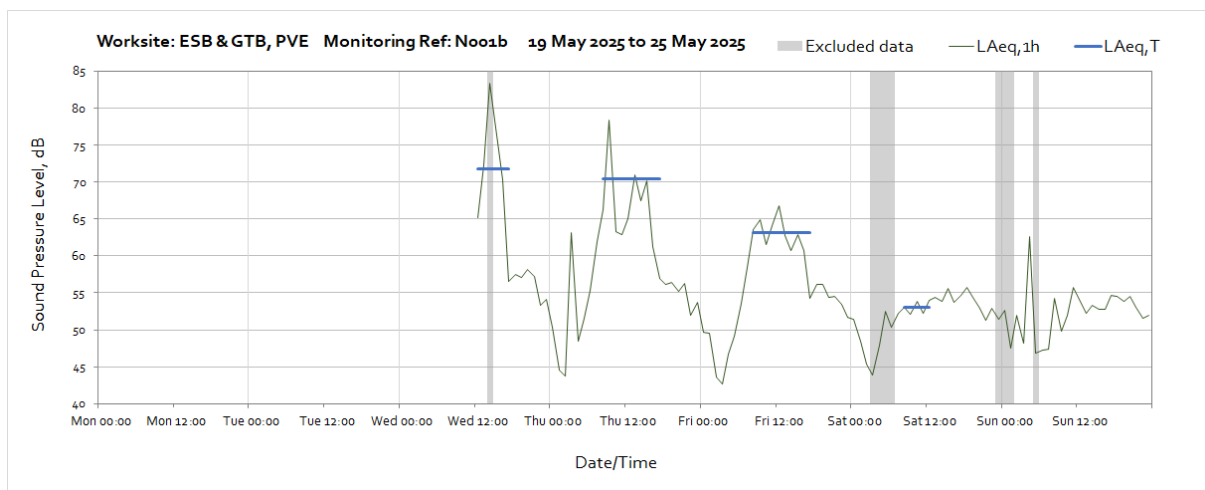
## Worksite: ESB & GTB, PVE – Monitoring Ref: N001b

Note: Monitoring station N001 temporarily relocated to N001b at 12:00 on Wednesday 21<sup>st</sup> May.
