## **Construction Noise and Vibration Monthly Report – June 2025**

**London Borough of Camden**

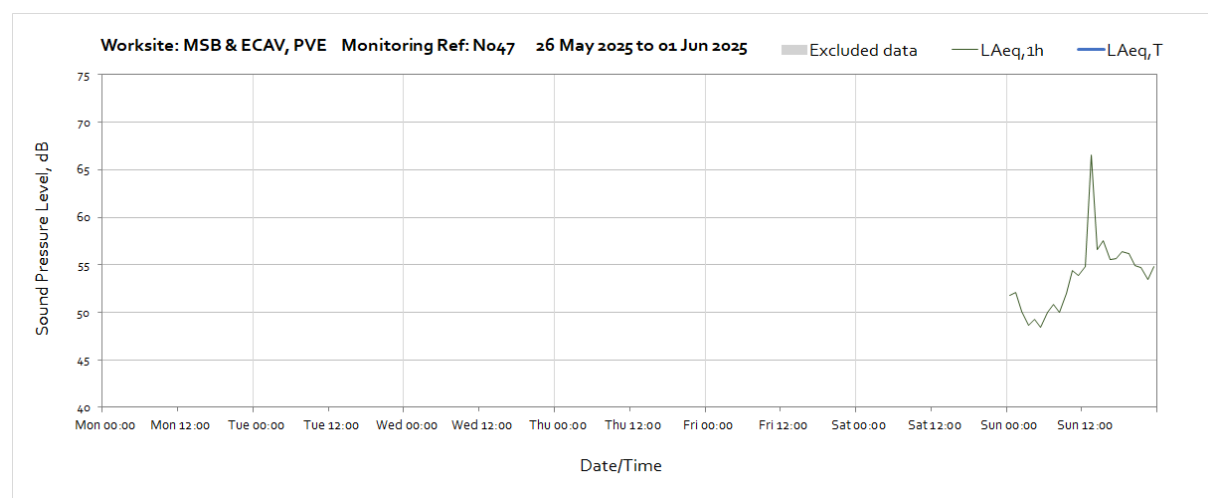
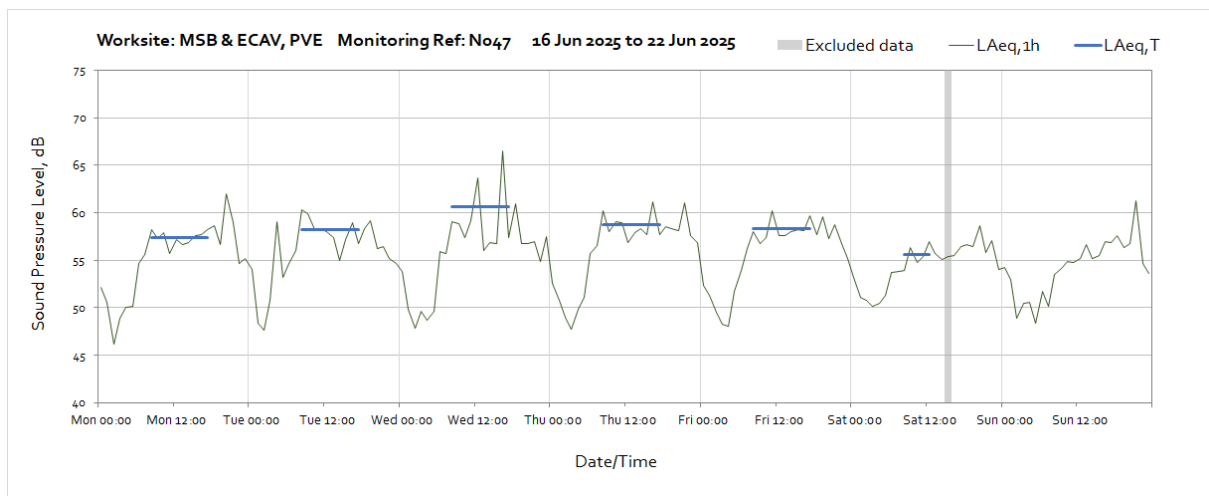
### Worksite: MSB & ECAV, PVE – Monitoring Ref: N047

The following graphs show the hourly measured ambient noise level  $L_{Aeq,1h}$  and, where relevant, the averaged noise level  $L_{Aeq,T}$  values, where the time period T is as specified in Table 1 of HS2 Information Paper E23. Periods where noise levels are adversely affected by weather or only measured for part of the period, which are not representative of HS2 construction works, have been greyed out and excluded from the calculation of the  $L_{Aeq,T}$  values in in Table 3 of the main report.
