Brandon Aggregate Manufacturing Facility, Suffolk

Appendix B: Site Surrender Report, for EP Full Surrender Application

Report: Full EP Surrender Application – Appendix B Site Surrender Report, OCO_2024.02/02_v1, 25 March 2025

Site: Brandon Aggregate Manufacturing Facility, High Street, Brandon, Suffolk, IP27 0AX (EPR/JP3332FK)

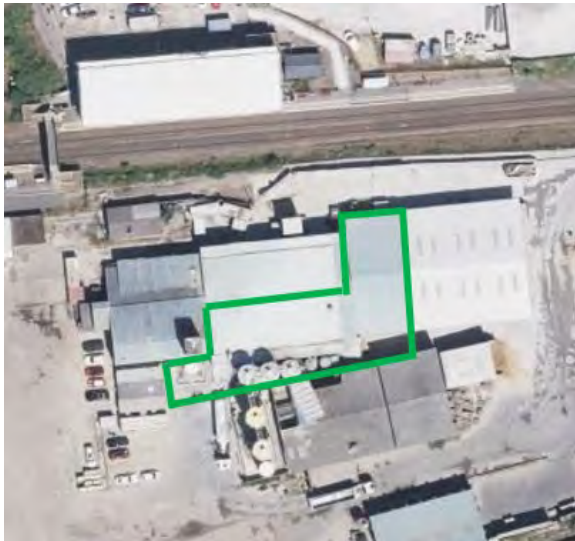
Figure SSR1: Original EP Boundary

The EP boundary was changed by variation V002 which was determined on 8 January 2014. This change was for the purpose of accommodating a second (identical) treatment line, and the associated raw material storage infrastructure and is presented in **Figures SSR1** and **SSR2** below.
