## **Construction Noise and Vibration Monthly Report – July 2025**

**Buckinghamshire**

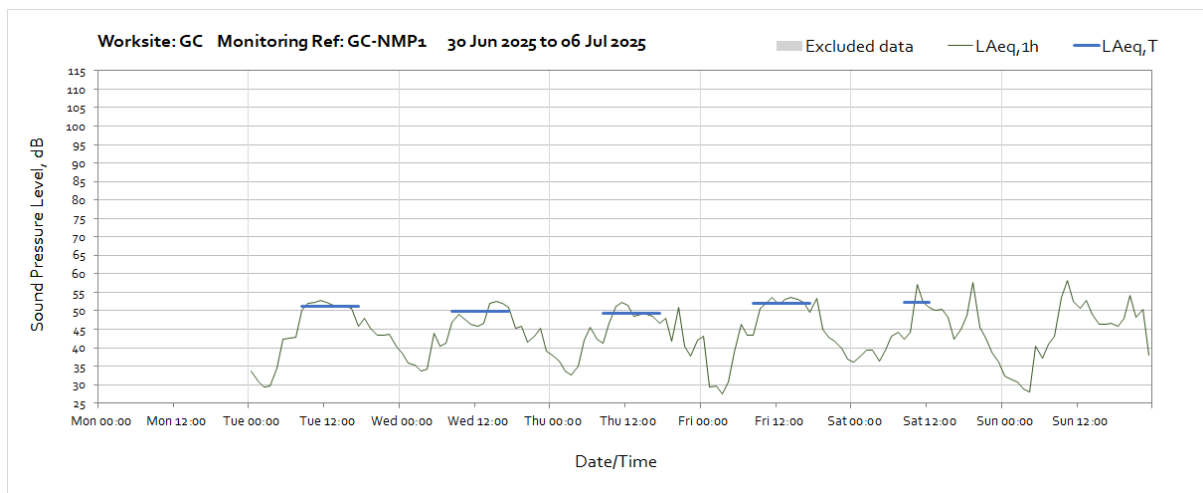
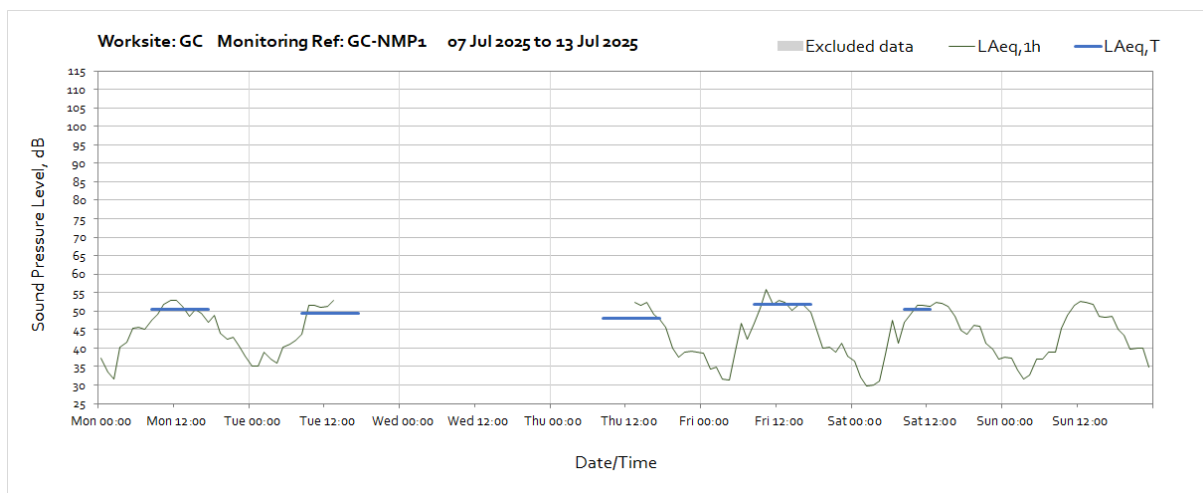
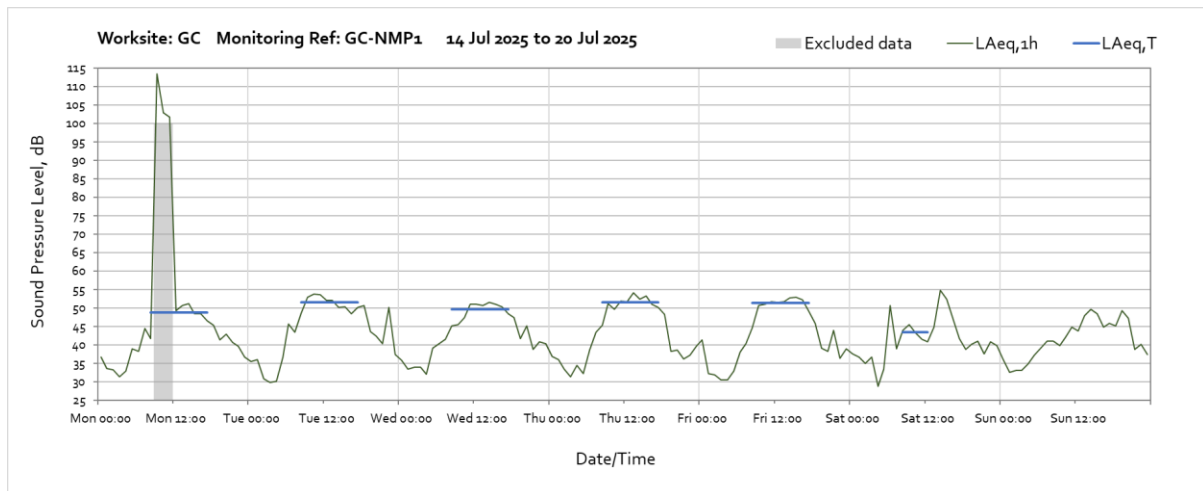
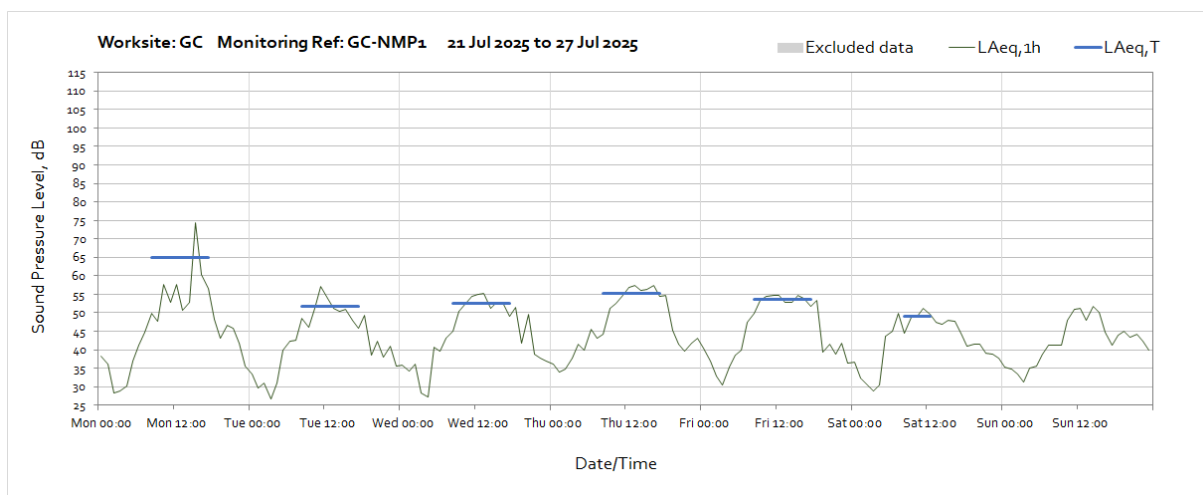
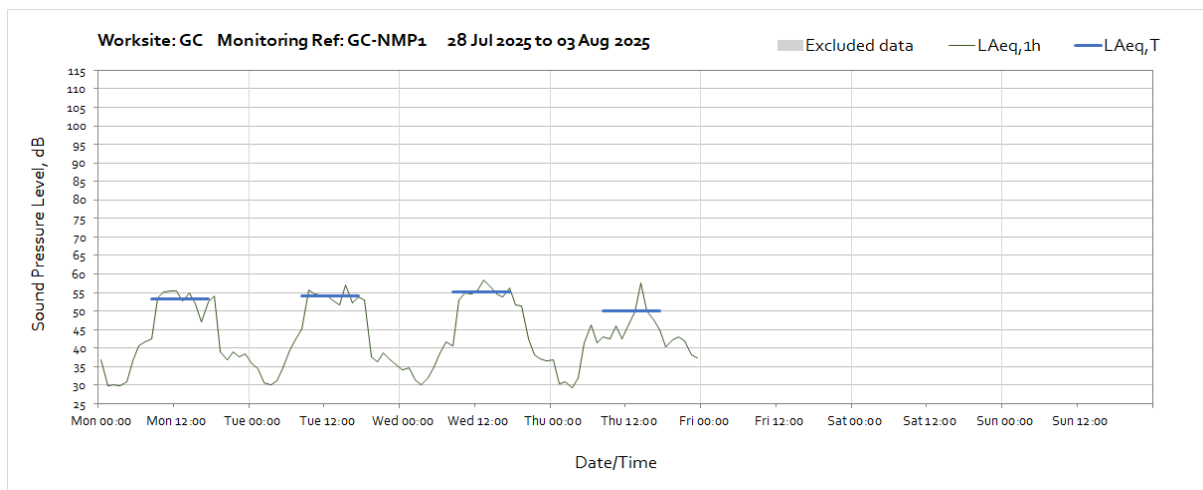
## Worksite: GC – Monitoring Ref: GC-NMP1

Note: Missing data between 14:00 on Tuesday 8<sup>th</sup> July and 13:00 on Thursday 10<sup>th</sup> July was due to a fault at the monitoring station.

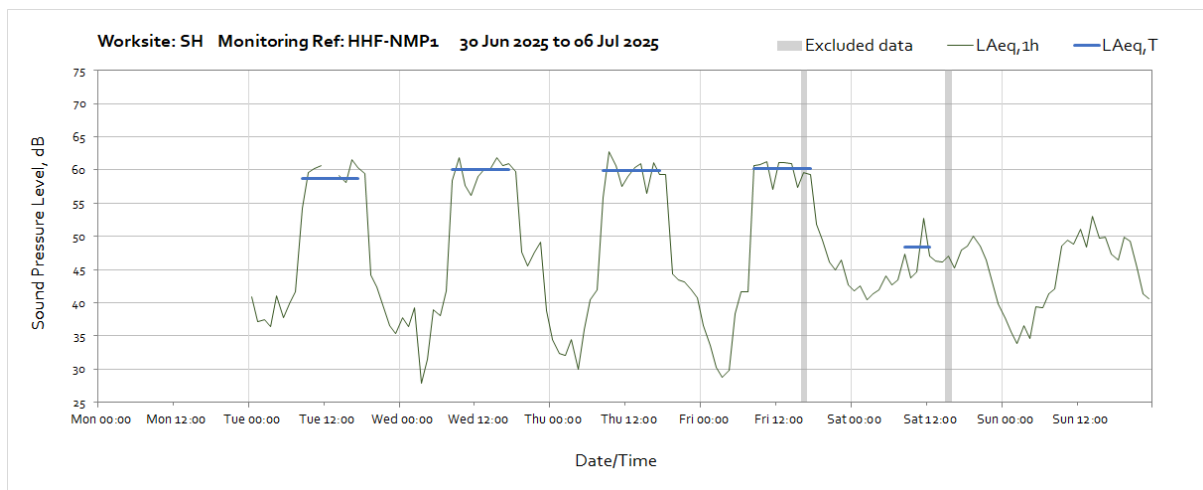
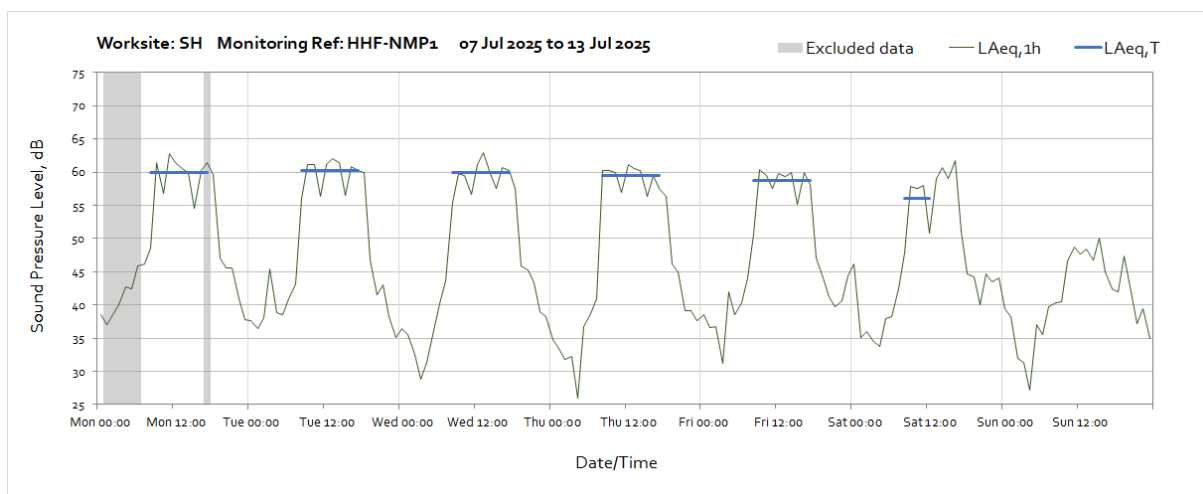
## Worksite: SH – Monitoring Ref: HHF-NMP1

Note: Missing data between 12:00 and 14:00 on Tuesday 1<sup>st</sup> July was due to monitor maintenance.

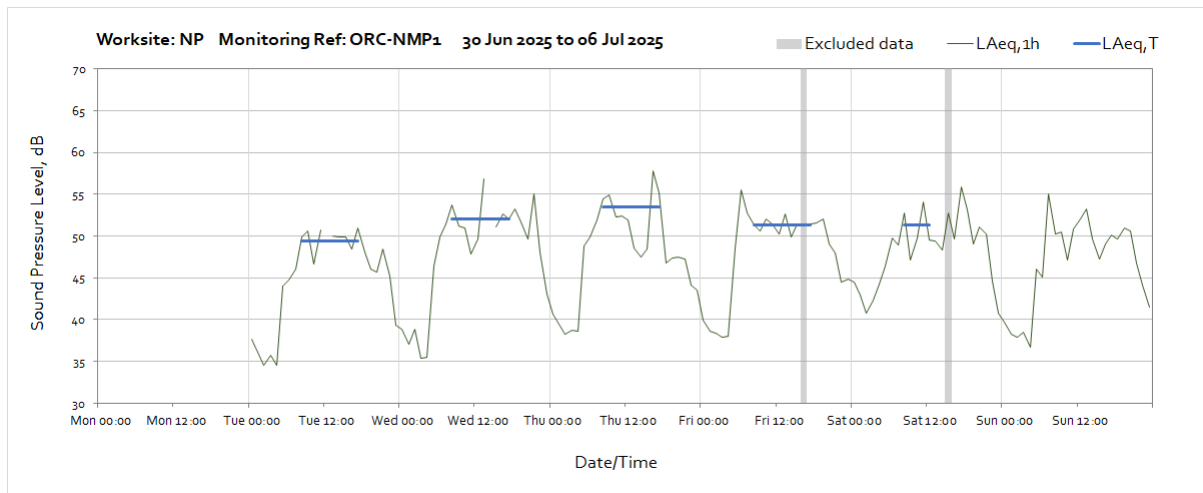
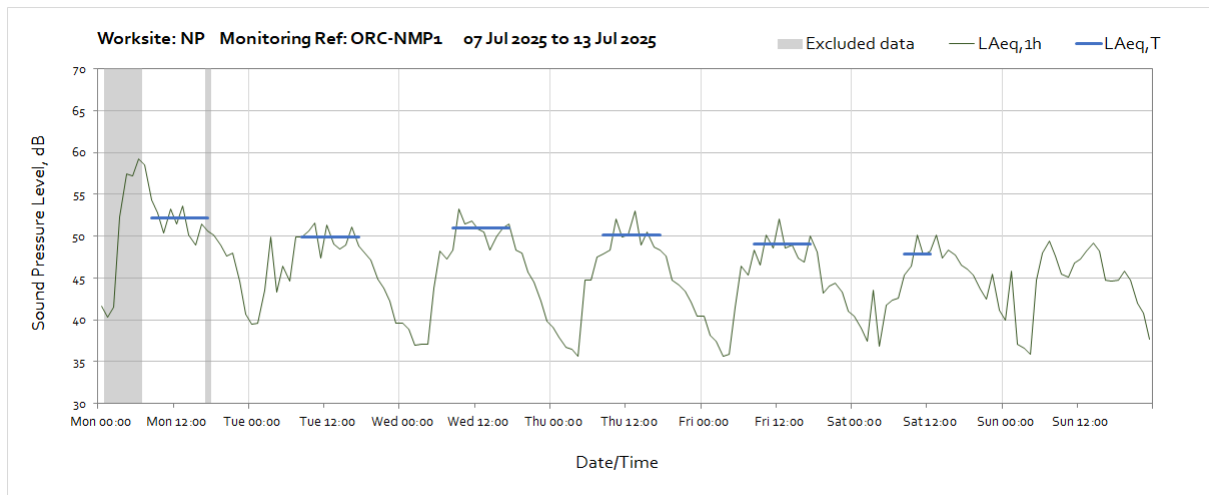
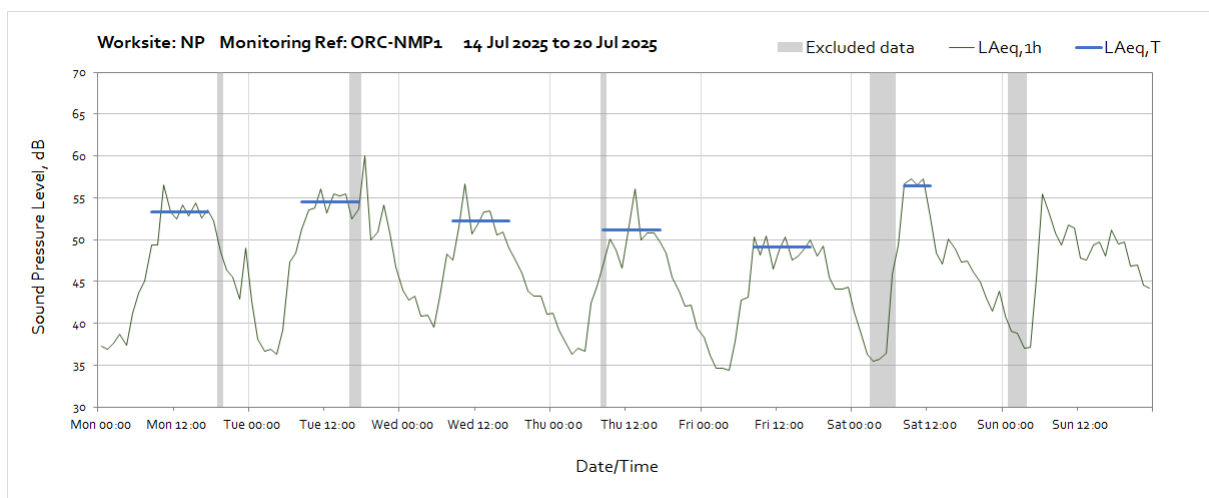
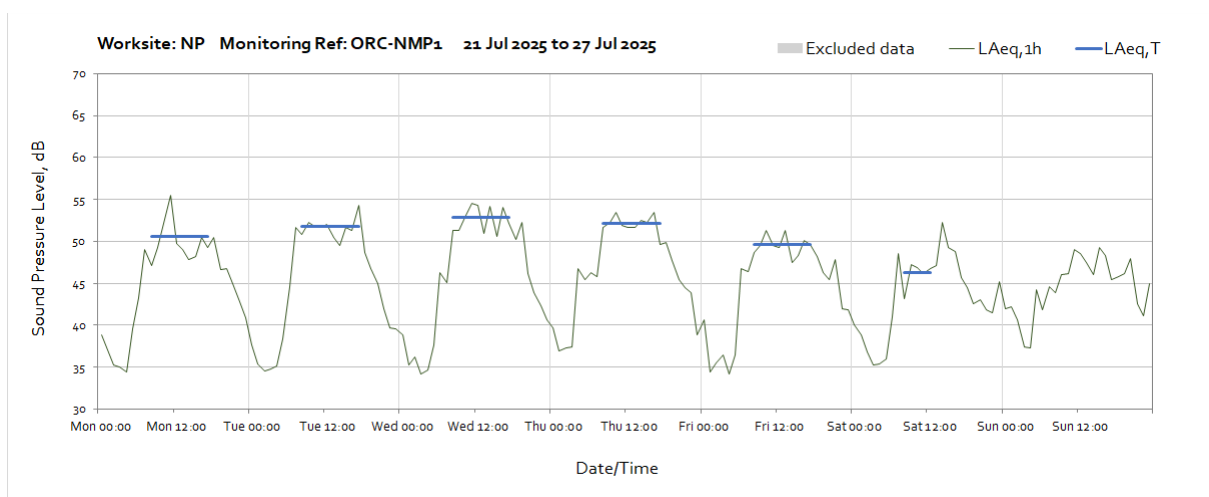
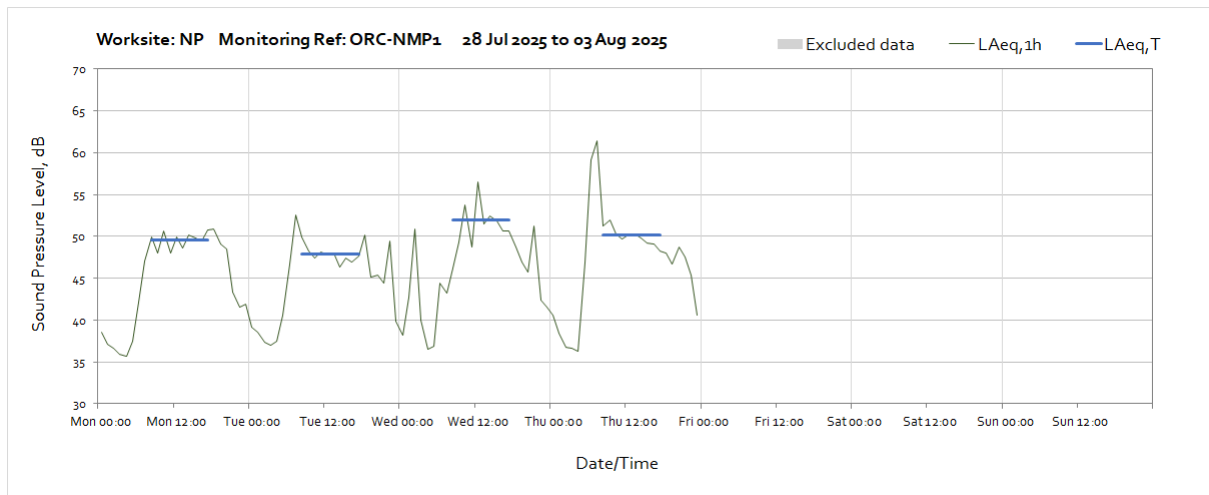
### Worksite: NP – Monitoring Ref: ORC-NMP1

Note: Missing data between 12:00 and 13:00 on Tuesday 1<sup>st</sup> July was due to monitor field calibration.  
Missing data between 14:00 and 15:00 on Wednesday 2<sup>nd</sup> July was due to a communication error between the monitoring station and server.

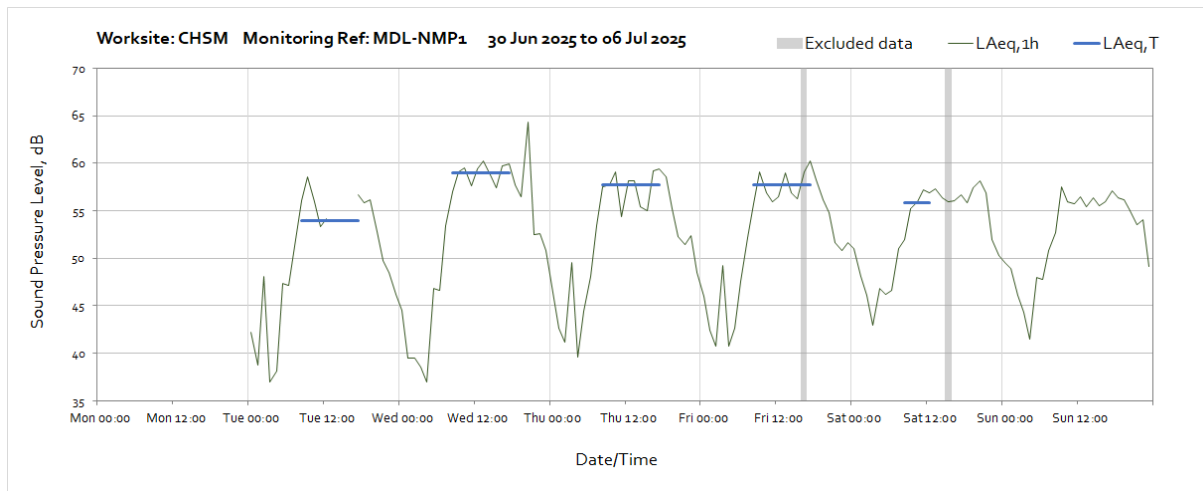
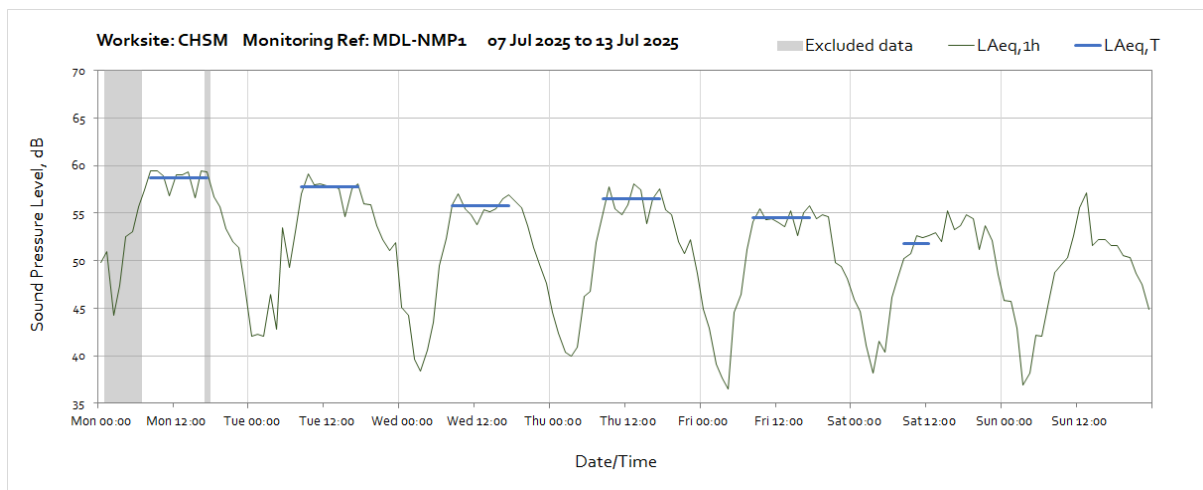
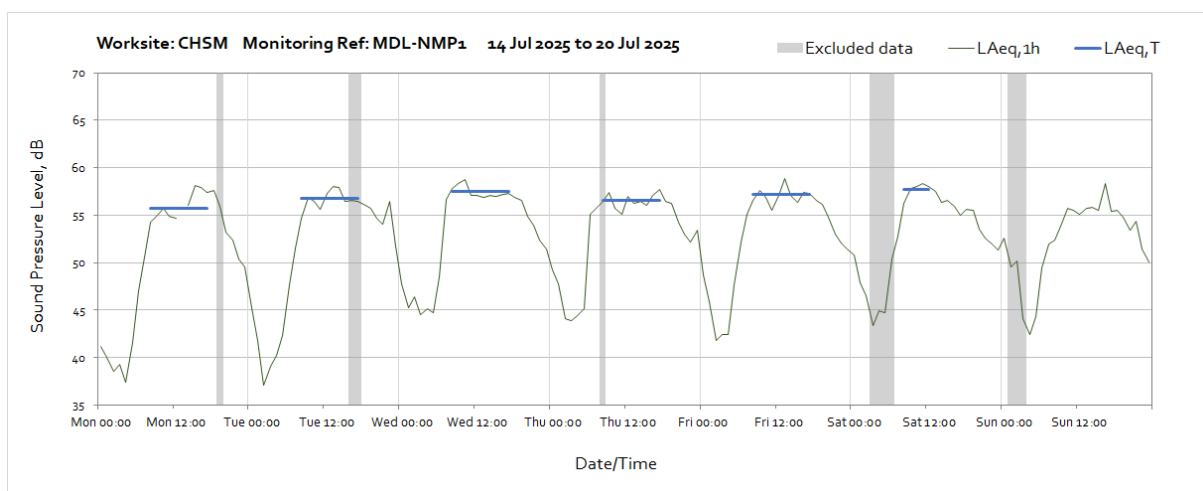
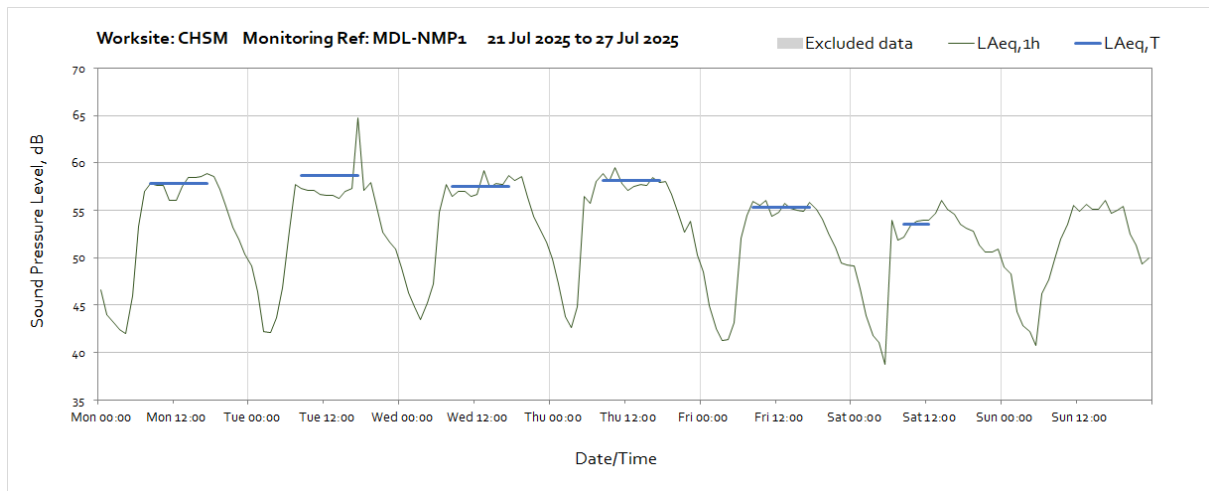
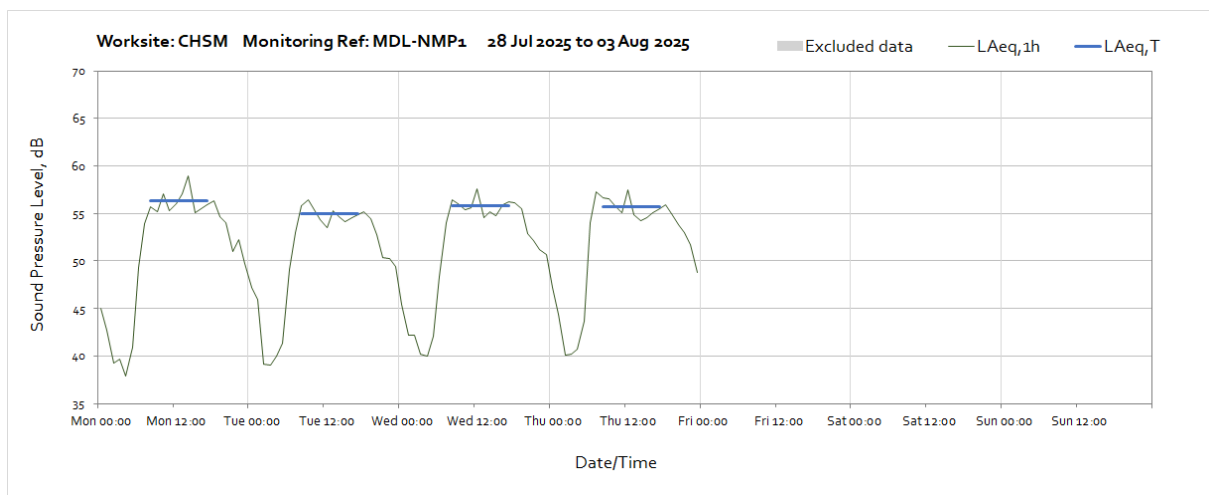
## Worksite: CHSM – Monitoring Ref: MDL-NMP1

Note: Missing data between 13:00 and 17:00 on Tuesday 1<sup>st</sup> July was due to monitor maintenance and swapping of monitors for laboratory calibration.

Note: Missing data between 13:00 and 14:00 on Monday 14<sup>th</sup> July was due to a communication error between the monitoring station and server.

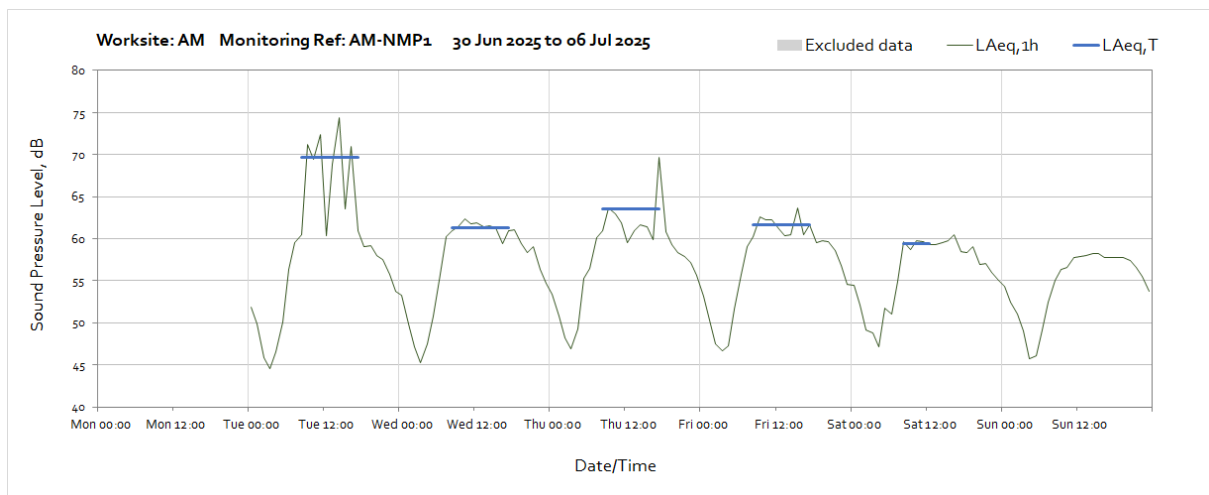
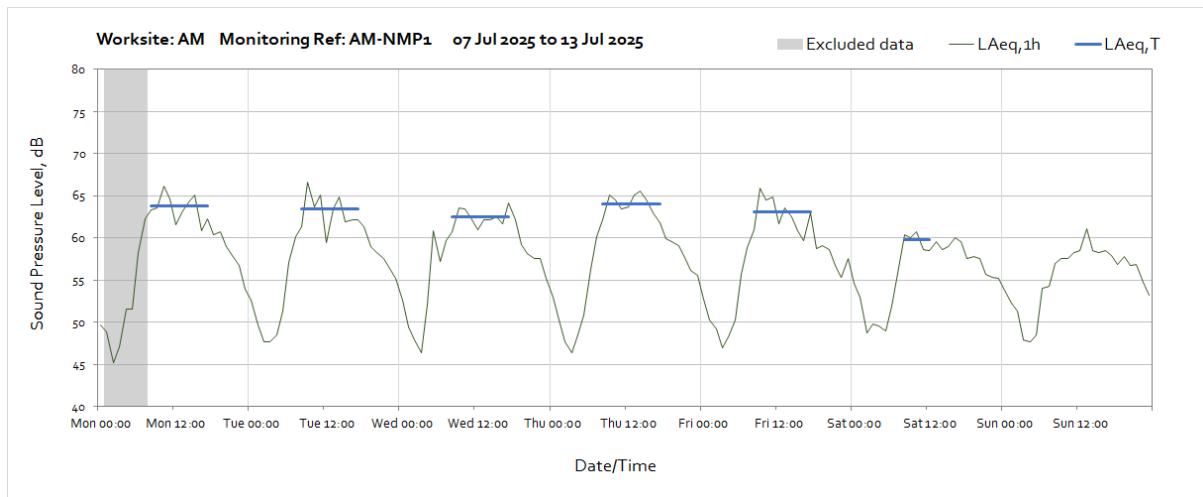
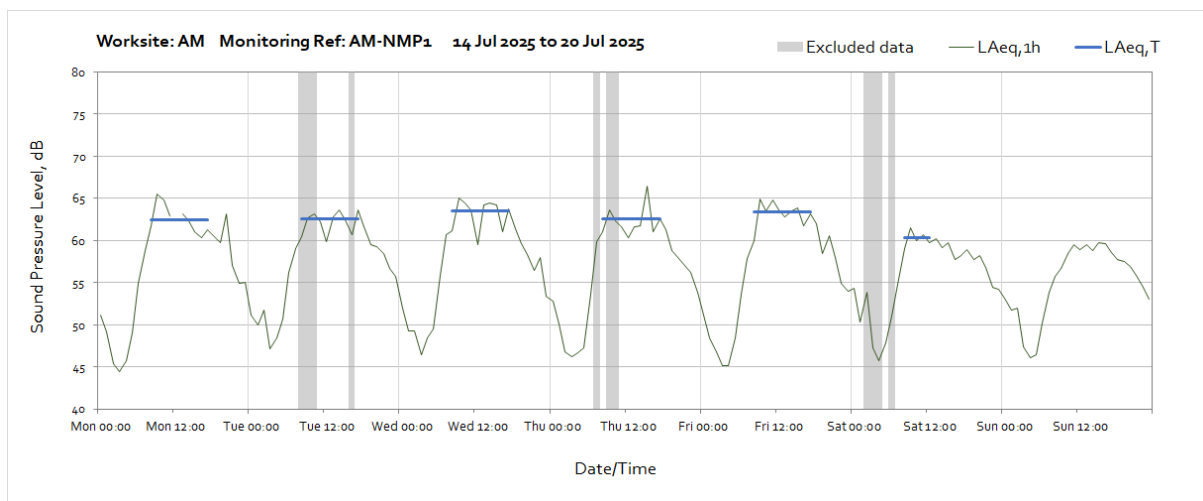
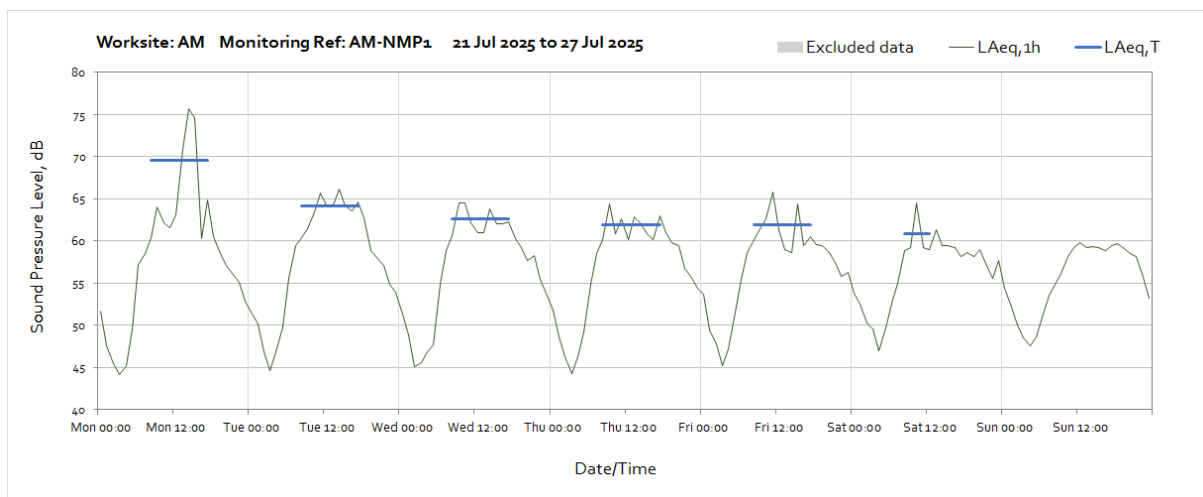
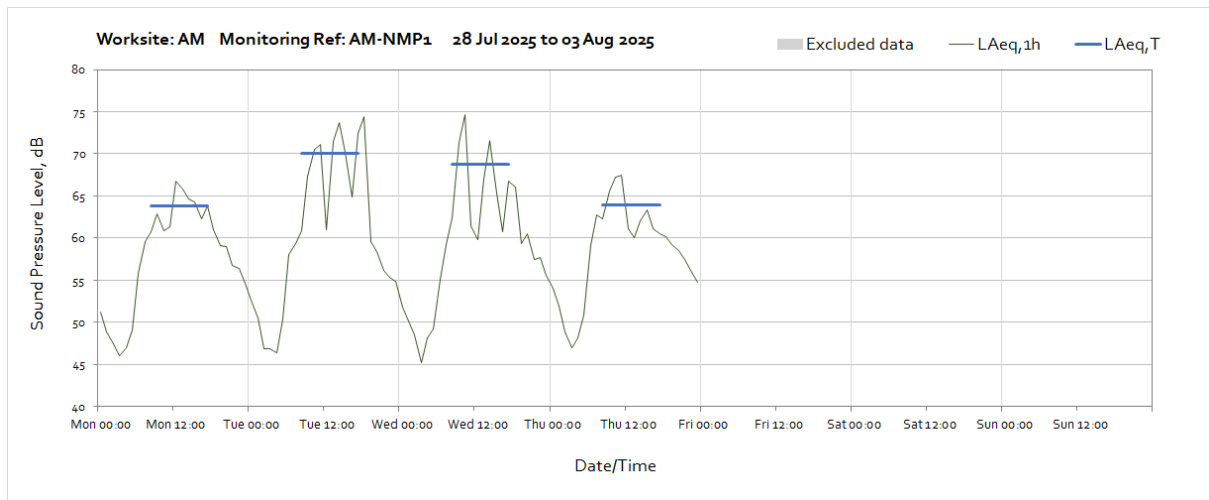
## Worksite: AM – Monitoring Ref: AM-NMP1

Note: Missing data between 12:00 and 13:00 on Monday 14<sup>th</sup> July was due to a communication error between the monitoring station and server.

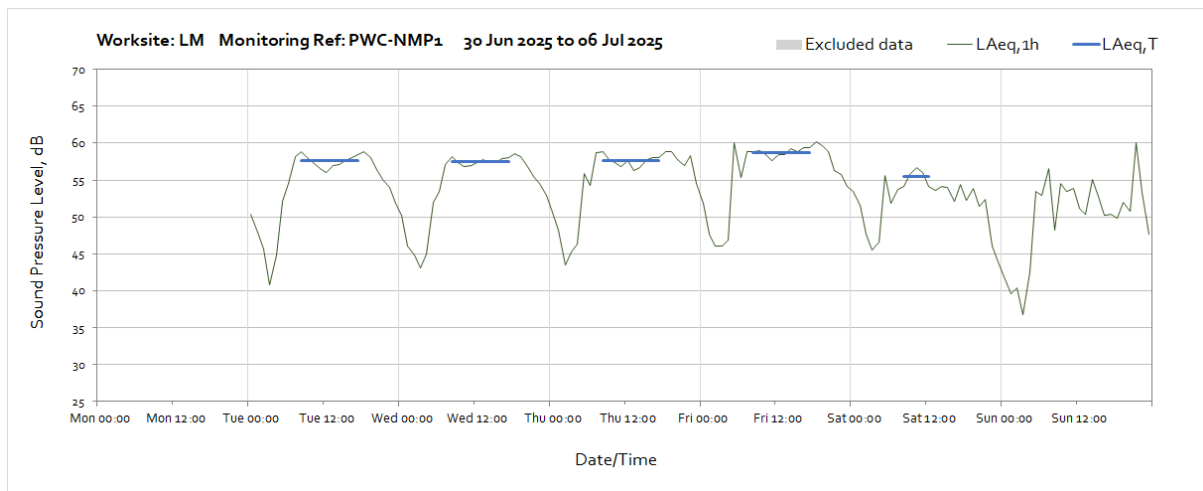
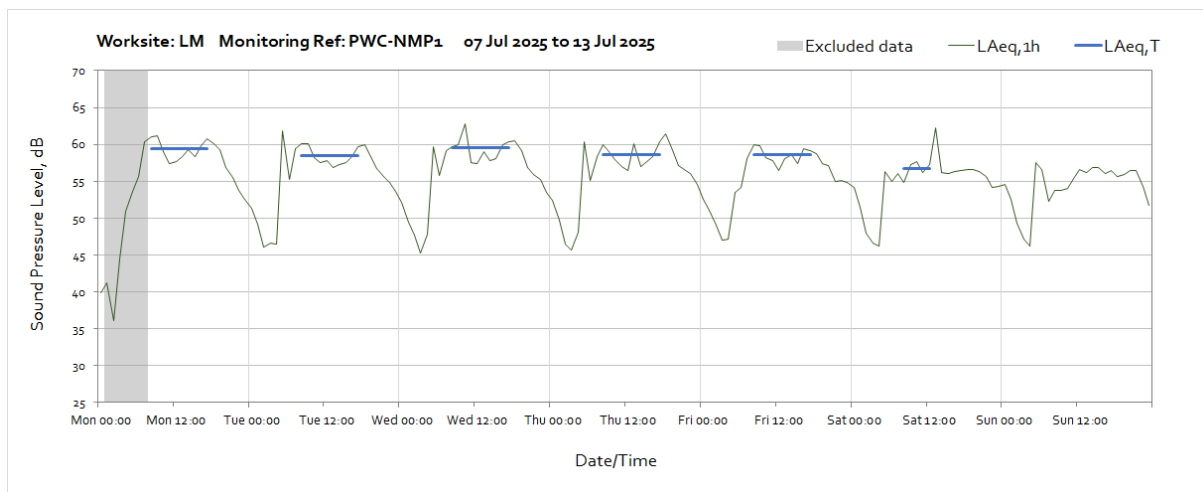
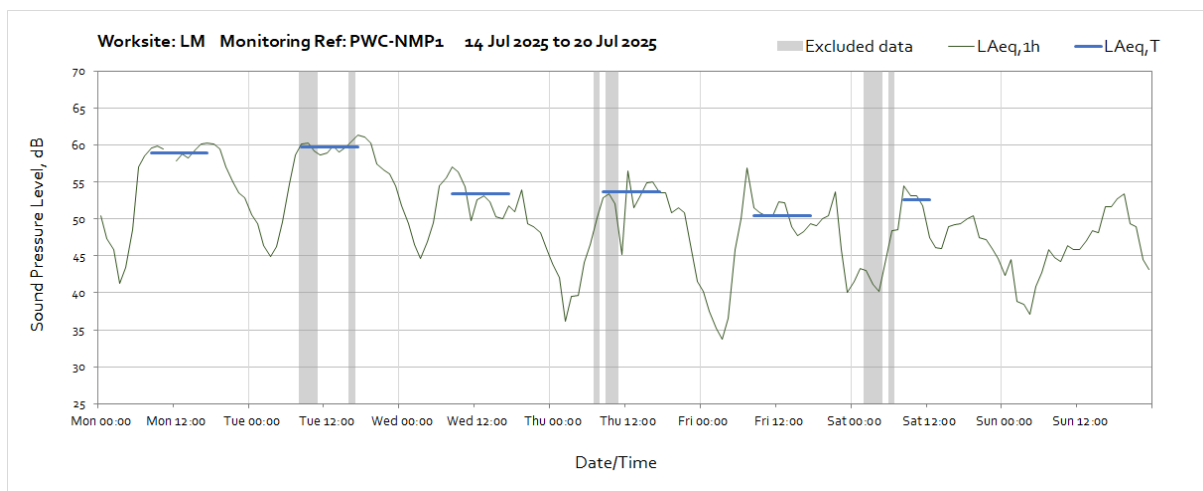
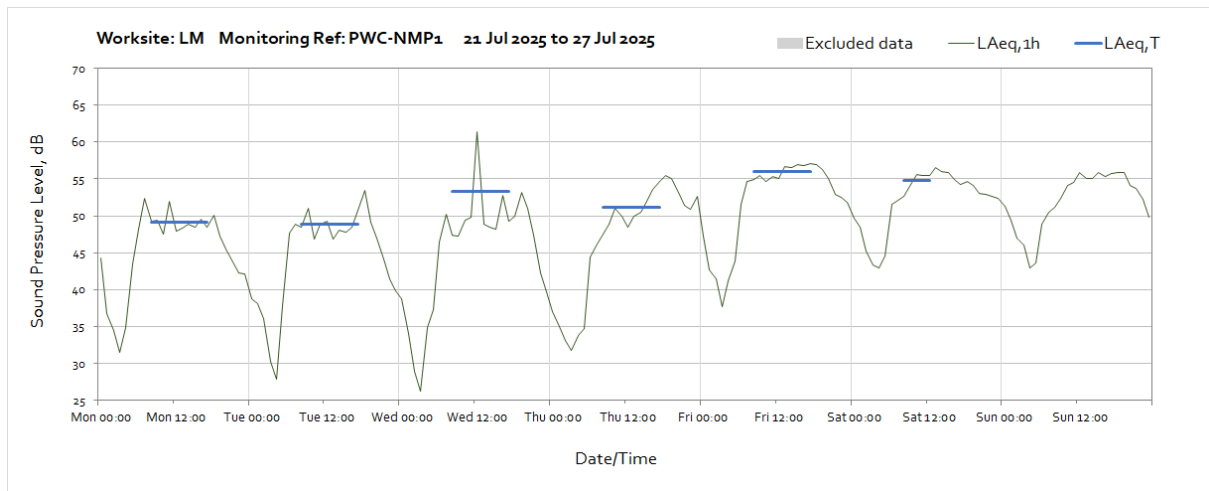
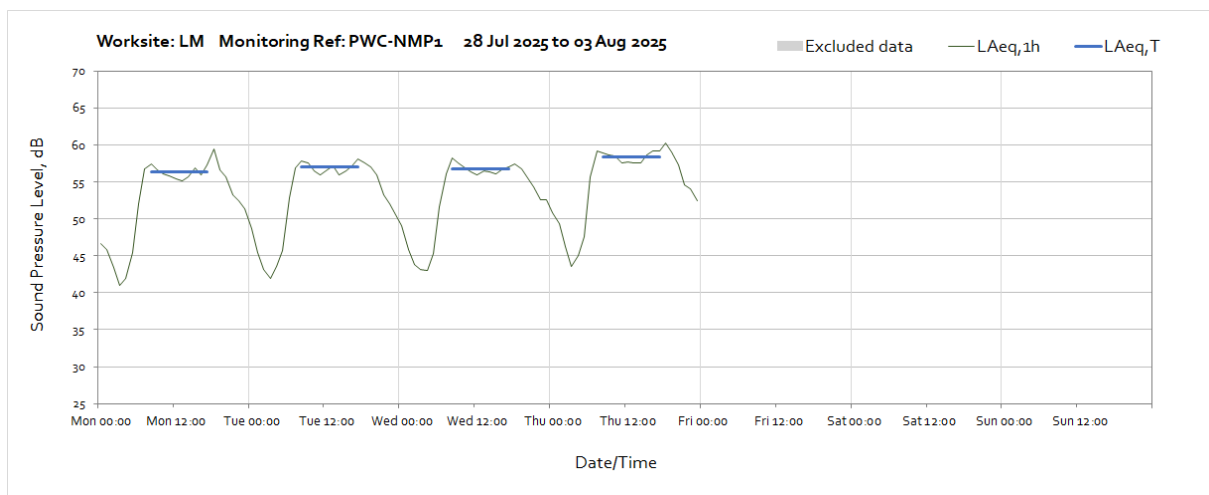
## Worksite: LM – Monitoring Ref: PWC-NMP1

Note: Missing data between 11:00 and 12:00 on Monday 14<sup>th</sup> July was due to monitor field calibration.

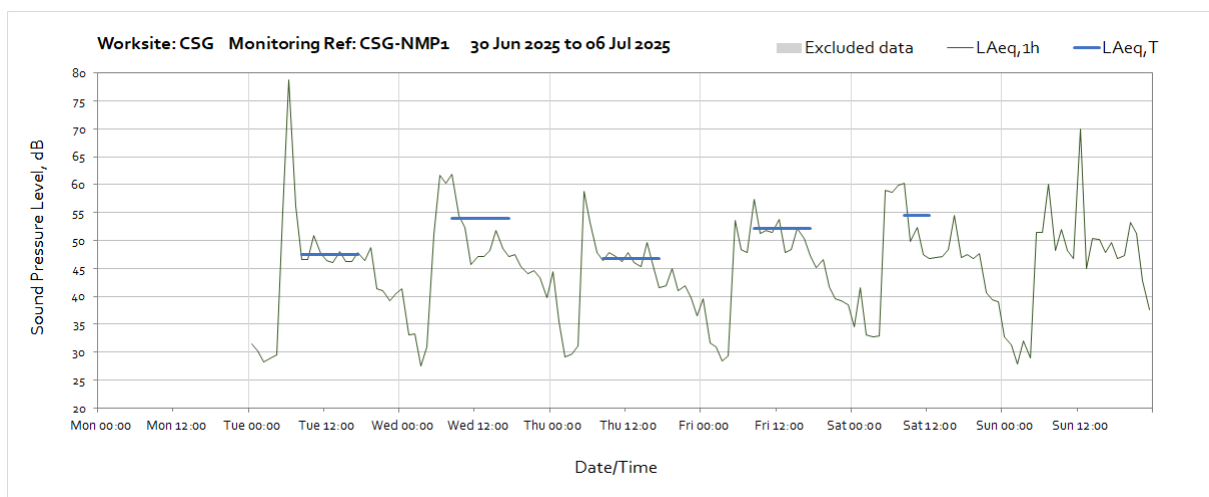
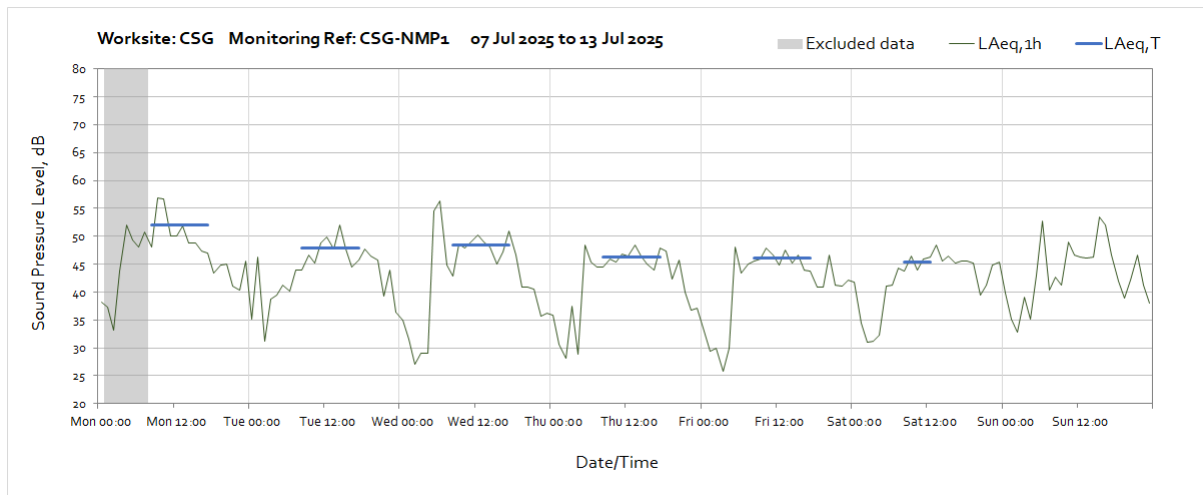
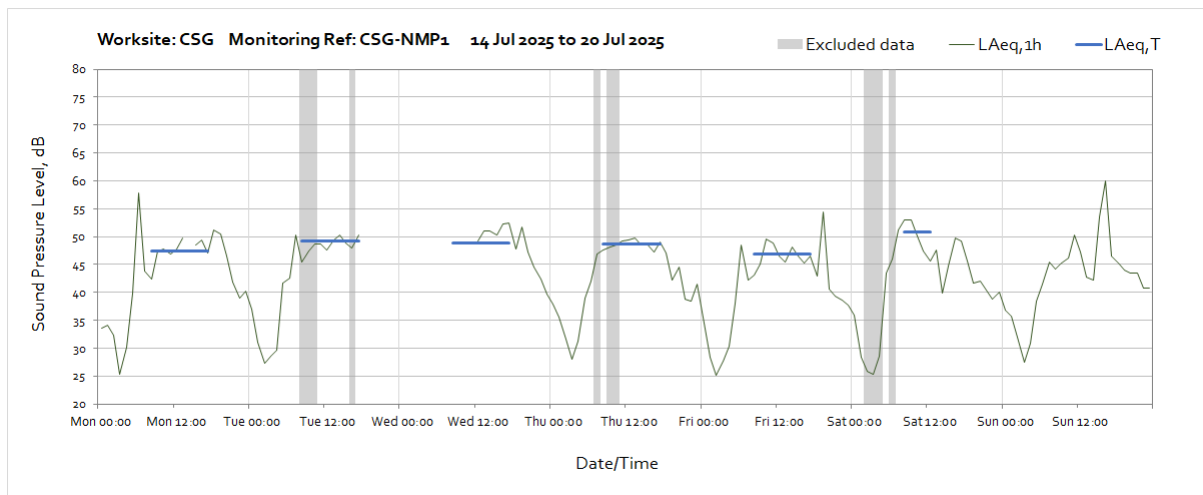
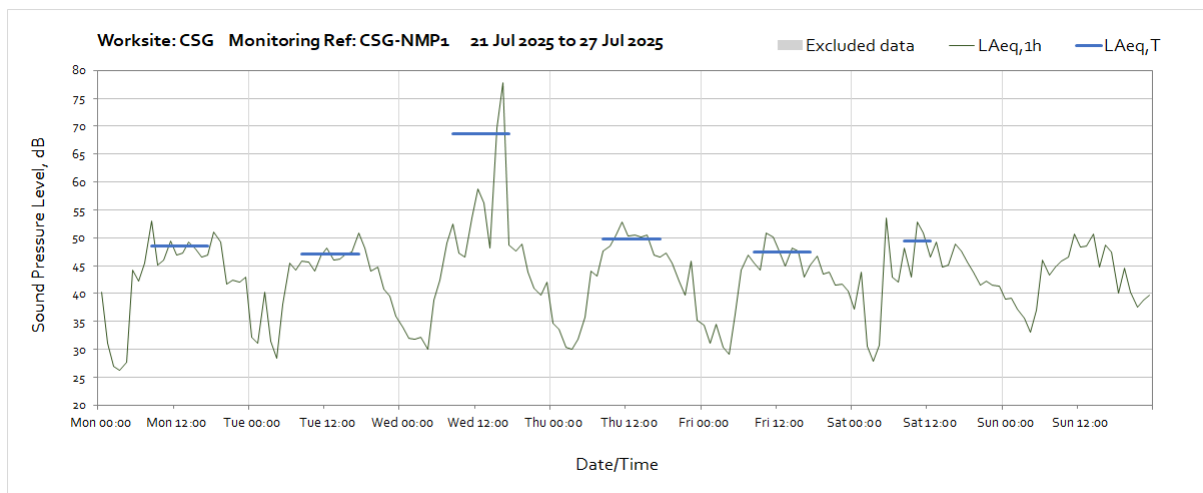
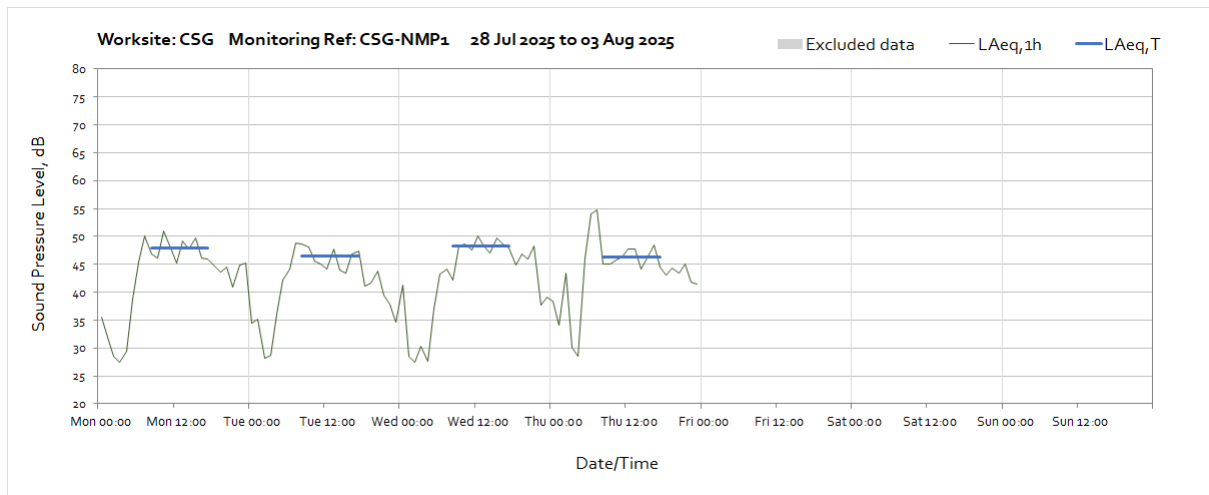
## Worksite: CSG – Monitoring Ref: CSG-NMP1

Note: Missing data between 14:00 and 15:00 on Monday 14<sup>th</sup> July was due to monitor field calibration. Missing data between 18:00 on Tuesday 15<sup>th</sup> July and 12:00 on Wednesday 16<sup>th</sup> July was due to loss of power.

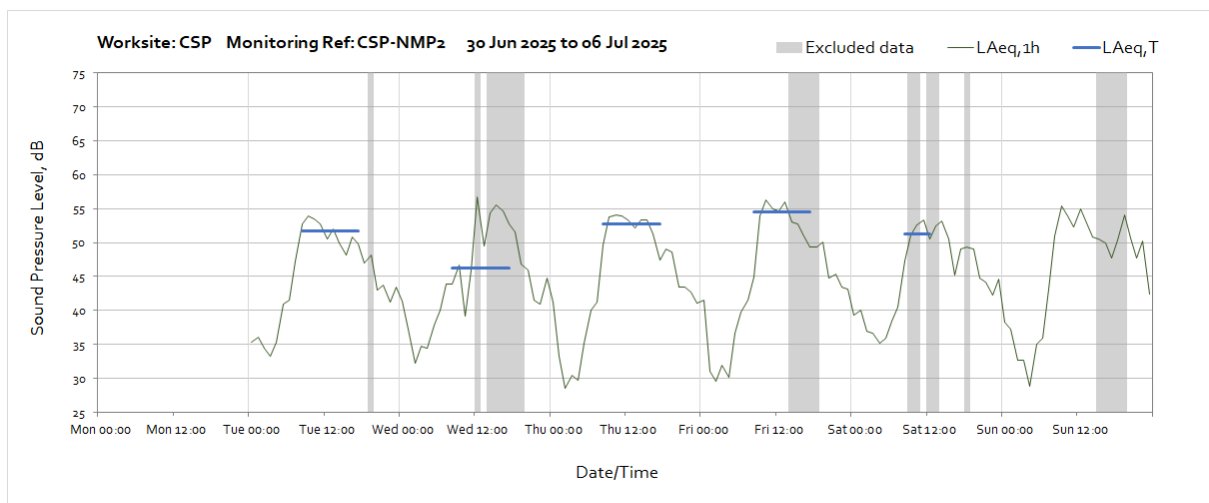
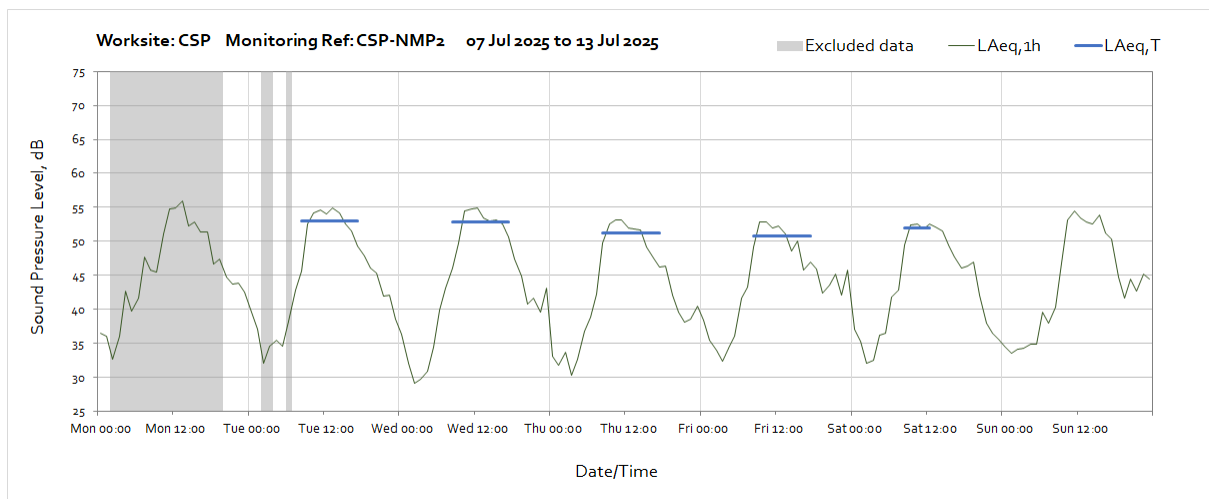
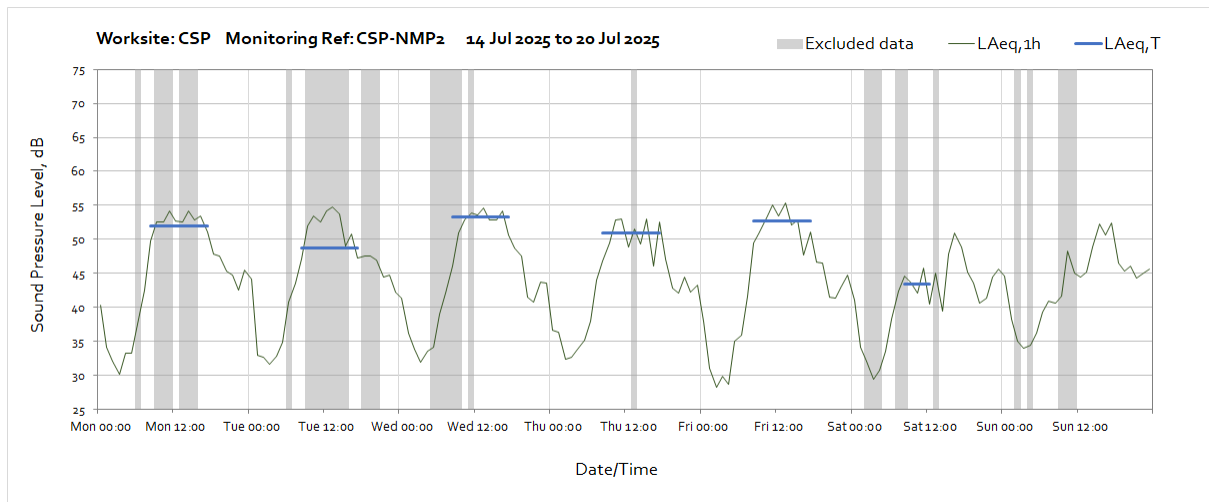
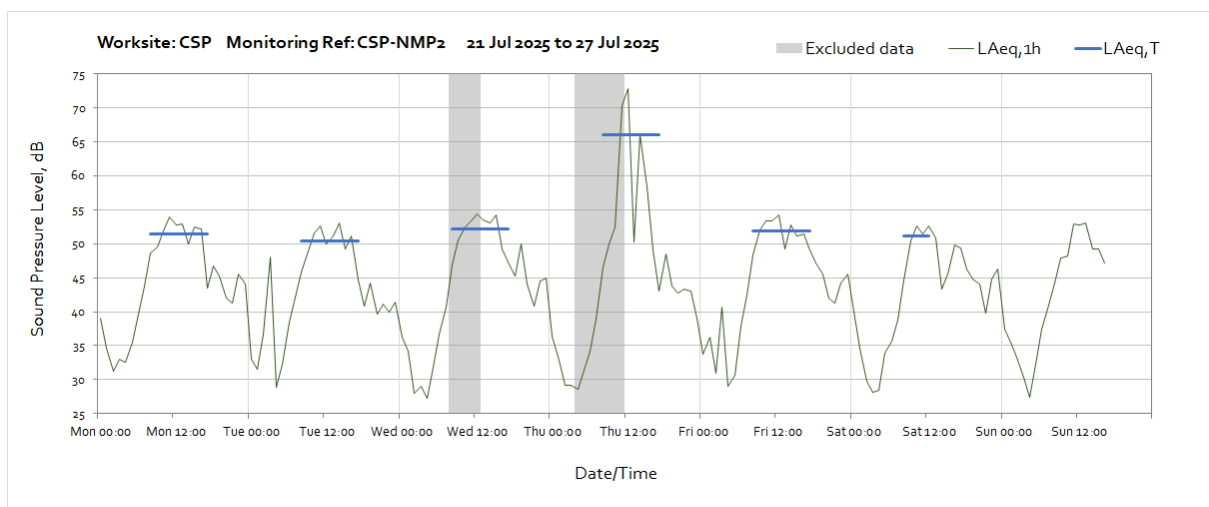
## Worksite: CSP – Monitoring Ref: CSP-NMP2

Note: Missing data from 17:00 on Sunday 27<sup>th</sup> July until month end was due to damage to the monitoring station cabling.
