## **Construction Noise and Vibration Monthly Report – July 2025**

**Buckinghamshire**

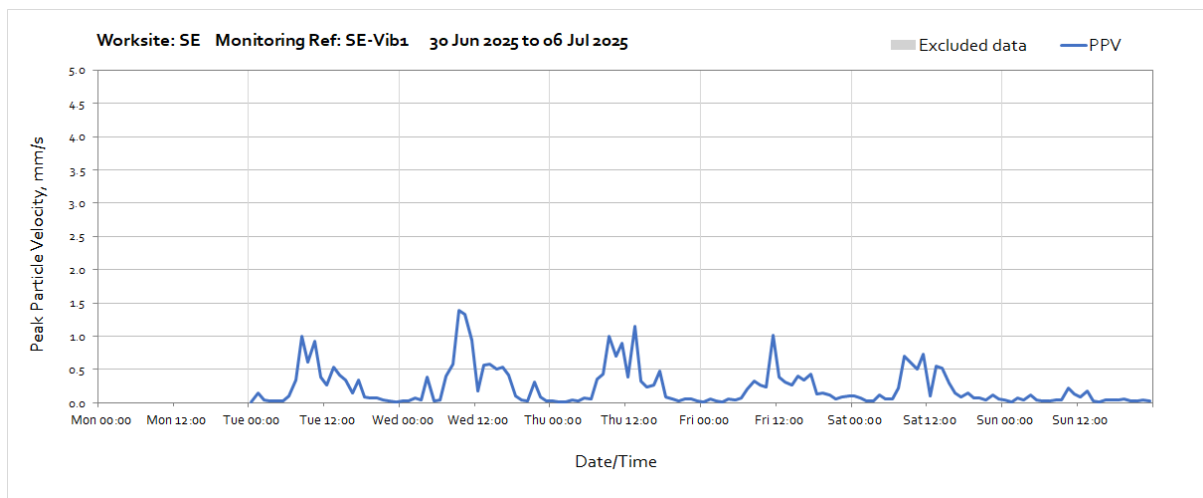
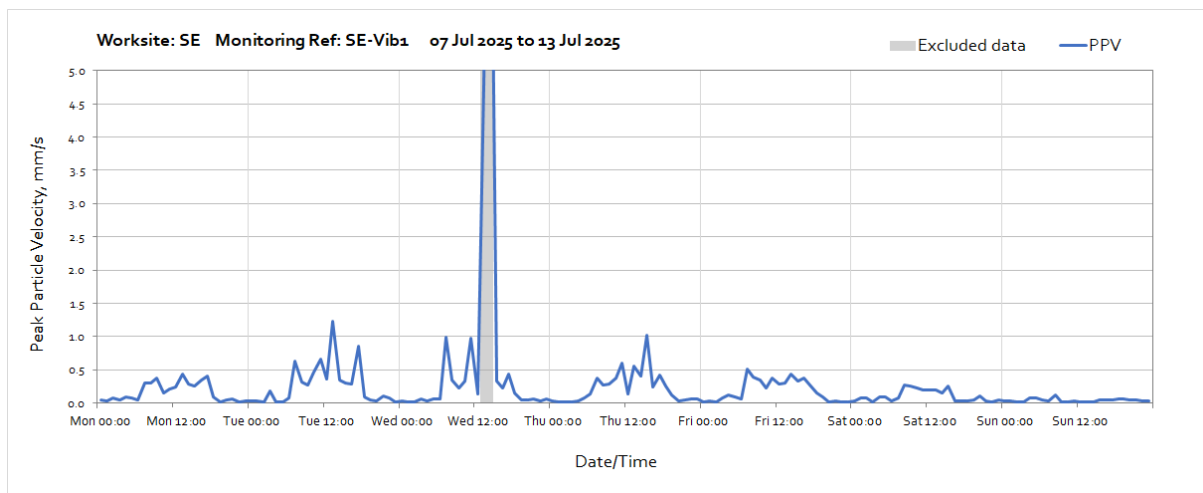
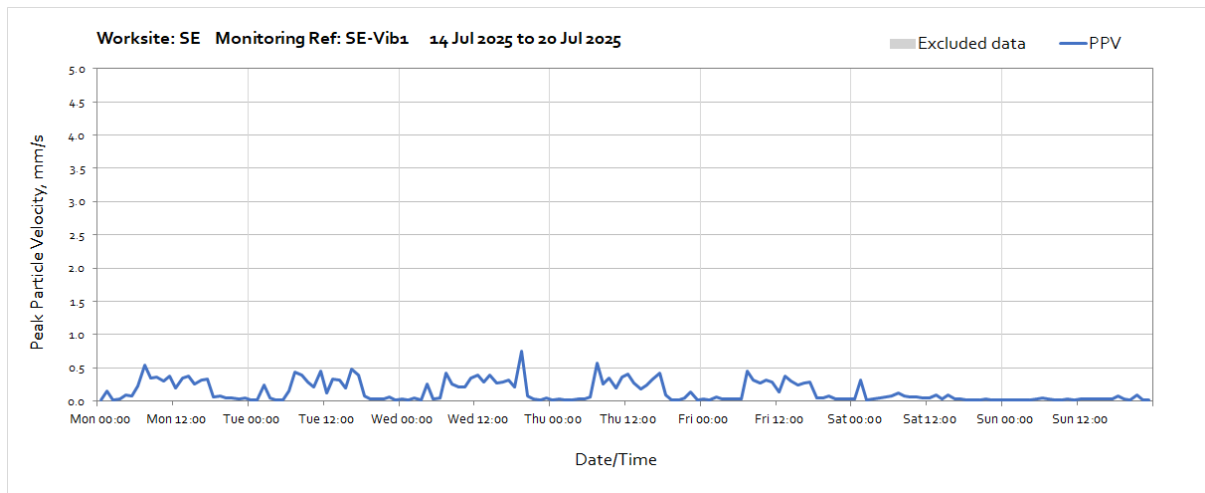
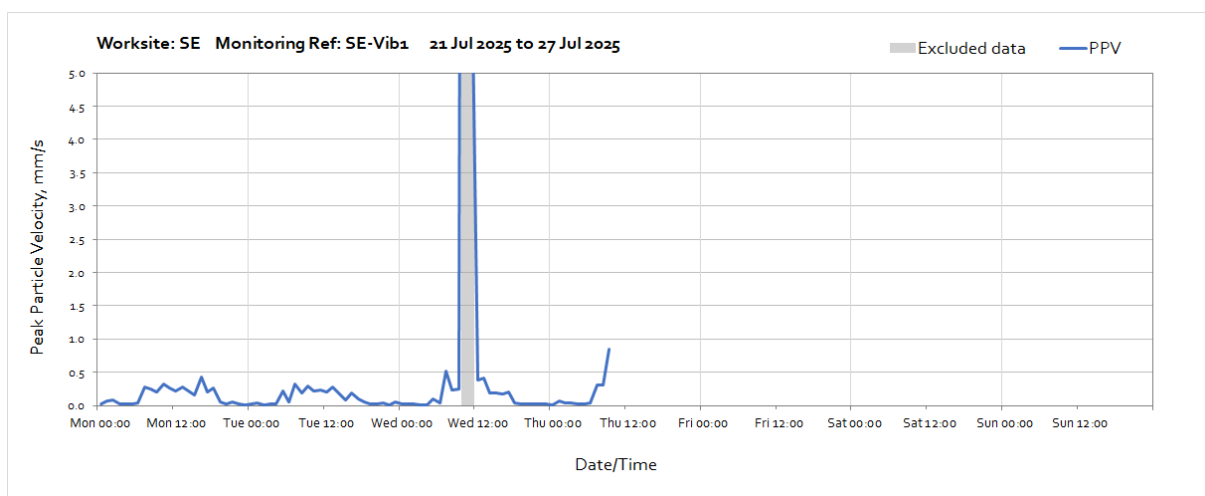
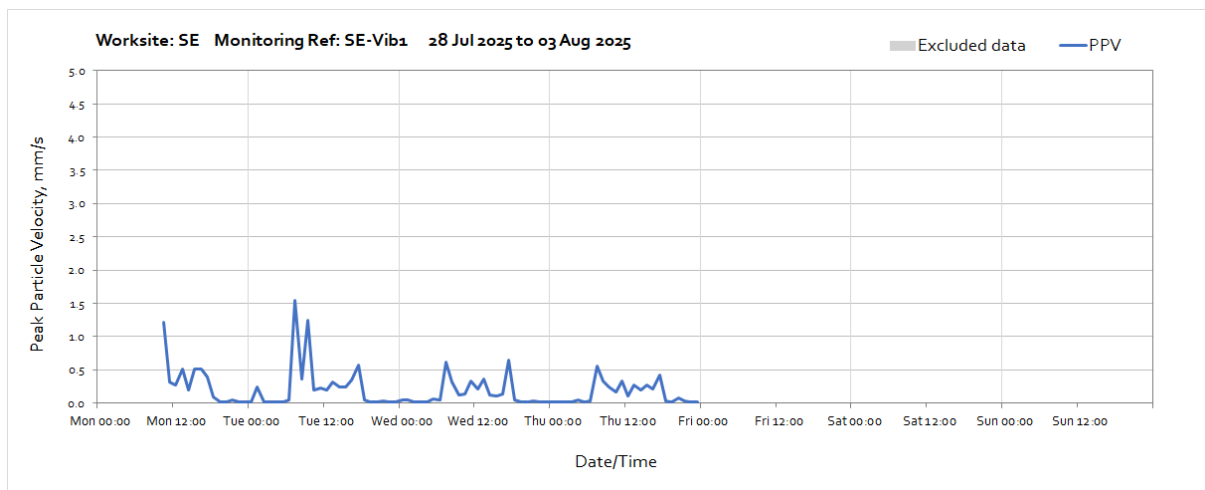
### Worksite: SE – Monitoring Ref: SE-Vib1

The following graphs show the hourly measured peak particle velocity PPV recorded during the monitoring period. The graphs show the highest PPV of the three orthogonal axes x, y and z. Periods where PPV values have been affected by local interference with the vibration monitor or only measured for part of the period, which are not representative of HS2 construction works, have been greyed out and excluded when calculating values in Table 4 of the main report.

Note: Missing data between 10:00 on Thursday 24<sup>th</sup> July and 10:00 on Monday 28<sup>th</sup> July was due to monitor retrieval for a monitor firmware update.

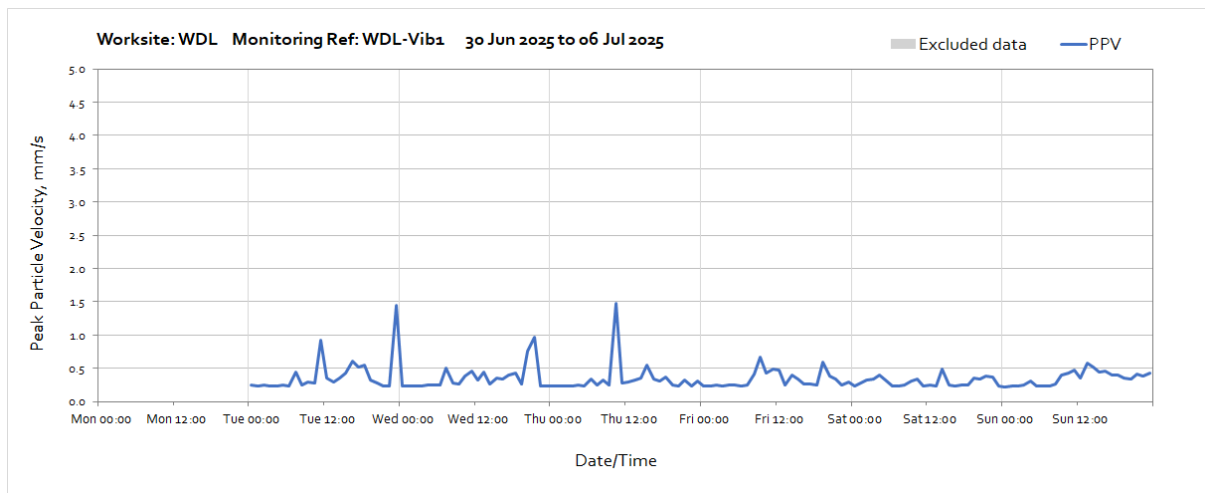
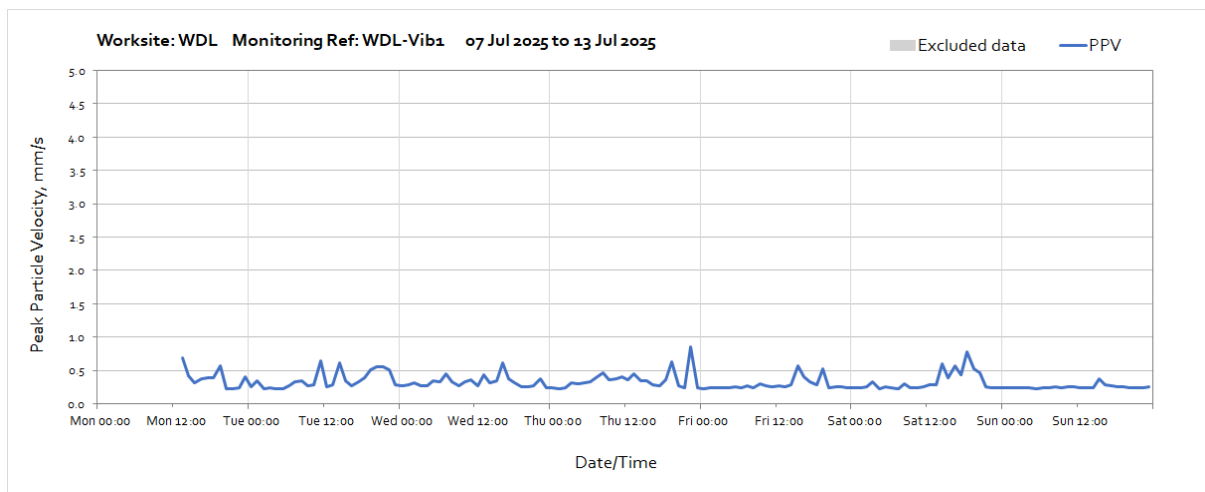
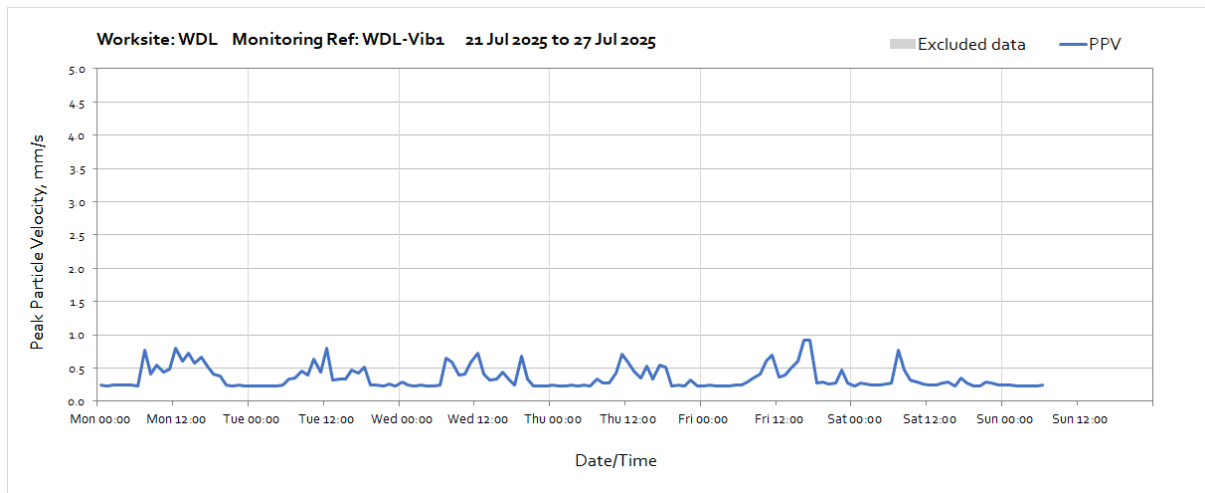
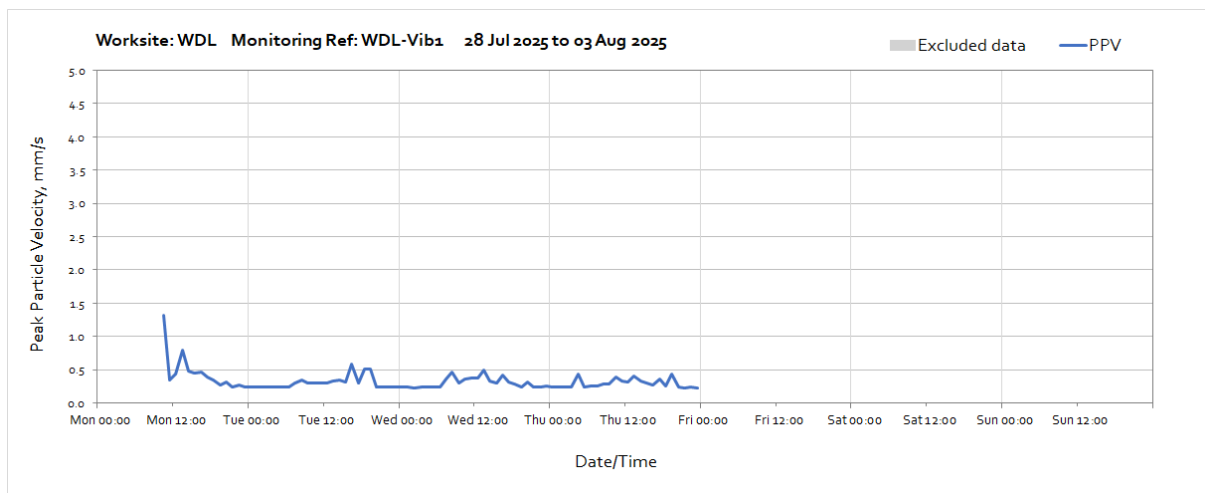
## Worksite: WDL – Monitoring Ref: WDL-Vib1

Note: Missing data between 01:00 and 13:00 on Monday 7<sup>th</sup> July was due to a depleted monitor battery.

Note: Missing data between 07:00 on Sunday 27<sup>th</sup> July and 10:00 on Monday 28<sup>th</sup> July was due to a depleted monitor battery.

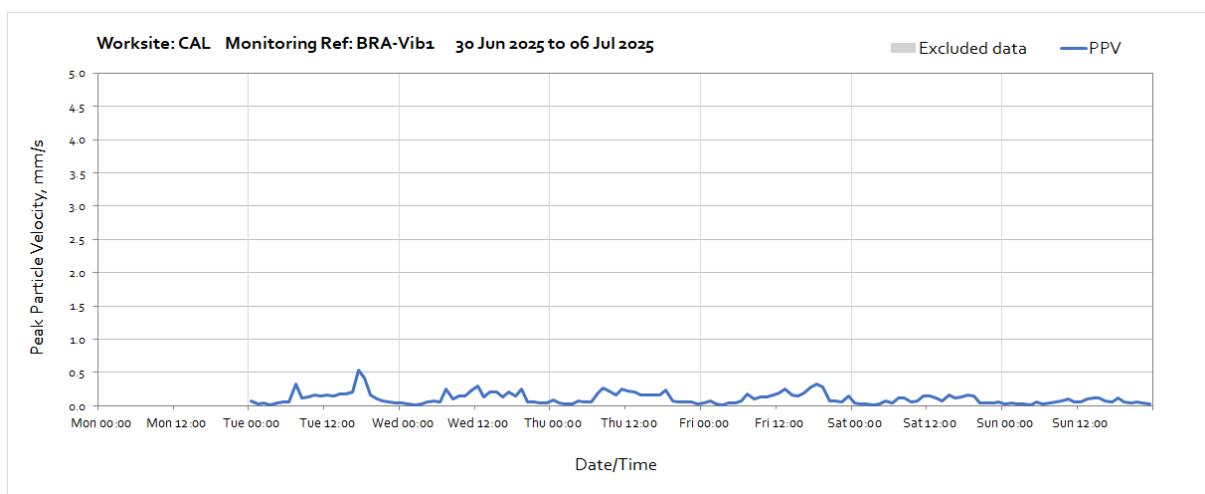
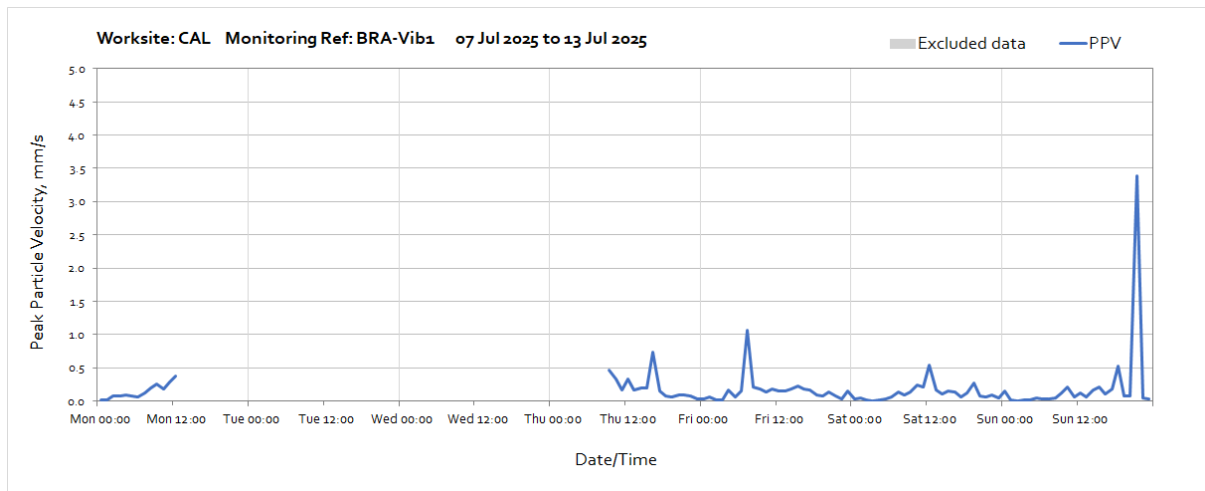
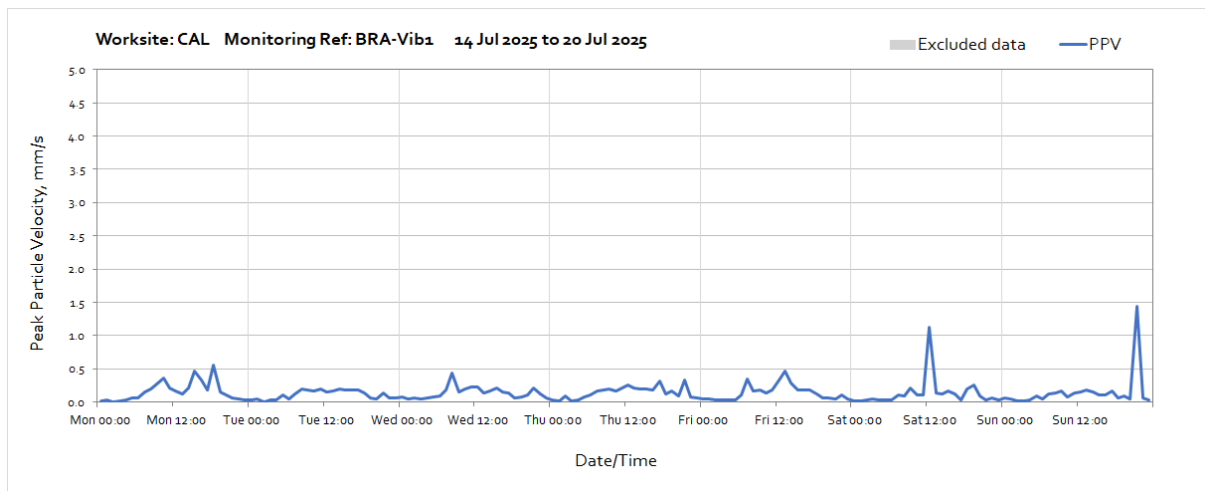
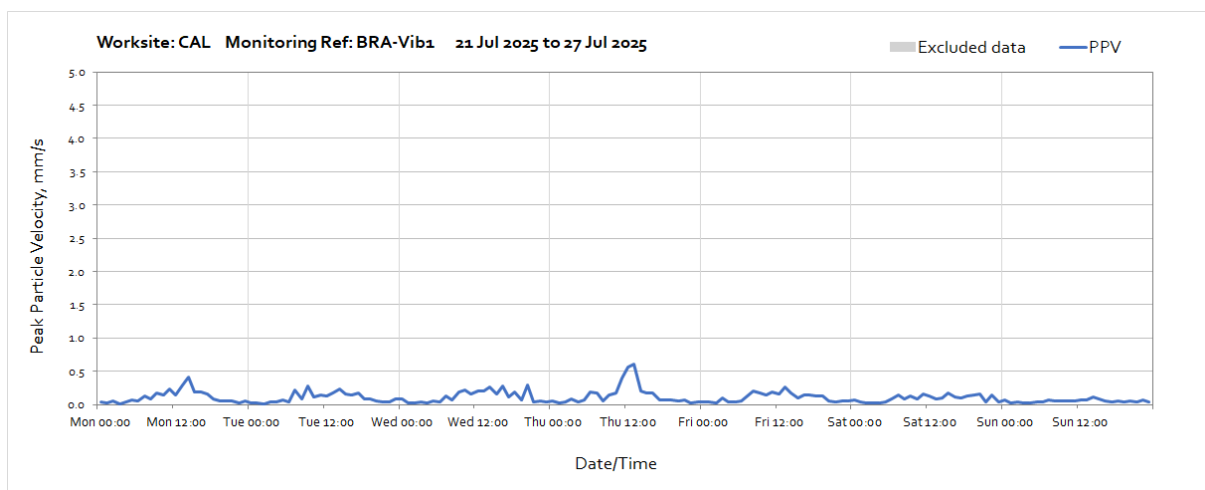
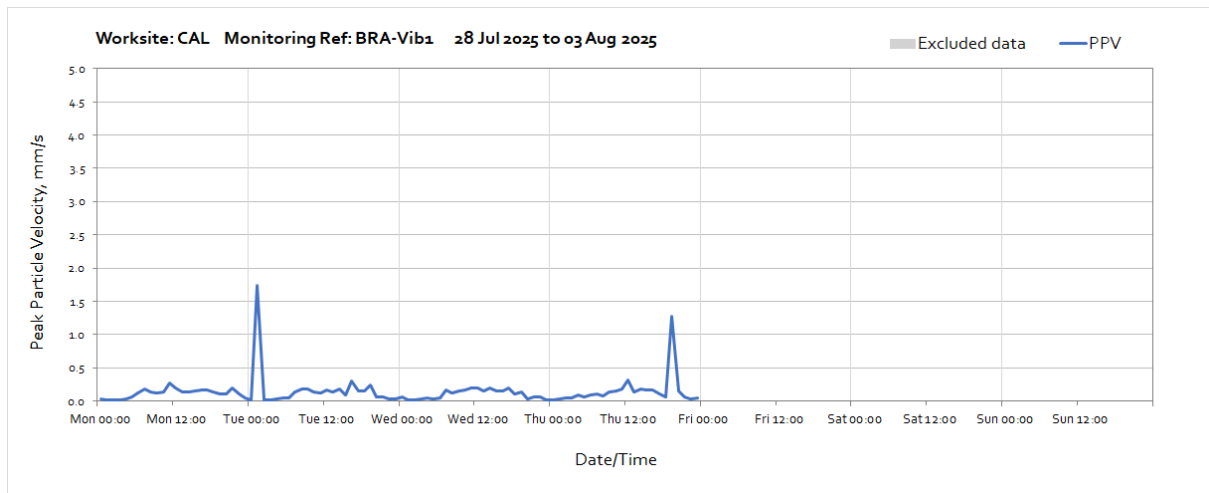
## Worksite: CAL – Monitoring Ref: BRA-Vib1

Note: Missing data between 13:00 on Monday 7<sup>th</sup> July and 09:00 on Thursday 10<sup>th</sup> July was due to monitor retrieval for monitor laboratory calibration.

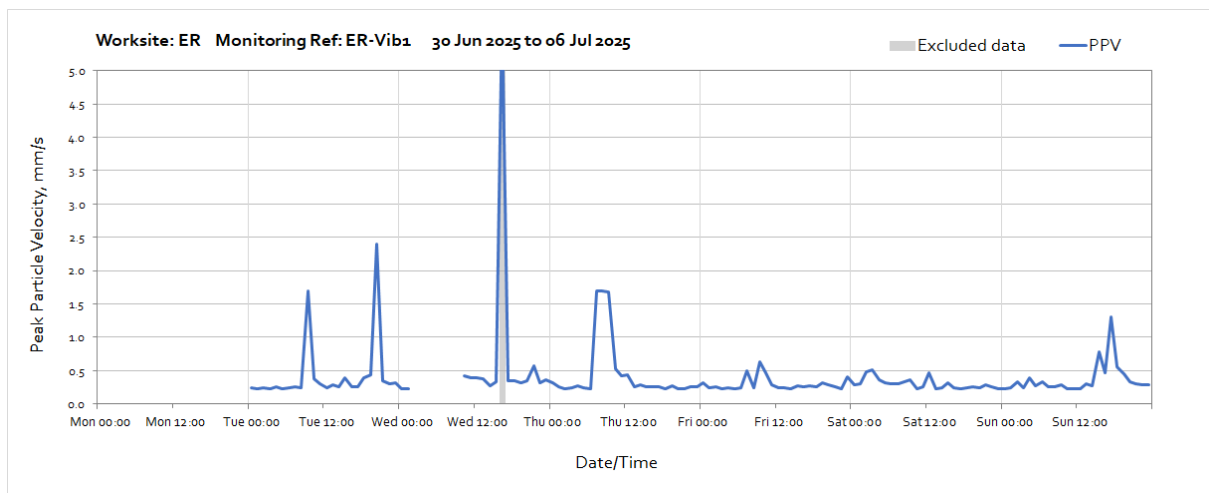
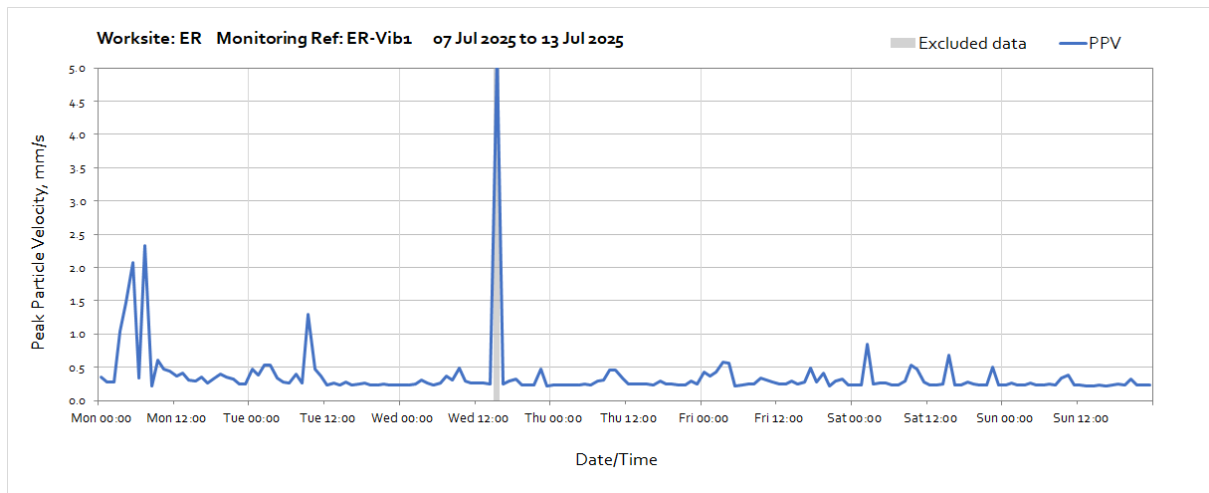
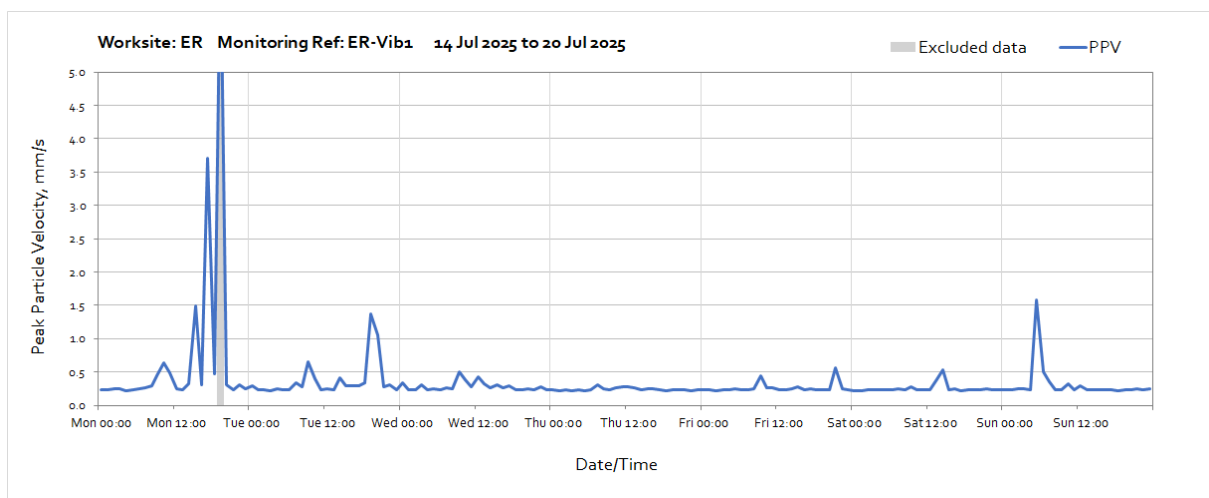
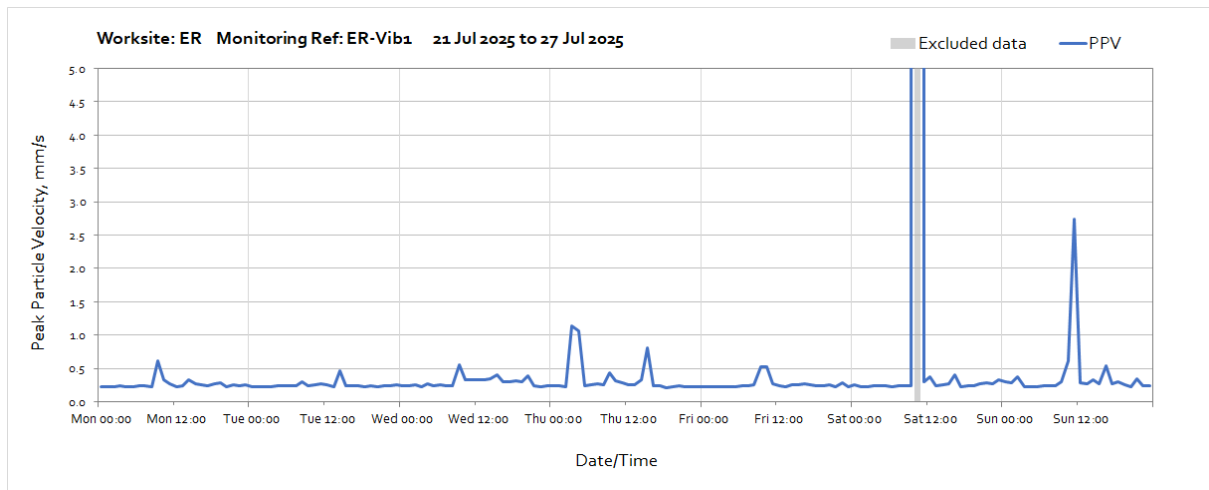
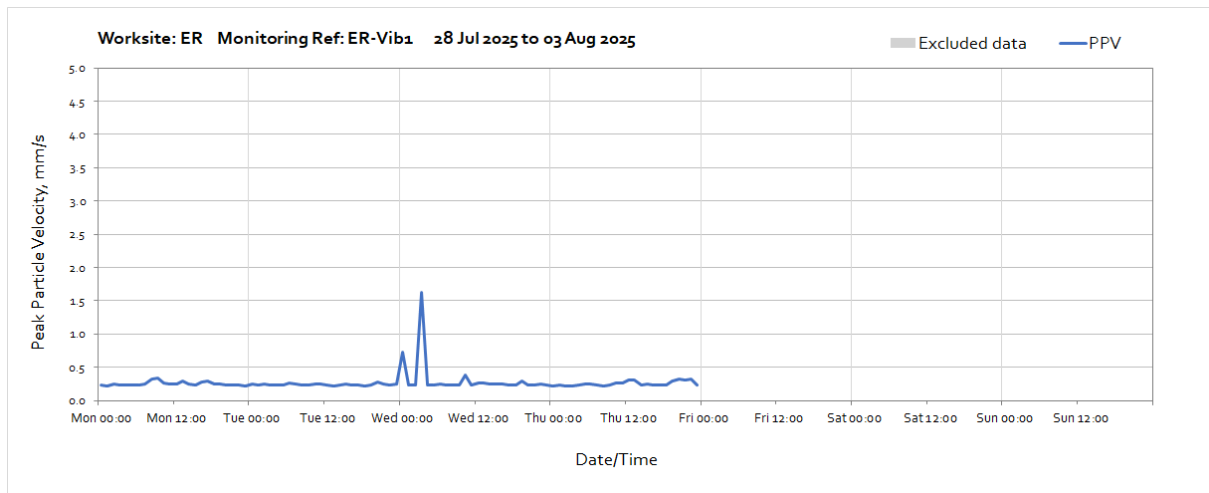
## Worksite: WGT – Monitoring Ref: ER-Vib1

Note: Missing data between 02:00 and 10:00 on Wednesday 2<sup>nd</sup> July was due to depleted monitor battery.
