# HS2

September 2025

## **Construction Noise and Vibration Monthly Report – July 2025**

**London Borough of Camden**

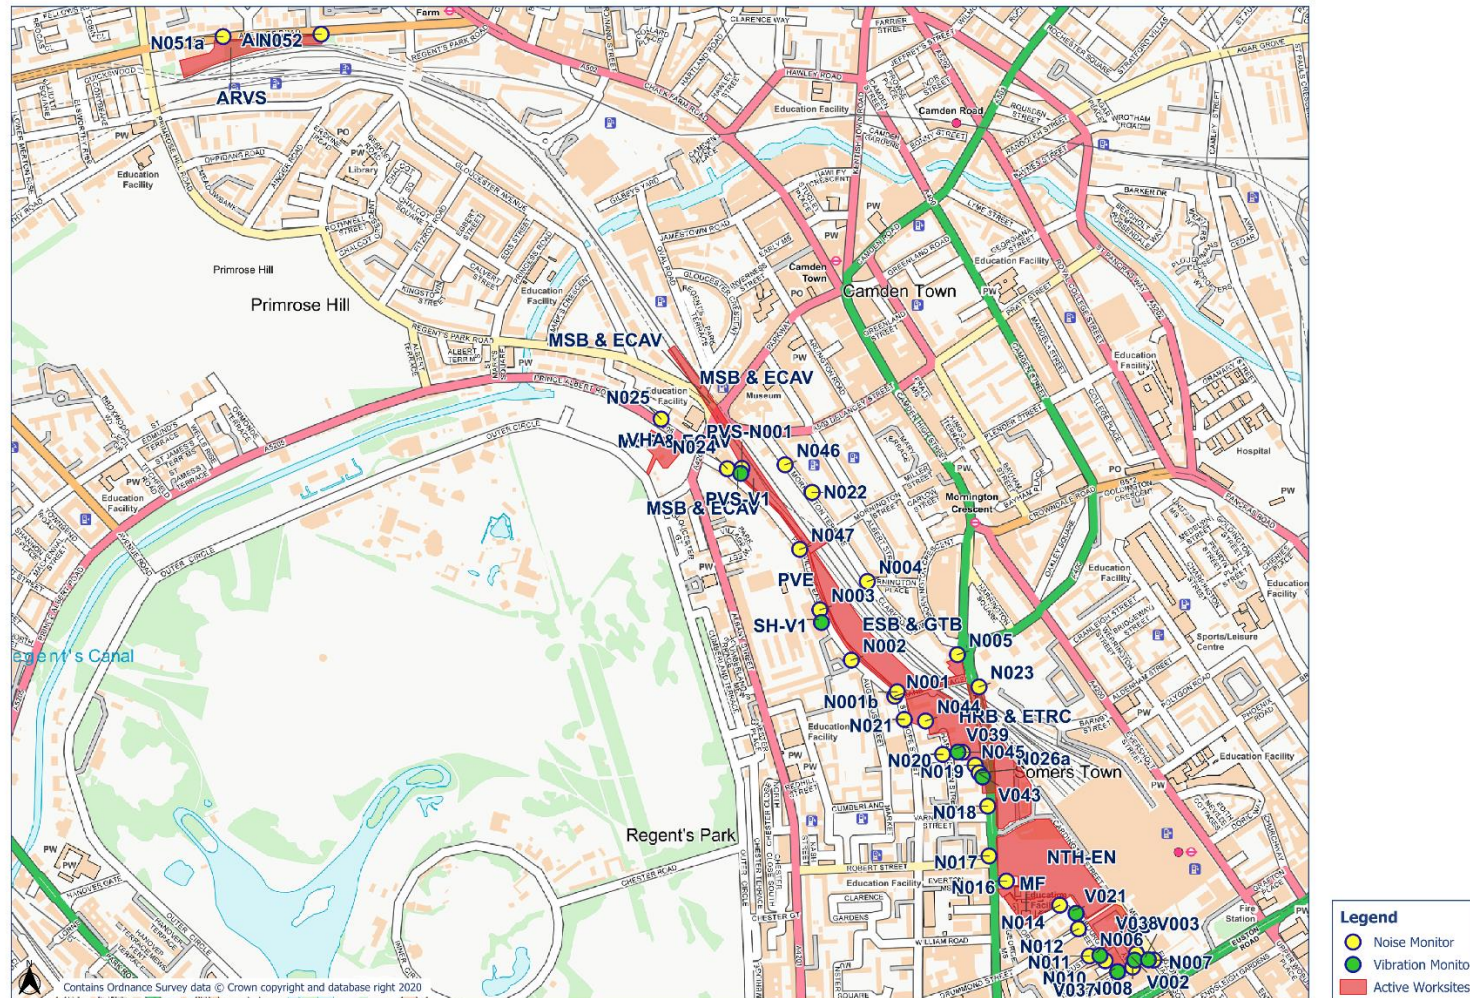
## HS2 Noise and Vibration Monitoring Plan - Overview

- 1.2.1 Thirty (30) noise and nine (9) vibration monitoring installations were active across eighteen worksites in May in the LBC area. Table 2 summarises the location of noise and vibration monitoring installations within the LBC area in July 2025.
- 1.2.2 Maps showing the position of noise and vibration monitoring installations are presented in Appendix B.

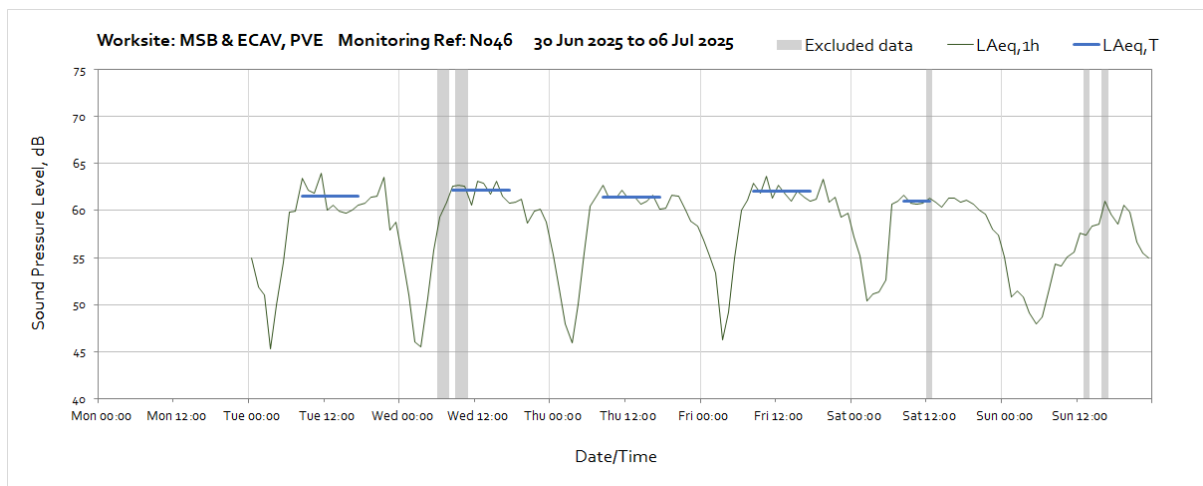
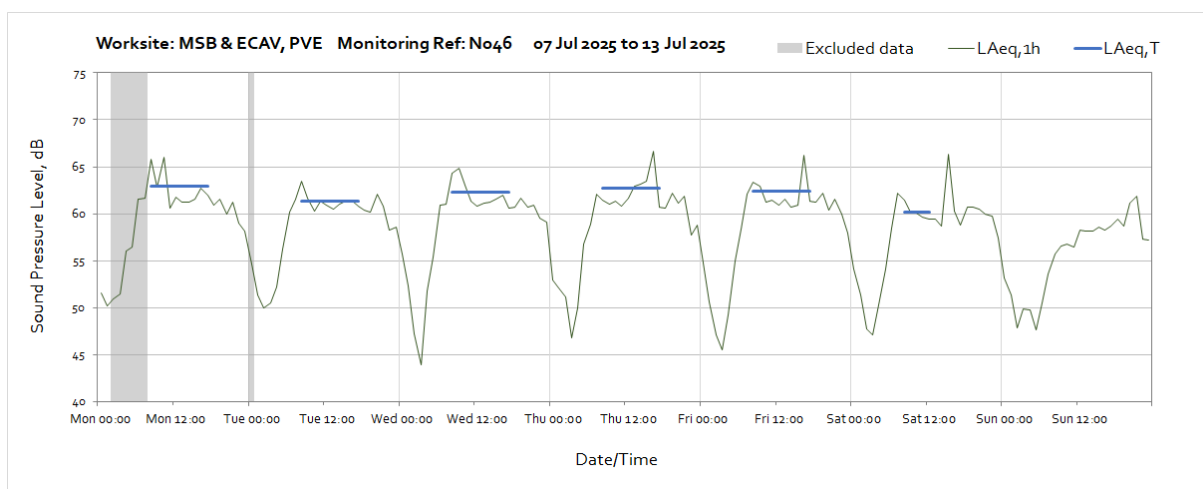
### Worksite: MSB & ECAV, PVE – Monitoring Ref: N046

2.1.3 Appendix C presents graphs of the noise and vibration monitoring data over the month for each of the measurement locations. Noise data presented consists of the hourly  $L_{Aeq}$  values and, where relevant, the  $L_{Aeq,T}$  values (where the time period T has been taken to be the averaging period as specified in Table 1 of HS2 Information Paper E23). Vibration data presented consist of hourly PPV values. The full data set for the monitoring equipment can be found at the following location:  
<https://data.gov.uk/dataset/24542ae7-dd44-444f-b259-871c4cc43b5e/environmental-monitoring-data>.

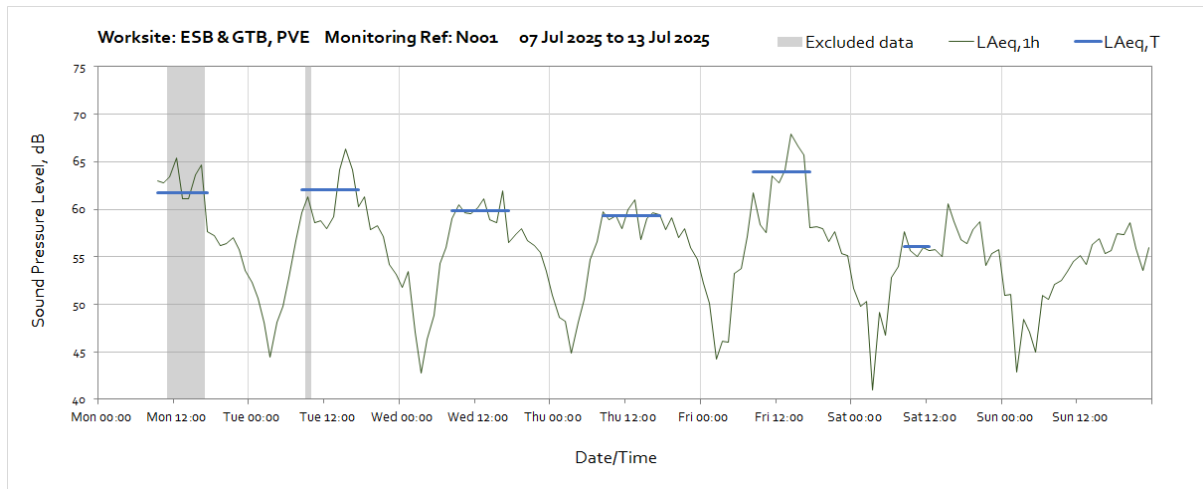
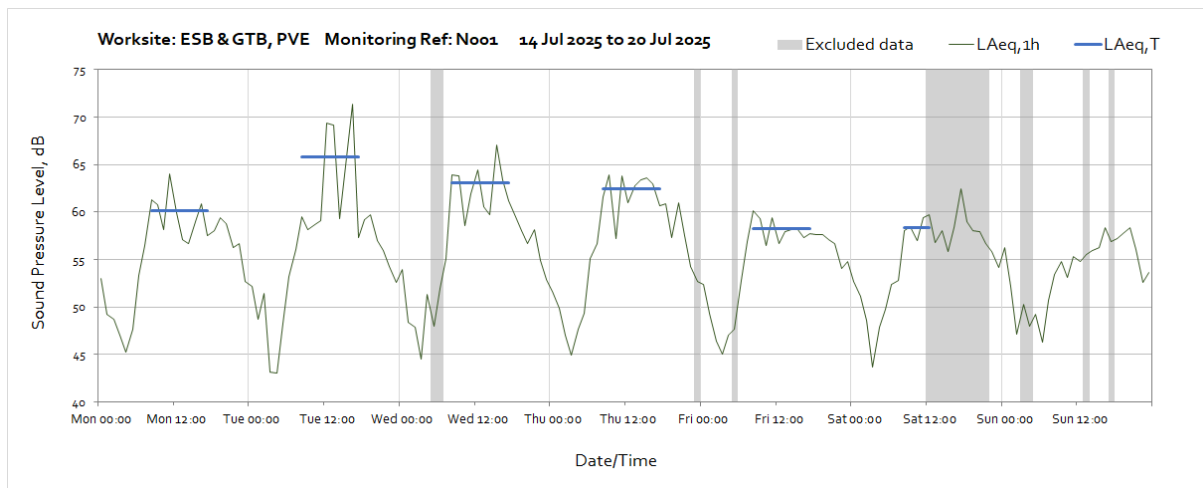
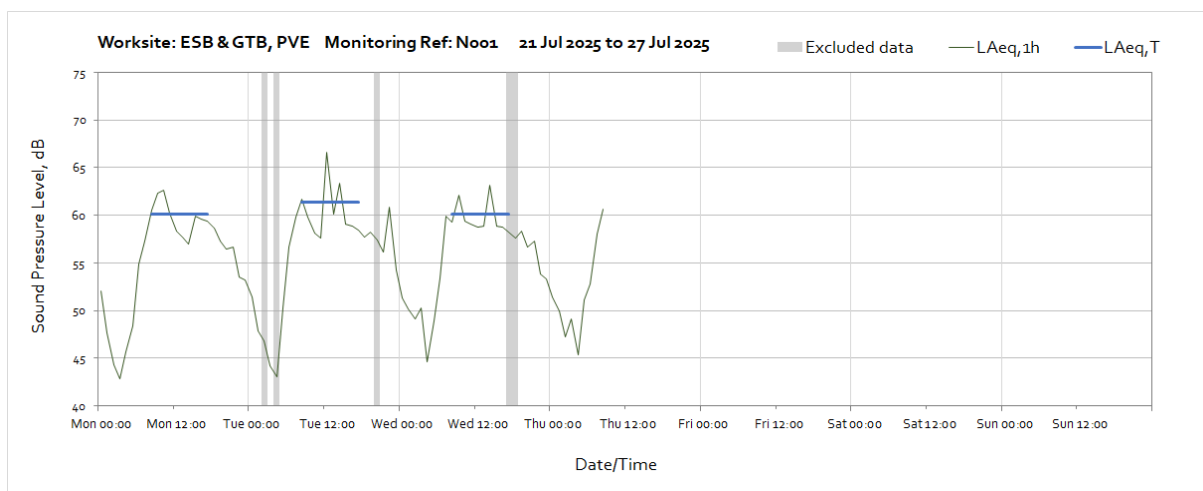
## Worksite: ESB & GTB, PVE – Monitoring Ref: N001

Note: Missing data between the start of the month and 09:00 on Monday 7<sup>th</sup> July was due to loss of power at the monitoring station.

Note: Missing data between 09:00 on Thursday 24<sup>th</sup> July and the end of the month was due to loss of power at the monitoring station

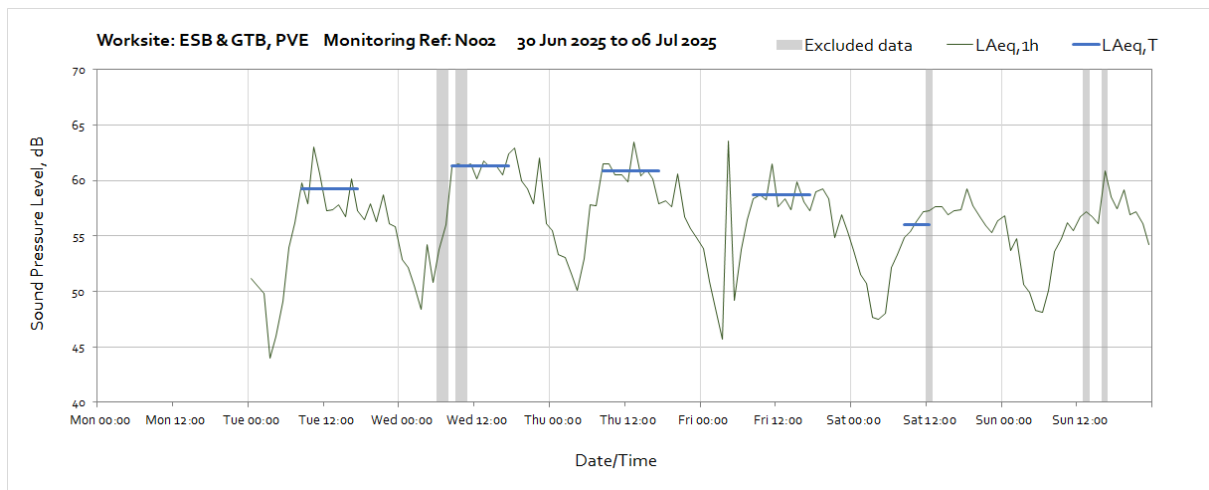
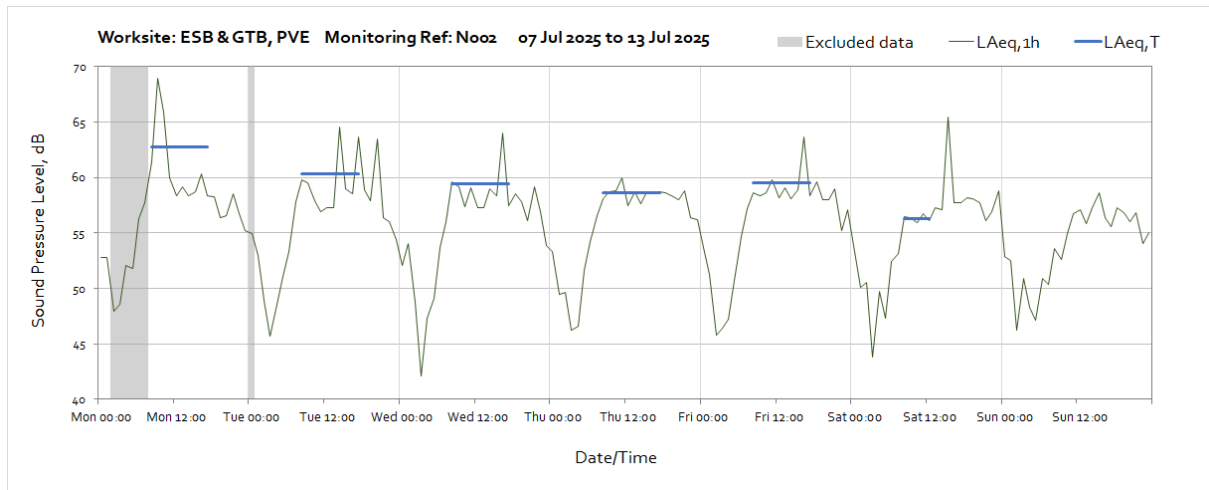
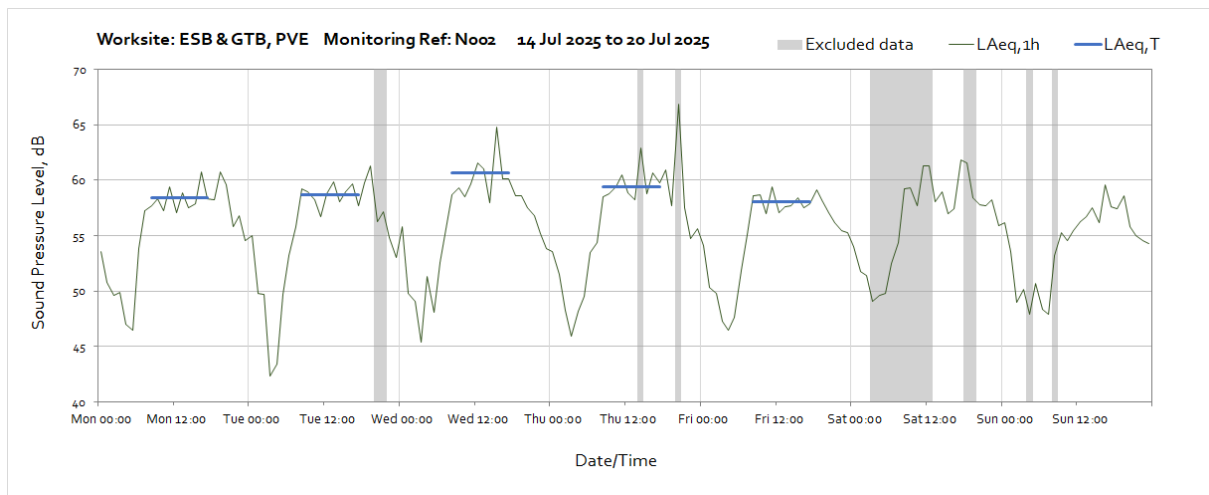
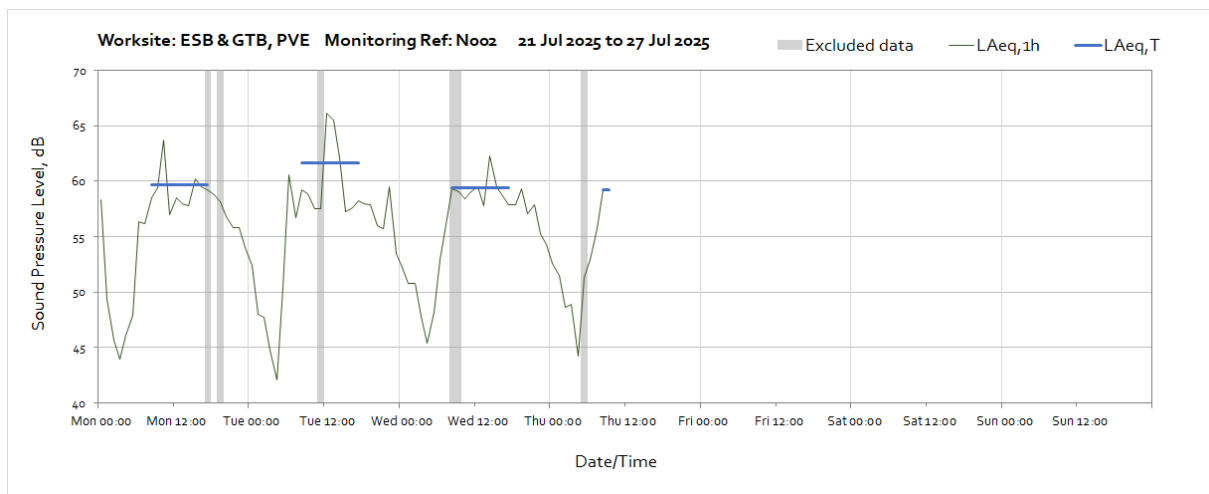
## Worksite: ESB & GTB, PVE – Monitoring Ref: N002

Note: Missing data between 10:00 on Thursday 24<sup>th</sup> July and the end of the month was due to loss of power at the monitoring station

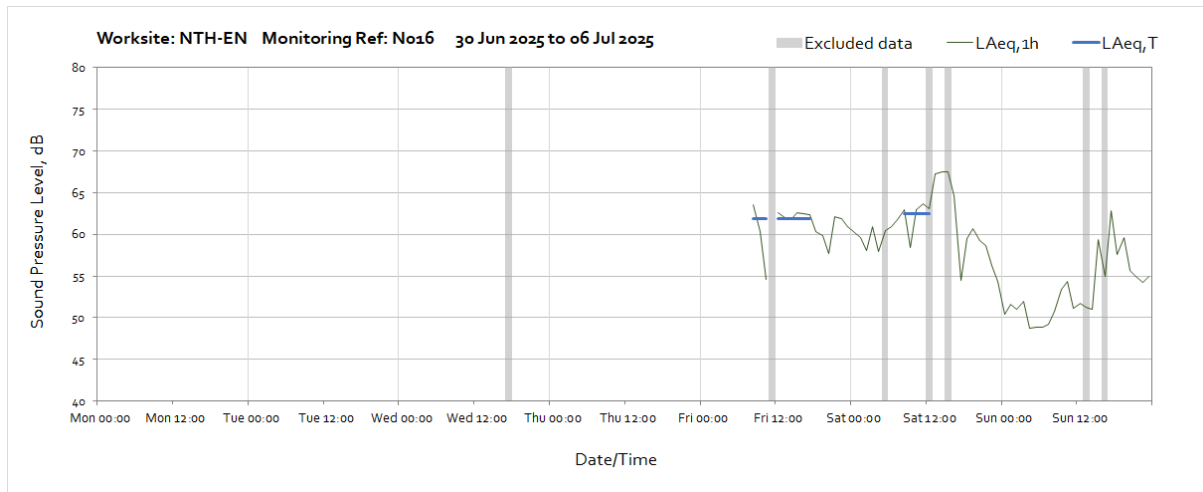
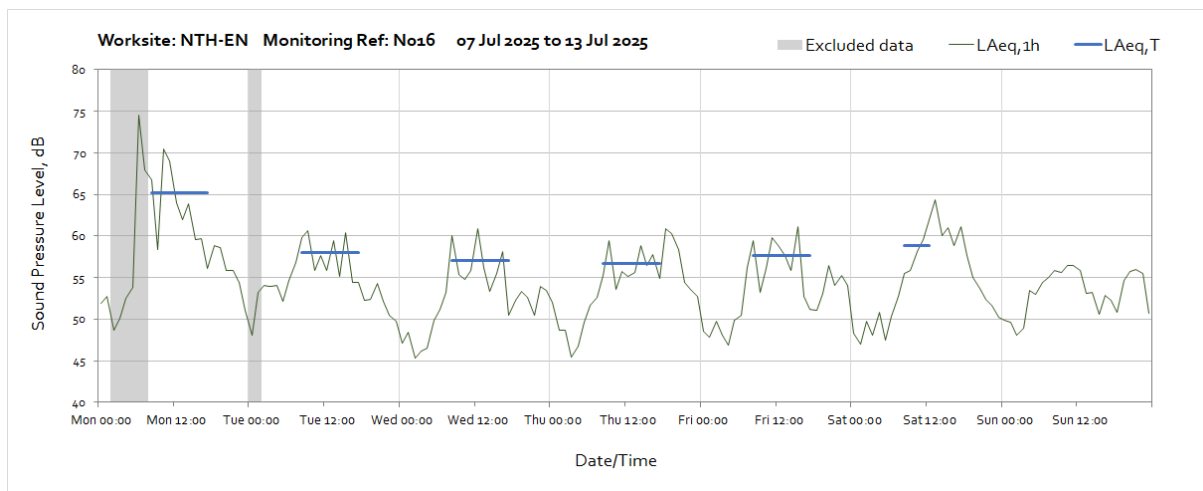
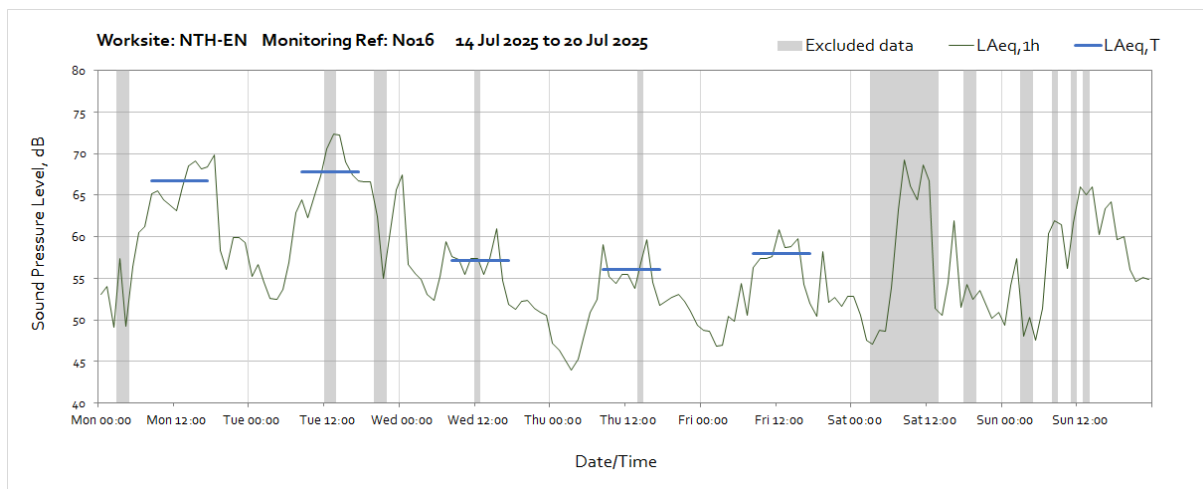
## Worksite: NTH-EN, MF – Monitoring Ref: N016

Note: Missing data between the start of the month and 07:00 on Friday 4<sup>th</sup> of July and between 10:00 and 12:00 on Friday 4<sup>th</sup> July was due to loss of power at the monitoring station and issues with the replacement monitoring station.

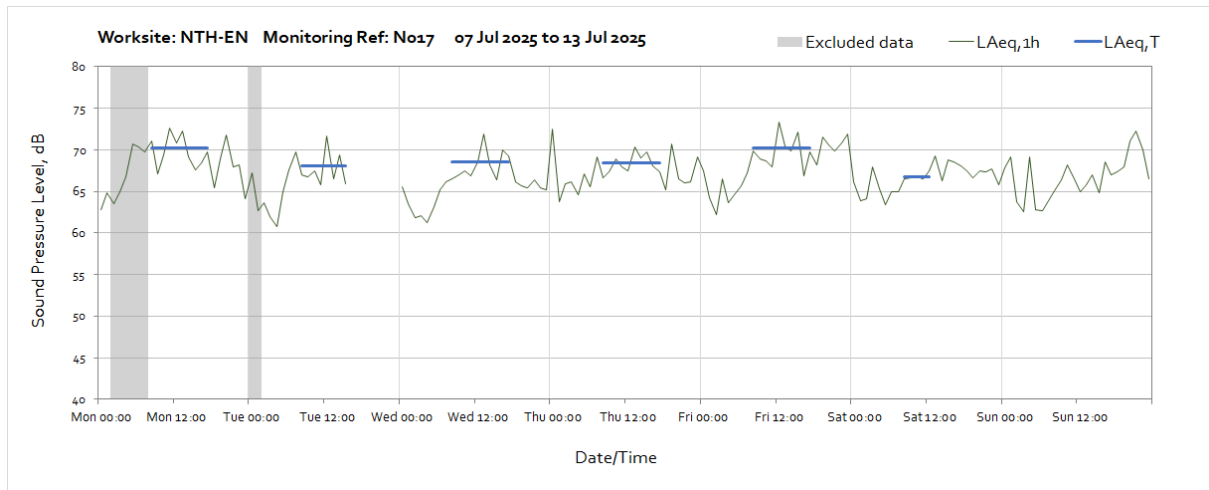
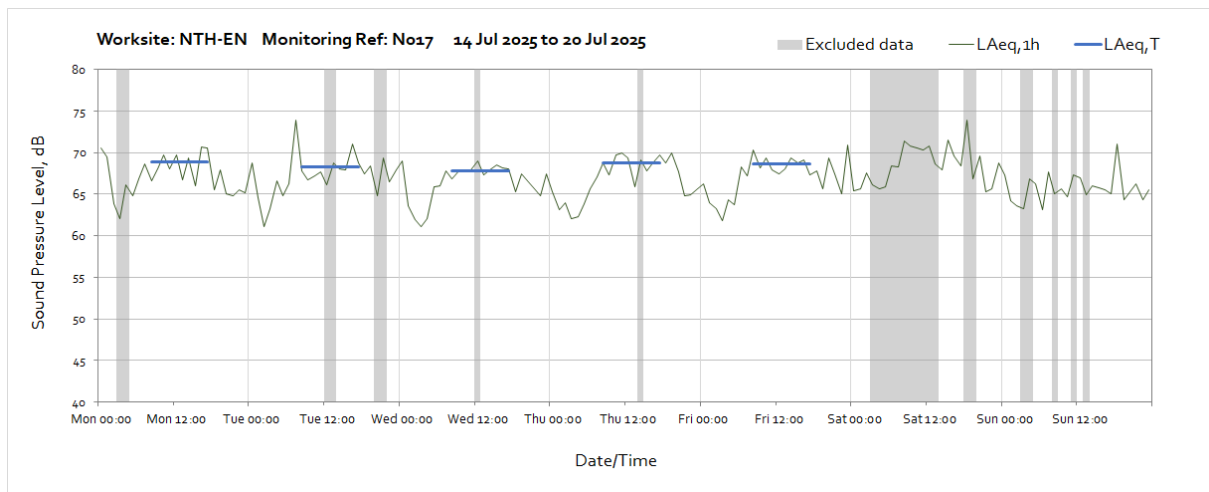
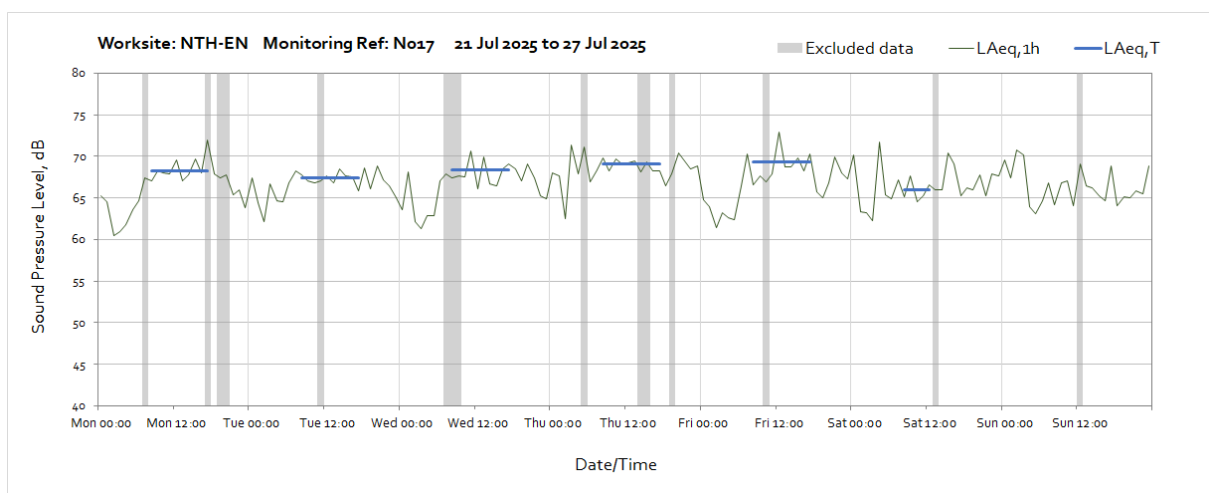
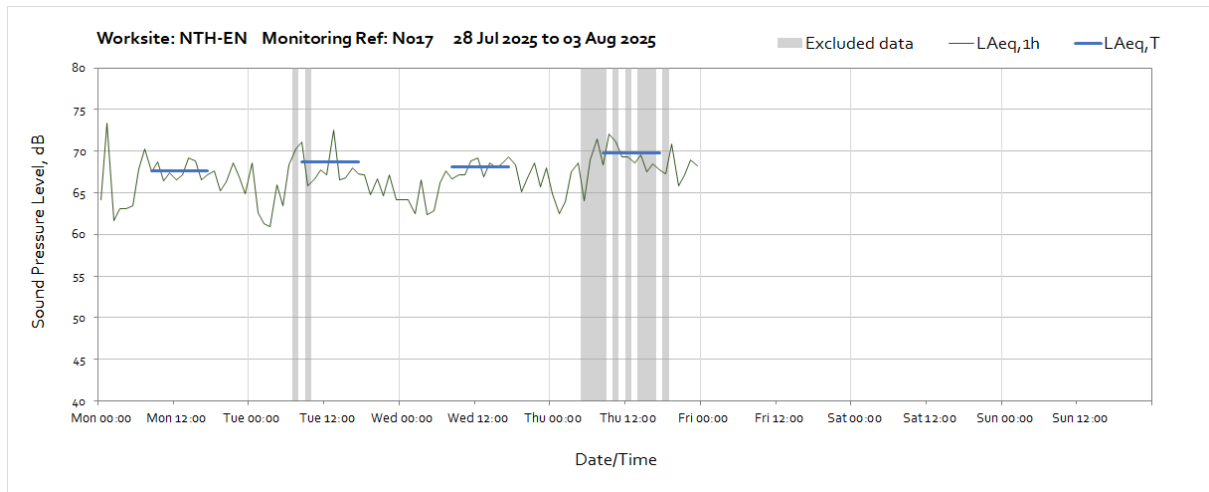
## Worksite: NTH-EN, MF – Monitoring Ref: N017

Note: Missing data between 16:00 and 23:00 on Tuesday 8<sup>th</sup> July was due to a monitoring station error.

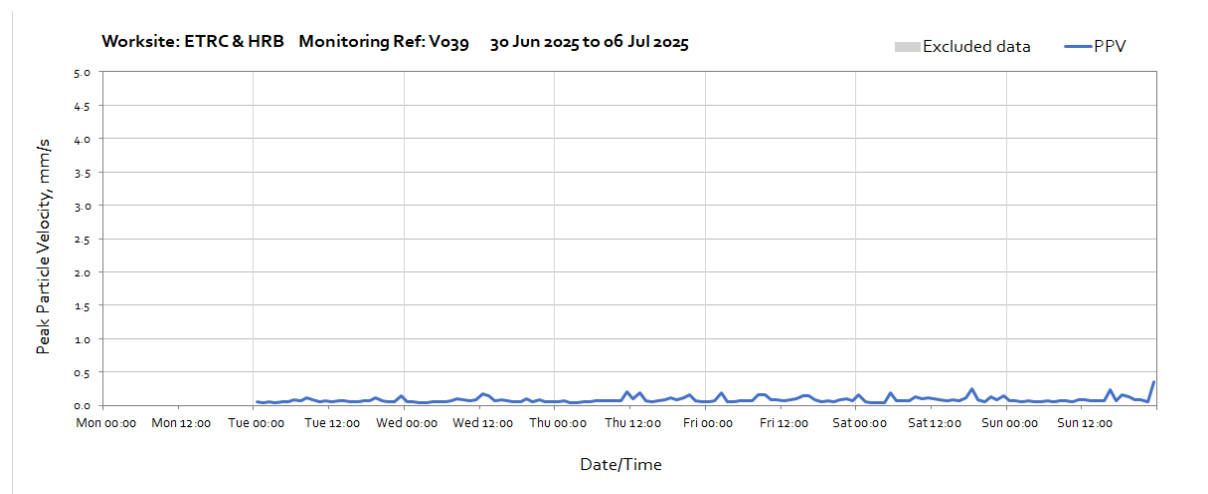
### Worksite: ETRC & HRB – Monitoring Ref: V039

The following graphs show the hourly measured peak particle velocity PPV recorded during the monitoring period. The graphs show the highest PPV of the three orthogonal axes x, y and z . Periods where PPV values have been affected by local interference with the vibration monitor or only measured for part of the period, which are not representative of HS2 construction works , have been greyed out and excluded when calculating values in Table 4 of the main report.
