EPR Compliance Assessment Report

Report ID: 50066/0394656

This form will report compliance with your permit as determined by an Environment Agency officer									
Site	Nick Brookes Demolition & Waste Disposal			Permit Ref	EAWML 50066 EPR/EP3798CS				
Operator/ Permit holder	Brookes Ni	ck							
Date	27/05/2021			Time in	10:30	Out	12:00		
What parts of the permit were assessed	Specified activities, Infrastructure, Management, Incident preventions, Amenity								
Assessment	Site Inspection	EPR Activity:	Installation	Waste Op X	Wat	er Disch	arge		
Recipient's name/position	, Transport Operations Manager								
Officer's name	Tammy Finlayson, Chris Woodcock			Date issued		08/06/2021

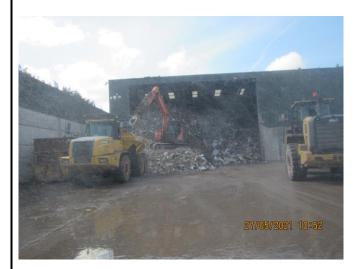
At the time of inspection the waste inside the transfer shed was high (see picture 1) and spilling out of the transfer shed. The Transport Operations Manager advised this was due to a breakdown with the trommel, which he had notified the inspecting officer of previously.

See picture (below) – Waste outside transfer station

At the time of inspection there was waste outside the right side of the transfer shed.

At the time of inspection the mixed waste was outside the transfer station and at the time of inspection the mixed waste at the back of the transfer station has been on site for two months.

ACTION: Ensure the conditions of the environmental permit and management systems are adhered to at all times.

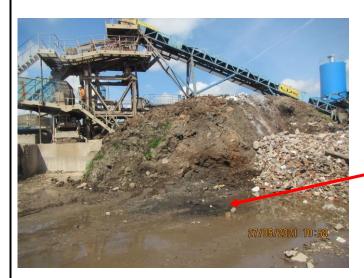
At the time of inspection there was a soil like stockpile (see picture 2), which had an unknown dark leachate coming from it. The inspecting officer asked where the soil like material has come from and what its intend use. The Transport Operations Manager advised the soil like material has come from the processing on site and will probably be send out for agriculture use once fully processed.

See picture (below) - Unknown dark leachate coming from the soil like stockpile

Unknown dark leachate

The inspecting officer advised the soil like material is required to be tested due to the unknown leachate, to demonstrate it is suitable for the intended use.

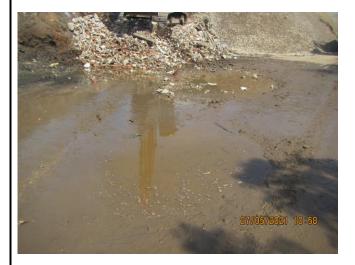
At the time of inspection the concrete adjacent to the construction and demolition stockpile was in disrepair (see picture 3), which caused water pooling. The Transport Operations Manager advised this was caused by wear and tear from vehicle movement.

See picture (below) - Concrete in disrepair and water pooling

At the time of inspection the concrete has fallen into disrepair in a couple of area areas.

It was agreed that all the concrete repairs would be completed by 28th June 2021.

ACTION: Ensure all concrete which has fallen into disrepair is repaired by 28th June 2021 by 10am.

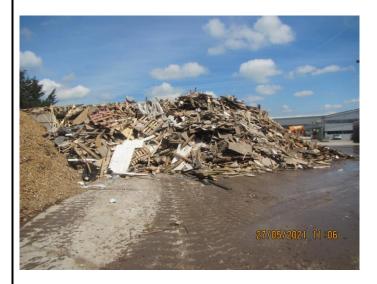
At the time of inspection the wood stockpile was high and the wood was over-spilling the bay (see picture 4).

See picture (below) - Wood over-spilling the bay

At the time of inspection the wood stockpile was overs-pilling the bay.

ACTION: Ensure the conditions of the environmental permit and management systems are adhered to at all times.
