## Audit Report Form

| <b>Permit Number</b> | <b>EAWML 50066/M01</b> | <b>Site Name</b> | <b>Nick Brookes</b> |
| <b>Date(s) of audit</b> | <b>18<sup>th</sup> June 2009</b> | <b>CAR ID No.</b> | <b>I/18.06.09/50066/M01</b> |

| <b>Title</b> | Audit report form for Nick Brookes | | | | |

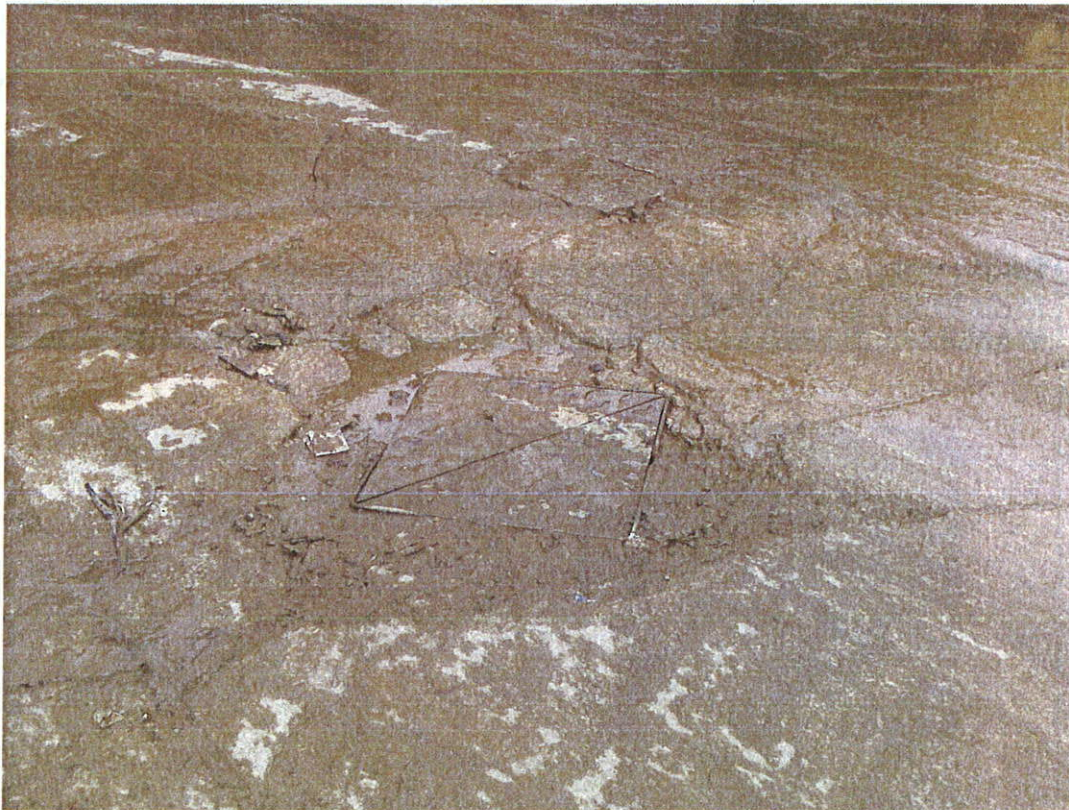
#### Photographs 1 Damaged concrete surface

Areas of cracks were observed on the site's concrete surface. The faults need to be repaired to prevent site drainage from entering and contaminating the ground below ( Photographs 1,2 & 3 ).

| Permit condition | CAR sub-riteria | Comments and suggested corrective action | Proposed date for completion | CCS score 4 – 1 | Environment Agency proposed response |
|---|---|---|---|---|---|
| 2.1.1<br>Table 2.1 b | B1 | Concrete surface is cracked in places and needs to be repaired. | immediate | C4 | Site warning |

Previous inspections have identified issues regarding poor drainage and standing surface water. Operator to ensure site drains are maintained to allow adequate drainage and prevent areas of standing water.

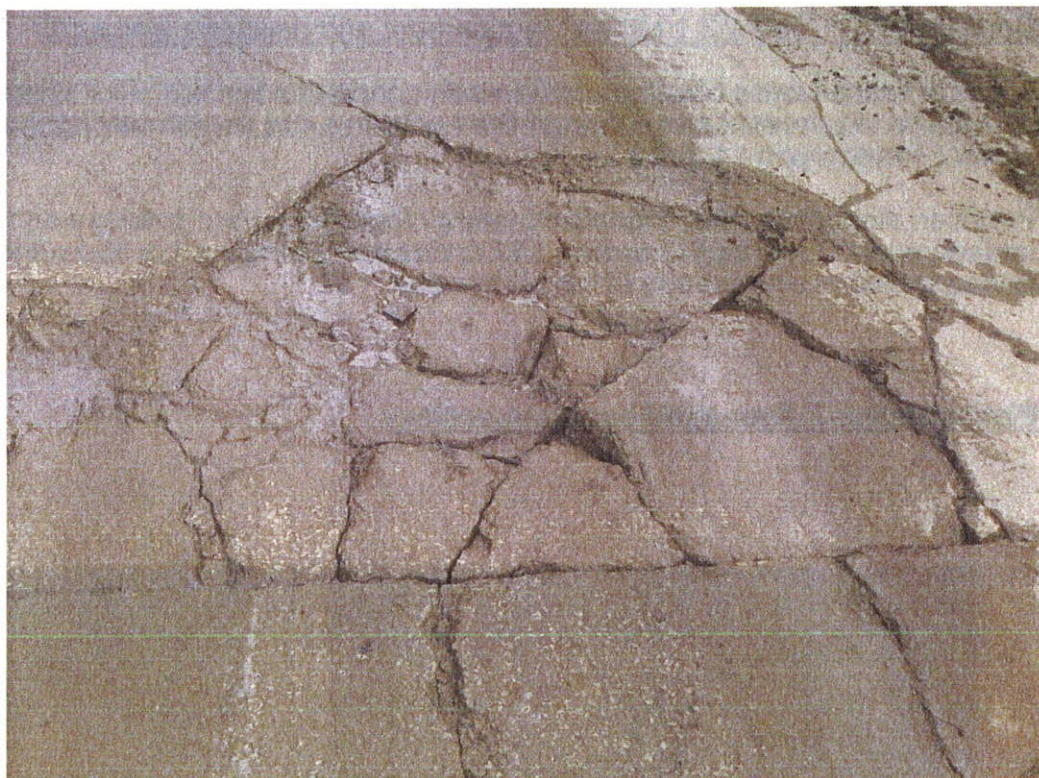
**Photograph 2 – Damaged concrete surface**

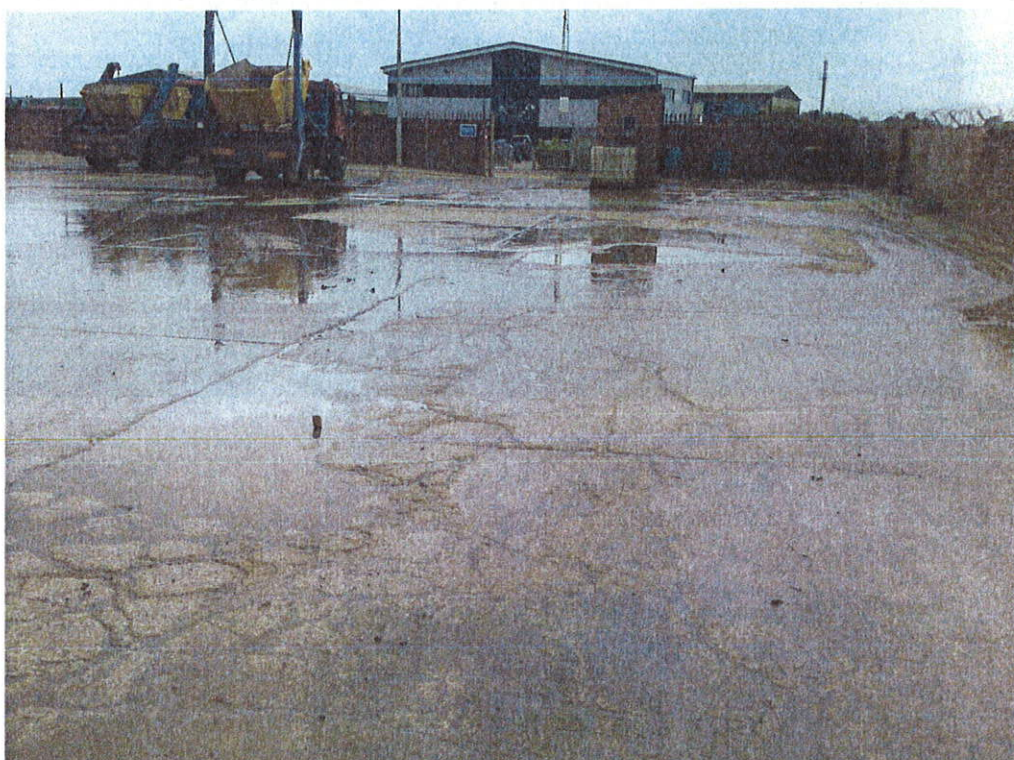
**Photograph 3 – Cracked concrete surface. Sprinklers had been operational prior to the inspection as indicated by the wet surface. No mud was noted at the time of the audit to be tracking off site and no dust emissions observed.**

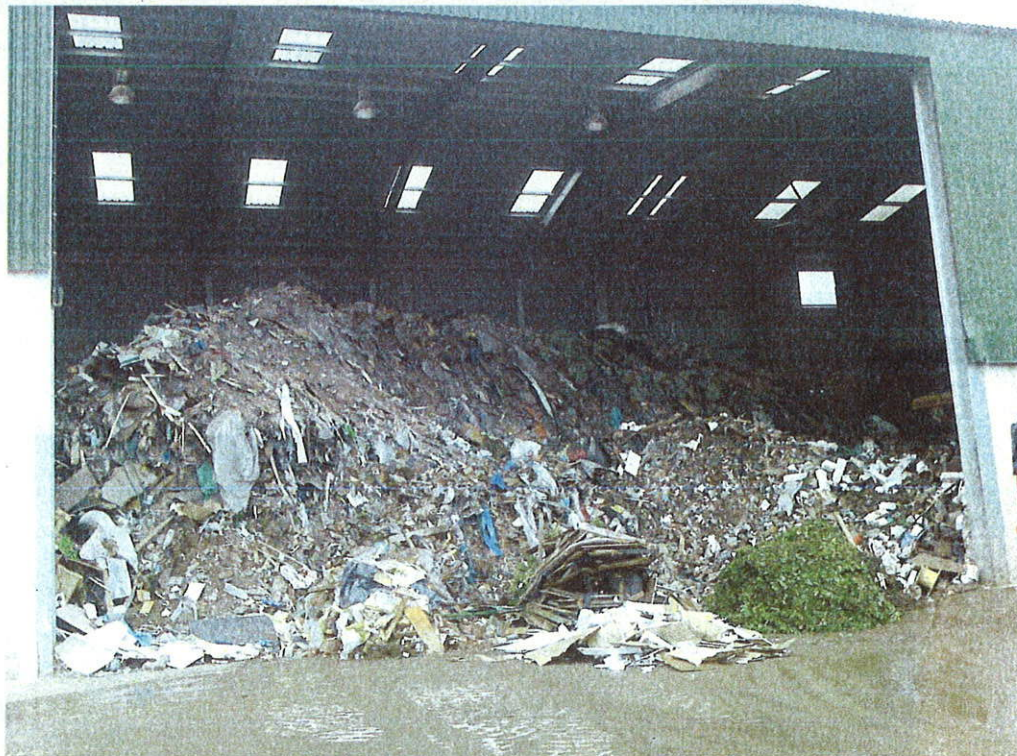
**Photograph 4 – Waste inside transfer building waiting to be sorted on the trommel and in the picking station. Operator confirmed that maintenance works were undertaken on the machine during the previous week and that the level of waste had built up, although not exceeding the permitted the storage height.**

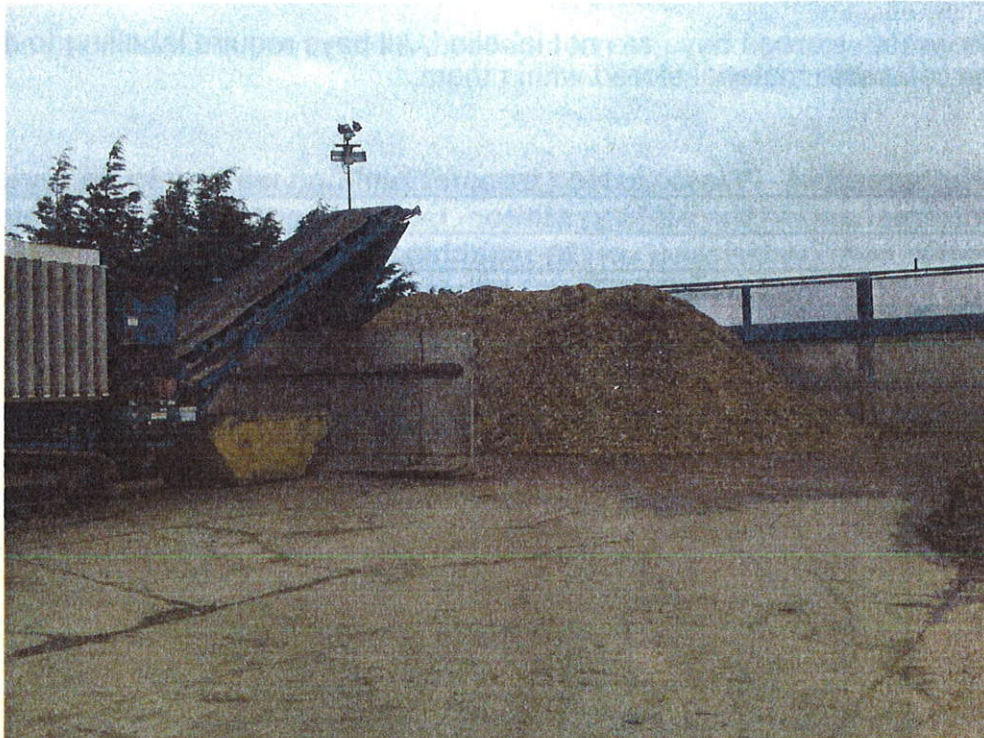
The waste storage bays are not labelled. All bays require labelling to describe the type of waste material stored within them.

**Photograph 5 – Stock pile of wood chip. Height of waste material just level with the site boundary netting. Designated storage bay not labelled.**

| Permit condition | CAR sub-riteria | Comments and suggested corrective action | Proposed date for completion | CCS score 4 – 1 | Environment Agency proposed response |
|---|---|---|---|---|---|
| Table 4.4 c) | C4 | Areas and bays should be clearly defined and labelled to identify the waste stored within them | immediate | C4 | Site warning |

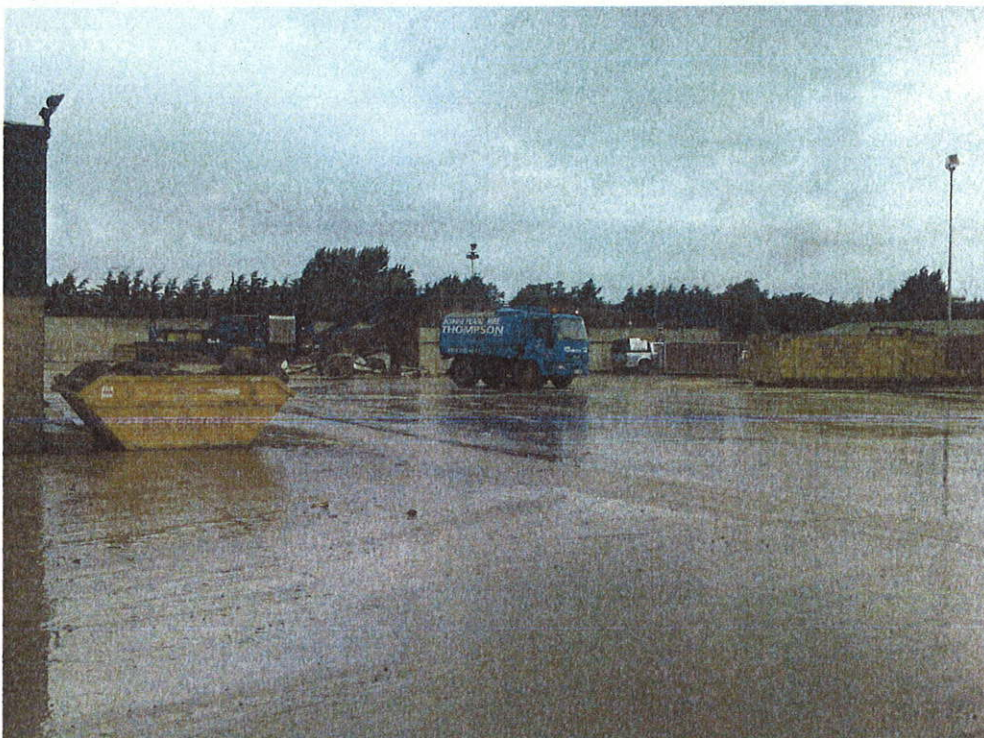
**Photograph 6 – site yard in good order at time of inspection**

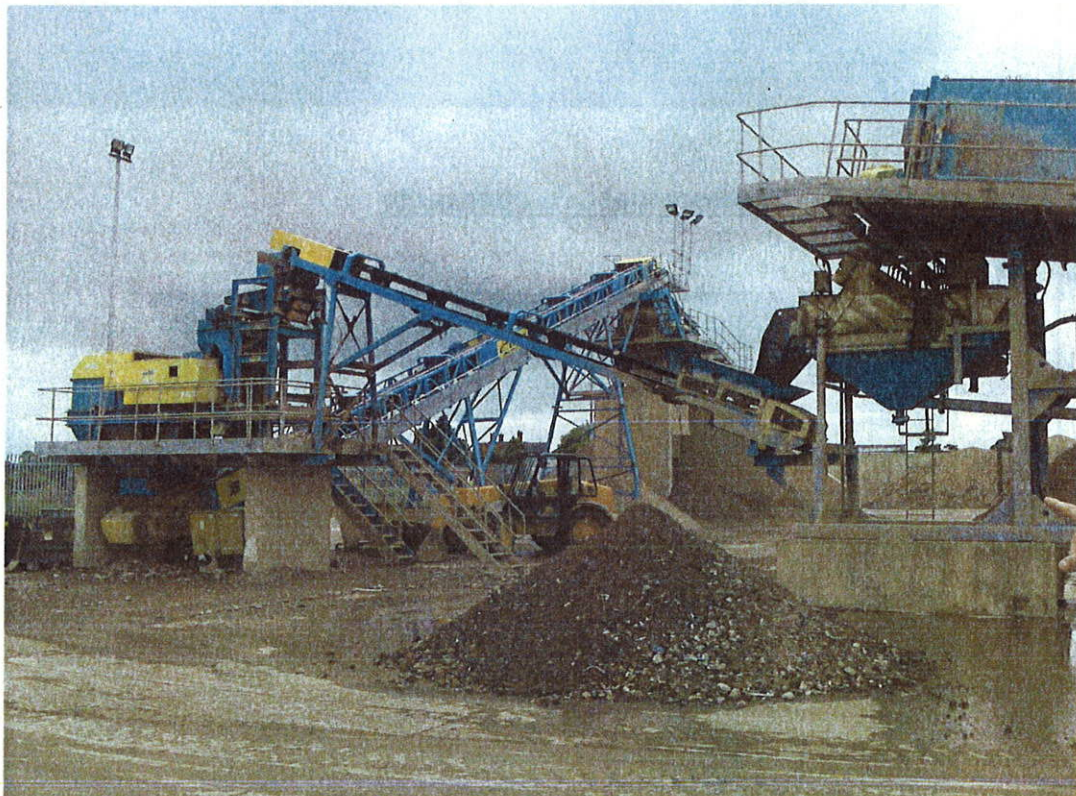
### Photograph 7 – Aggregate washing plant

The fixed washing plant is located at the rear of the site behind the transfer building. Operations are carried out under a paragraph 13 exemption. Waste streams permitted under the activity include demolition or construction material, ash, slag, clinker, rock, bark, paper, straw or gypsum.

The plant is producing a variety of mixed products - 6F2, Type 1 and Type 2 sub base ( MOT ), pipe bedding ( eg. 4-20mm ), aggregates for use in concrete and

Uncontaminated inert waste can be processed under the acceptance criteria of the WRAP Aggregates protocol. It is evident that the feed stock for the paragraph 13 activity comprises of pre-mixed material - HCL waste and construction / demolition waste, and it does not fit the criteria of the exemption.

Operator is requested to submit proposals to demonstrate compliance with the Paragraph 13 exemption and WRAP Aggregates Protocol.

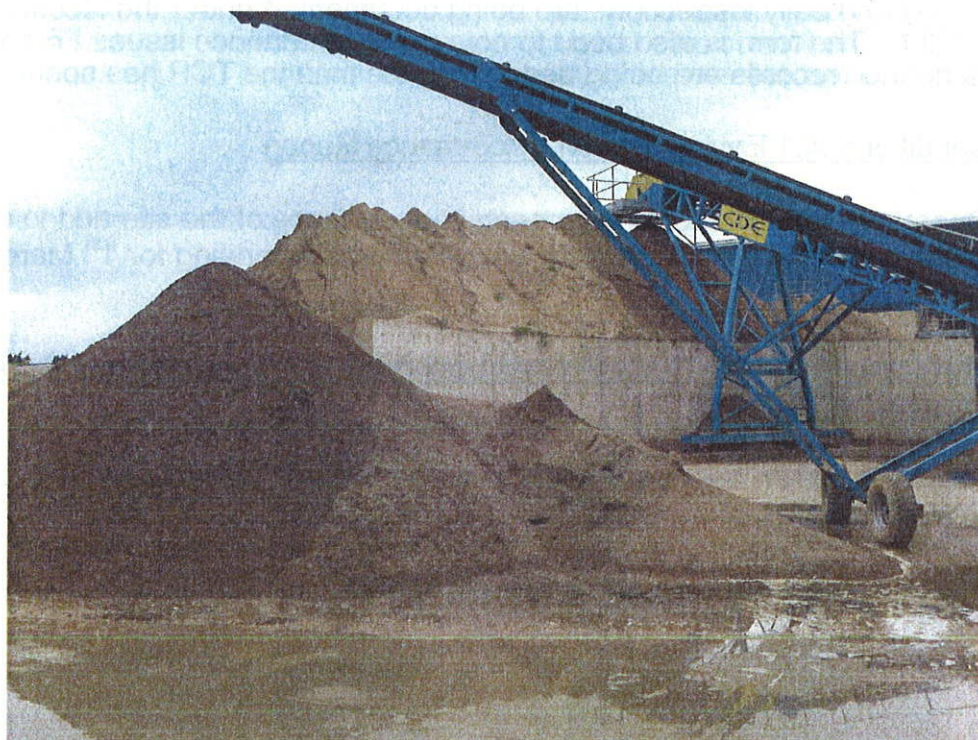
**Photographs 8 – Product washed sand**

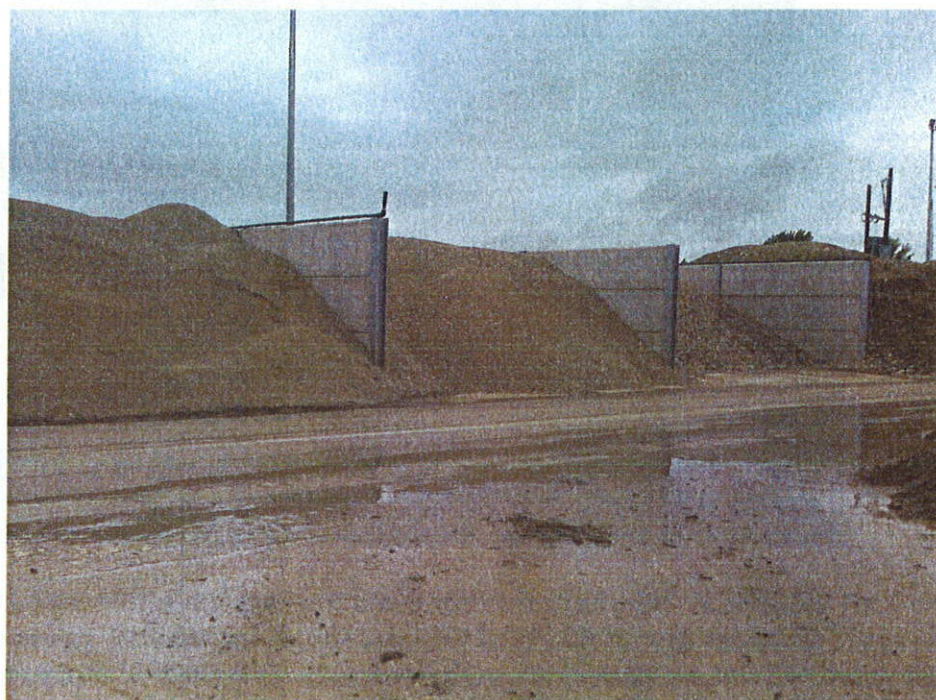
**Photograph 10 – Clearly define storage product bays**

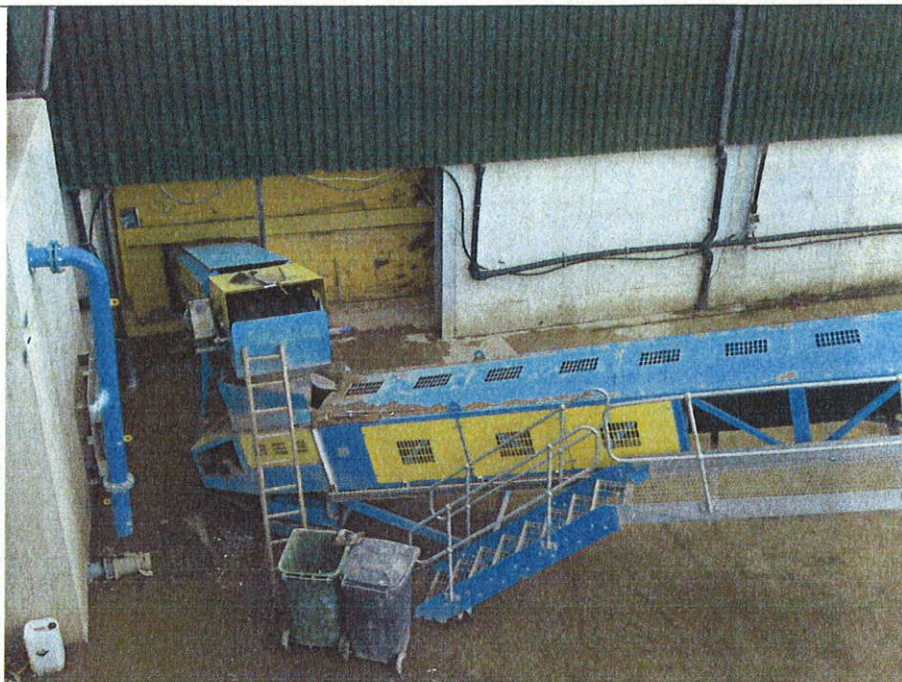
The mixed HCL and construction and demolition waste is originally accepted under the permit EAWML/50066. The waste is then processed by the trommel and from this the operator estimated that approximately 95% of the current feed flow of waste (fines ) from the transfer station is sent to the wash plant. Approximately 5% of brick and concrete material is tipped at the rear of the washing facility. The majority of this material comprises of Utilities tipping on site.

**Photograph 11 –Trommel feeding the fines from the transfer station to the aggregate washing plant**

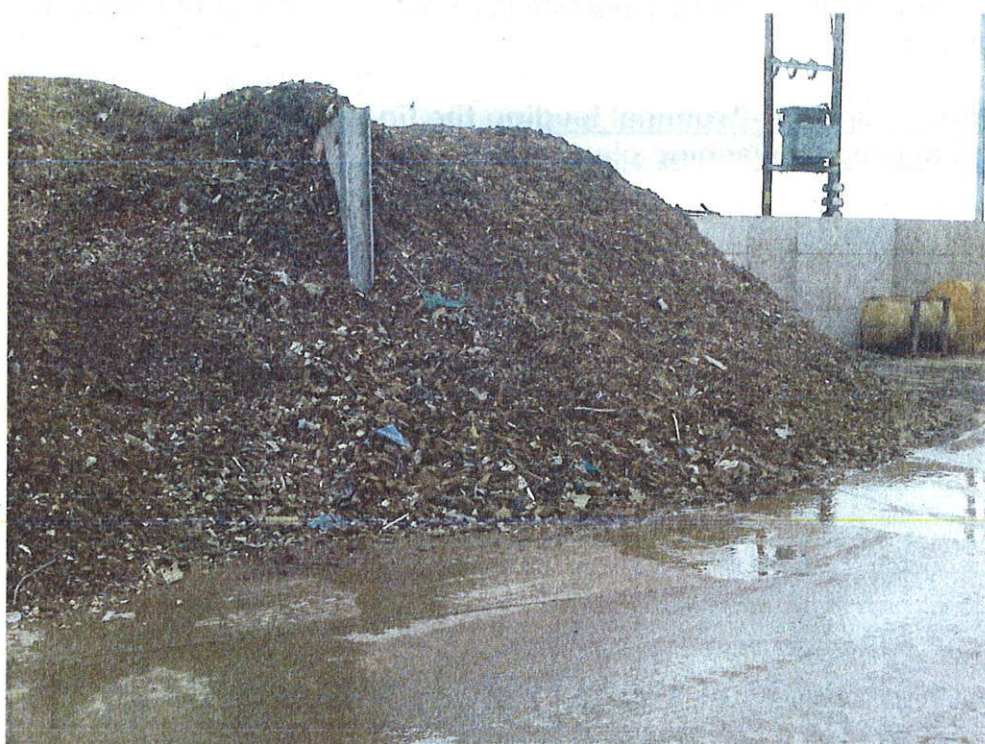
The inert material is blended and rinsed and the are fines removed. Polymer and anti foam products are added to aid separation. A log washer takes off any floatable which are removed via a trash screen. The trash is stored in two bays and the material taken to landfill.

**Photograph 12 – Stockpile of unsuitable material arising from the wash Plant which are taken to landfill**

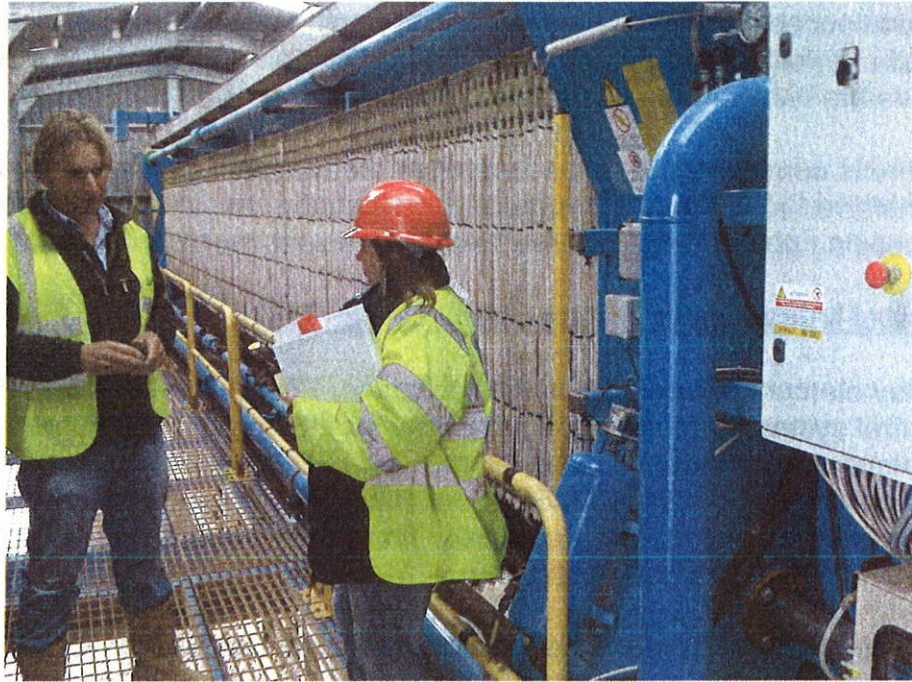
**Photograph 13 - The Press room**

The fines are taken out and graded. The sludge sinks and is then held in a holding tank. From here the sludge is pressed in the press room to form silt and clay products. The sludge can be made into any consistency required and can make a good soil conditioner.

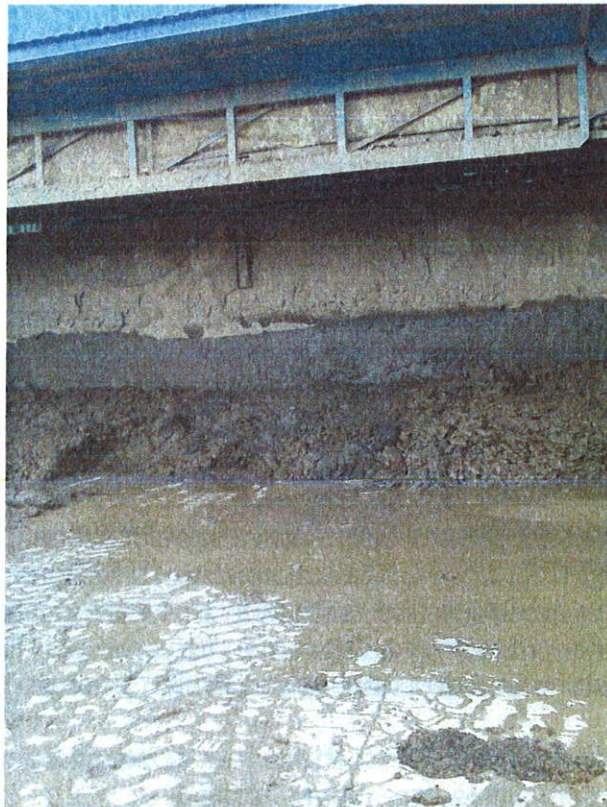
**Photograph 14 - The presses squeeze out the water and the clay drops to the ground. A full cycle takes approximately 30-40 minutes.**
