Air Quality and Dust Monitoring Monthly Report - August 2025

West Northamptonshire District Council

A report prepared by EWCs and MWCCs on behalf of HS2 Ltd.

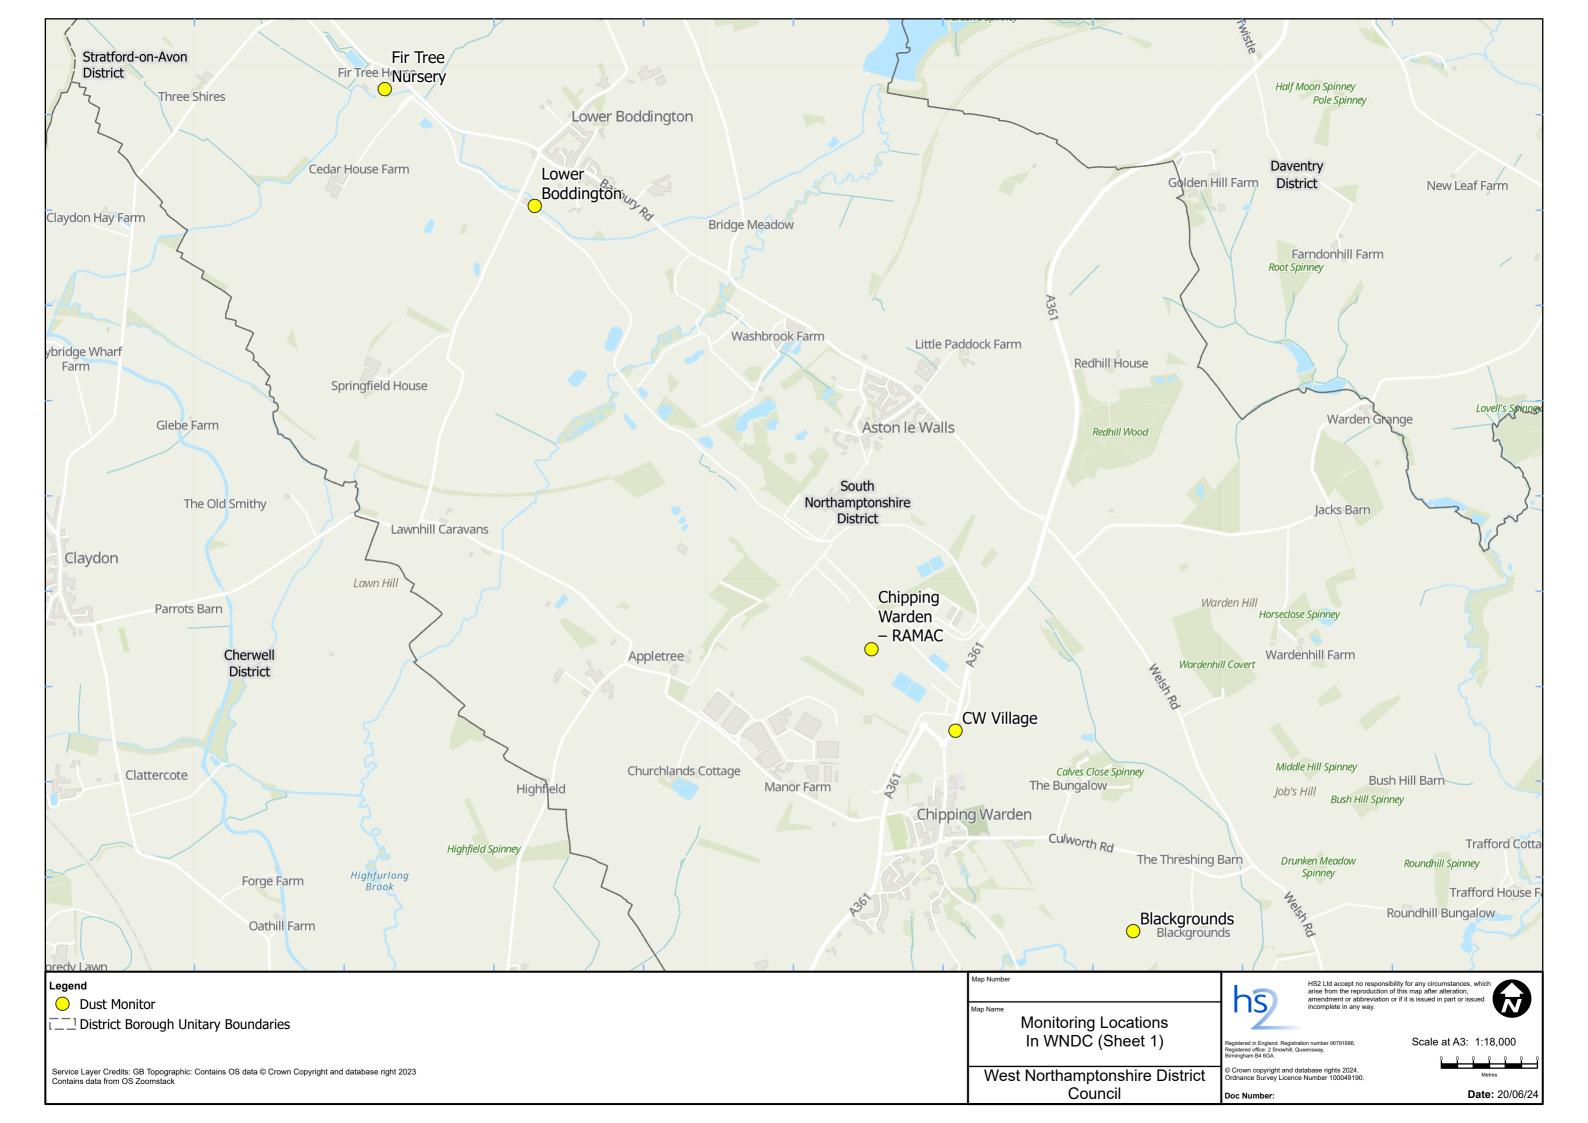
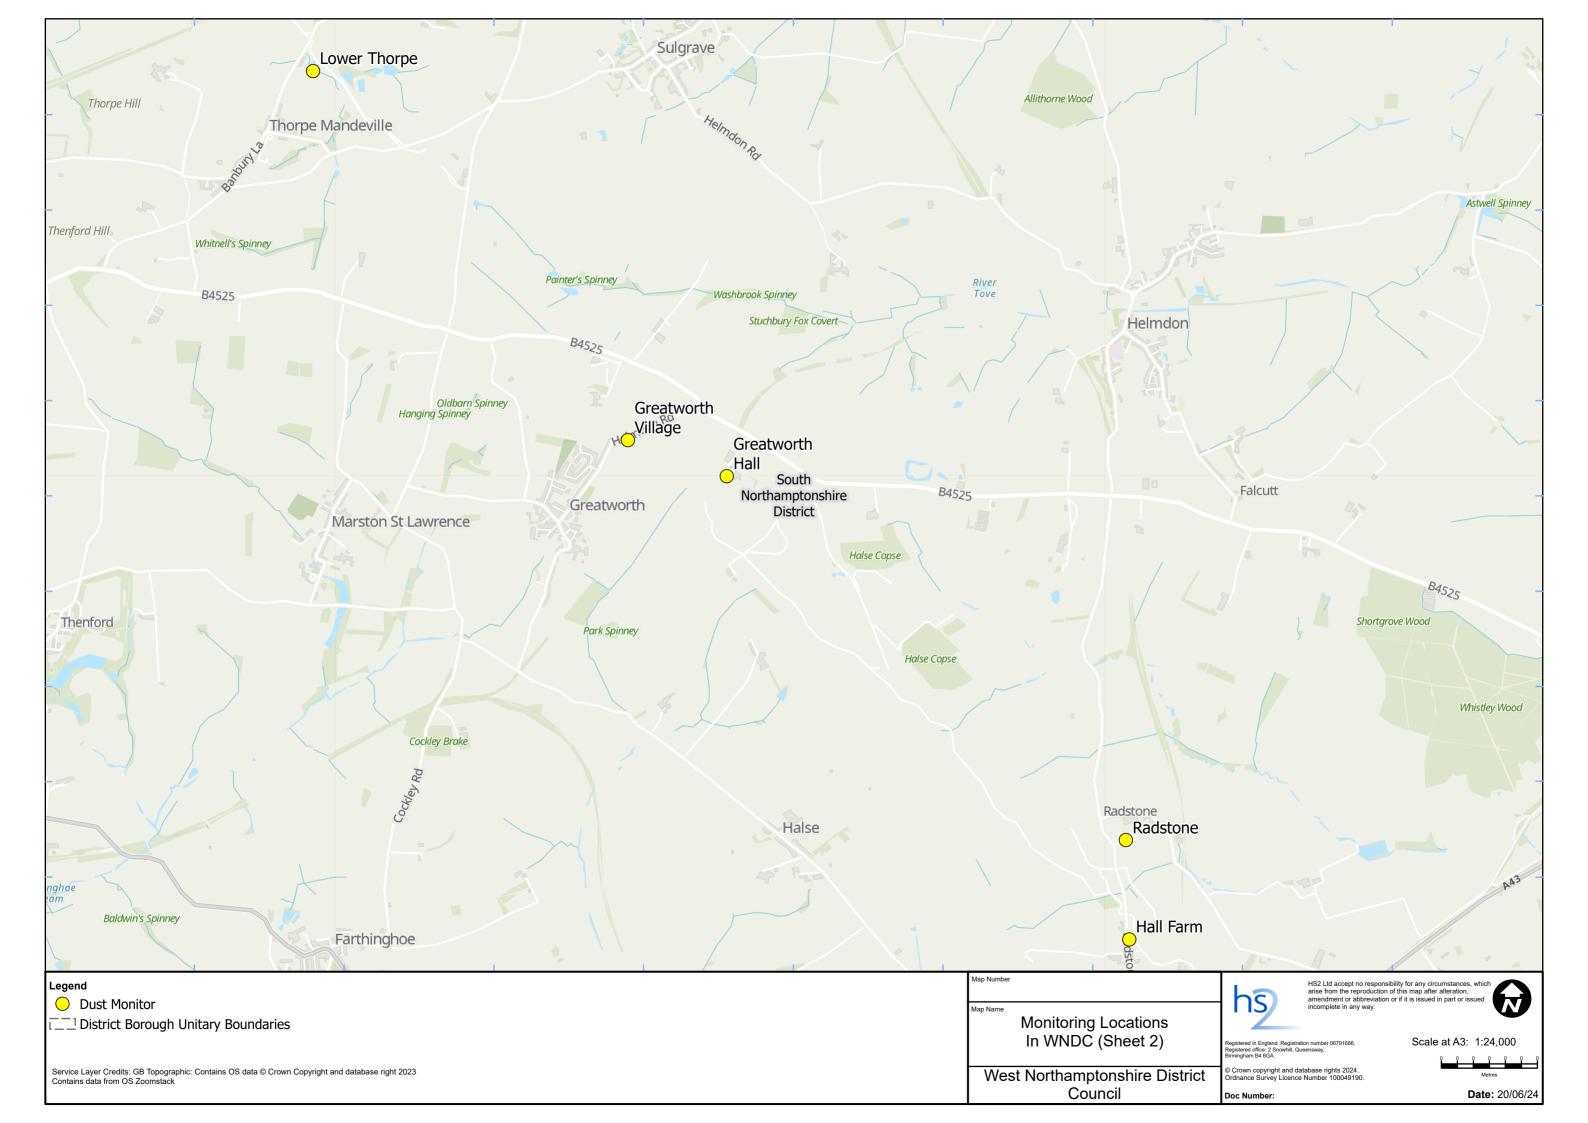
Figures 1 and 2: Worksites and Monitoring Locations within WNDC

- 1.1.2 Figure 1 and Figure 2 in Appendix A present the current worksites together with the dust monitoring locations.
- 1.1.3 This summary should be read in conjunction with the overview monitoring report available from www.gov.uk/government/collections/monitoring-the-environmental-effects-of-hs2, which highlights: the applicable standards and guidance, as well as the air quality and dust monitoring methodologies to be implemented by nominated undertakers throughout construction.

- 1.1.4 The current worksites, as presented in Appendix A, Figure 1 and Figure 2, include:

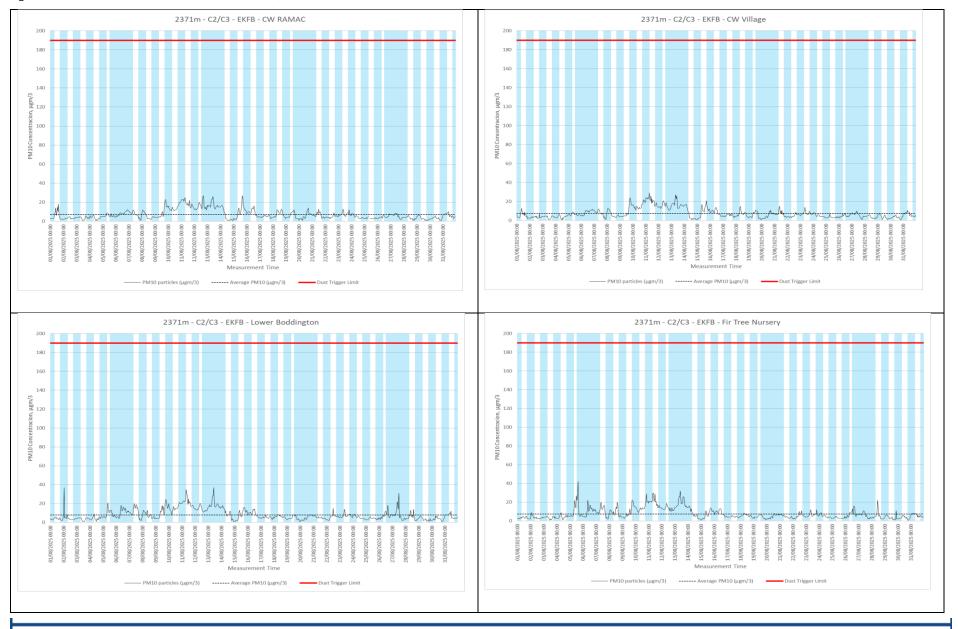
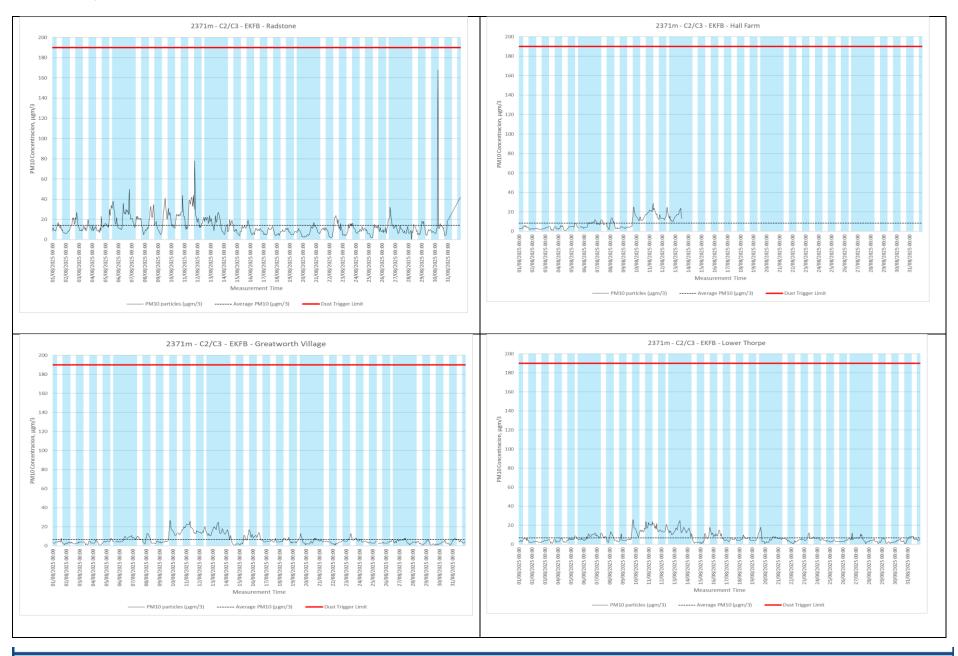
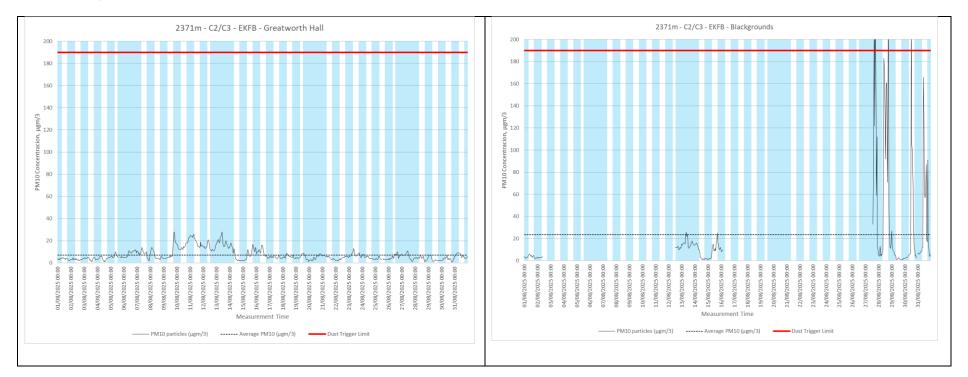
Figure 3: Continuous dust 1-hour mean indicative PM₁₀ concentration for all monitors

- 1.1.6 Dust monitoring locations and results are presented in Appendix B, Table 2, together with line charts of monthly data from each dust monitor, presented in Figure 3. All continuous dust monitoring is undertaken using indicative monitors. Despite being Environment Agency (MCERTS) certified, indicative monitors carry a higher level of uncertainty than reference monitors, and therefore cannot be strictly compared with Air Quality Standards for human health and the environment. The purpose of the monitoring undertaken is to ensure the effectiveness of the on-site mitigation.

- 1.1.7 The trigger level for PM₁₀ concentrations of 190 μg/m³, over a 1-hour period, in accordance with the updated guidance document 'Guidance on Monitoring in the Vicinity of Demolition and Construction Sites (October 2018)' has been applied.

| Monitoring Site ID | Period of trigger alert & Concentration recorded | Investigation | Outcomes / Resolution / Remedial measures implemented |
|---|---|---|---|
| Blackgrounds | 27/08/2025: 15:01 - 16:00; 218 µg/m ³ 17:01 - 18:00; 242 µg/m ³ 28/08/2025: 17:01 - 18:00; 228 µg/m ³ 30/08/2025: 11:01 - 12:00; 219 µg/m ³ | Exceedances were investigated and found not to be linked to a precise activity on site but due to the dry and hot weather, causing dust to develop faster than mitigation measures were able to dampen. | The site team has been asked to further dampen down dust in the area with more spraying. These were all isolated incidences which did not trigger any complaints. |
