## Abbreviated Noise Monitoring Report

Monitoring Period: 01 September 2025 to 28 September 2025

| <b>Project:</b> | Grenfell Tower |
| <b>Document Ref:</b> | EEMC-NMR-201/101 – Grenfell Tower Rev 00 |

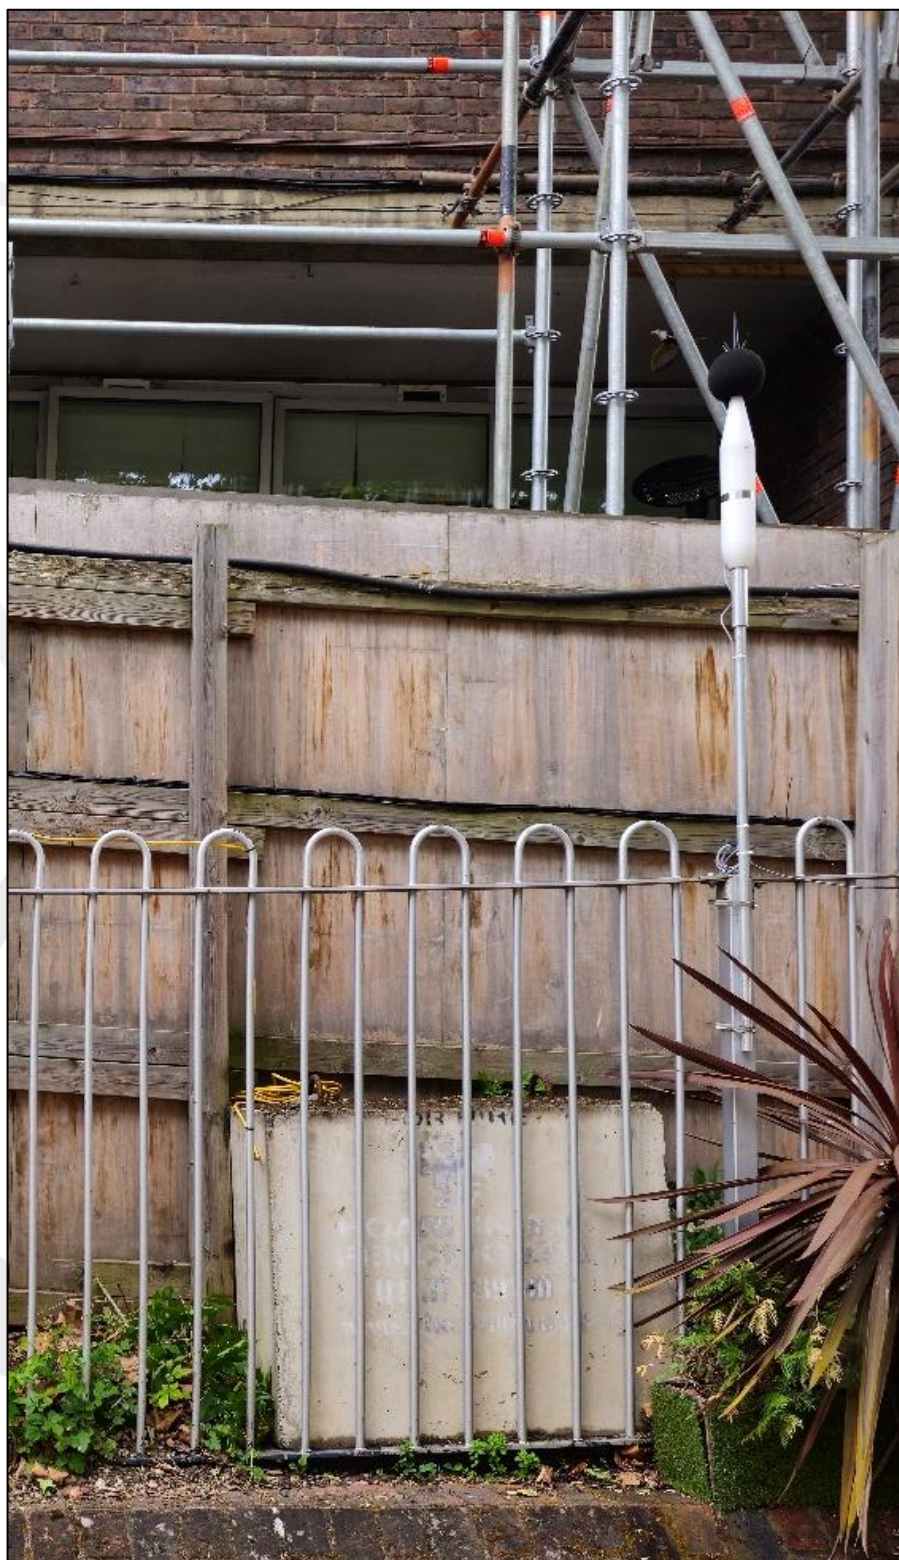
**Image 1 –NMP1 Monitoring Location (19<sup>th</sup> May 2025)**

| ID Reference | Location |
|---|---|
| <b>NMP1</b> | South-East of site on the hoarding |

Three (3) Class 1 compliant noise monitors have been deployed to undertake noise monitoring on the site. A map indicating the location of the noise monitors is provided as Figure 1 and a photograph of the installed noise monitor NMP1 is provided as Image 1. A copy of the calibration certificate for this monitor is attached as Appendix 1.

The noise monitors are installed with an all-weather protective system fitted to the remote microphone, at elevations and locations previously agreed with RBKC. Each system is fitted with a modem to allow remote access to the measurement data via the internet. The modem also enables the provision of automatic email alerts.

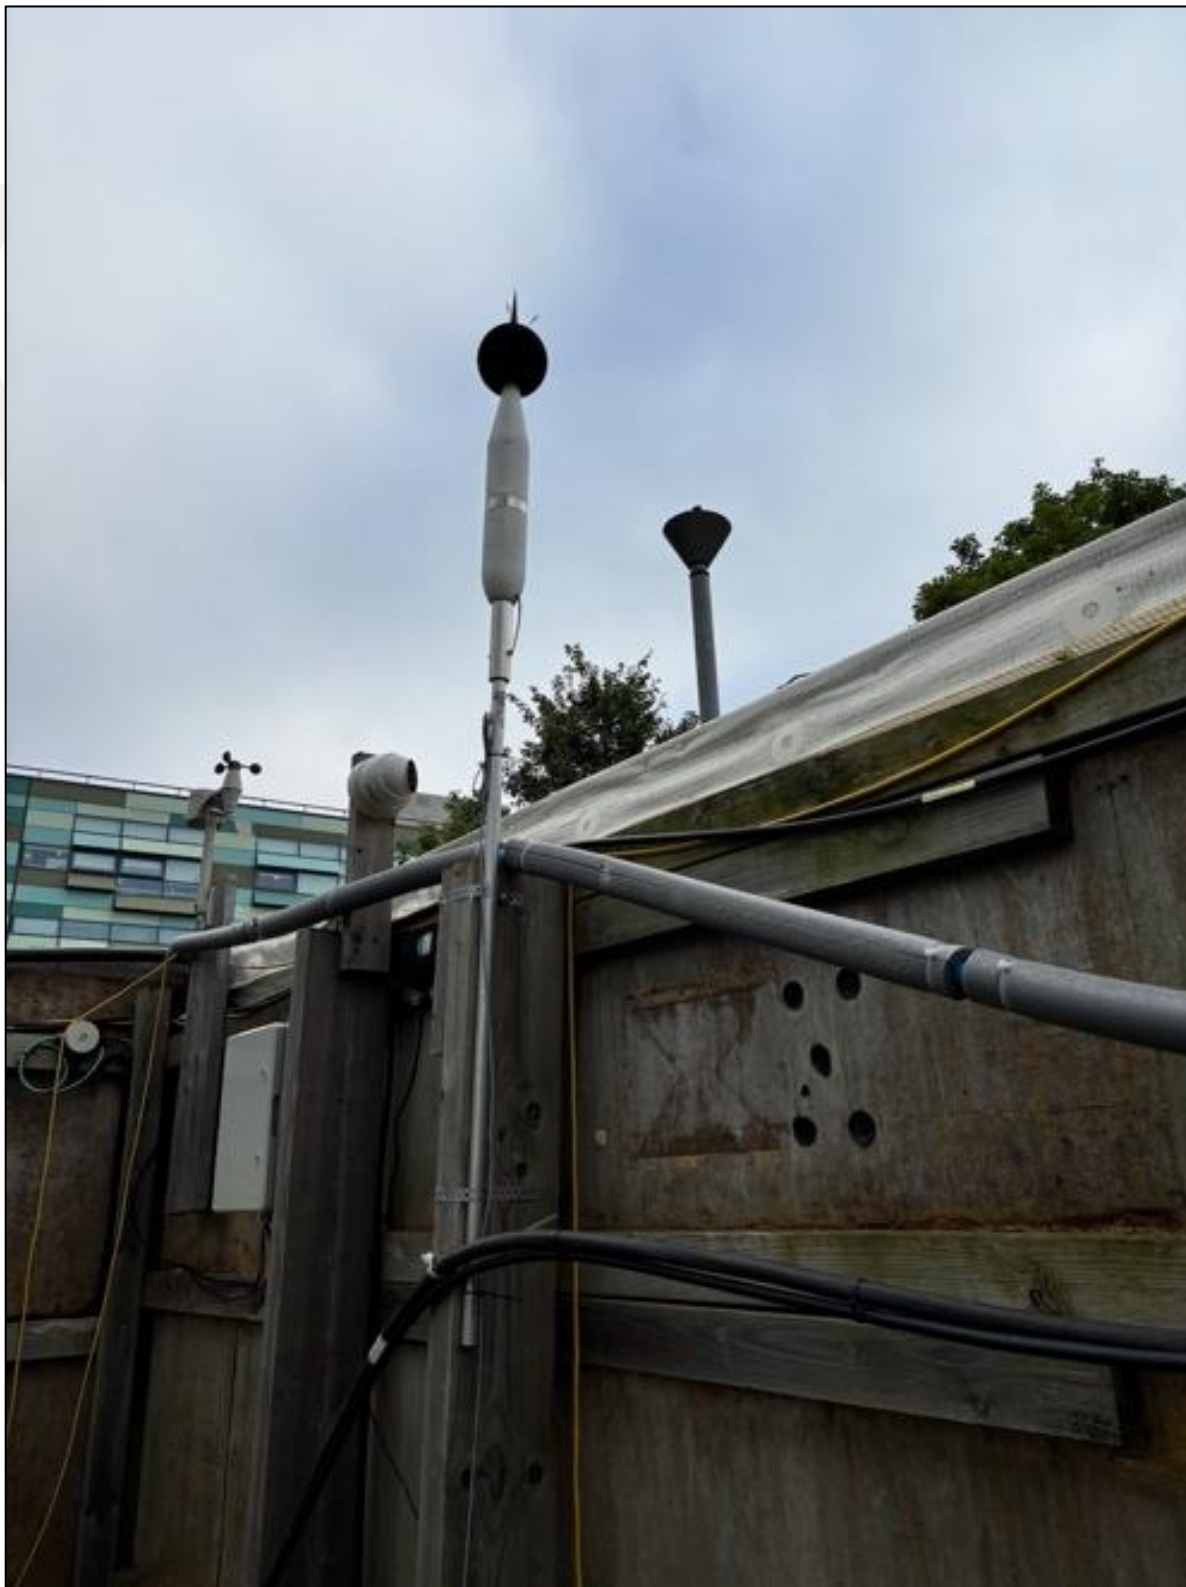
**Image 2 –NMP2 Monitoring Location (9<sup>th</sup> May 2025)**

| ID Reference | Location |
|---|---|
| <b>NMP2</b> | North-East of site on the hoarding |

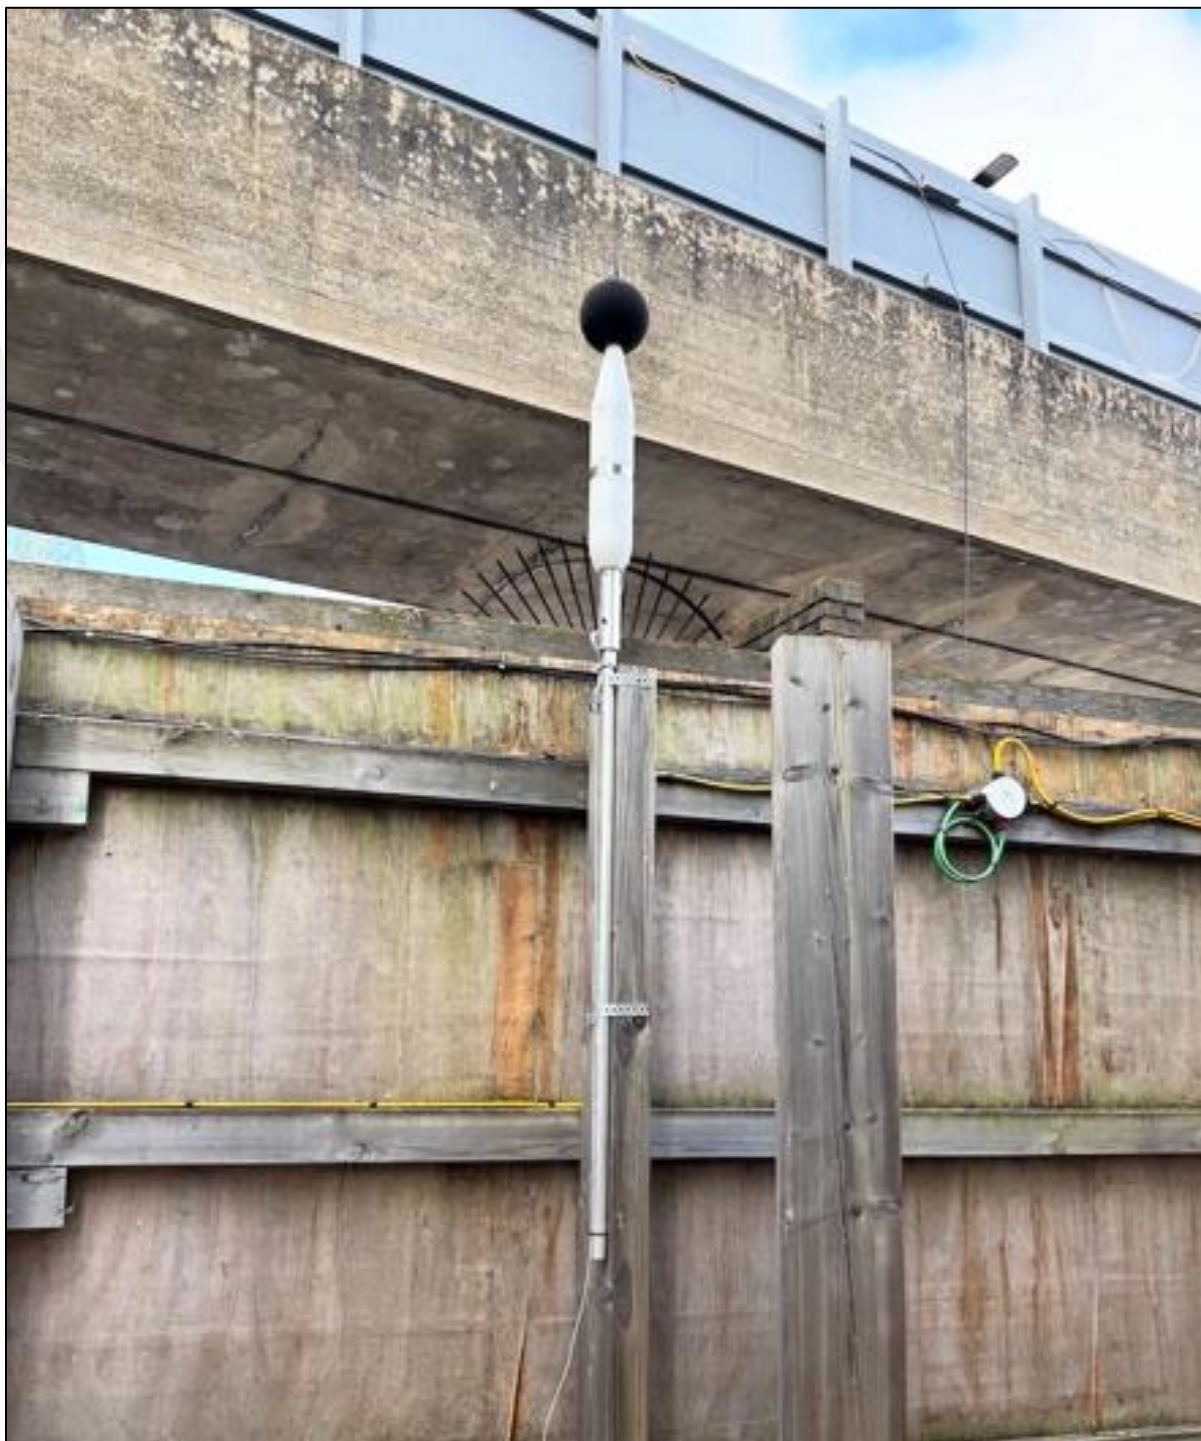
**Image 3 –NMP3 Monitoring Location (9<sup>th</sup> May 2025)**

| ID Reference | Location |
|---|---|
| <b>NMP3</b> | South-West of site on the hoarding |
