## Abbreviated Vibration Monitoring Report

Monitoring Period: 01 September 2025 to 28 September 2025

**Project:** Grenfell Tower

**Document Ref:** EEMC-VMR-201/101 – Grenfell Tower Rev 02

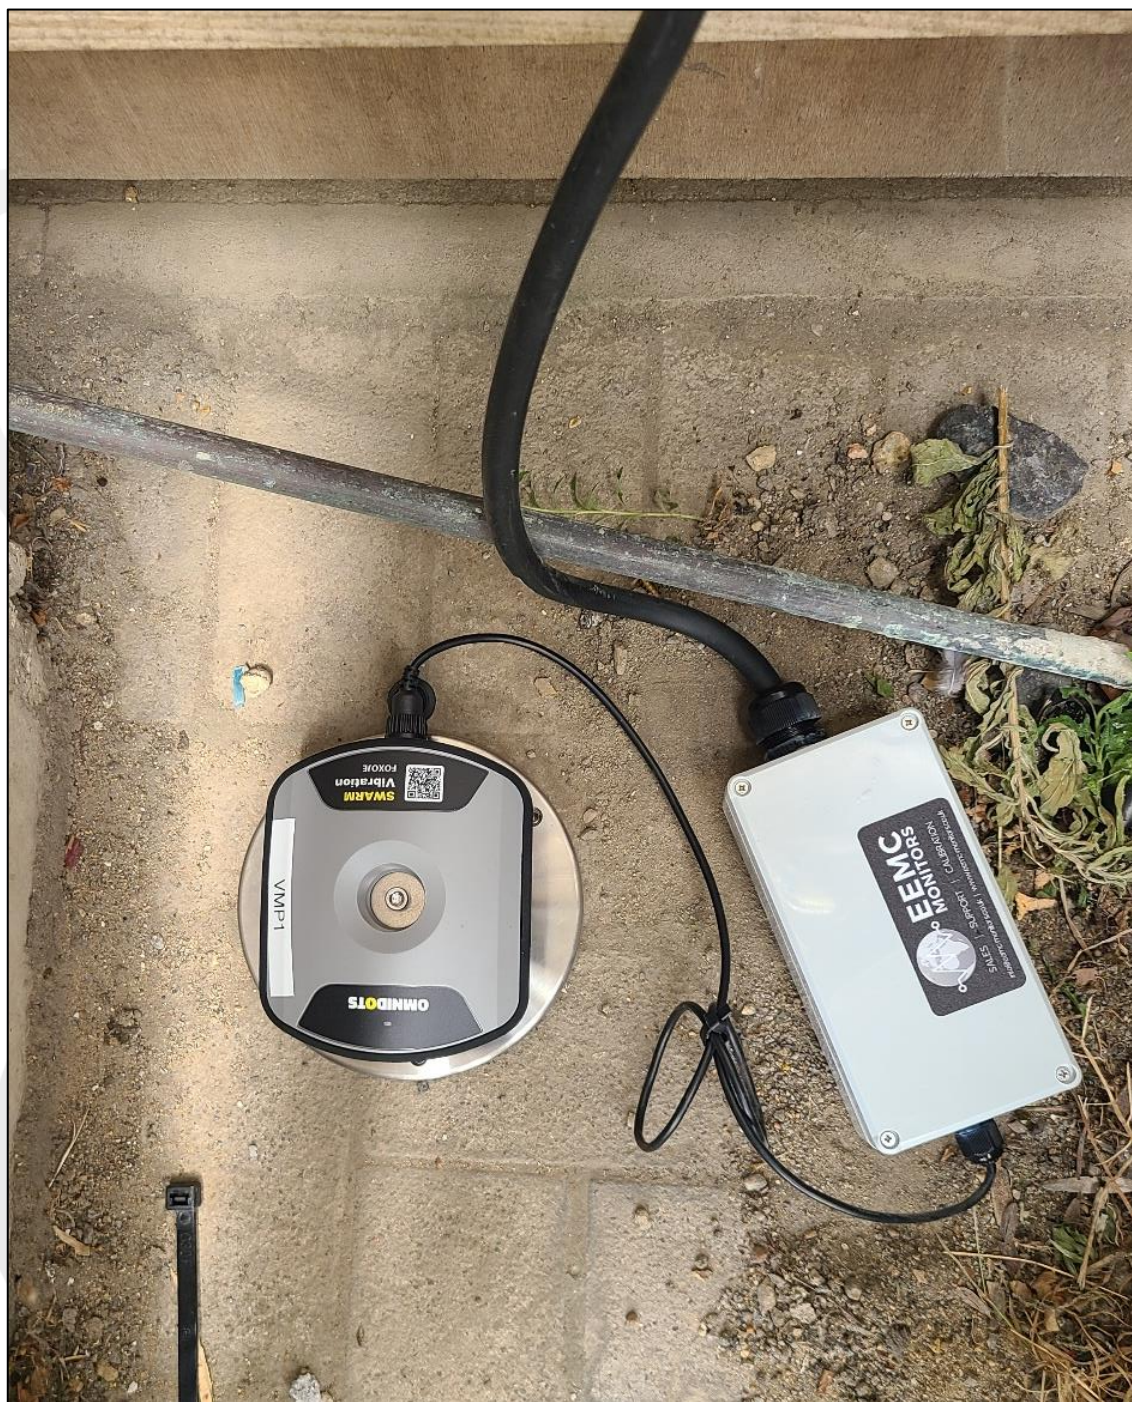
**Image 1 – VMP1 Monitoring Location**

| ID Reference | Location |
|---|---|
| VMP1 | Opposite Southeast corner of tower between two (2) concrete blocks |

The Swarm monitors record Peak Particle Velocity (PPV) in orthogonal (x, y and z) directions in mm/s continuously over 1-minute periods. A map showing the locations of the monitors is in Figure 1. A photograph showing the monitoring location is shown in Image 1.

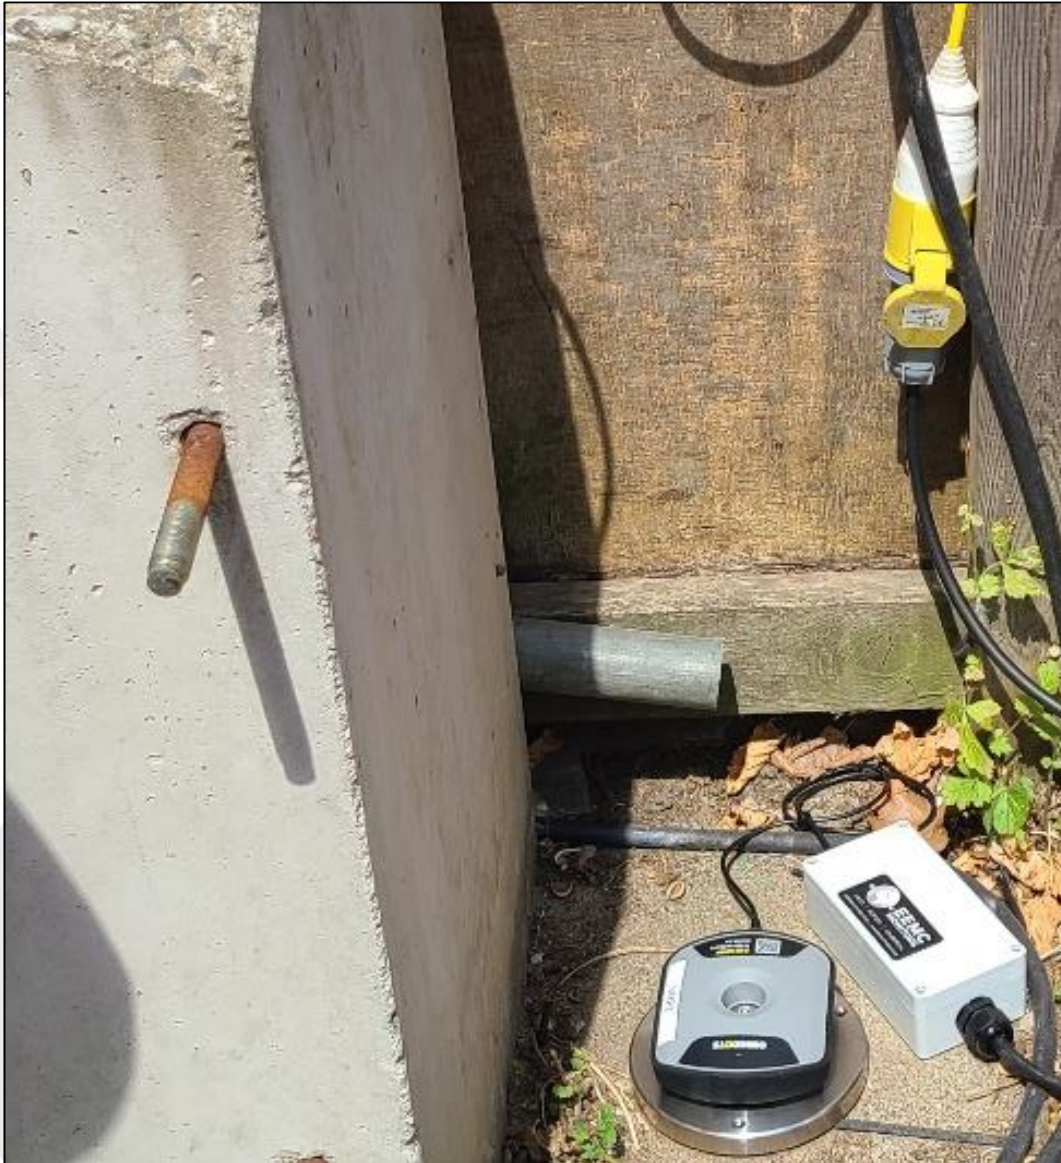
**Image 2 – VMP1 – VMP3 Monitoring Location**

| ID Reference | Location |
|---|---|
| VMP2 | Base of North hoarding co located with NMP2 |
| VMP3 | Mobile unit- Located base of NW hoarding with DMP5 and NMP3 |

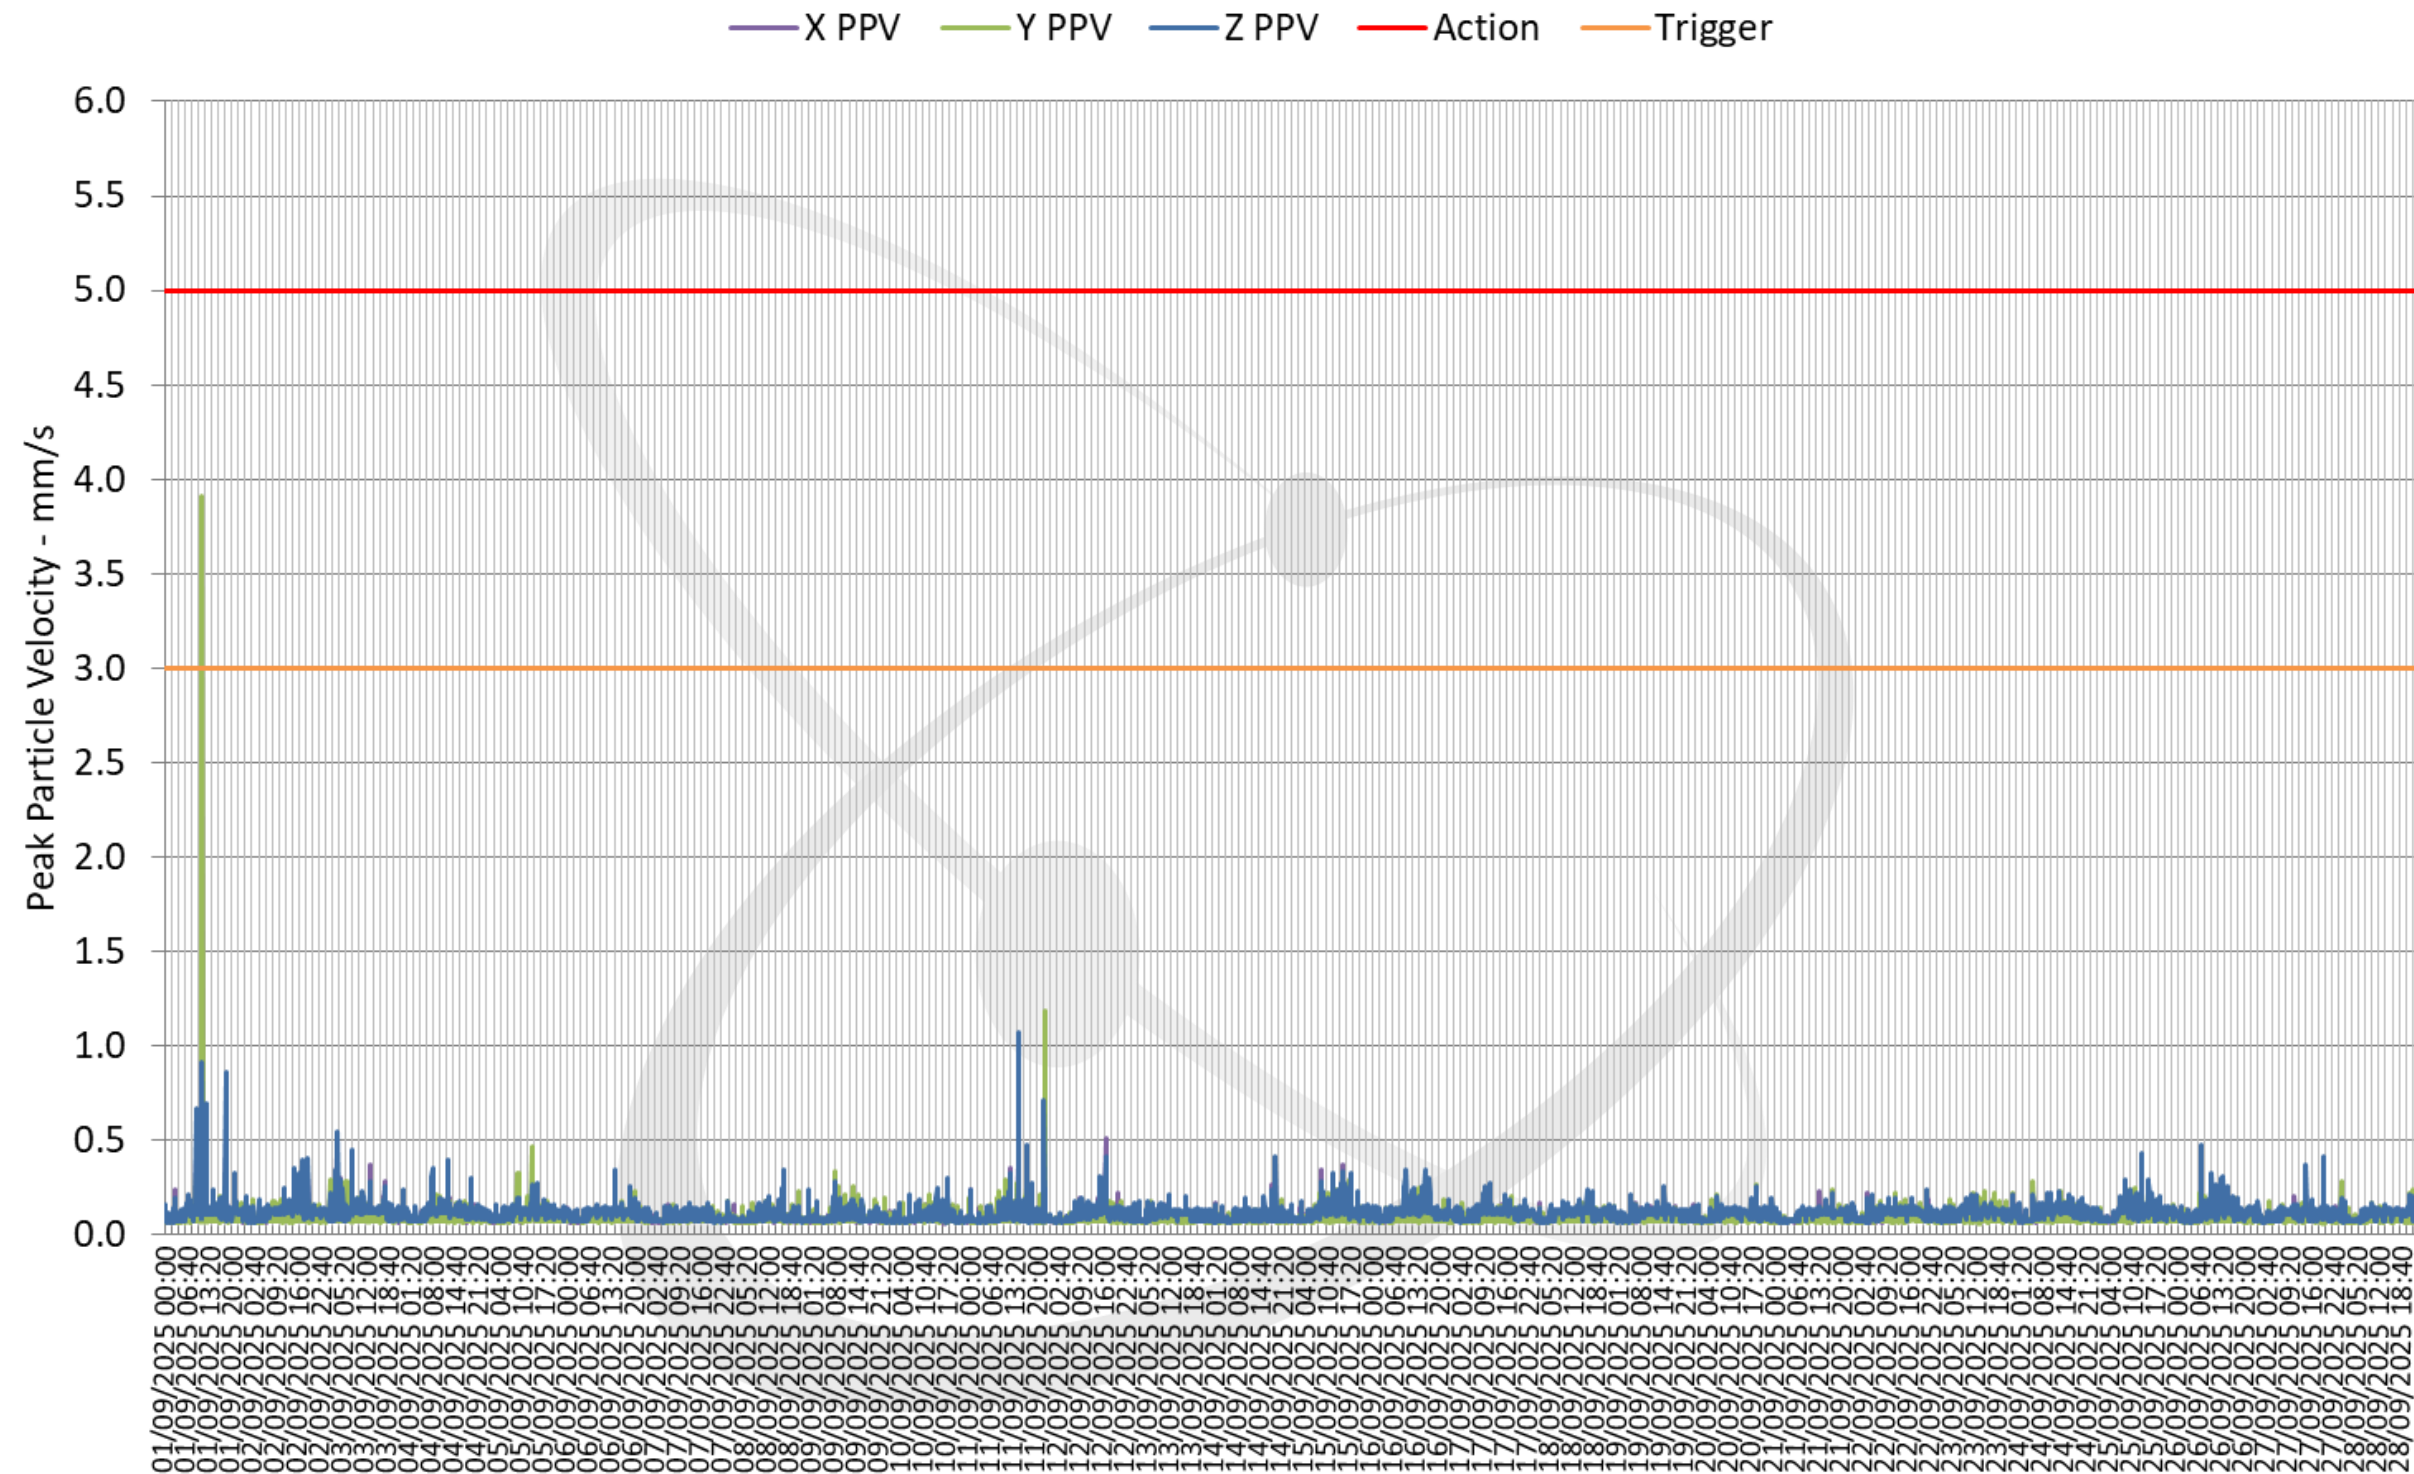
### Grenfell Tower VMP3: 01/09/25 - 28/09/25 Vibration Data

- There were three (3) exceedances of the red action level 5.0mm/s and twenty-seven (27) exceedances of the amber trigger level 3.0mm/s at **VMP1**.
- There were two (2) exceedances of the Red Action level 5.0mm/s, and two (2) exceedances of the Amber Trigger level 3.0mm/s at **VMP2**.
- There were **no exceedances** of the Red Action level 5.0mm/s, one (1) exceedance of the Amber Trigger level 3.0mm/s at **VMP3**.

| VMP3 (3 mm/s) | 01/09/2025 11:15 | 3.91 | 3.0 | Bobcat Movement<br>* Due to monitor being in close proximity to machinery pathway. |
