Health and Safety Executive Final Report

Compartment wall/roof junction experiments

Prepared for: The Building Safety Regulator

Report Number: P122986-1015 (M29E15V3)

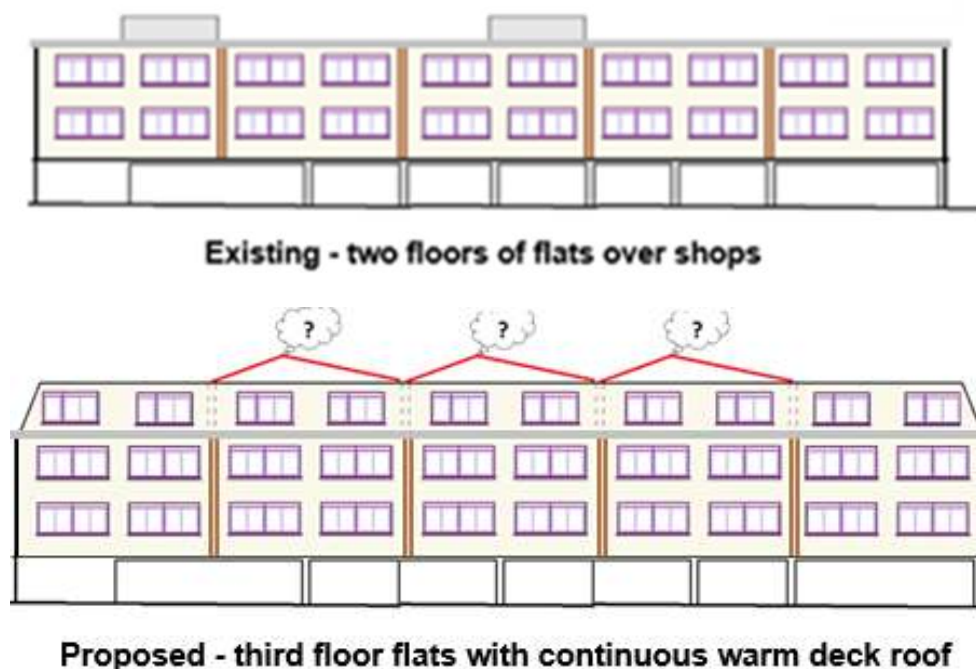
Figure 3 – A typical development opportunity where the building (after the work is complete) would remain less than 15 m tall and therefore the guidance at b., in Figure 1 above, would apply

A reasonably foreseeable development opportunity may be likely to occur where an existing low-rise building (flats above shops) is to be vertically extended – see Figure 3. In this instance, one might see a timber roof construction, to keep the weight of the new storey down and thereby avoid the disruption of underpinning the pre-existing foundations. The use of a timber roof could also help a developer demonstrate to the Local Planning Authority that the form of construction was largely sustainable.

The consideration for service penetrations would include ventilation ducts e.g. from a kitchen's mechanical extract system, or a whole flat heat recovery system and or soil and vent pipes. This risk arises from modern design in congested zones¹ where there are back to back bathrooms or kitchens, either side of a party wall. This situation may arise in a development opportunity as shown in Figure 3 (above).

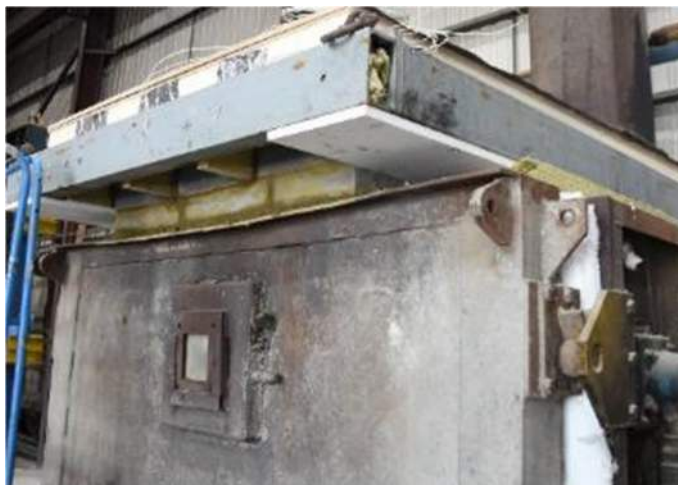
Figure 5 – A photograph of a sample undergoing installation onto the 1.5 m cube intermediate furnace

Figure 5 shows the masonry string course, onto which the joists of the sample were bearing as well as the masonry infilling between joists. The masonry string course was built off the steel front wall of the furnace, and was representative of a compartment party wall. The different roof constructions were lifted onto the furnace, in effect creating the ‘furnace lid’. Masonry was then used to infill the spaces between the joists. Mineral wool fire stopping was or was not provided (see the eight scenarios listed in Section 1 Validation of concept (above) and Section 4 Experimental programme (below)).

The programme was undertaken using the BRE Global 1.5 m cube intermediate furnace, shown in Figure 5.

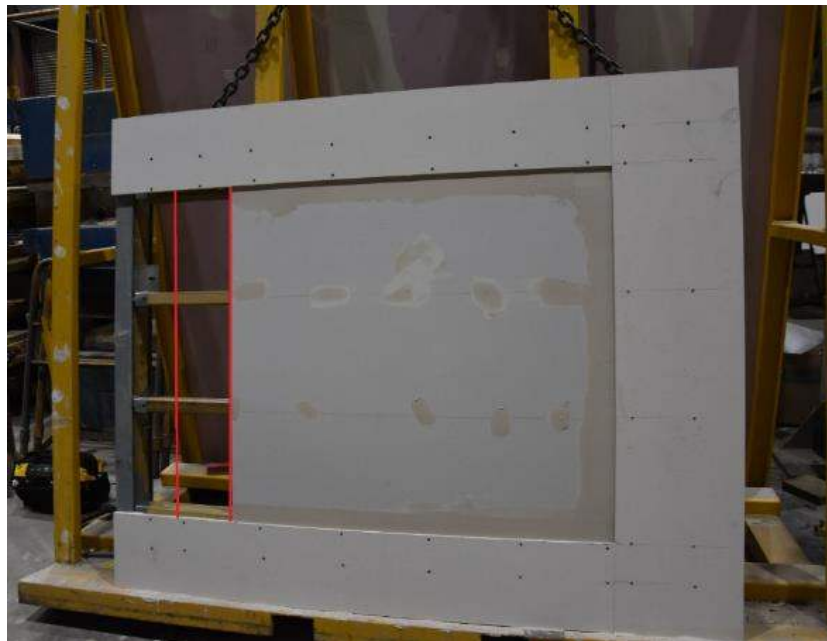
Figure 11 – A roof sample laid on its side showing the calcium silicate boarded perimeter and the plasterboard 'ceiling' in the centre.

The red lines indicate where the compartment wall will rise between the three joist bays

Figure 11 shows the underside of a typical test sample during construction.

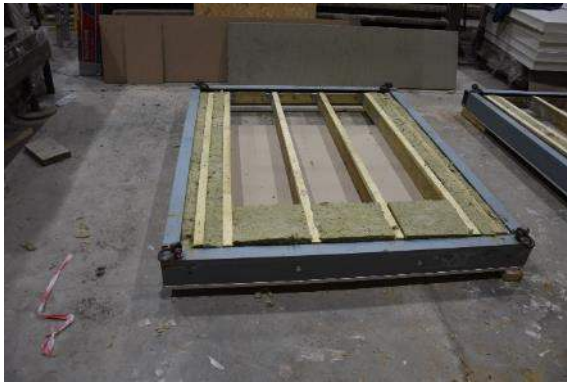
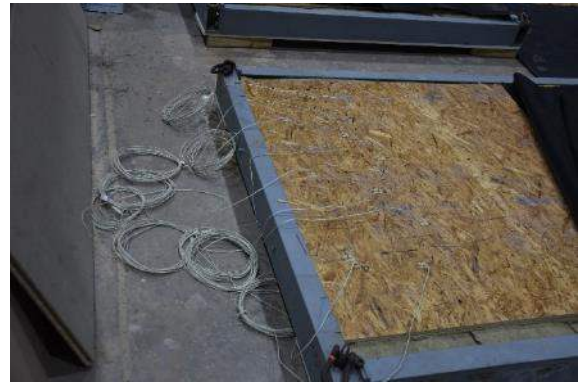
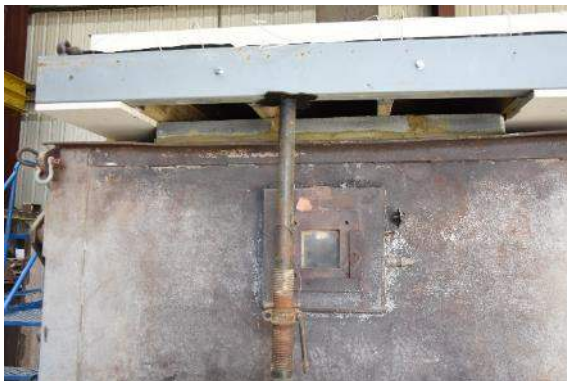
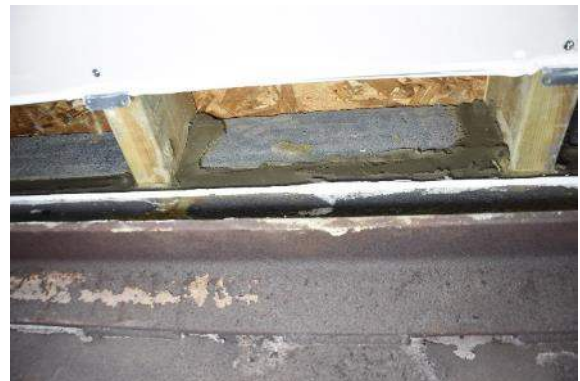
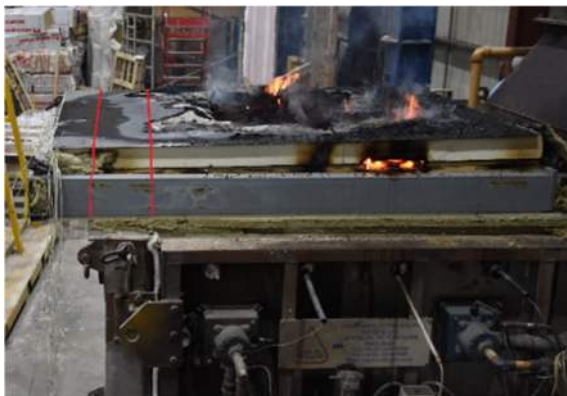
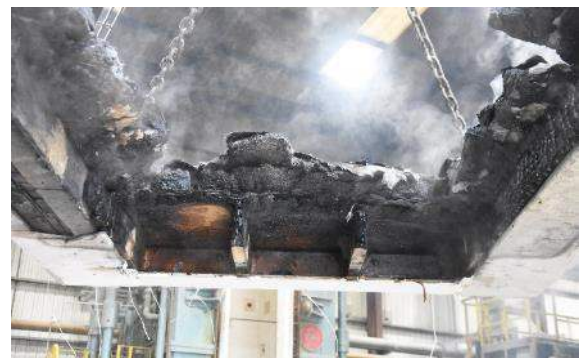
Figure 15 is a selection of build and burn photographs. The double red lines provide a visual cue as to whether visible flaming reached the exposed edge of the party wall or spread further.

Figure 15 – A selection of build and burn photographs for Experiment 1

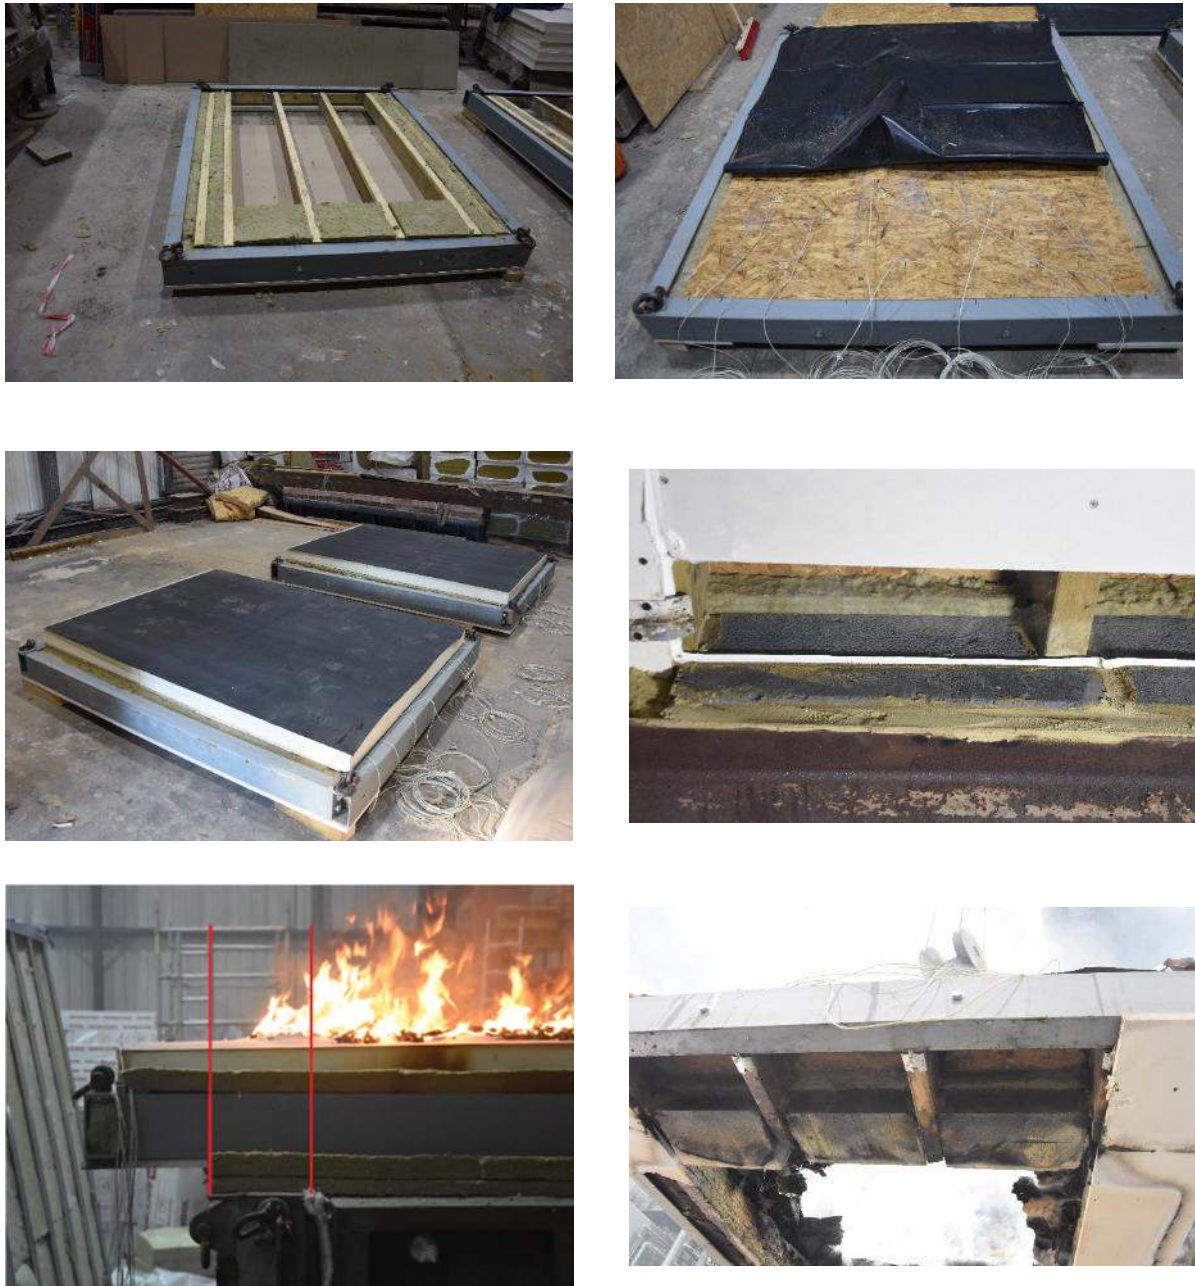
Figure 19 is a selection of build and burn photographs. The double red lines provide a visual cue as to whether visible flaming reached the exposed edge of the party wall or spread further.

Figure 19 – A selection of build and burn photographs for Experiment 2

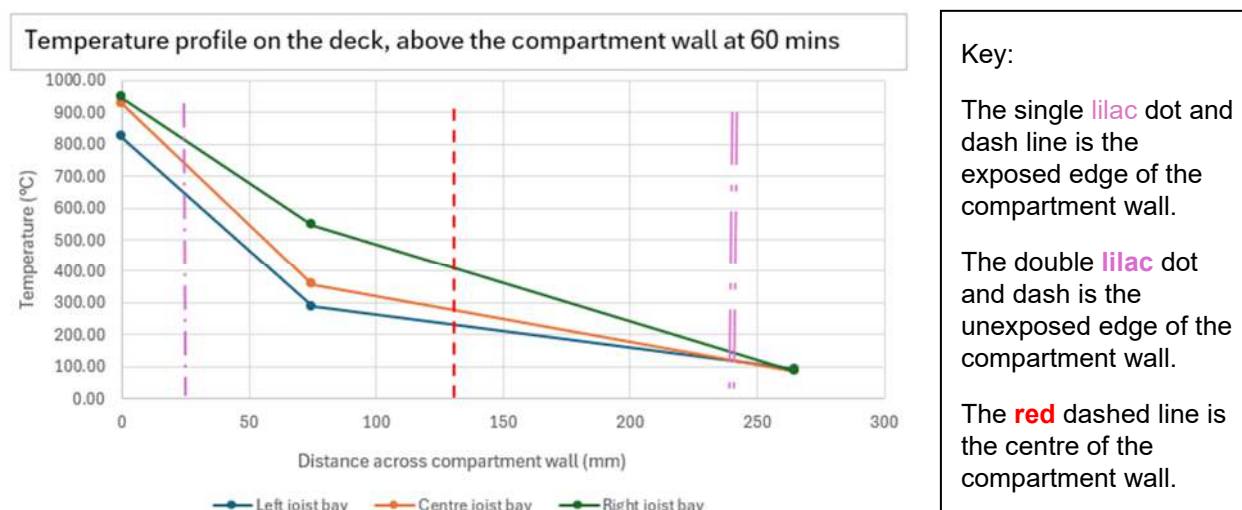
Figure 21 – Temperature profiles on the deck above the compartment wall at 60 minutes, created from data prior to correcting for ambient air temperature

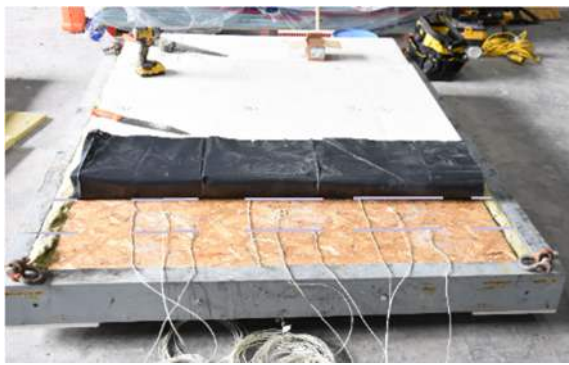
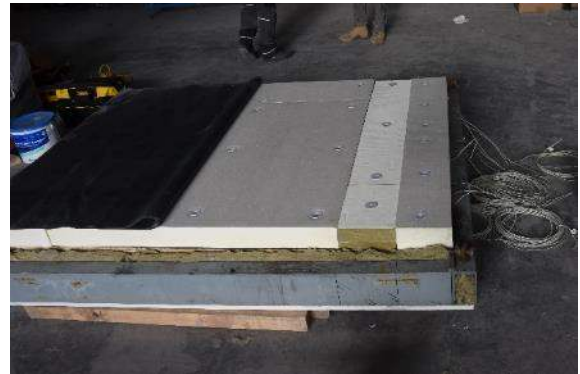
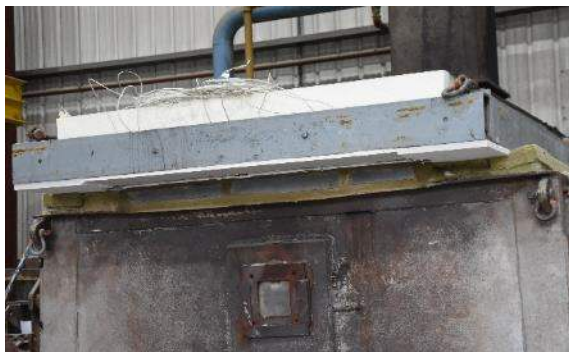
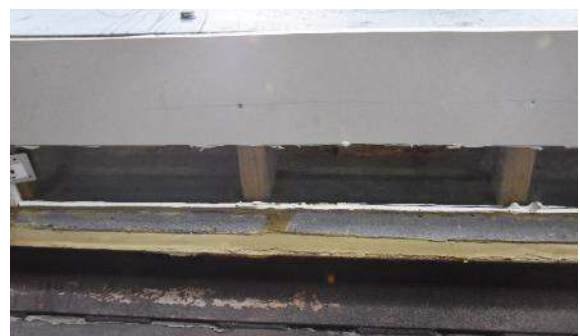
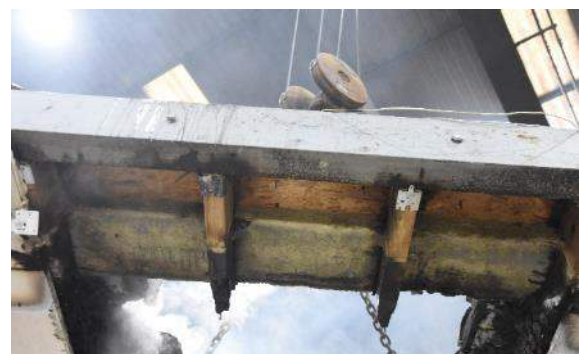
Figure 24 is a selection of build and burn photographs. The double red lines provide a visual cue as to whether visible flaming reached the exposed edge of the party wall or spread further.

Figure 24 – A selection of build and burn photographs for Experiment 3

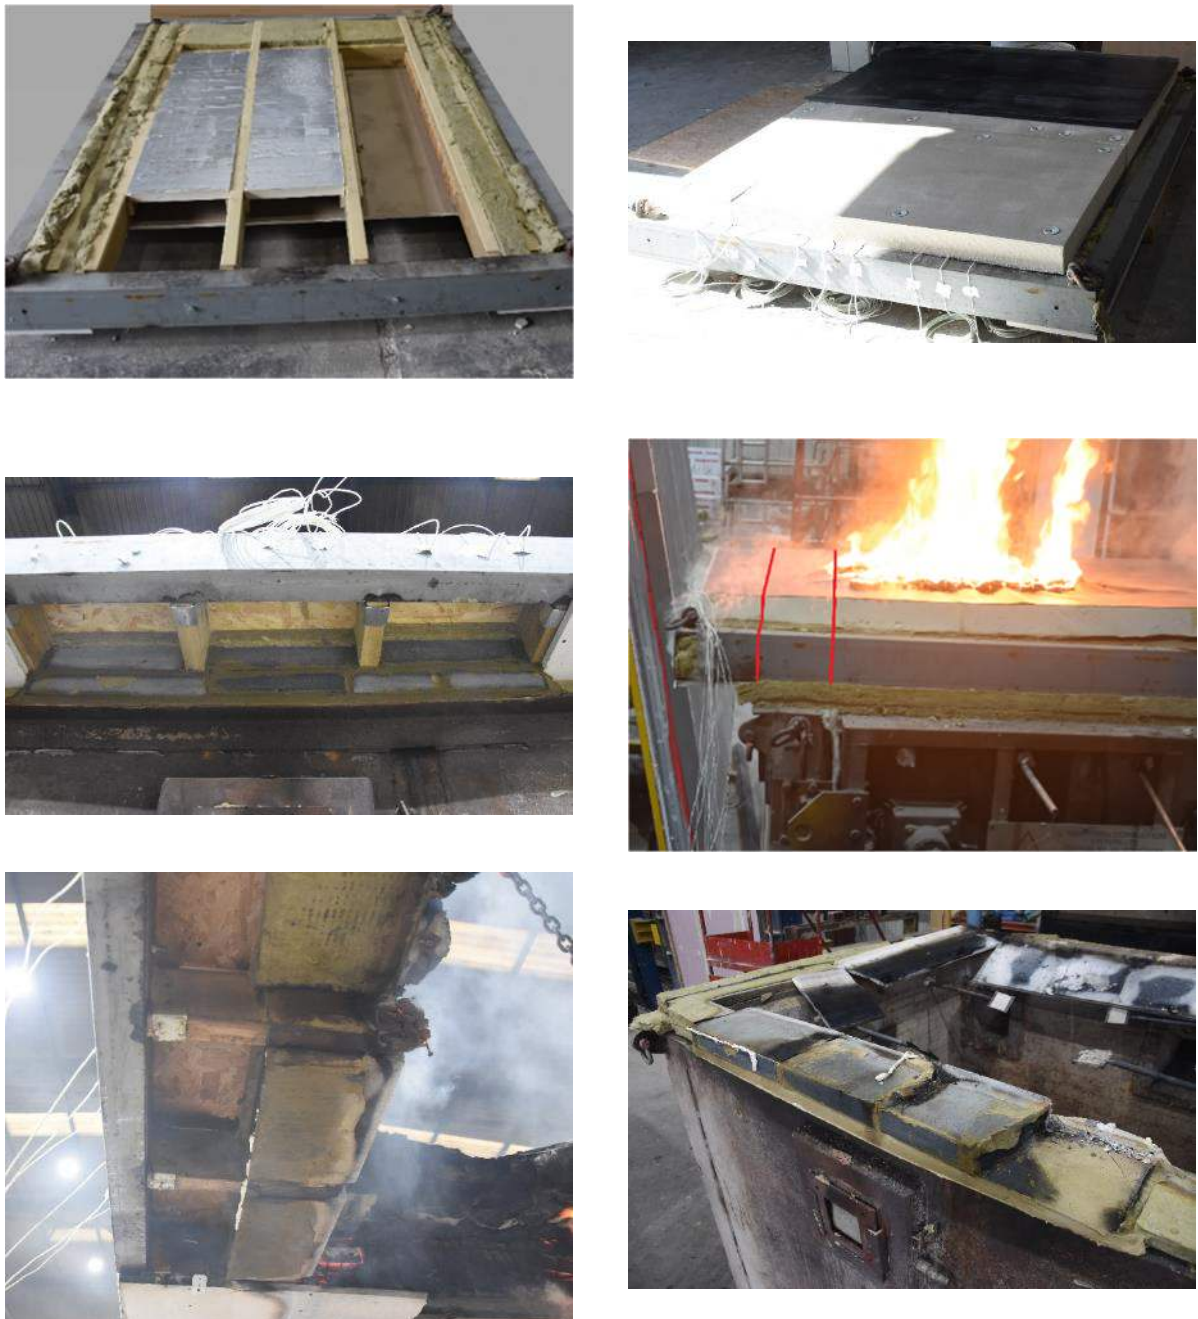
Figure 27 is a selection of build and burn photographs. The double red lines provide a visual cue as to whether visible flaming reached the exposed edge of the party wall or spread further.

Figure 27 – A selection of build and burn photographs for Experiment 4

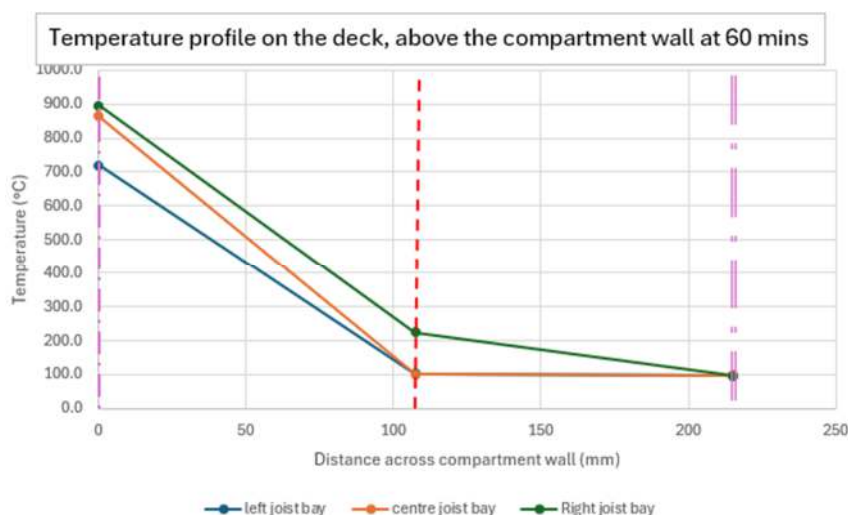
Figure 29 shows the temperature profiles on the deck.

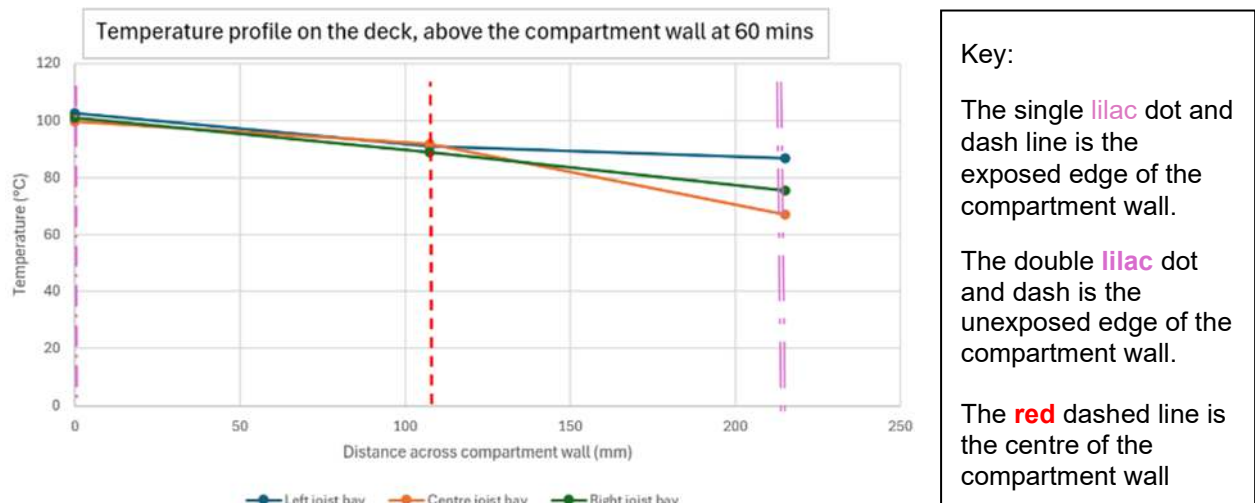
Figure 33 – Temperature profiles on the deck of the composite board created from data without the need to correct for ambient air temperature since the temperatures at the centreline and unexposed edge were all less than 140°C

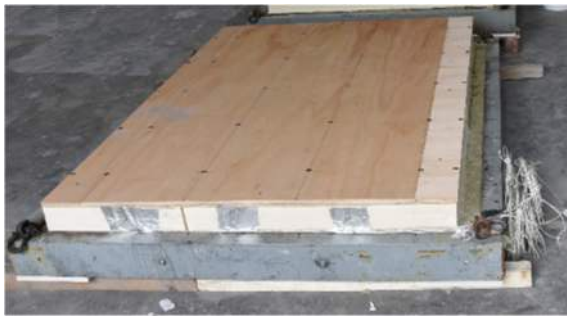
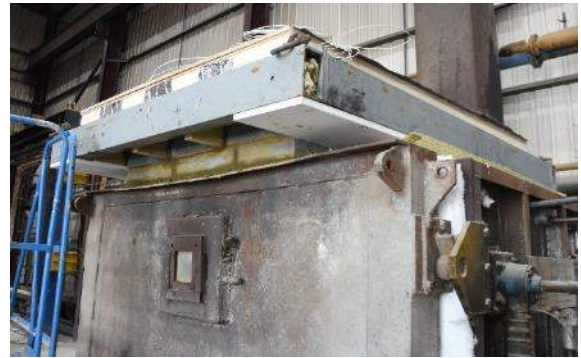
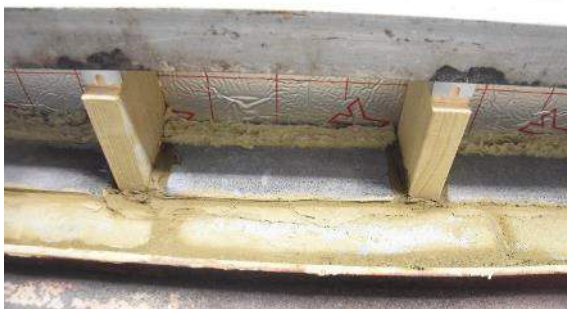
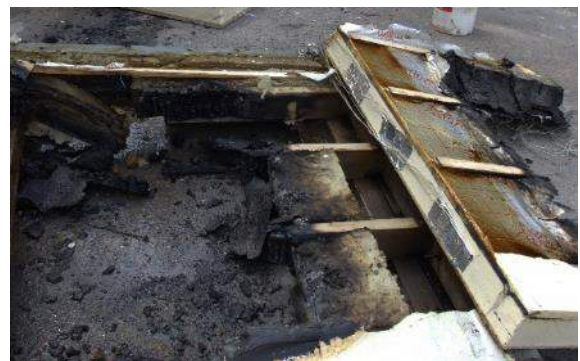
Figure 34 is a selection of build and burn photographs. The double red lines provide a visual cue as to whether visible flaming reached the exposed edge of the party wall or spread further.

Figure 34 – A selection of build and burn photographs for Experiment 6

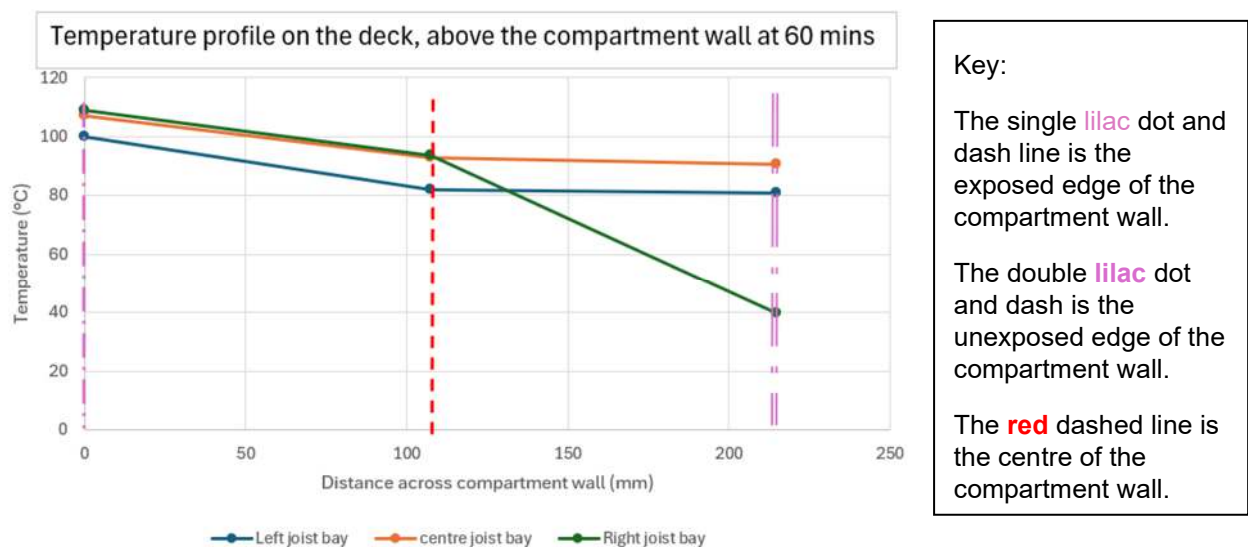
Figure 36 – Temperature profiles on the deck of the composite board created from data without the need to correct for ambient air temperature since the temperatures at the centreline and unexposed edge were all less than 140°C

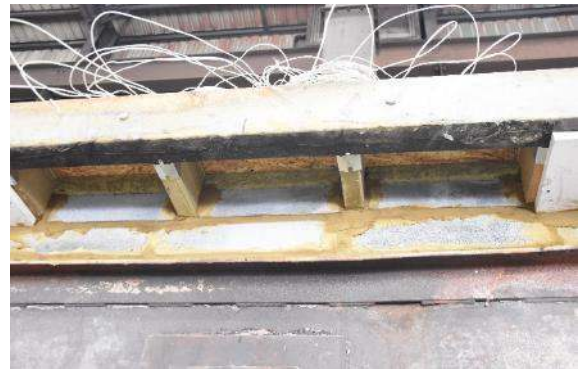
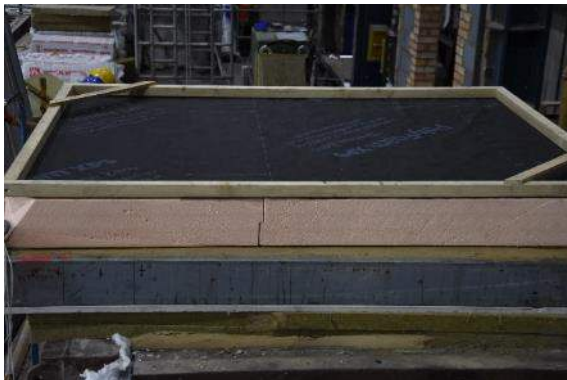
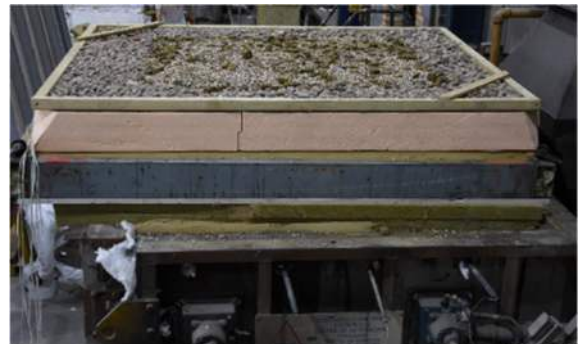
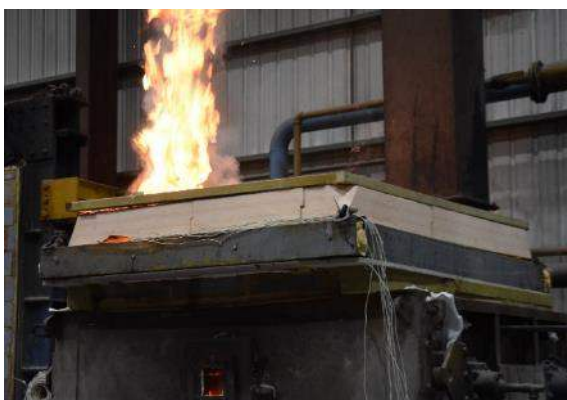
Figure 37 is a selection of build and burn photographs. The double red lines provide a visual cue as to whether visible flaming reached the exposed edge of the party wall or spread further.

Figure 37 – A selection of build and burn photographs for Experiment 7

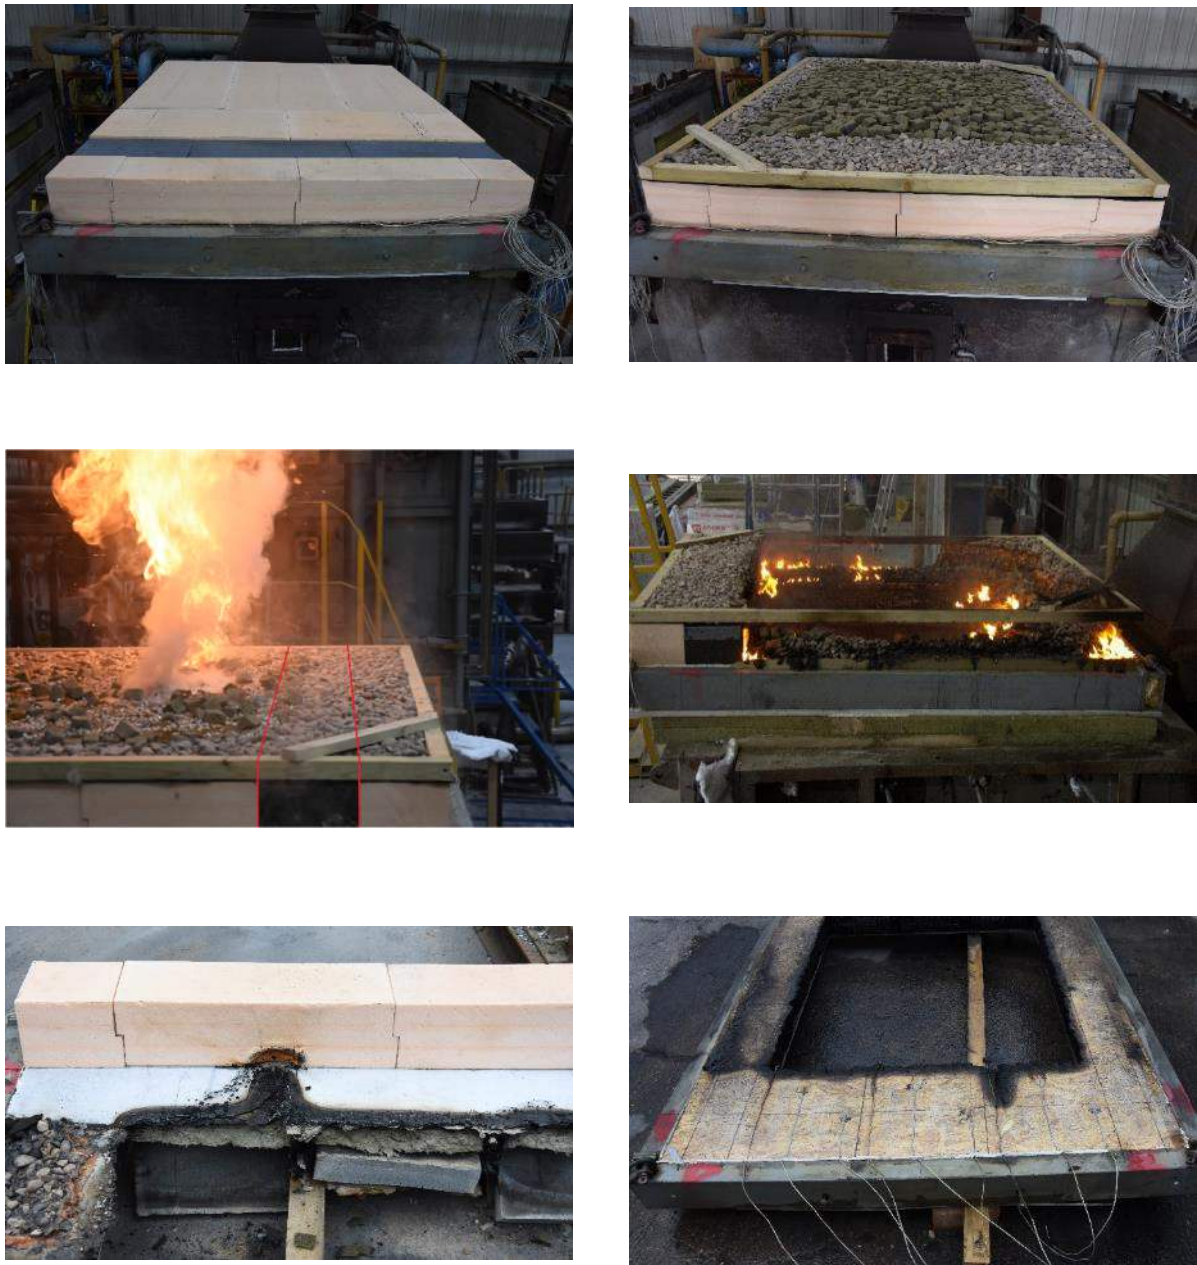
Figure 40 is a selection of build and burn photographs. The double red lines provide a visual cue as to whether visible flaming reached the exposed edge of the party wall or spread further.

Figure 40 – A selection of build and burn photographs for Experiment 8
