Rail Accident Investigation Branch

# Investigating fatigue: Collision Between Freight Trains at Loversall Carr Junction, Doncaster 05.07.2022

# Summary of the Accident – Loversall Carr Junction, Doncaster, Tuesday 5th July at 06:21 hrs

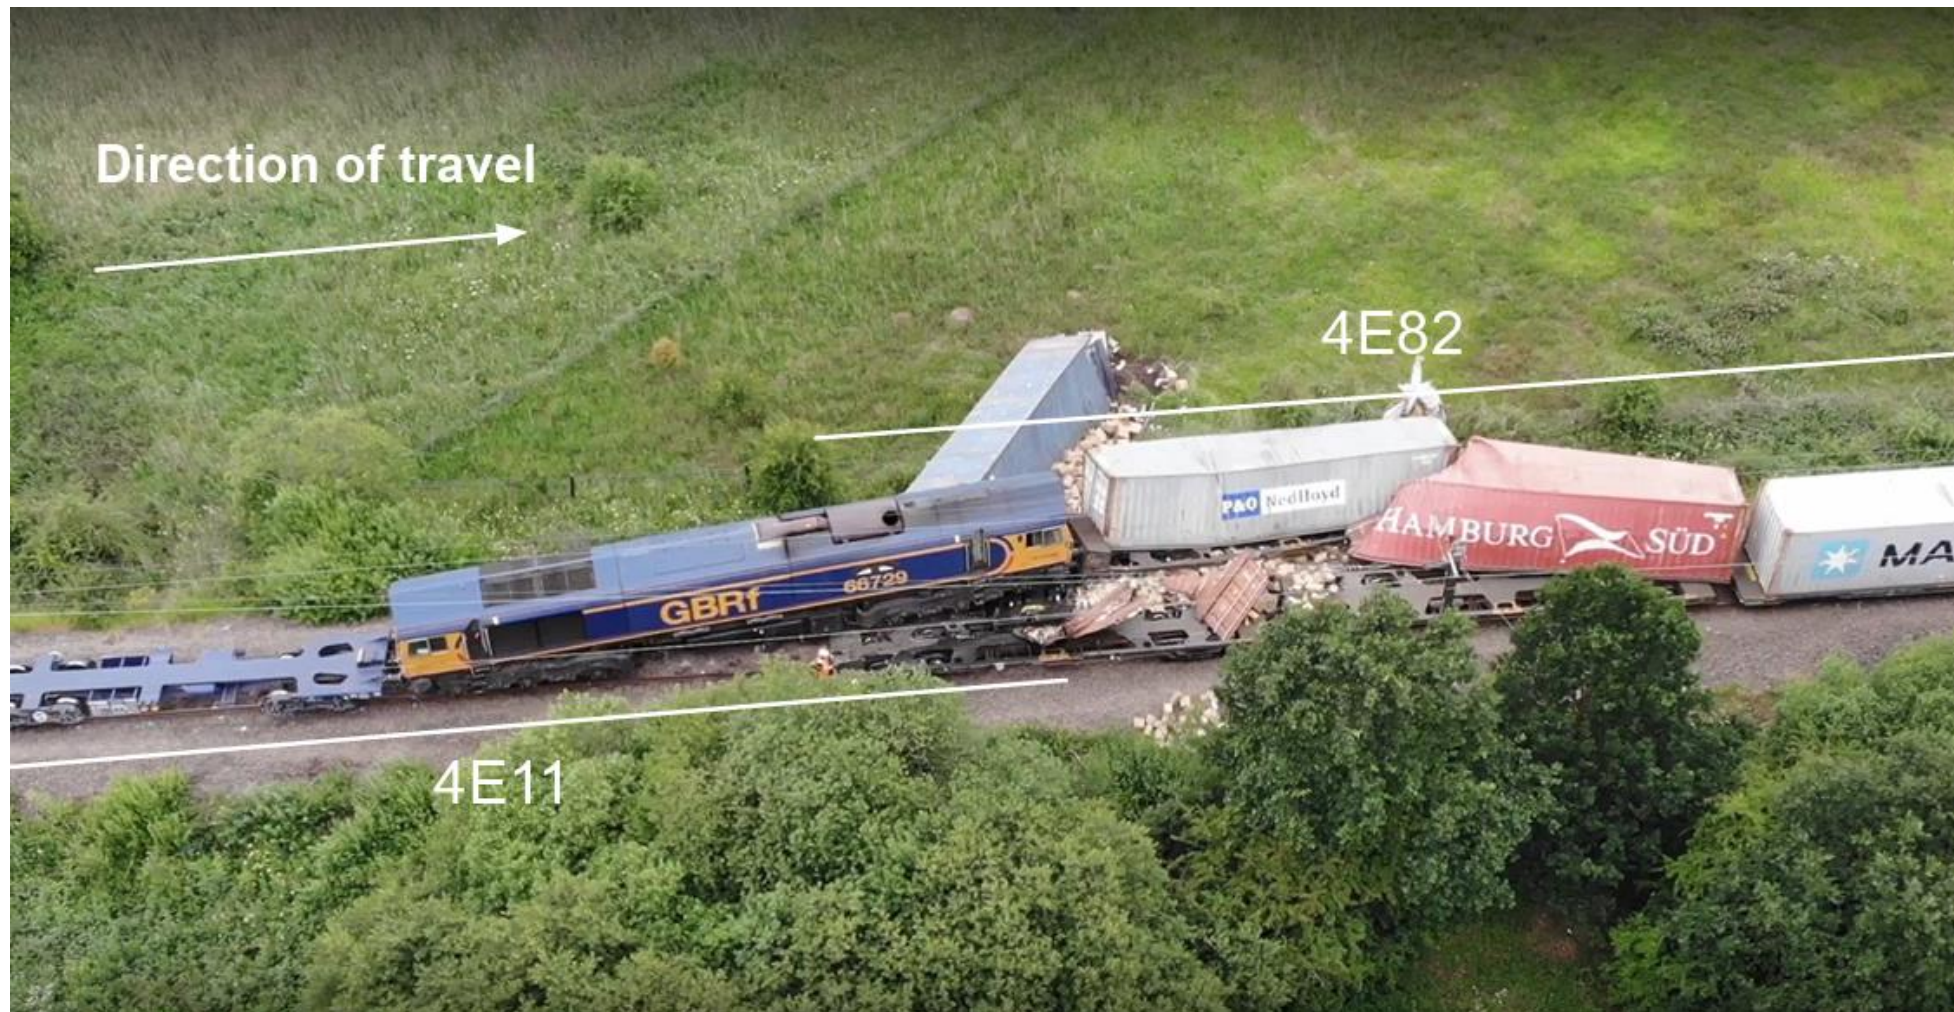
# SPAD and collision

- Freightliner 4E82 (00:36 Felixstowe – Tinsley) with 29 wagons was standing at signal D207, awaiting acceptance into Decoy Yard. Signal in rear is **D197**
- 231 metres from D197 to rear of 4E82. Overlap is 183 metres
- GBRF **4E11** travelling from Felixstowe to Masborough (via ECML) loaded with a rake of 35 wagons [FEA(13)/FIA(1)/FWA(21)]
- 4E11 leaves the ECML on a steady cautionary (Y) aspect and feather at D191 onto the Down Slow / Up West Slow
- **4E11 has SPAD of D197. 4E11 collided with the rear of 4E82 at 28mph**
- No injuries. Damage/derailment to a number 4E11 & 4E82 wagons. Considerable damage to 4E11 loco, 4E82 cargo containers and track. 4E82 narrowly avoiding second SPAD at D207. Route closed for 26 days for recovery and track repair work (reopened 31/07/22)
