## Abbreviated Noise Monitoring Report

Monitoring Period: 29 September 2025 to 02 November 2025

| <b>Project:</b> | Grenfell Tower |
| <b>Document Ref:</b> | EEMC-NMR-201/102 – Grenfell Tower Rev 00 |

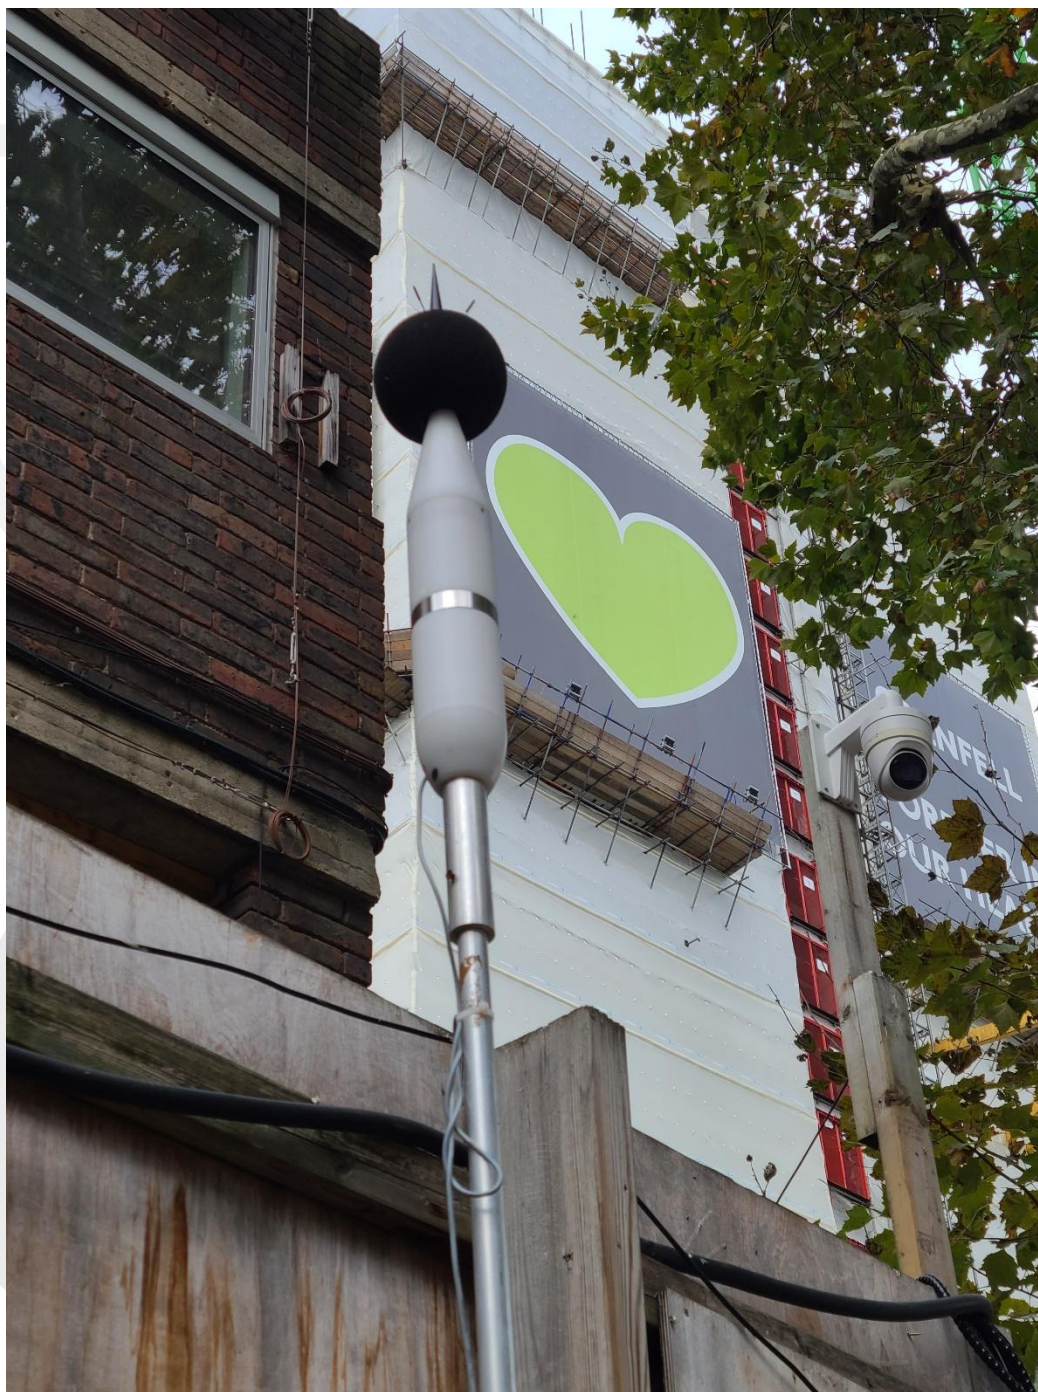
**Image 1 –NMP1 Monitoring Location (19<sup>th</sup> May 2025)**

| ID Reference | Location |
|---|---|
| NMP1 | South-East of site on the hoarding |

Three (3) Class 1 compliant noise monitors have been deployed to undertake noise monitoring on the site. A map indicating the location of the noise monitors is provided as Figure 1 and a photograph of the installed noise monitor NMP1 is provided as Image 1. A copy of the calibration certificate for this monitor is attached as Appendix 1.

The noise monitors are installed with an all-weather protective system fitted to the remote microphone, at elevations and locations previously agreed with RBKC. Each system is fitted with a modem to allow remote access to the measurement data via the internet. The modem also enables the provision of automatic email alerts.

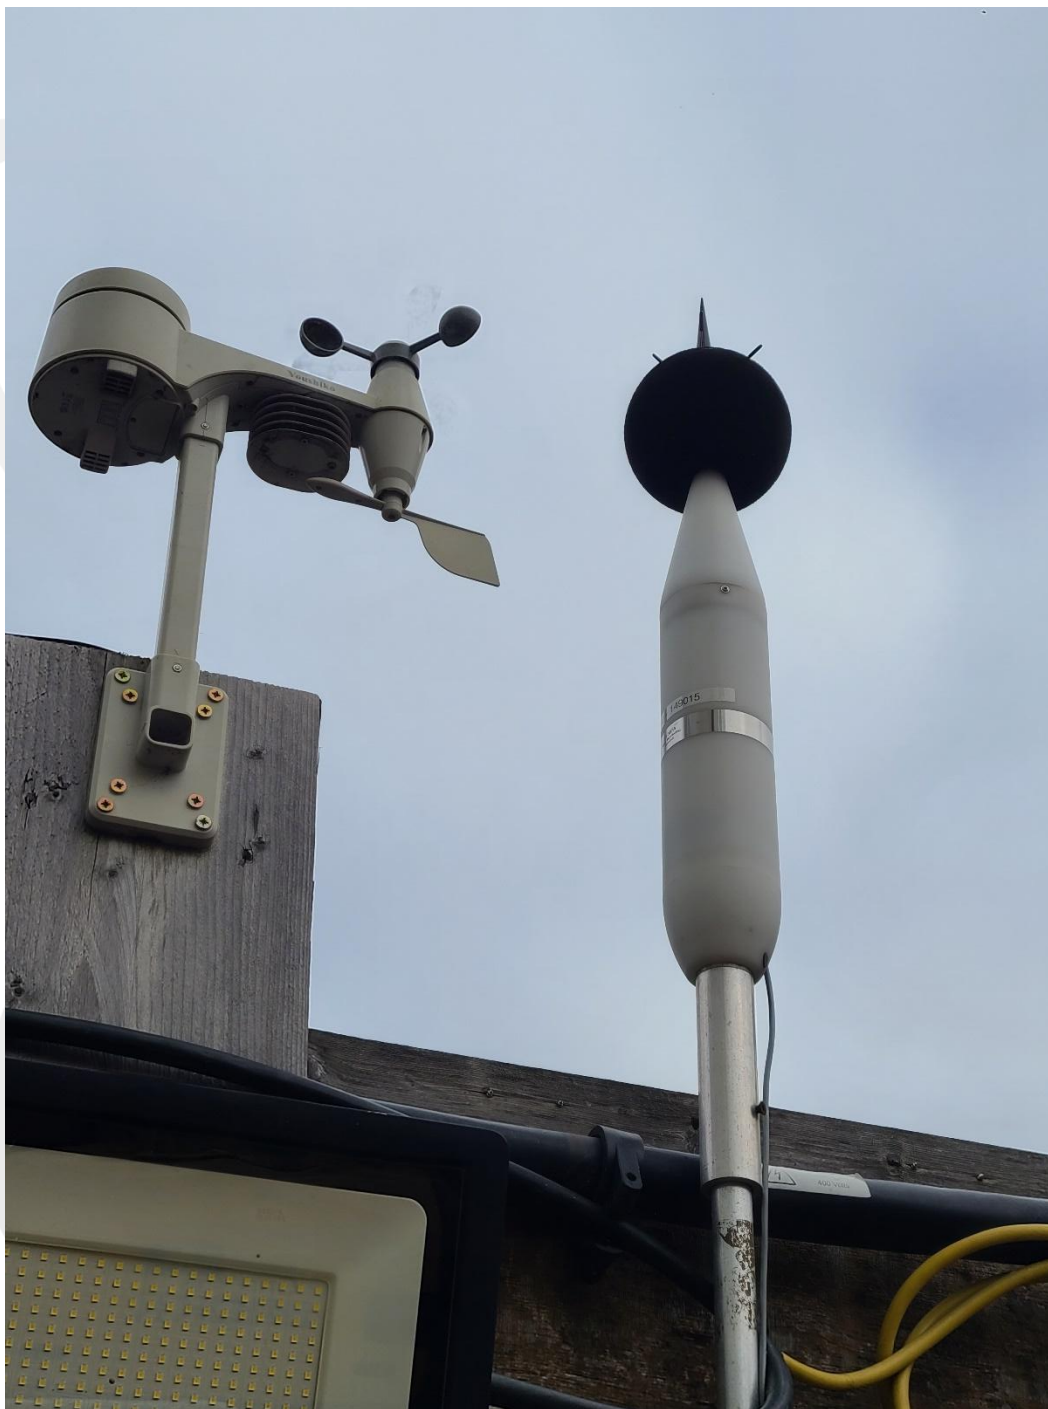
**Image 2 –NMP2 Monitoring Location (9<sup>th</sup> May 2025)**

| ID Reference | Location |
|---|---|
| NMP2 | North-East of site on the hoarding |

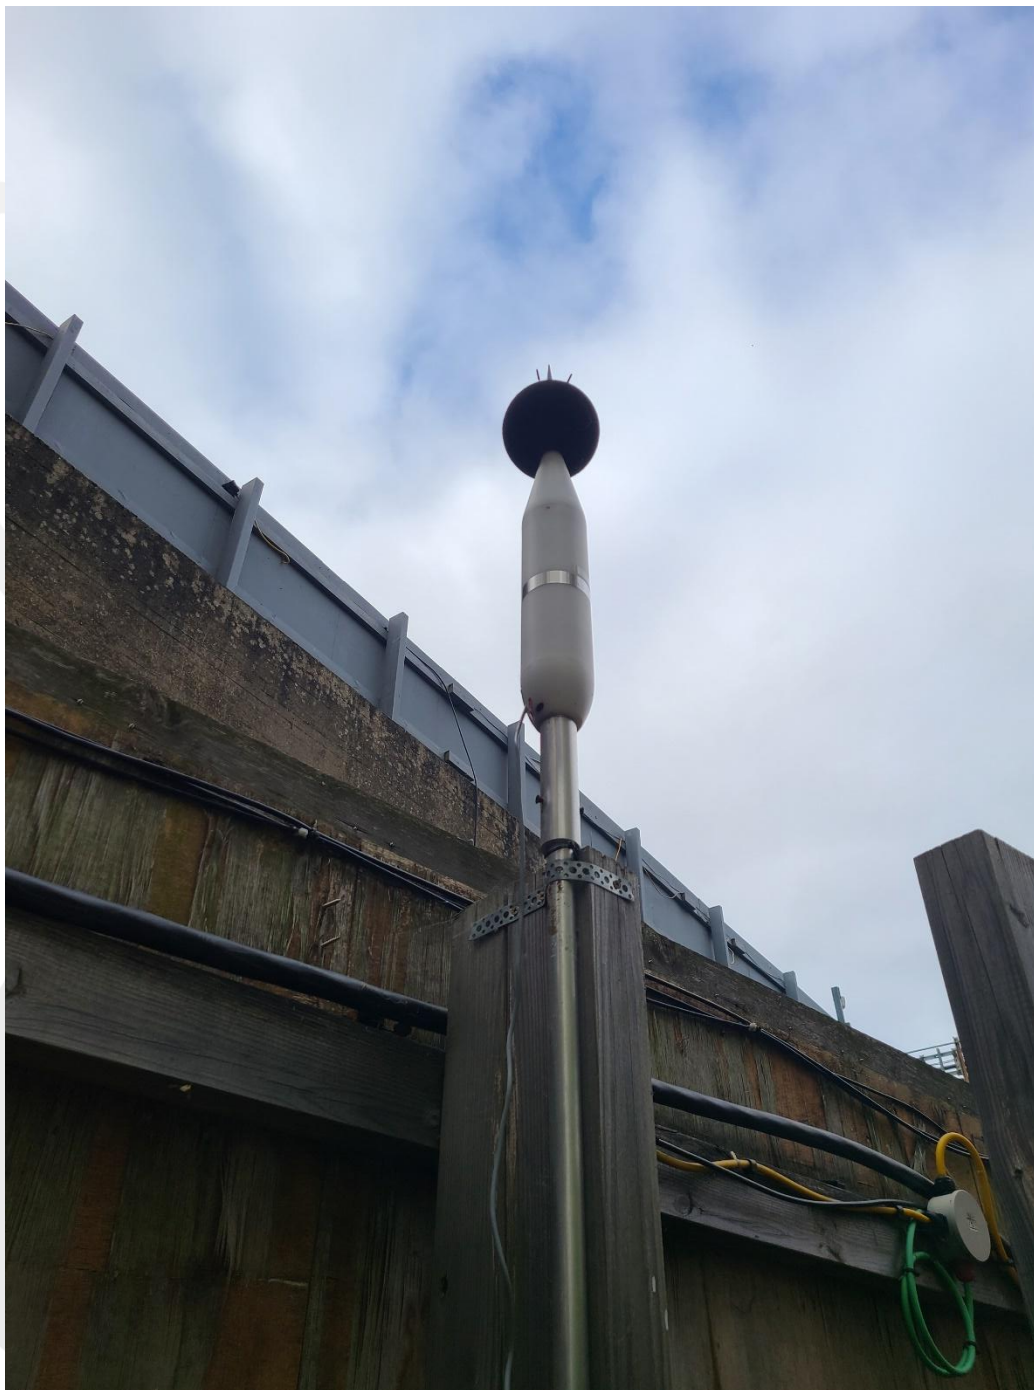
**Image 3 –NMP3 Monitoring Location (9<sup>th</sup> May 2025)**

| ID Reference | Location |
|---|---|
| NMP3 | South-West of site on the hoarding |
