Abbreviated Dust Monitoring Report

Monitoring Period: 29 September 2025 to 02 November 2025

Project:	Grenfell Tower
Document Ref:	EEMC-DMR-201/102 – Grenfell Tower Rev 01
Period:	29 September 2025 to 02 November 2025

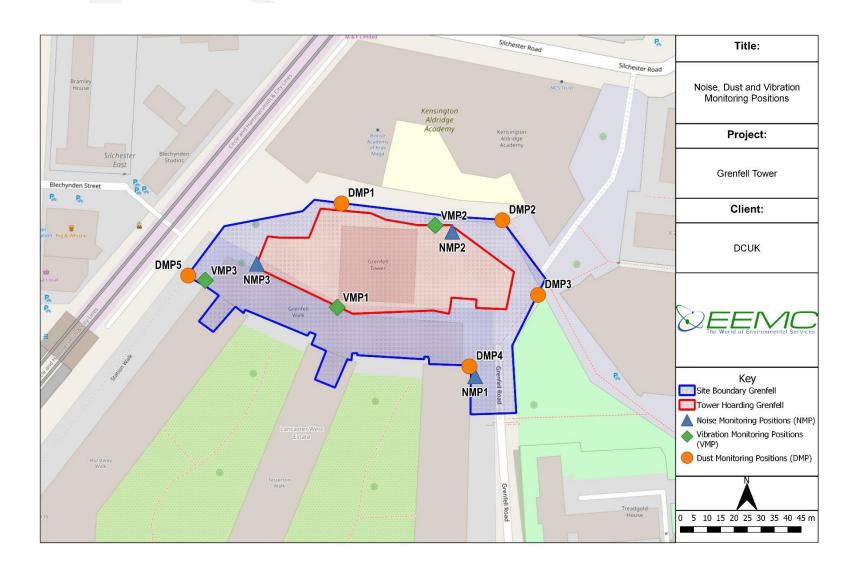
Figure 1- Map of Dust, Dust & Vibration Monitoring Locations

The site boundary and hoarding line of this project is shown in Figure 1. The project is located at Grenfell Tower, Grenfell Road, W11 1TQ. The entire site is located within Royal Borough of Kensington & Chelsea (RBKC) and is bordered by residential blocks to the south, and a school and football pitches to the north and a leisure centre to the east. The London Underground viaduct is 70m to the west and Latimer Road Tube station is 200m from the project

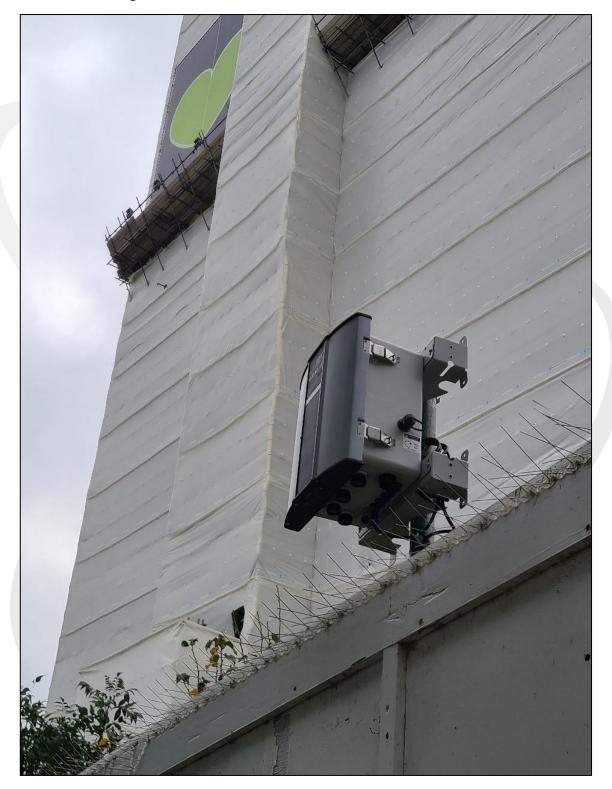
Images 1 – DMP1 Monitoring Location (photo taken on site on 19/5/2025).

ID Reference	Location	
DMP1	North west hoarding, opposite Krav Maga centre	
DMP2	North east Hoarding, opposite school academy	
DMP3	East Hoarding	
DMP4	South East Hoarding, on Grenfell Road	
DMP5	West Hoarding, near Station Walk, opposite the under pass

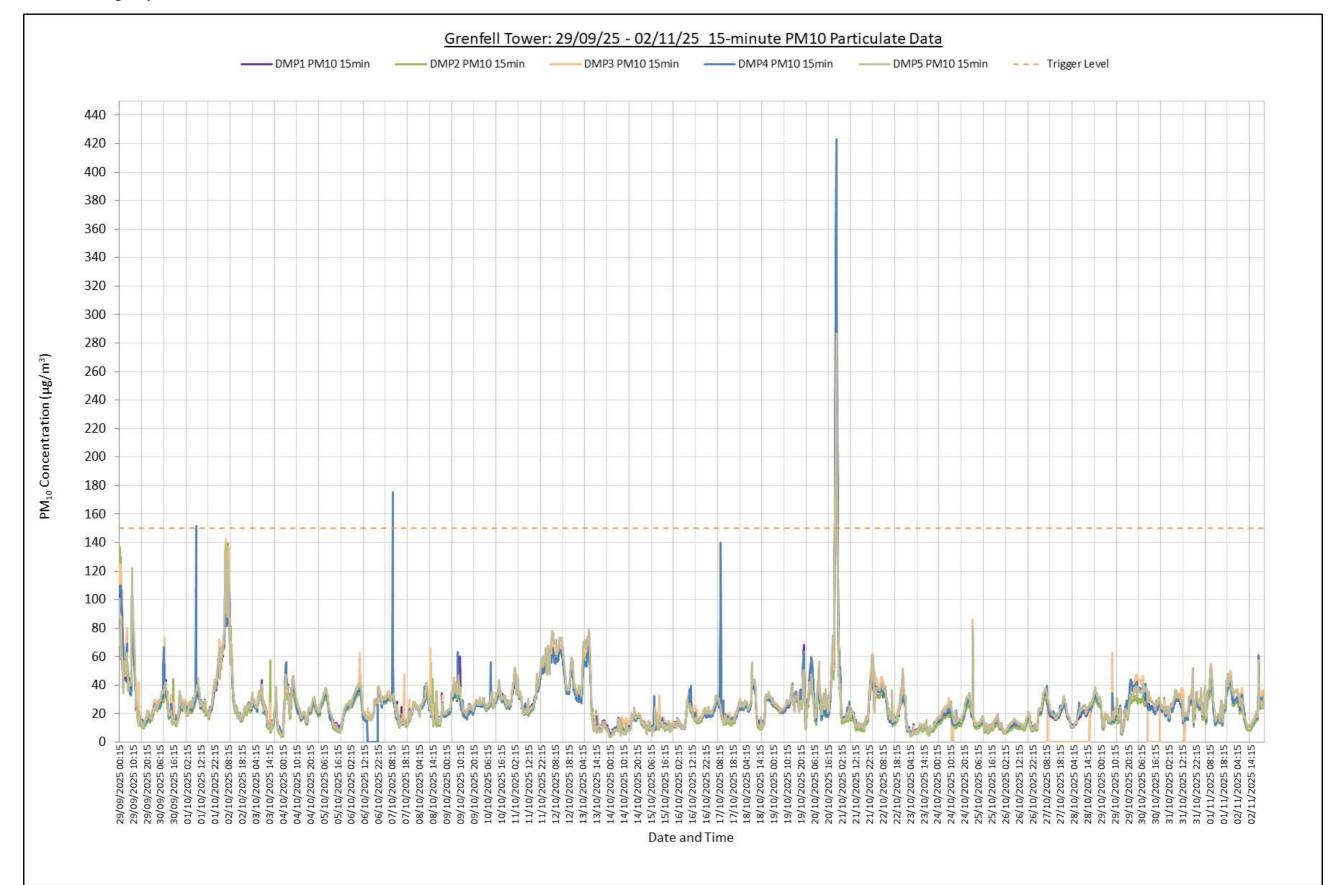
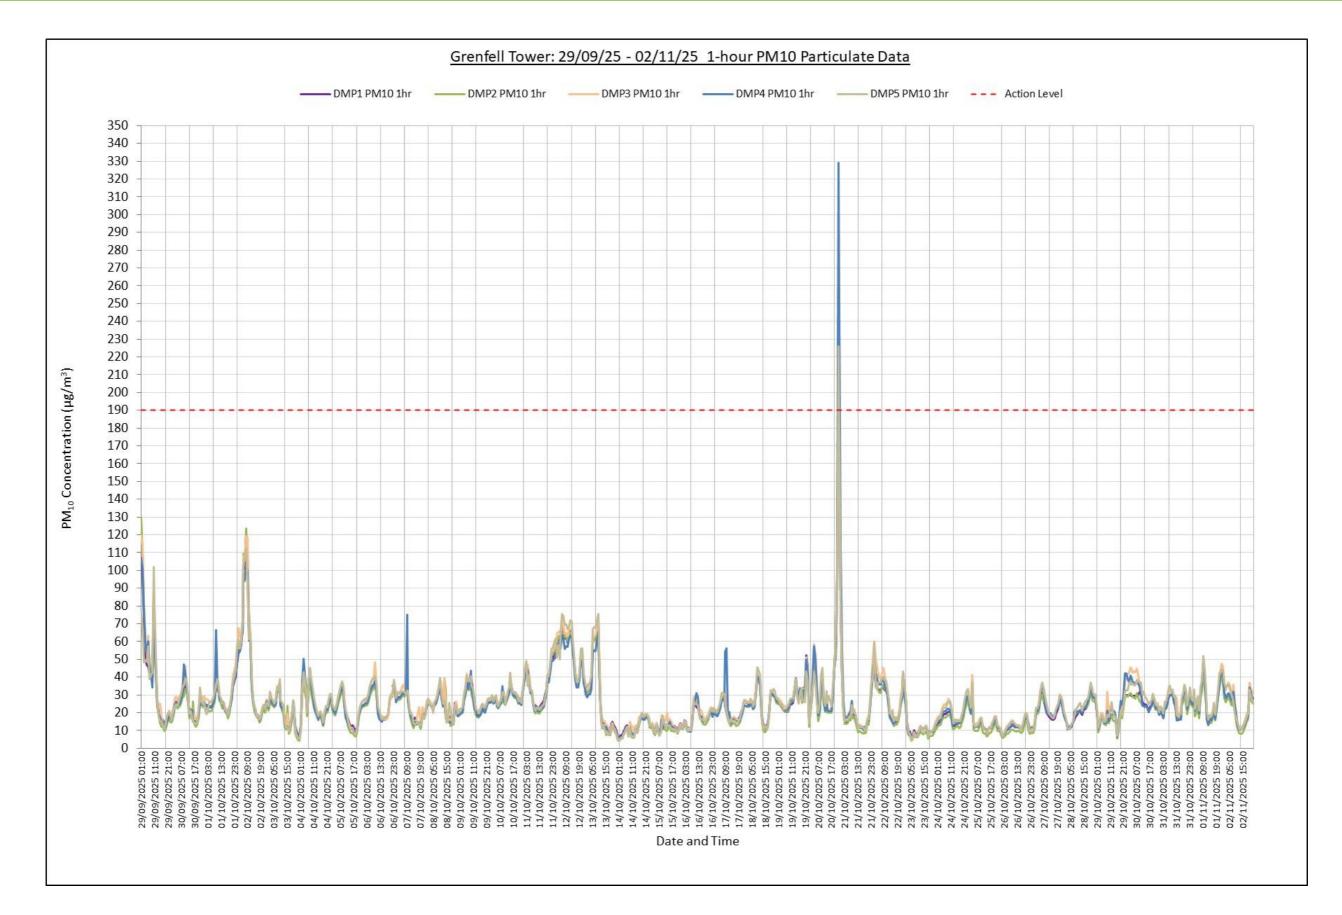
7. PM₁₀ Dust Monitoring Graphs

All Amber and Red exceedances this month were between 21:00 – 8:45 and as such are either:

- Due to the high humidity readings, and similar exceedances from all monitors. It is very likely that these exceedances were <u>caused</u> by <u>fine rain/misty weather</u> and are not representative of any site works, or;
- Due to the time of these exceedances occur, the date being 20th October and similar exceedances being shown from all monitors, these are most likely <u>caused by fireworks from Diwali celebrations</u> in the area.
- At DMP4 exceedance at 08:45 on 07 October 2025, due to Vehicle idling, site mitigation advice was to
 instruct any vehicles awaiting security instruction near monitoring location to turn engines off to reduce
 emissions being recorded by said monitor.

The results of the Dust measurements in this period are presented graphically for PM_{10} and $PM_{2.5}$ in Sections 7 and 8 respectively of this report.
