**Castle House, Bristol**

**Preliminary Bat Roost Assessment**

AE616  
Revision: 1  
August 2025

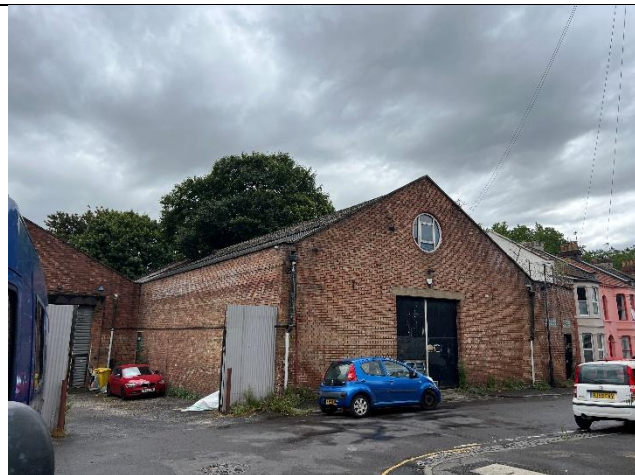
A1 Main elevation. Crevices in brickwork are around the white downpipe seen to the left of the main doors

Therefore, inspection of these crevices must be repeated with an endoscope immediately (no more than 48 hours) prior to building works commencing. The south façade of the rear boundary wall with Gaunt's Ham Park had crevices in the stonework which could be suitable for winter roosting bats, but with no evidence of use found. If these crevices will be repointed, a pre-commencement inspection of these features will also need to be completed.

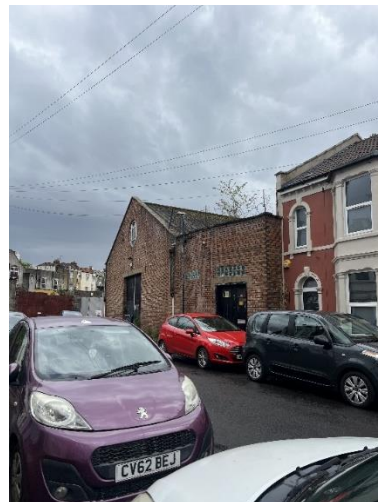
A2 Main elevation showing streetlighting, and parapet wall on roof

Even though there is nearby lighting, best practice should be followed including designing lighting sensitively in accordance with *Bats and Artificial Lighting at Night* (ILP, 2023) to avoid any impacts on nearby potential bat habitat. External lighting must only be used where absolutely necessary. Features such as PIR sensors or short-duration timers and wall mounted, bollard and/or downward-facing lights should be used for external lights. Floodlighting should be avoided.

No evidence of nesting birds was found. However, there were features with potential for nesting that could not be fully seen from the ground, specifically the parapet walls and hoppers. If works commence during main bird nesting season (i.e. commence during March to August inclusive), a pre-commencement nesting bird check will need to be completed no more than 48 hours before roofing or building demolition works commence. If any active bird nests are unexpectedly found, all works must cease and an ecologist must be contacted for advice. The nest would need to be left undisturbed until chicks have fledged. This can take up to six weeks.

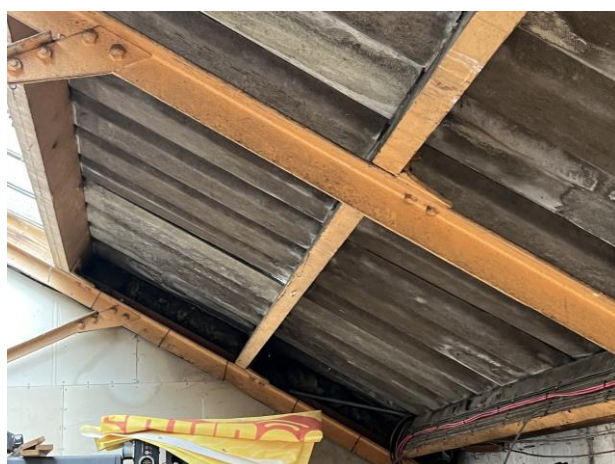
A4 Internal roof structure and roof in good condition

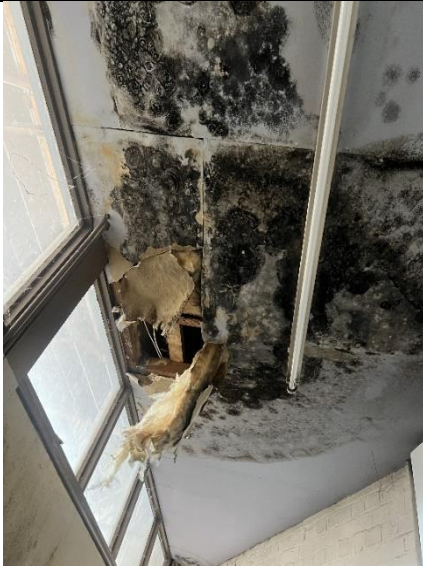
A5 One of the internal rooms with plyboarded ceiling and a hole. This room is lit by daylight and no bat access to be seen.

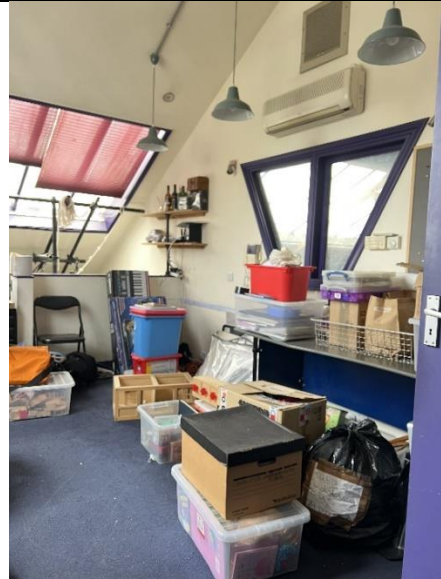
A6 Loft space that has been boarded. Windows and no bat access could be seen

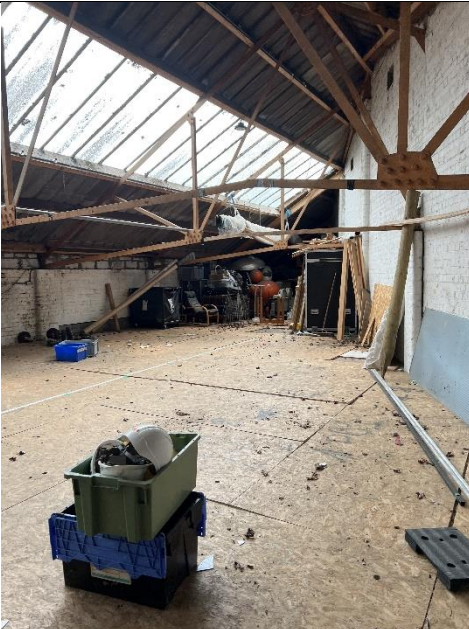
A7 Mezzanine level allowed good access to inspect roof internally. No evidence or access points seen.

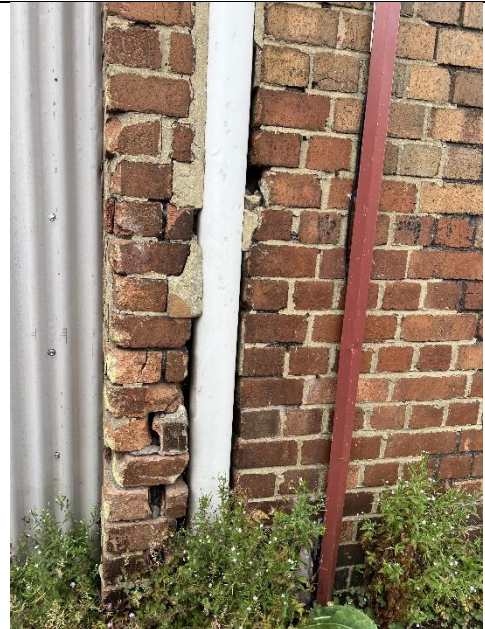
Externally, the brickwork is largely in good condition, with intact and sealed mortar. Small buddleia *Buddleja davidii* and maidenhair spleenwort *Asplenium trichomanes* are growing out of cracks on the front (west) elevation but have not damaged the brickwork. There is a downpipe to the left of main door which had some cracks and crevices progressing to approximately 15cm. These have negligible potential to support summer roosting bats due to being unlikely to hold a stable warm temperature, but they have low potential to support hibernating bats. No evidence of roosting bats was found during an inspection with an endoscope. There is a security light and streetlights illuminating the front (west) of the building which further reduces the potential to roosting bats to be present.

A8 Downpipe to the left of main door had some cracks and crevices

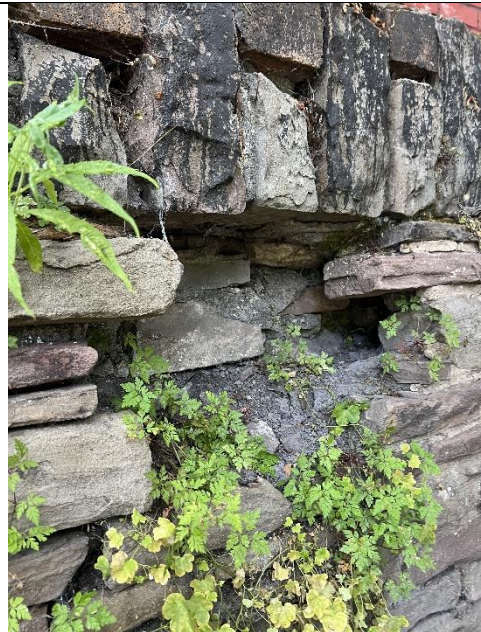
To the rear, the site is adjacent to Gaunt's Ham Park, a typical urban playground and park. A large stone wall defines the boundary. There are occasional, mostly shallow (less than 10cm deep) gaps in the stone wall. Although these are unlikely to support summer roosting bats due to lack of stable warm temperatures, but there is a low risk of use by hibernating bats. No evidence of use by bats was found during inspection using torches or endoscopes. Two mature sycamore trees are within 50cm of this wall.

A10 Some crevices in the stone wall adjacent to Gaunt's Ham Park

There is no suitable habitat at present for other mammal species. However, if the wall adjacent to Gaunt's Ham Park is removed entirely or in part during works, then on-site excavations must be covered overnight or fitted with escape ramps suitable for use by species such as badger and hedgehog.

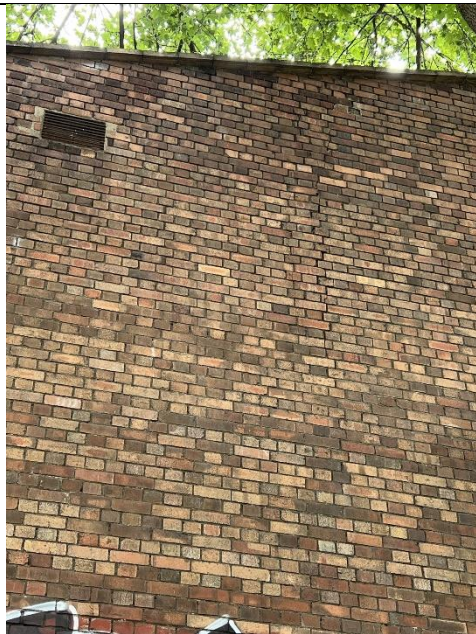
panels. The warehouse is internally subdivided into different rooms, most of which are lit by windows or perspex panels to the exterior. Some of the rooms are sealed from others by closed and sealed doors. No bat access points could be seen. All wall vents were fitted with a grill, which would prevent bats from entering internal areas of the building.

A11 Grill internally covered the air vents to prevent bat access. The crack in the brickwork offers future potential for bats if it enlarges.
