## Coal Mining Risk Assessment

265 Church Road

Report Ref: B4664/25/1

**MCGOWAN HAYES PROPERTY LTD**

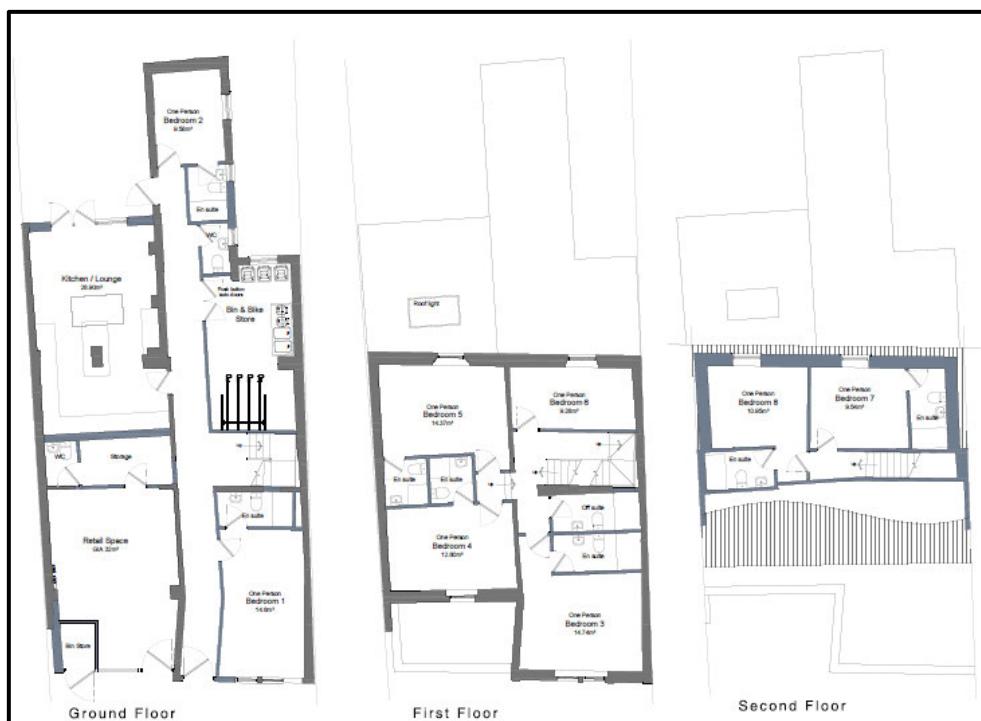
**Figure 1 – Proposed Development Floor Plan**

- 1.3 It is proposed to renovate the existing building into an 8 bedroom dwelling with retail space at the front of the property. It is understood no new buildings will be constructed.
- 1.4 Details of the proposed development are shown in Figure 1 below.

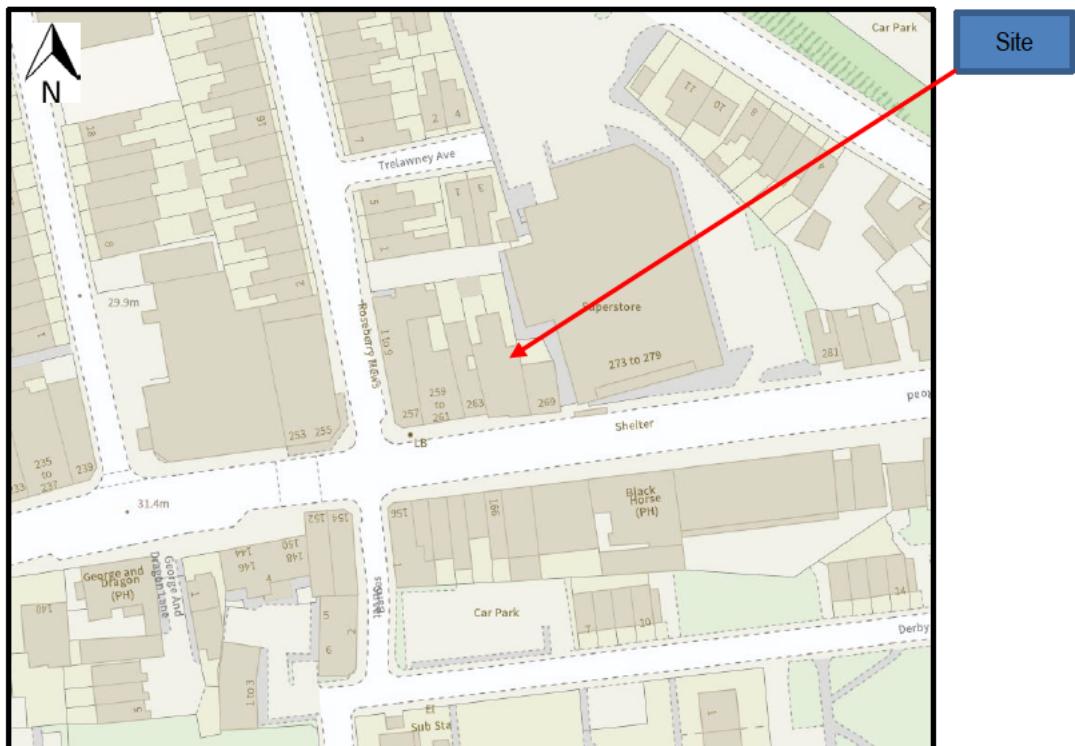
**Figure 2 – Site Location Plan**

- 2.1 The site is located at 265-267 Church Road (A420), Redfield in Bristol at National Grid Reference 361698, 173555 and with a nearest post code of BS5 9HT.
- 2.2 The site location is shown in Figure 2 below.

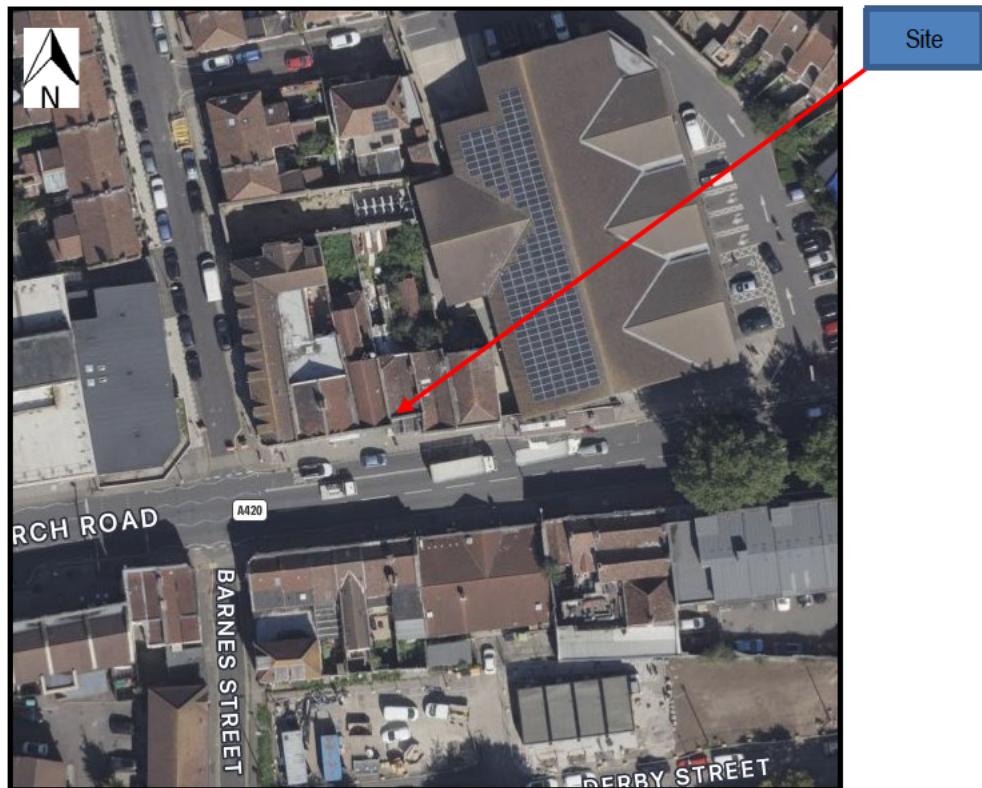
Figure 3 – Aerial Photograph Showing Site Location and Surrounding Area

- 2.3 The site is located in a residential area and is bounded on all sides by houses and associated gardens. There is an Aldi store 10m east and a Tesco store 50m west.
- 2.4 The site is mix use residential and commercial space with a small commercial unit at the front of the property and residential space on the first floor. At the time of writing this report, it is not known if there are any occupants within the building. The commercial space appears to be disused.
- 2.5 The site and surrounding area are shown in Figure 3 overleaf.

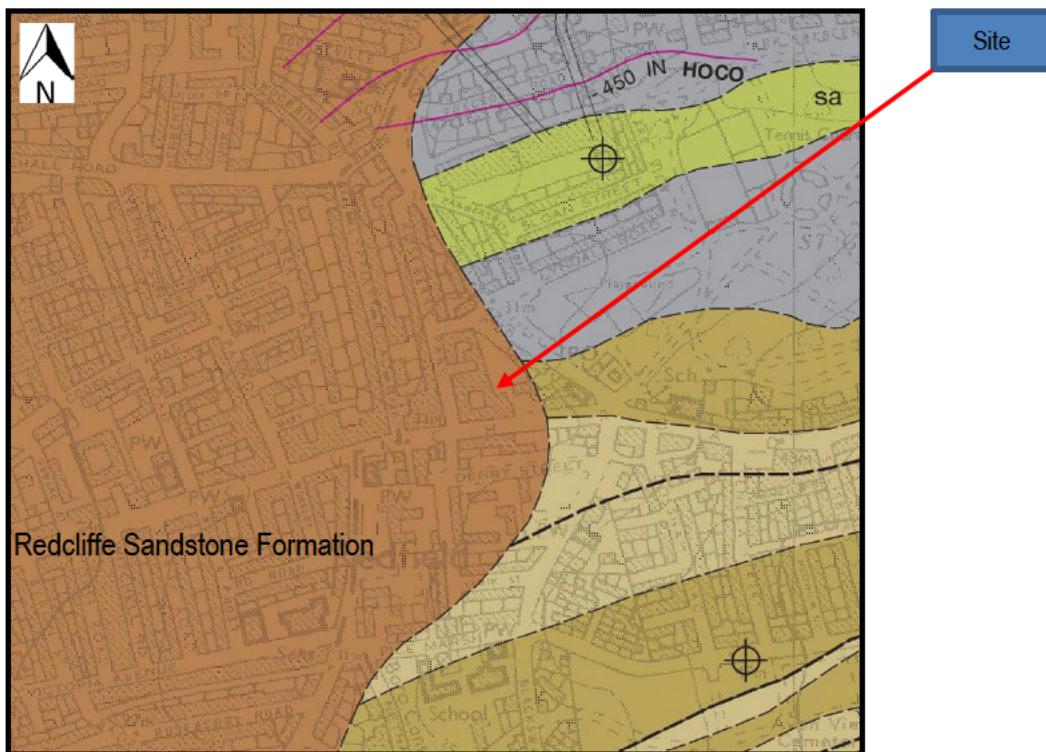
**Figure 4 – Geological Map Extract**

- 3.1 The geology of the site has been determined from acquisition of geological maps for the area and examination of Coal Authority records.
- 3.2 The British Geological Survey (BGS) map and online maps shows that the site is not located on or near an area of infilled land.
- 3.3 The BGS suggests the site is not underlain by superficial or made ground. The bedrock geology beneath the site is the Redcliffe Sandstone Member of Triassic Period, described as distinctive fine to medium grained, deep red, calcareous and ferruginous sandstone, commonly decalcified at shallow depths below the surface, giving rise to an uncemented sand.
- 3.4 The Redcliffe Sandstone lies unconformably over Coal Measures strata.

- 3.5 An historical BGS borehole record (BGS ref: ST67SW456) is noted 43m southeast of the site and is situated within the Redcliffe Sandstone Member of Triassic Period. The record is for a discovered well that had been capped with a natural stone and discovered when excavating a slip trench. The approximate dimensions are 700-800mm in diameter and 5500mm depth.

Two historical BGS borehole records, located 93m northwest (BGS ref. ST67SW87) and 96m north-northwest (BGS ref. ST67SW88) show Redcliffe sandstone, thickness 3-5m overlying Coal Measures strata with evidence of coal at approximately 13.4mbgl and 17.4mbgl respectively.

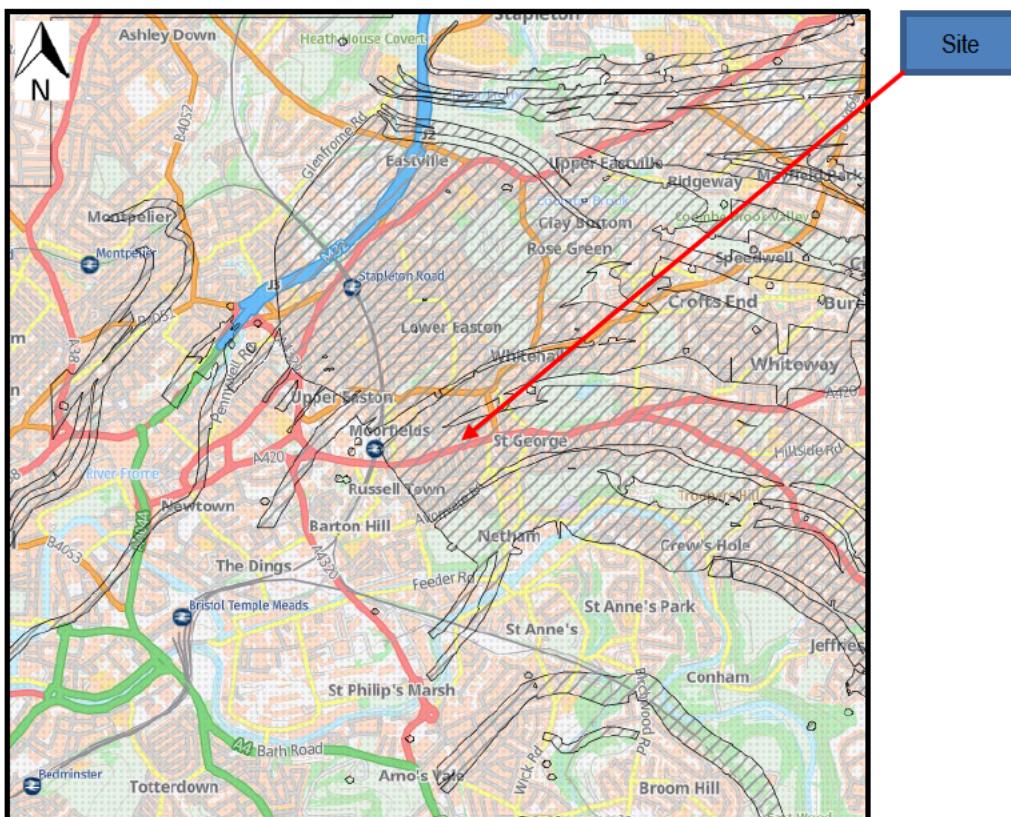
**Figure 5 – Plan Showing Site Within the Development High Risk (Hatched) Area**

- 3.7 A Coal Authority Mining Report has been acquired for the site and is included in Appendix 1.
- 3.8 The Report indicates there are 17 records of past underground mining beneath the site, the shallowest of which is at 75m depth, the Garden Course coal seam, dipping 41.2° to the southeast with an extraction thickness of 1.2m, last worked in 1900.
- 3.9 The Coal Authority Report indicates the site is underlain by probable unrecorded shallow depth workings.
- 3.10 Examination of the Coal Authority online interactive map viewer indicates the site is located within a Development High Risk Area (DHRA) associated with unrecorded shallow workings.

- 4.8 The site is located within a Development High Risk Area, associated with unrecorded shallow depth mine workings, which could potentially influence development at surface, depending on depth and size. However, the geology beneath the site indicates Coal Measures (and any potential seam workings) are likely to be at depth beneath the Redcliffe Sandstone, which lies unconformably over the Coal Measures.
