Thames Field

Decommissioning Programmes (Installation & Pipeline) Close Out Report

PUK DOCUMENT No: PER-SNS-DECOM-THA-009

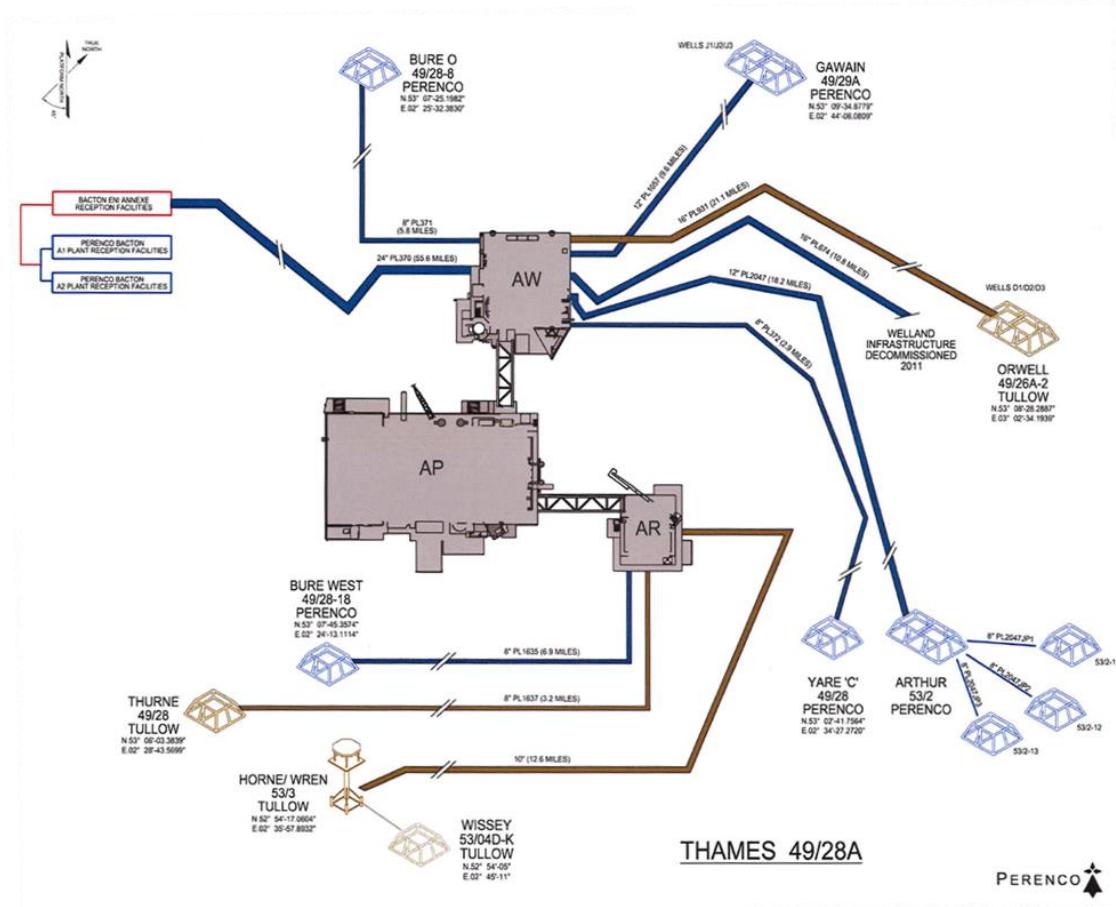
Figure 1.3a: Installation Schematic

Figures 1.3(a) - 1.3(e) are schematics of the Thames Complex Installations being decommissioned.

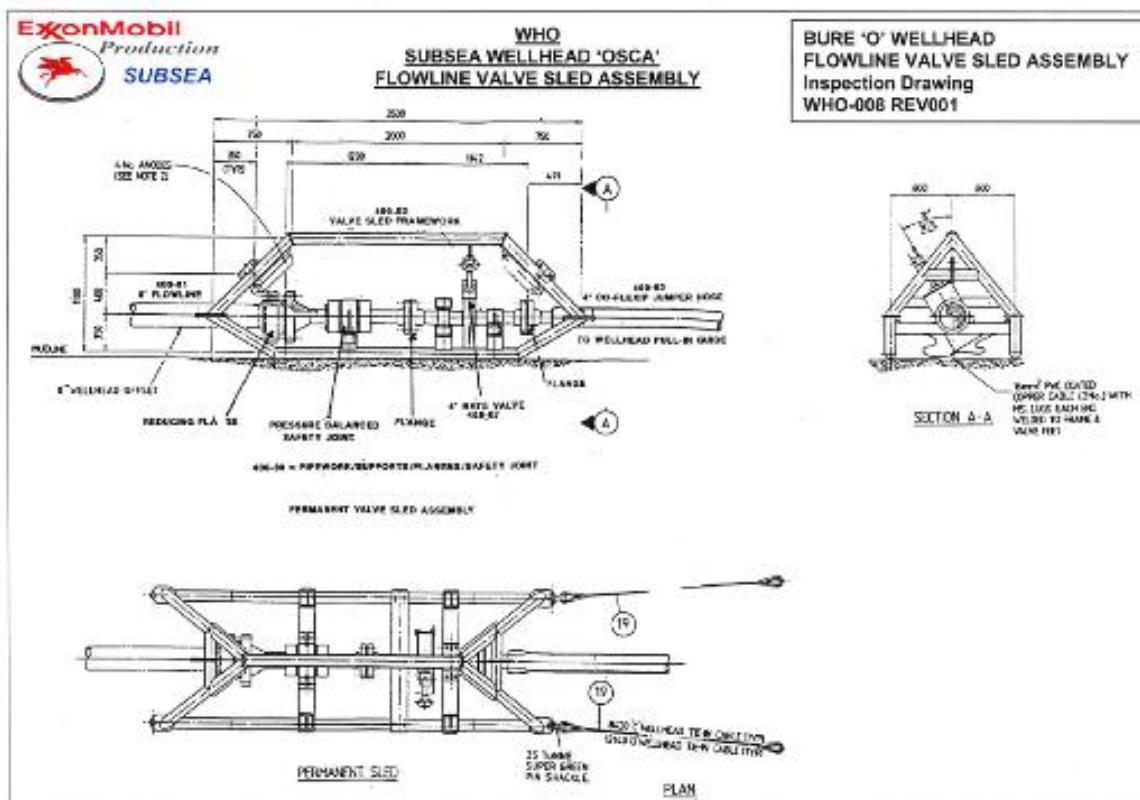
Figure 2.1 – PLET ‘Sled’ Assembly

During the campaign in Q3 2019 to undertake the removal of the subsea wellheads, it was identified that the Bure O PLET assembly had not been removed (ref. Figure 2.1). The Bure O PLET assembly was removed in Q3 2020. An ROV as-found survey was unable to locate the Yare C PLET and the Bure W PLET. It was assumed that they were buried below the seabed, so have been left in-situ.

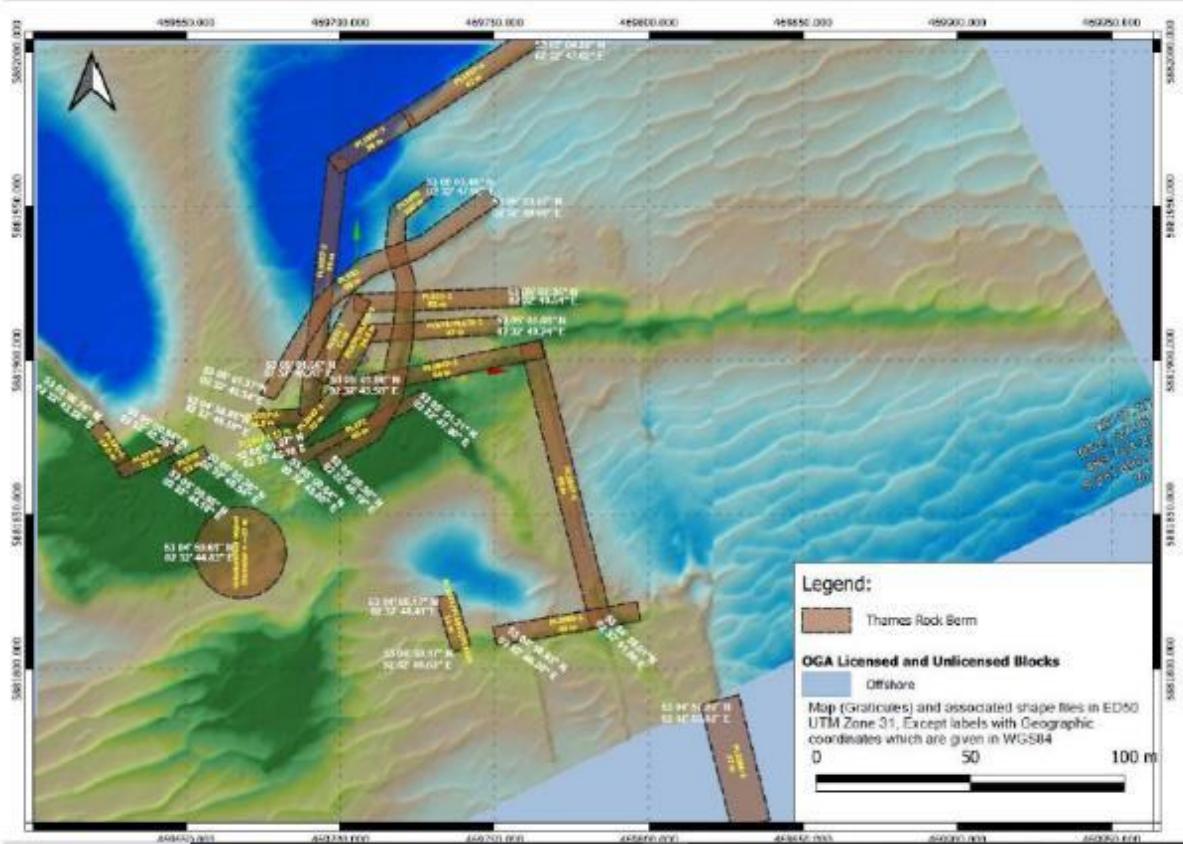
Figure 2.2 – Rock placement Thames Complex Area post-remediation

The pre-decommissioning survey carried out in 2016 before the removal of the Thames platforms identified several exposed pipeline sections within the former Thames Safety Zone. In 2021, a post-decommissioning survey of the Thames Complex Area identified that the pipelines and cut pipeline ends within the Thames 500m Safety Zone remained exposed and presented a significant snagging hazard for fishermen.

The conclusion on comparing the two survey datasets, (which are 5 years apart), was that seabed movement in the Thames Complex area had not changed significantly and that natural remediation in the short to medium term was unlikely. As there was no Safety Zone in place, PUK were unable to justify waiting for natural infill as a remediation method and alternative remediation methods were required in the short term to mitigate the known snagging hazards. PUK requested that the Safety Zone be reinstated. However, as the installation had already been removed, the HSE advised that the current regulation would not allow for the reinstatement of the Safety Zone.

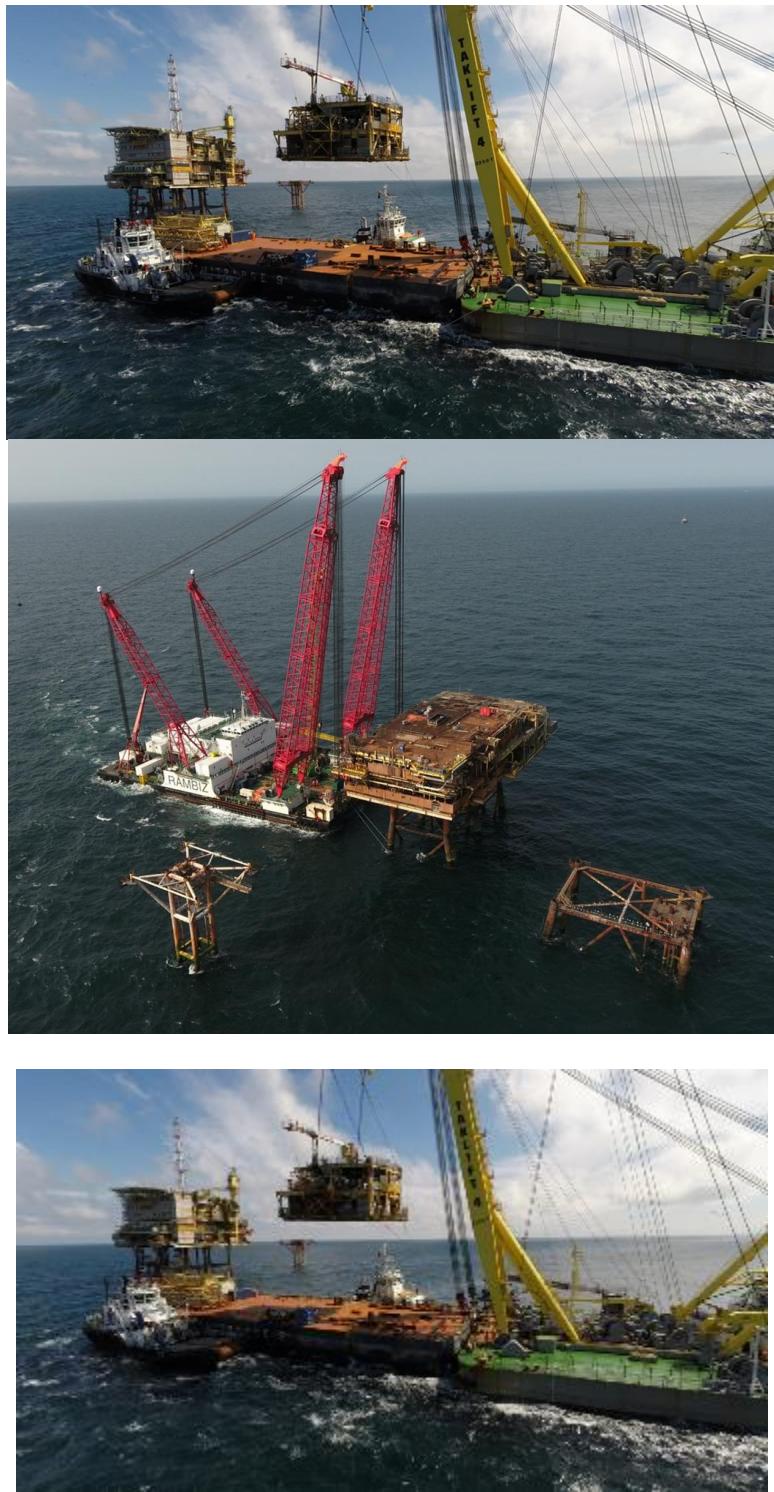
Figure 8.1 – Removal of Thames Complex Topsides

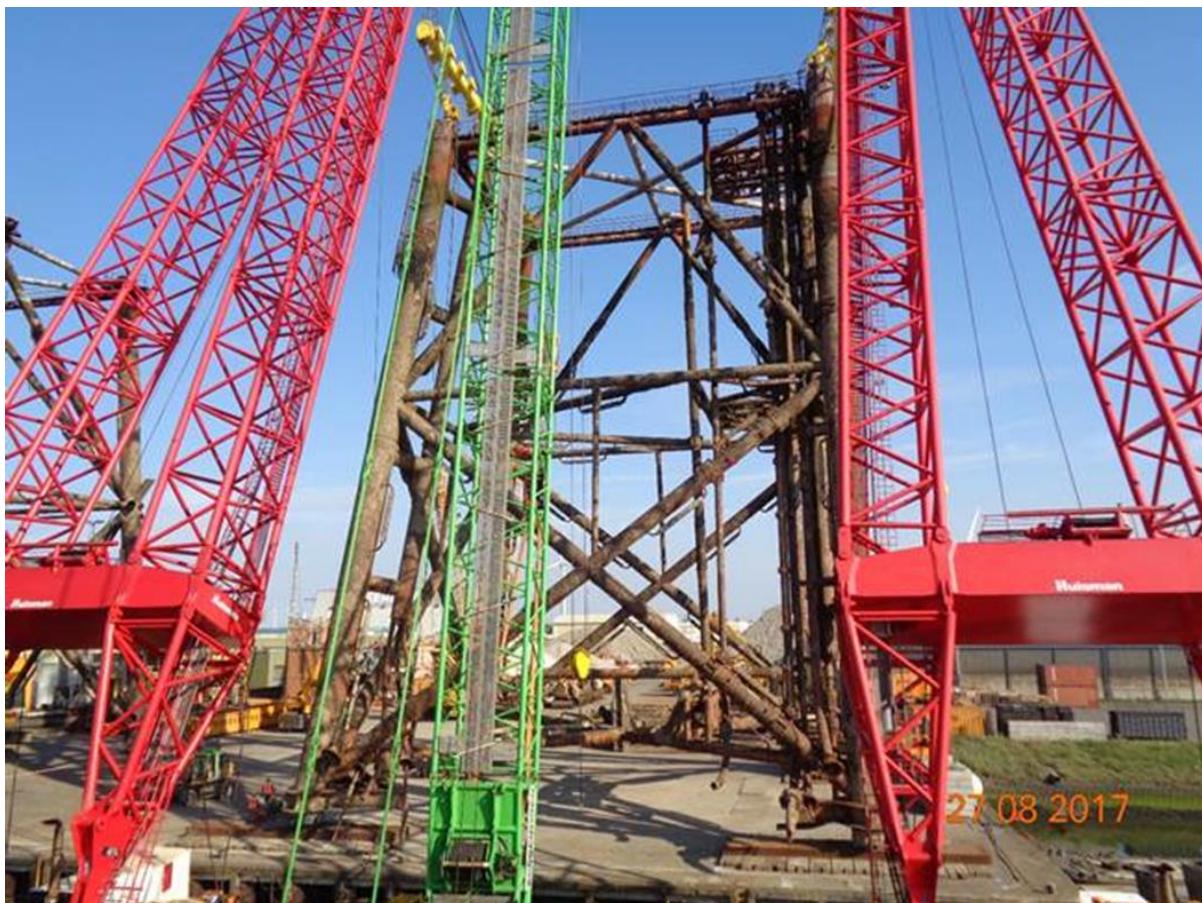
Figure 8.2 – AW Jacket set down at Hoondert disposal yard, Netherlands

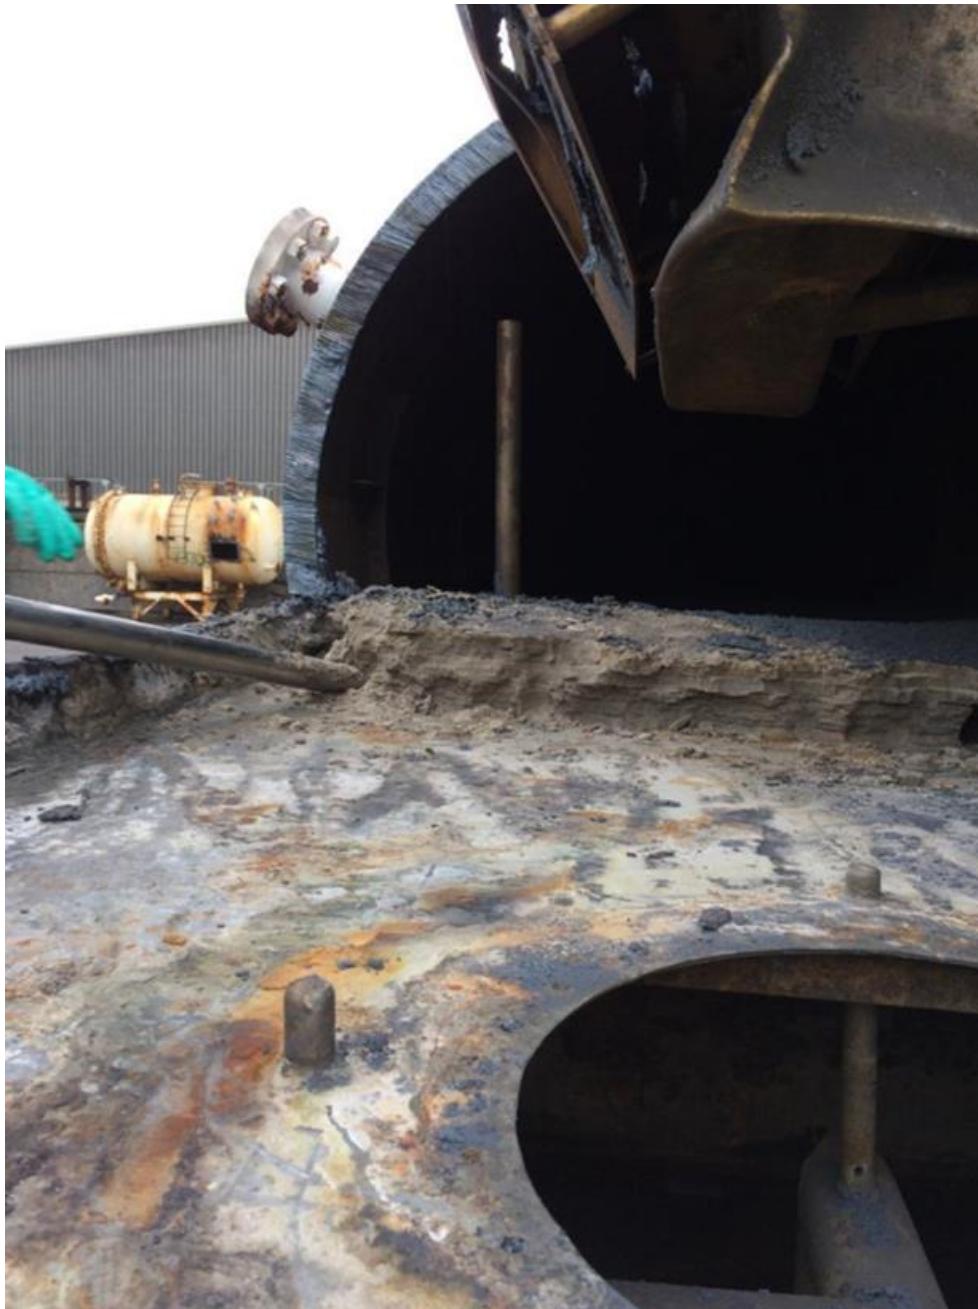
Figure 8.3 – Removal of NORM contaminated sand from Thames process vessel at Hoondert Yard

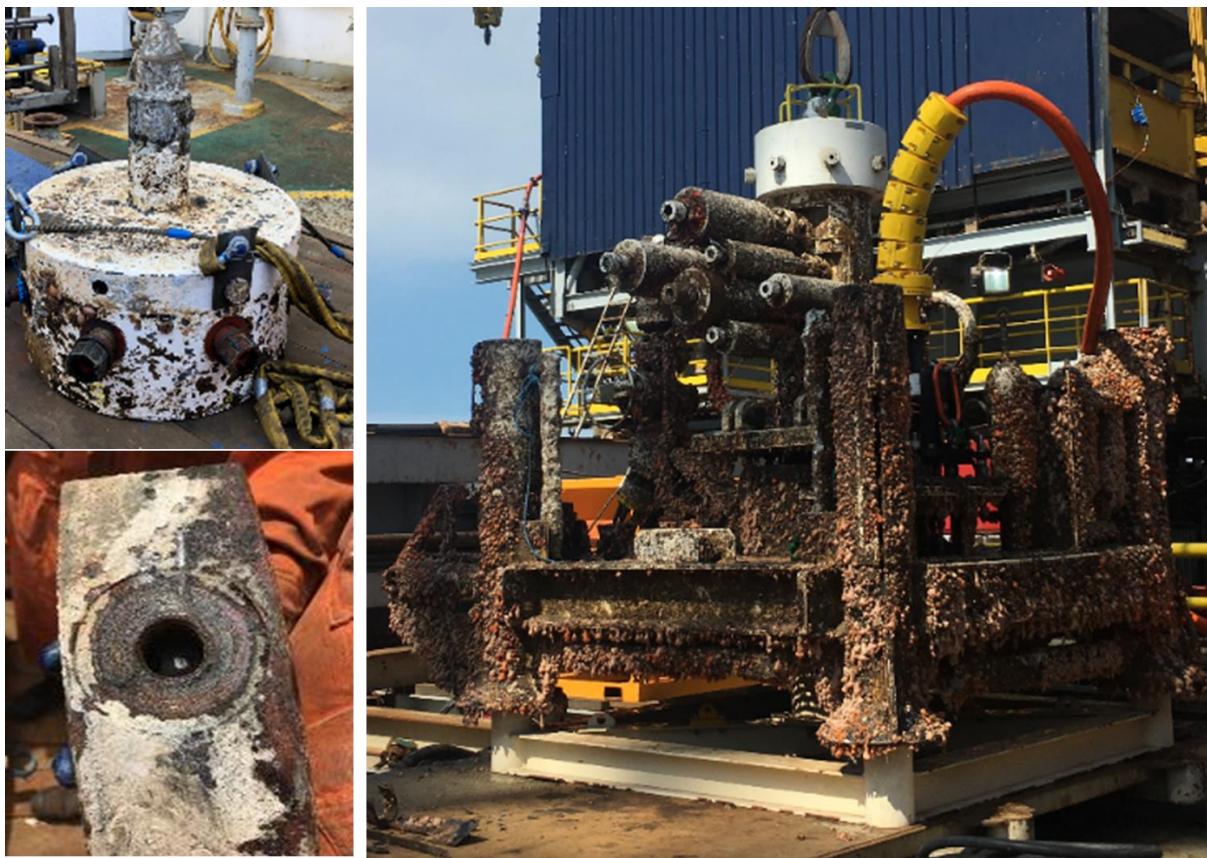
Figure 8.4 – Removal of Bure Oscar subsea wellhead onto barge

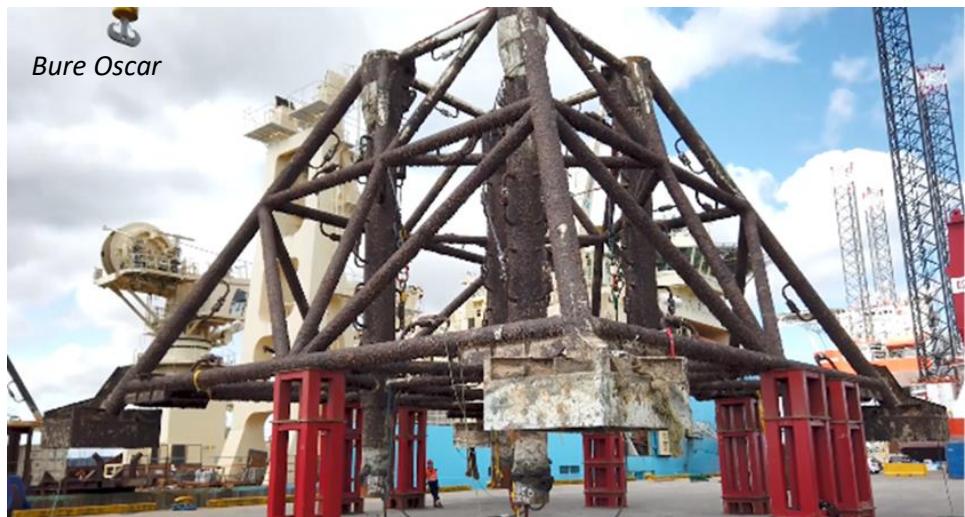
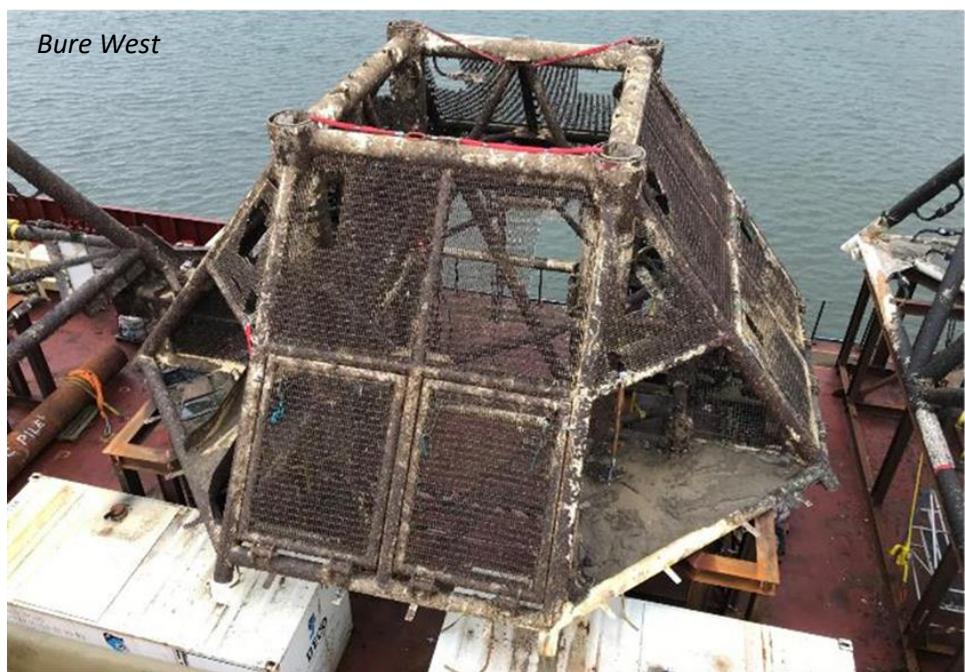
Figure 8.5 – Set-down of Bure Oscar subsea protective at Port Blythe yard & Removal of Bure W subsea protective cage onto the barge.

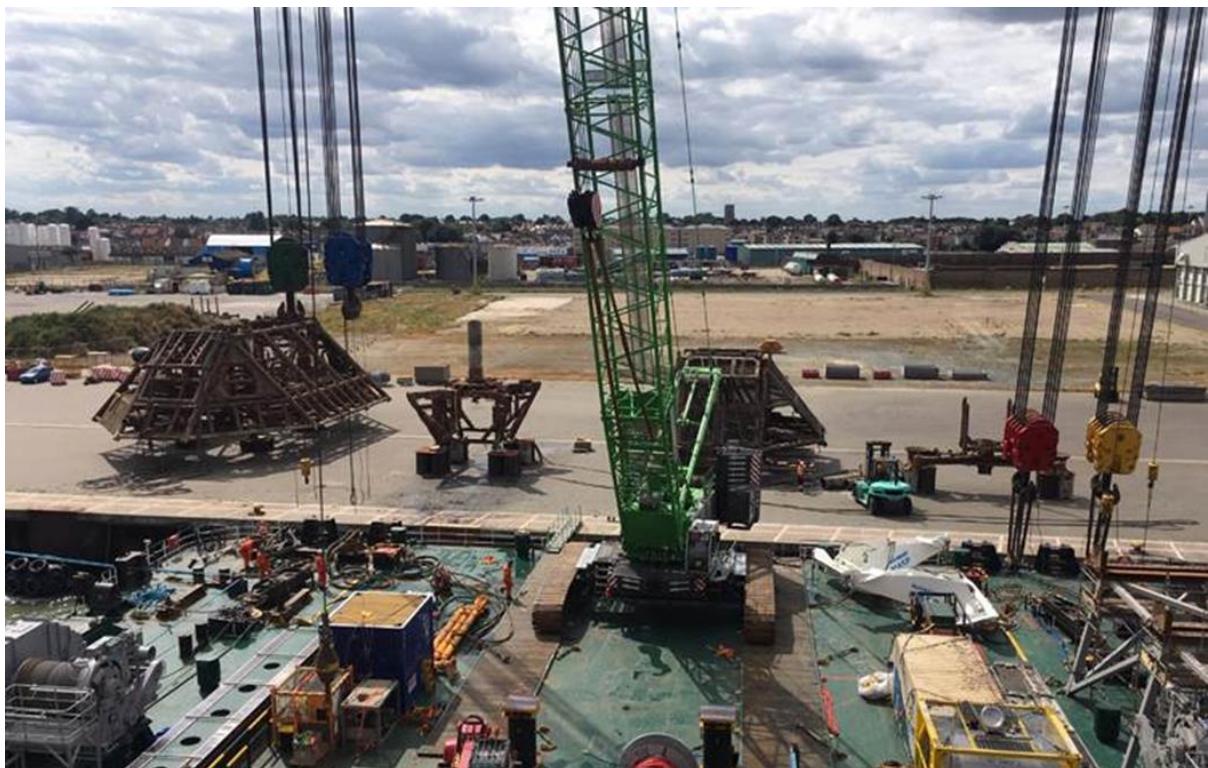
Figure 8.6 – Set down of Thurne WHPS structure (behind crane) on the quayside at GY Veolia yard.
